Christophe Chevalier, Frédérique Larrarte, Hugues Chollet, Franziska Schmidt, Mohamed Belmokhtar, et al.. Scour monitoring on bridge pier: two French returns on experience. 11th International Conference on Scour and Erosion, Sep 2023, Copenhagen, Denmark. hal-04413932

Scour monitoring on bridge pier: two French returns on experience

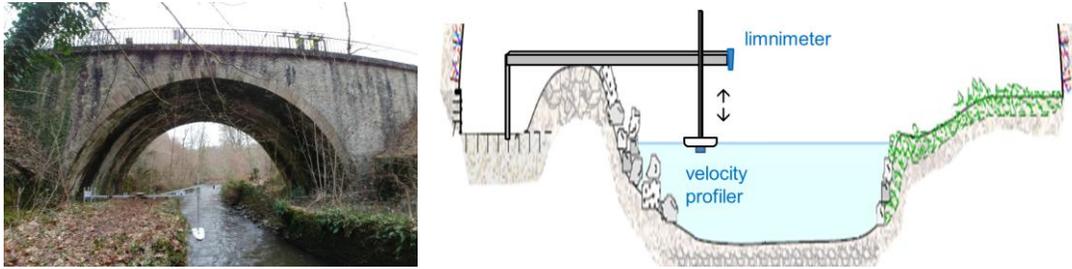
Figure 1. Site of the bridge over the Aurence River near Limoges (France): (left) view of the instrumented site and (right) scheme of the instrumentation (Chevalier et al. 2021).

Aurence bridge. The first site to be instrumented was the SNCF rail bridge over the Aurence river at Isle near Limoges (Haute Vienne department, France). It is a masonry arch structure characteristic of the secondary rail network located on the Limoges-Angoulême line (Fig. 1). This site is affected by scouring near the left abutment. The masonry abutment is partially collapsed and numerous blocks in the river bed have been found. At the foot of the abutment, a scour hole of 1.7m in length and 0.5m in depth was measured. A bathymetric survey by Cerema/LR Blois confirmed that an eroded area exists under the bridge with an even deeper section on the upper side of the river. It was decided to locate the sensors in this area.

The complete installed set-up is shown in Figure 1. It is composed of:

- an Ijinus LNU06V3-82-3G water level meter to measure the water level,
- a Ubertone UBF156 Ub-flow ultrasonic profilometer mounted on a vertically movable board to measure velocity profile and water depth,

- a HIK Vision 4 MP WDR camera to monitor the test device,
- an acquisition and transmission box powered by 2 solar panels.

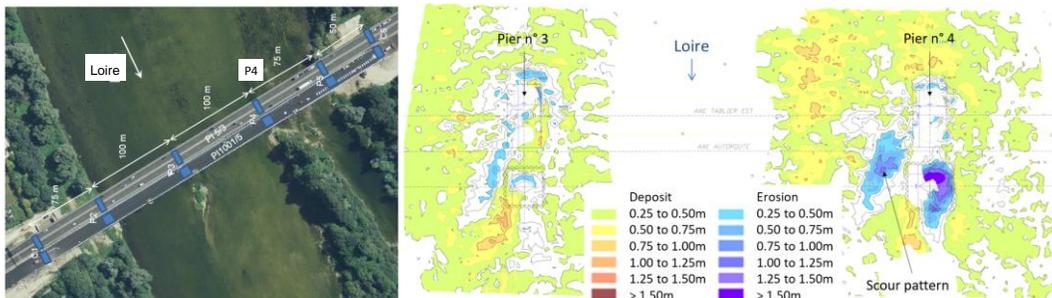
Figure 2. A71 motorway double viaduct in Orléans (France) over Loire river: (left) aerial view of the bridge and (right) bathymetric surveys comparison between January 2018 and May 2016 (Chevalier et al. 2021).

A71 viaduct. The A71 motorway viaduct (Cofiroute) over the Loire at Orléans (Loiret department, France) was the second site instrumented. As shown in Figure 2, the bridge is approximately 400 m long and rests on 6 supports, 4 piers located in the river bed (noted P2 to P5 from the right bank to the left bank) and two abutments (C1 and C6).

Cerema/LR in Blois has a long-standing partnership with the motorway company Vinci Autoroutes/Cofiroute, which manages the structure, and has been assessing scour on various bridges for many years. SONAR bathymetry was carried out in 1993, 2004, 2011, 2016 and 2018 showing active erosion/deposition sites, particularly on the left of the support of pier P4 as shown in Figure 2. It is this area that was therefore decided to monitor.

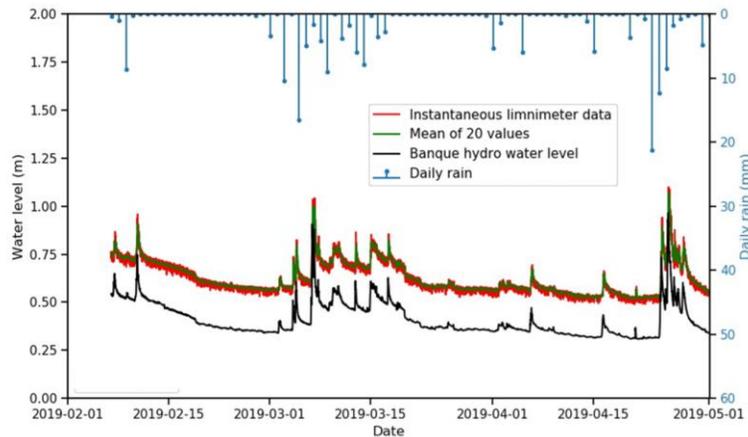
Figure 3. Monitoring of water levels and rainfall over 3 months at Aurence Bridge.

Water and sediment levels. Figure 3 shows the water level results (defined to a constant, chosen so that, at the start of monitoring, the water level is equal to the water height measured by the Ub-flow profilometer) obtained over 3 months with the Ijinus water level meter. They are in very good agreement with the data of the hydrometric measurement station of the “Hydro bank” system (<https://hydro.eaufrance.fr/>) located approximately 2km upstream. We can also observe a very good agreement between the rainfall at the site and the water levels observed: the Aurence river is a small and very reactive river.

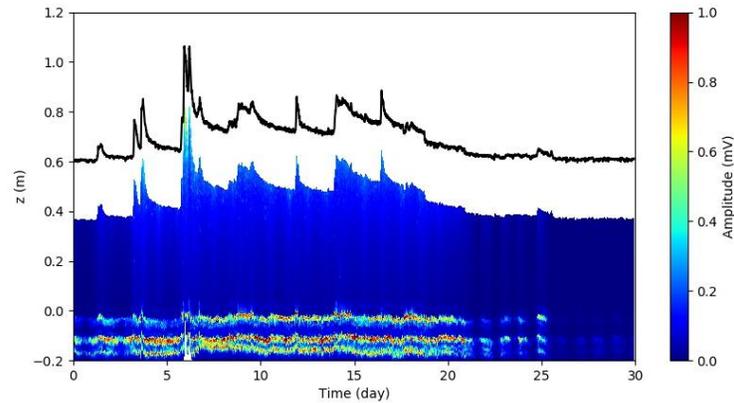
Figure 4. Evolution of the amplitude profile of the Ub-flow backscatter signal in March 2019. The black curve represents the position of the free surface.

The Ub-flow measurements were used to measure both the water height and the velocity profile. Figure 4 shows the profile of the backscattered signal intensity as a function of time at a certain distance from the surface (black curve), over the month of March 2019. High values indicate the presence of an obstacle (a strongly backscattering surface in practice), the first intensity peak is characteristic of the presence of the bottom. The high backscatter values remain at the same level (notably $z=0\text{m}$, corresponding to the sediment bottom). No significant difference (greater than the order of a centimeter) and therefore no erosion was observed over these 30 days as well as over the 9 months of the complete study.

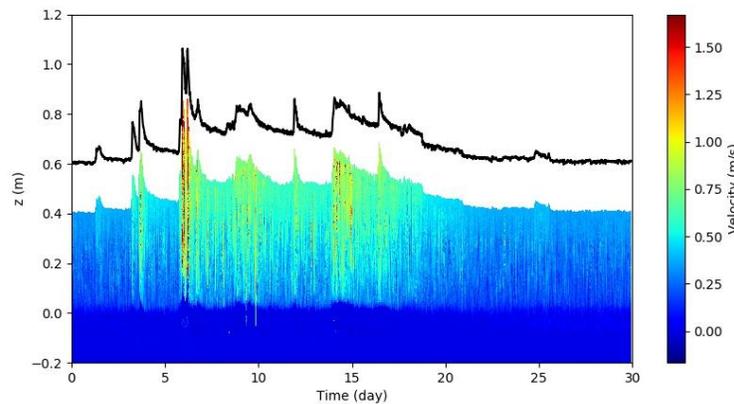
Figure 5. Evolution of the horizontal velocity profile from the Ub-flow in March 2019. The black curve represents the position of the free surface.

Characterisation of the velocity field. Several velocity data are recorded by the Ub-flow according to different configurations (maximum velocity, depth of investigation, average...). Figure 5 shows, as a function of time, the velocity profile (horizontal component in the plane of the Ub-flow) obtained from various configurations of the Ub-flow. This profile is derived from a numerical pre-processing in Python allowing the rectification of signals subjected to Nyquist limits (Fischer 2004, Larrarte et al. 2020).

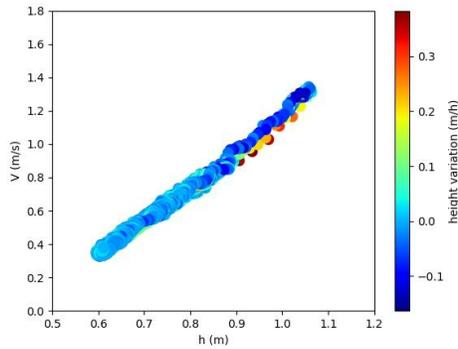
Figure 6. Flow characterization in March 2019: velocity as a function of water level.

Characteristic velocities (close to the surface) can then be deduced. Figure 6 shows the evolution of these velocities for different values of water height. The evolution of the average height is also represented (colour scale). This makes it possible to obtain a characteristic curve of the water course. It should be noted that no notable hysteresis is observed

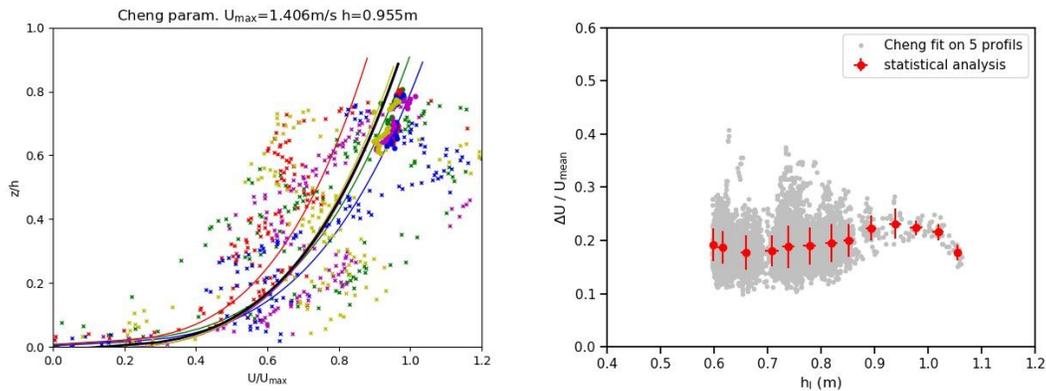
Figure 7. (left) Examples of 5 successive profiles (5 minutes apart) of scaled velocities fitting by a Cheng's law on each profile (coloured curves) or on the whole data (black curve). (right) Evolution of the characteristic deviation from velocity data to the adjustment (Cheng's law on 5 successive profiles) as a function of the water level for the month of March 2019 (all values, mean and standard deviation).

An example of such adjustments is shown in Figure 7. Large fluctuations in measurements are observed both when considering a single profile and between the 5 successive profiles. This is a characteristic of the flow in a real river which is not as controlled as in a

laboratory channel. However, a good fit can be obtained with the equation (1) to evaluate shear rates for example. These measurements allow characterizing the different hydraulic conditions of the river. A statistical analysis can be done on the dispersion of the instantaneous measurements compared to the adjustment. This analysis is represented on Figure 7. It can be identified that the deviation of the speed represents approximately 25% of the average speed, whatever the water level making it possible to characterize the deviation of the instantaneous values of speeds with the averaged profile in real situations.

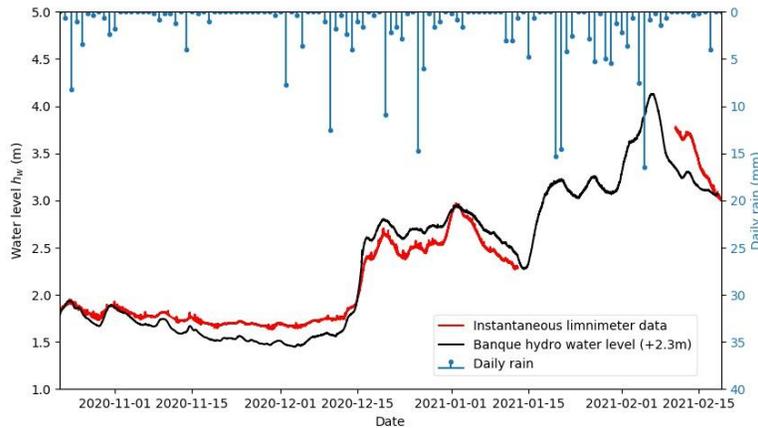
Figure 8. Monitoring of water levels and rainfall over 4 months.

Water and sediment levels. Figure 8 shows the water level results obtained over 4 months with the Valeport VRS water level meter. They are in very good agreement with the data of the hydrometric measurement station of the “Hydro bank” system (<https://hydro.eaufrance.fr/>) located upstream. We can also observe a quite good agreement between the rainfall near the site.

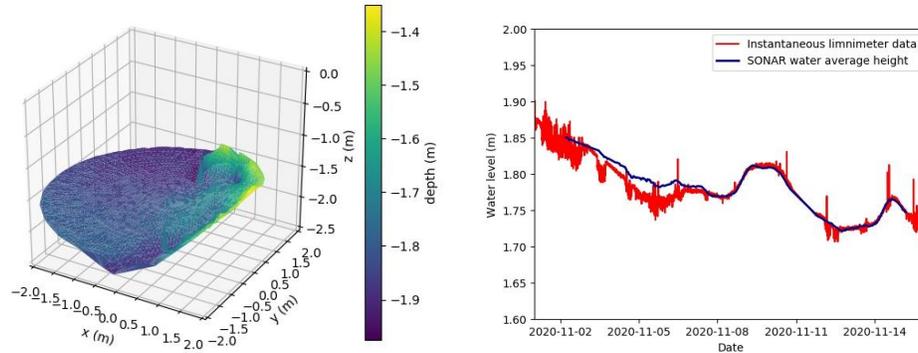
Figure 9. Monitoring of sediment surface by SONAR and comparison between SONAR average water height and Valeport VRS water level over 18 days.

The SONAR takes bathymetric measurements every hour. In contrast to the Aurence monitoring, a significant part of the sediment surface (and not a single point) can be monitored as shown in Figure 9. Beyond the average flow depths that can be evaluated and correlated with the water level measurements, it is therefore possible, with this configuration, to follow the dynamics of the whole scouring pit. However, this requires the implementation of correlation algorithms between the various bathymetric surveys in order to be able, on the one hand, to spatially reposition the data and, on the other hand, to identify the evolutionary zones. A first simple analysis shows that the average water depth evaluated with the SONAR evolves in a coherent way with the water level measured with the Valeport VRS gauge (Fig. 9).

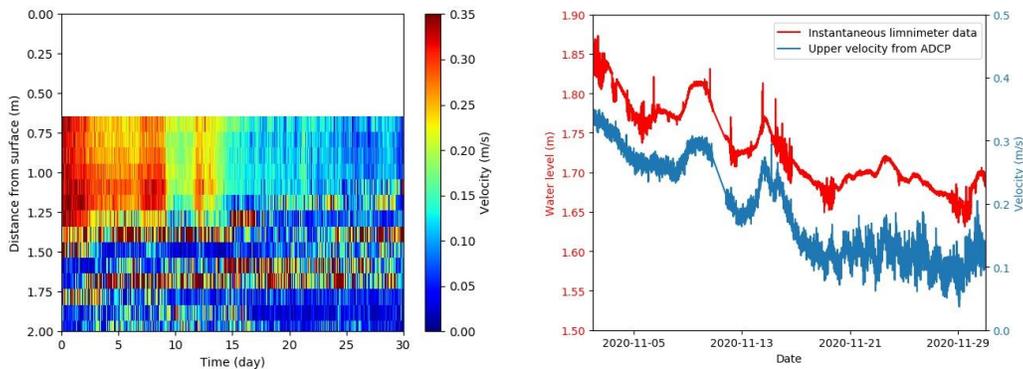
Figure 10. Monitoring of velocity profile and water level and max velocity over 1 month.

Velocity field. Figure 10 presents, over a period of one month, a follow-up of the speeds with the ADCP speed profiler. The upper velocities measured at a distance of between 0.60 and 1.20m from the surface (average of the ADCP measurements) are compared with the water level monitoring. The dynamics of the two data are extremely similar with a decrease during the first

15 days and fluctuations thereafter with an almost stable water level. A more advanced treatment of the data (with taking into account their fluctuation) could thus probably lead to the obtaining of a "taring curve" of the flow as considered in Figure 6 for the case of the instrumentation on the Aurence Bridge.

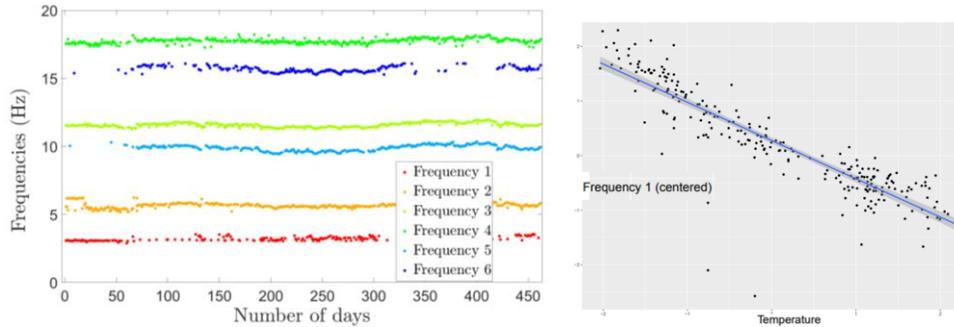
Figure 11. Daily natural frequencies of bridge pier P4 over 1.5 years and example of temperature correlation.

Vibration analysis. Scour assessment using vibration-based monitoring is performed by analyzing the changes in natural frequencies over time. This method has been shown to be feasible through laboratory tests (Bao et al. 2017, Boujia et al. 2020) and offers significant advantages compared to other methods (Wang et al. 2017). In fact, from the response of the bridge piers, the health of the structure can be monitored in real time with global information including a change in boundary conditions such as scour. An inverse method is used to identify the mechanical parameters of the pier through natural frequencies (Shinoda et al, 2008). However, natural frequencies are highly sensitive to environmental factors such as temperature and external excitations (traffic loading and wind essentially). In that way first step is to filtering signals to reduce noise by using correlations between signals (Belmokhtar et al 2022). Then, a correction must be made for temperature effects. Figure 11 plots the daily natural frequencies of bridge pier P4 (Figure 2) over time and includes an example of temperature correction using linear regression. The evolution of natural frequencies can then be studied.

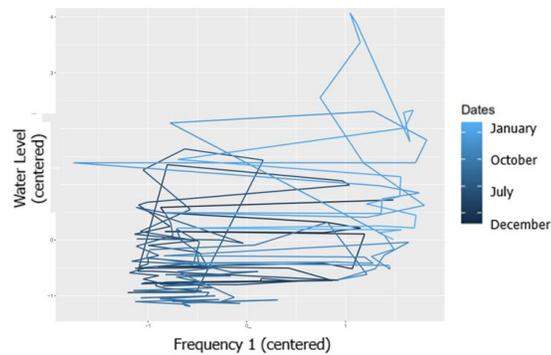
Figure 12. Evolution of the first frequency with water level changes.

As a first attempt to correlate natural frequencies and hydraulics, Figure 12 compares the first frequency with water level changes (data are centered and normalized). Some variations are due to an added mass effect on the structure when the water level increases but no clear correlation is observed. Further research is needed to establish a reliable scour assessment by comparing data to bathymetry evolution.
