Scour monitoring on bridge pier: two French returns on experience

Christophe Chevalier, Frédérique Larrarte, Hugues Chollet, Franziska Schmidt, Mohamed Belmokhtar, et al.. Scour monitoring on bridge pier: two French returns on experience. 11th International Conference on Scour and Erosion, Sep 2023, Copenhagen, Denmark. hal-04413932

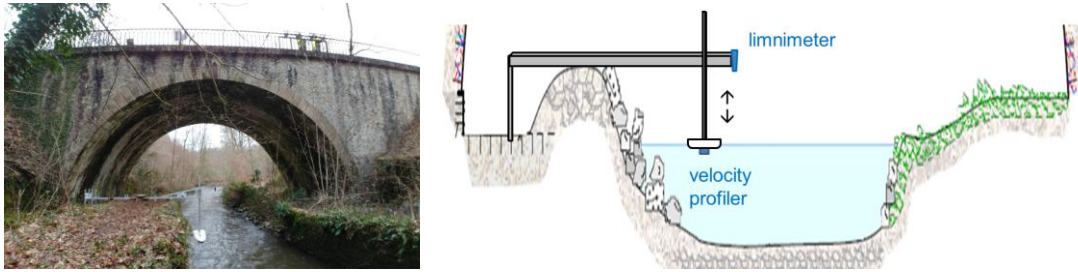
Figure 1. Site of the bridge over the Aurence River near Limoges (France): (left) view of the instrumented site and (right) scheme of the instrumentation (Chevalier et al. 2021).

Aurence bridge. The first site to be instrumented was the SNCF rail bridge over the Aurence river at Isle near Limoges (Haute Vienne department, France). It is a masonry arch structure characteristic of the secondary rail network located on the Limoges-Angoulême line (Fig. 1). This site is affected by scouring near the left abutment. The masonry abutment is partially collapsed and numerous blocks in the river bed have been found. At the foot of the abutment, a scour hole of 1.7m in length and 0.5m in depth was measured. A bathymetric survey by Cerema/LR Blois confirmed that an eroded area exists under the bridge with an even deeper section on the upper side of the river. It was decided to locate the sensors in this area.

The complete installed set-up is shown in Figure 1. It is composed of:

- an Ijinus LNU06V3-82-3G water level meter to measure the water level,
- a Ubertone UBF156 Ub-flow ultrasonic profilometer mounted on a vertically movable board to measure velocity profile and water depth,

- a HIK Vision 4 MP WDR camera to monitor the test device,
- an acquisition and transmission box powered by 2 solar panels.

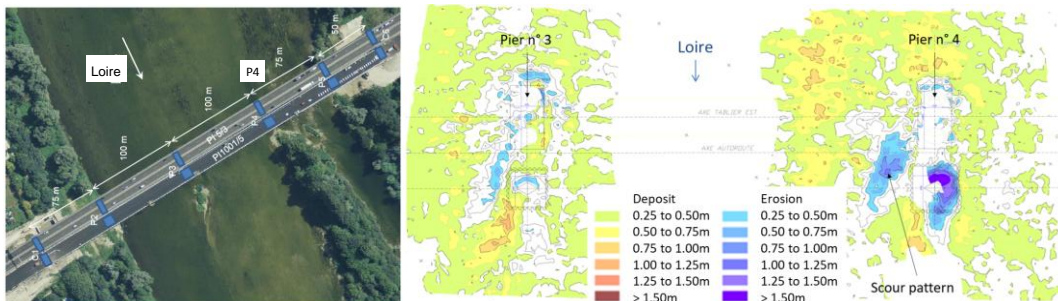
Figure 2. A71 motorway double viaduct in Orléans (France) over Loire river: (left) aerial view of the bridge and (right) bathymetric surveys comparison between January 2018 and May 2016 (Chevalier et al. 2021).

A71 viaduct. The A71 motorway viaduct (Cofiroute) over the Loire at Orléans (Loiret department, France) was the second site instrumented. As shown in Figure 2, the bridge is approximately 400 m long and rests on 6 supports, 4 piers located in the river bed (noted P2 to P5 from the right bank to the left bank) and two abutments (C1 and C6).

Cerema/LR in Blois has a long-standing partnership with the motorway company Vinci Autoroutes/Cofiroute, which manages the structure, and has been assessing scour on various bridges for many years. SONAR bathymetry was carried out in 1993, 2004, 2011, 2016 and 2018 showing active erosion/deposition sites, particularly on the left of the support of pier P4 as shown in Figure 2. It is this area that was therefore decided to monitor.

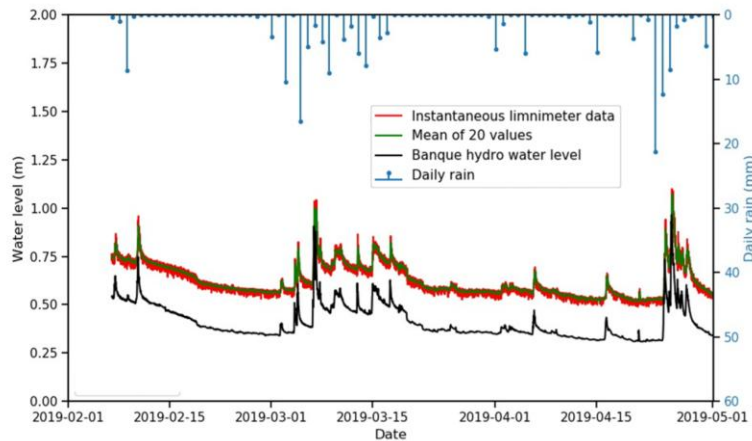
Figure 3. Monitoring of water levels and rainfall over 3 months at Aurence Bridge.

Water and sediment levels. Figure 3 shows the water level results (defined to a constant, chosen so that, at the start of monitoring, the water level is equal to the water height measured by the Ub-flow profilometer) obtained over 3 months with the Ijinus water level meter. They are in very good agreement with the data of the hydrometric measurement station of the “Hydro bank” system (<https://hydro.eaufrance.fr/>) located approximately 2km upstream. We can also observe a very good agreement between the rainfall at the site and the water levels observed: the Aurence river is a small and very reactive river.

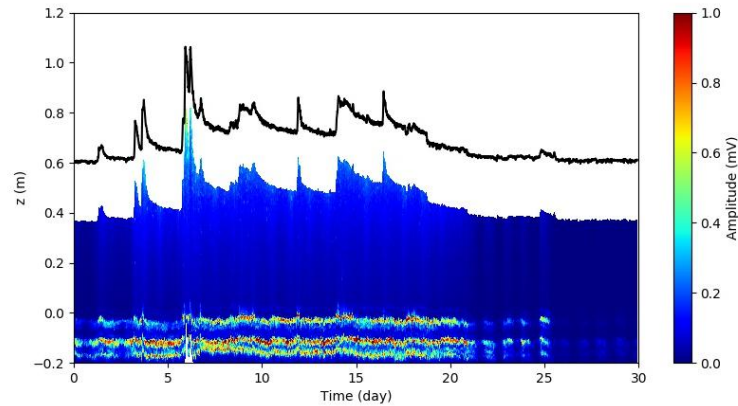
Figure 4. Evolution of the amplitude profile of the Ub-flow backscatter signal in March 2019. The black curve represents the position of the free surface.

The Ub-flow measurements were used to measure both the water height and the velocity profile. Figure 4 shows the profile of the backscattered signal intensity as a function of time at a certain distance from the surface (black curve), over the month of March 2019. High values indicate the presence of an obstacle (a strongly backscattering surface in practice), the first intensity peak is characteristic of the presence of the bottom. The high backscatter values remain at the same level (notably $z=0\text{m}$, corresponding to the sediment bottom). No significant difference (greater than the order of a centimeter) and therefore no erosion was observed over these 30 days as well as over the 9 months of the complete study.

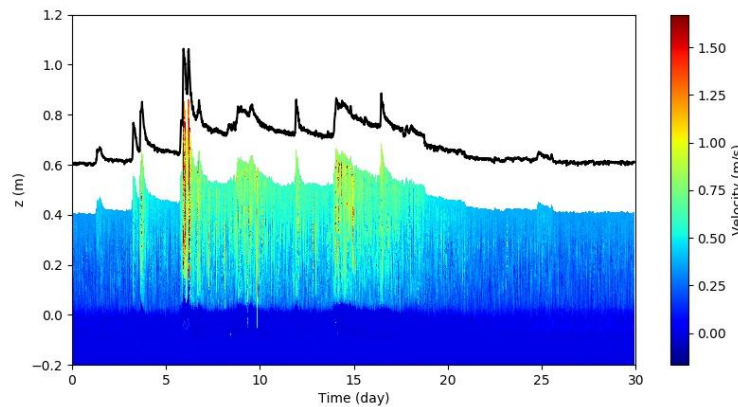
Figure 5. Evolution of the horizontal velocity profile from the Ub-flow in March 2019. The black curve represents the position of the free surface.

Characterisation of the velocity field. Several velocity data are recorded by the Ub-flow according to different configurations (maximum velocity, depth of investigation, average...). Figure 5 shows, as a function of time, the velocity profile (horizontal component in the plane of the Ub-flow) obtained from various configurations of the Ub-flow. This profile is derived from a numerical pre-processing in Python allowing the rectification of signals subjected to Nyquist limits (Fischer 2004, Larrarte et al. 2020).

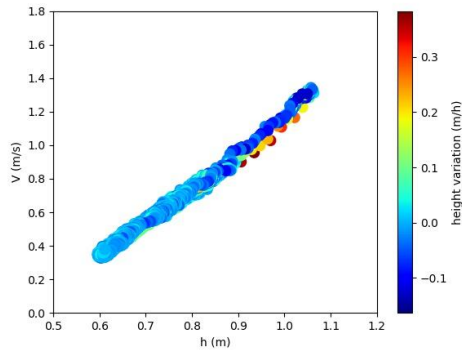
Figure 6. Flow characterization in March 2019: velocity as a function of water level.

Characteristic velocities (close to the surface) can then be deduced. Figure 6 shows the evolution of these velocities for different values of water height. The evolution of the average height is also represented (colour scale). This makes it possible to obtain a characteristic curve of the water course. It should be noted that no notable hysteresis is observed

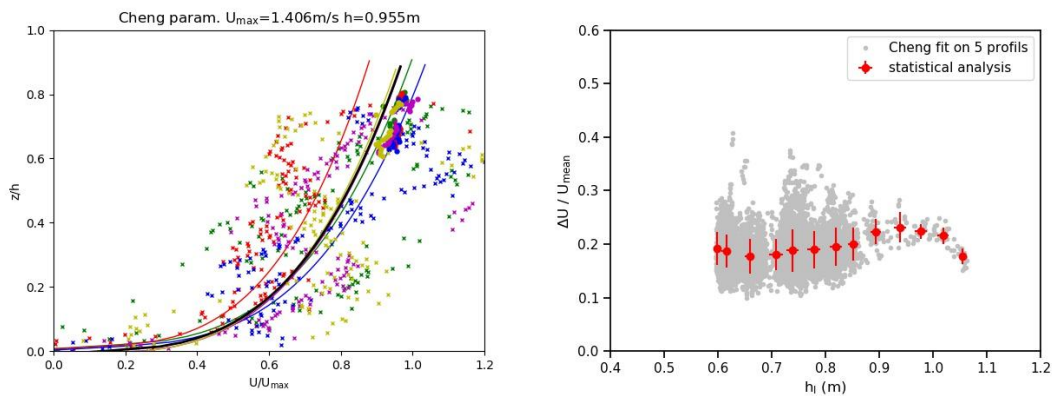
Figure 7. (left) Examples of 5 successive profiles (5 minutes apart) of scaled velocities fitting by a Cheng's law on each profile (coloured curves) or on the whole data (black curve). (right) Evolution of the characteristic deviation from velocity data to the adjustment (Cheng's law on 5 successive profiles) as a function of the water level for the month of March 2019 (all values, mean and standard deviation).

An example of such adjustments is shown in Figure 7. Large fluctuations in measurements are observed both when considering a single profile and between the 5 successive profiles. This is a characteristic of the flow in a real river which is not as controlled as in a

laboratory channel. However, a good fit can be obtained with the equation (1) to evaluate shear rates for example. These measurements allow characterizing the different hydraulic conditions of the river. A statistical analysis can be done on the dispersion of the instantaneous measurements compared to the adjustment. This analysis is represented on Figure 7. It can be identified that the deviation of the speed represents approximately 25% of the average speed, whatever the water level making it possible to characterize the deviation of the instantaneous values of speeds with the averaged profile in real situations.

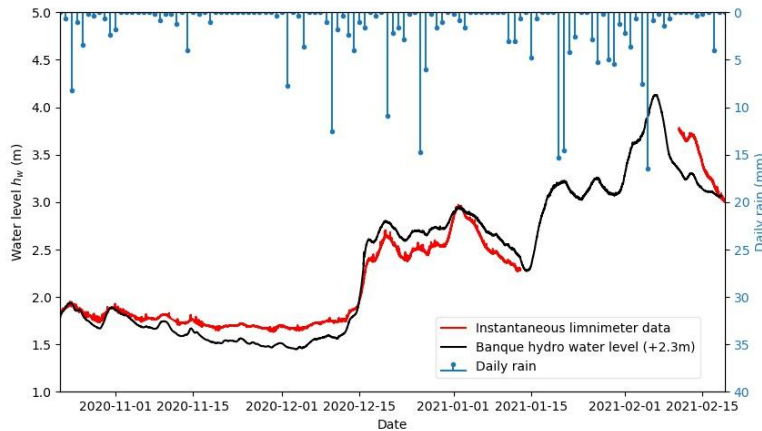
Figure 8. Monitoring of water levels and rainfall over 4 months.

Water and sediment levels. Figure 8 shows the water level results obtained over 4 months with the Valeport VRS water level meter. They are in very good agreement with the data of the hydrometric measurement station of the “Hydro bank” system (<https://hydro.eaufrance.fr/>) located upstream. We can also observe a quite good agreement between the rainfall near the site.

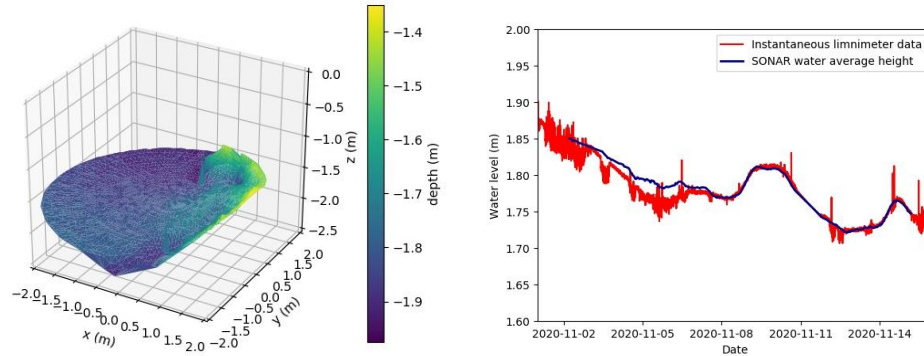
Figure 9. Monitoring of sediment surface by SONAR and comparison between SONAR average water height and Valeport VRS water level over 18 days.

The SONAR takes bathymetric measurements every hour. In contrast to the Aurence monitoring, a significant part of the sediment surface (and not a single point) can be monitored as shown in Figure 9. Beyond the average flow depths that can be evaluated and correlated with the water level measurements, it is therefore possible, with this configuration, to follow the dynamics of the whole scouring pit. However, this requires the implementation of correlation algorithms between the various bathymetric surveys in order to be able, on the one hand, to spatially reposition the data and, on the other hand, to identify the evolutionary zones. A first simple analysis shows that the average water depth evaluated with the SONAR evolves in a coherent way with the water level measured with the Valeport VRS gauge (Fig. 9).

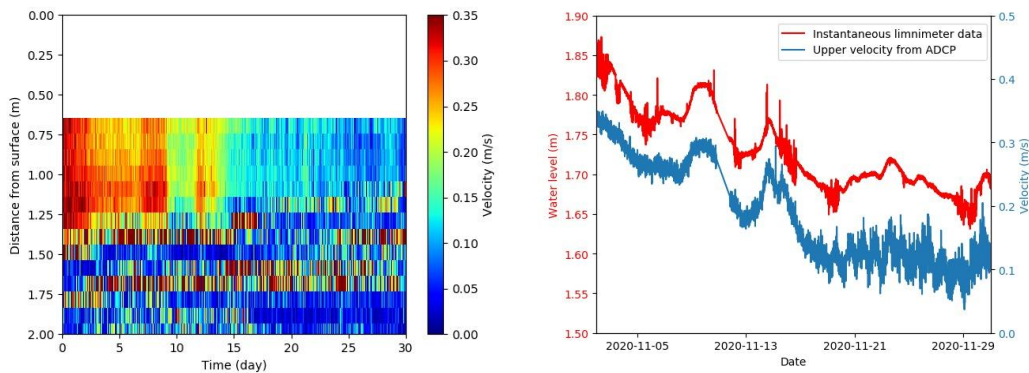
Figure 10. Monitoring of velocity profile and water level and max velocity over 1 month.

Velocity field. Figure 10 presents, over a period of one month, a follow-up of the speeds with the ADCP speed profiler. The upper velocities measured at a distance of between 0.60 and 1.20m from the surface (average of the ADCP measurements) are compared with the water level monitoring. The dynamics of the two data are extremely similar with a decrease during the first

15 days and fluctuations thereafter with an almost stable water level. A more advanced treatment of the data (with taking into account their fluctuation) could thus probably lead to the obtaining of a "taring curve" of the flow as considered in Figure 6 for the case of the instrumentation on the Aurence Bridge.

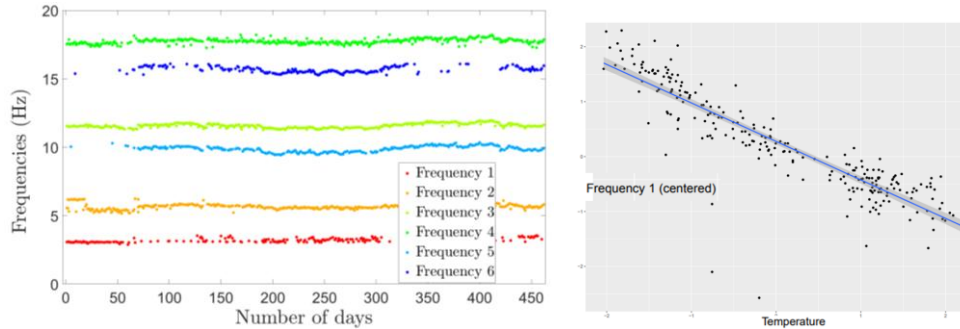
Figure 11. Daily natural frequencies of bridge pier P4 over 1.5 years and example of temperature correlation.

Vibration analysis. Scour assessment using vibration-based monitoring is performed by analyzing the changes in natural frequencies over time. This method has been shown to be feasible through laboratory tests (Bao et al. 2017, Boujia et al. 2020) and offers significant advantages compared to other methods (Wang et al. 2017). In fact, from the response of the bridge piers, the health of the structure can be monitored in real time with global information including a change in boundary conditions such as scour. An inverse method is used to identify the mechanical parameters of the pier through natural frequencies (Shinoda et al, 2008). However, natural frequencies are highly sensitive to environmental factors such as temperature and external excitations (traffic loading and wind essentially). In that way first step is to filtering signals to reduce noise by using correlations between signals (Belmokhtar et al 2022). Then, a correction must be made for temperature effects. Figure 11 plots the daily natural frequencies of bridge pier P4 (Figure 2) over time and includes an example of temperature correction using linear regression. The evolution of natural frequencies can then be studied.

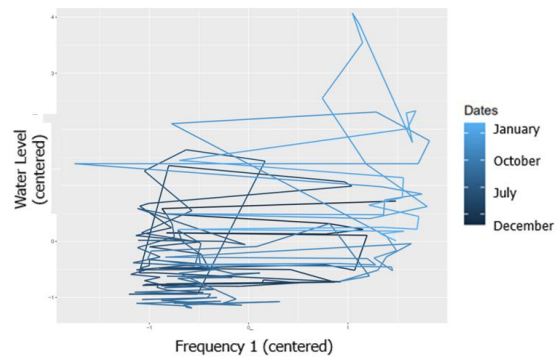
Figure 12. Evolution of the first frequency with water level changes.

As a first attempt to correlate natural frequencies and hydraulics, Figure 12 compares the first frequency with water level changes (data are centered and normalized). Some variations are due to an added mass effect on the structure when the water level increases but no clear correlation is observed. Further research is needed to establish a reliable scour assessment by comparing data to bathymetry evolution.
