Moenjodaro UNESCO Emergency Mission Following Disastrous Rainfall in 2022: Intermediate Progress report

UNESCO Emergency Mission Following Disastrous Rainfall in 2022

Intermediate Progress report

April 2023

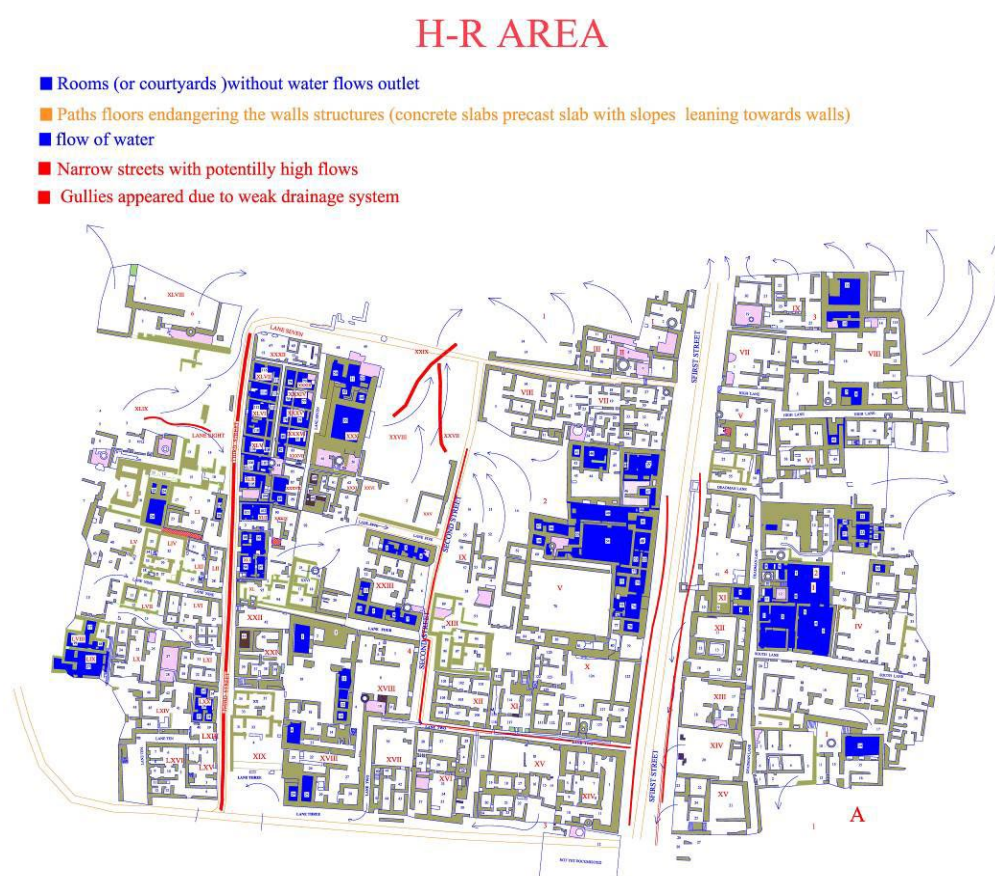
Example of plan produced by Moenjodaro team after the 1st UNESCO expert mission which were presented and discussed during zoom meetings. Drainage issues at HR area, December 2022.

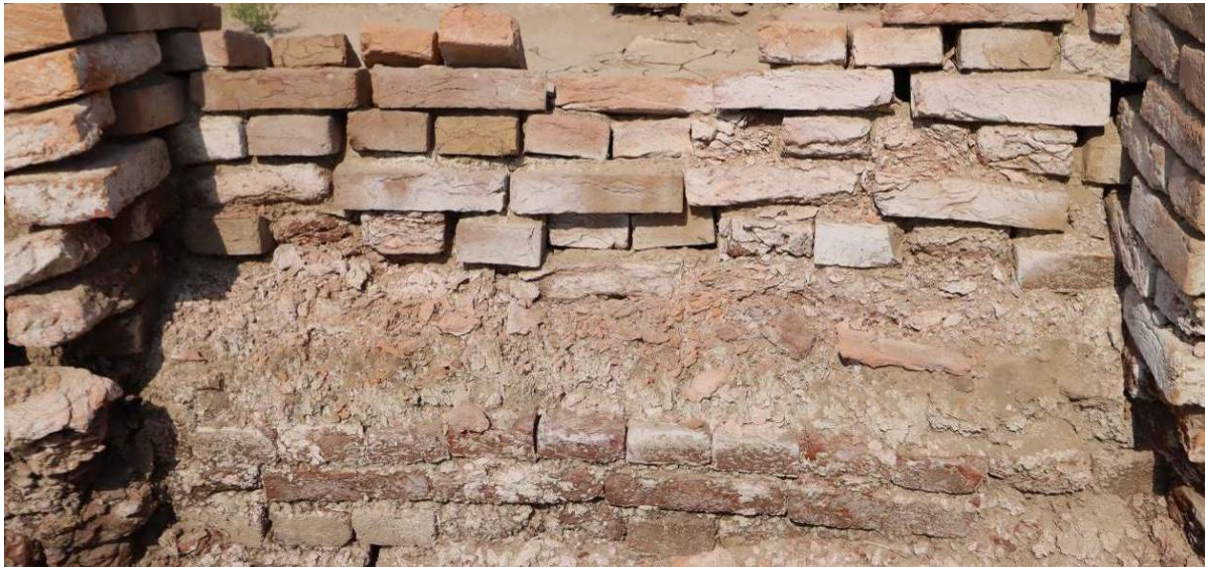
One of the examples discussed: the variety of quality of burnt bricks is very visible on this wall at DKG area, very good state at the base, almost fully disintegrated in the middle, acceptable at the top

This calls for launching a process for re-installing a more systematic process for the quality of the materials being used at Moenjodaro, both for the earth and for the burnt bricks:

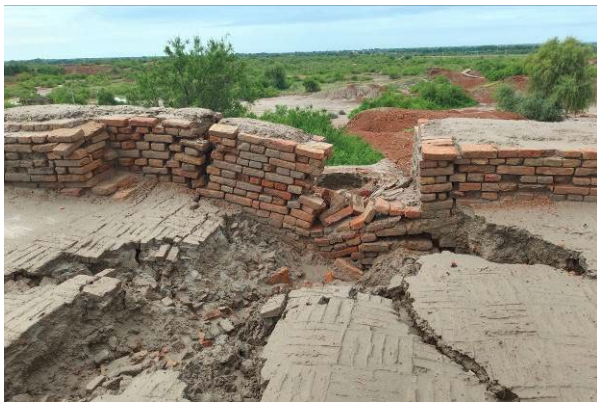
Failure of drainage system at SD area © N. A. Sangha:

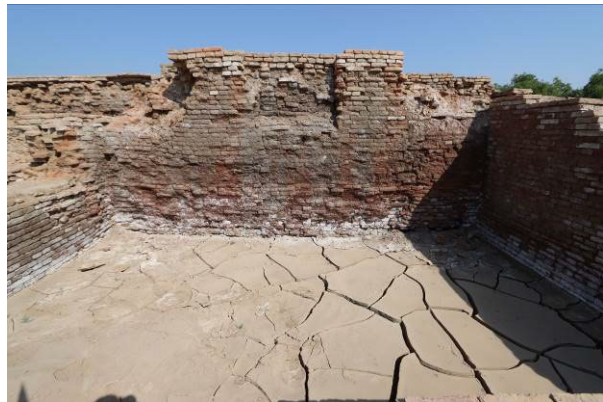
Temple at HR area, with traces of high water level

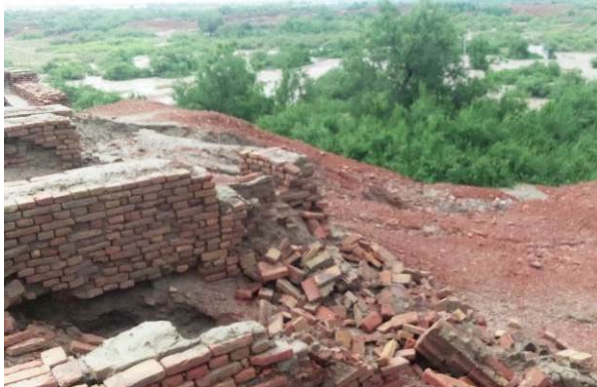
Undermining of wall by run-off, SD area © N. A. Sangha

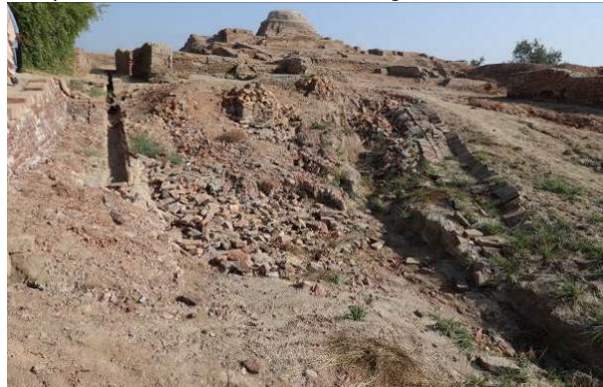
Ancient drainage systems damaged, south of SD area

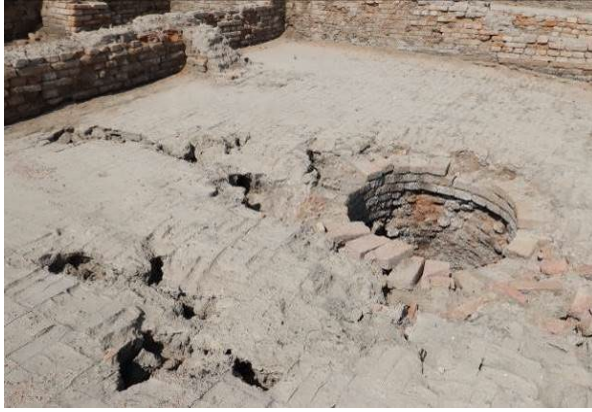
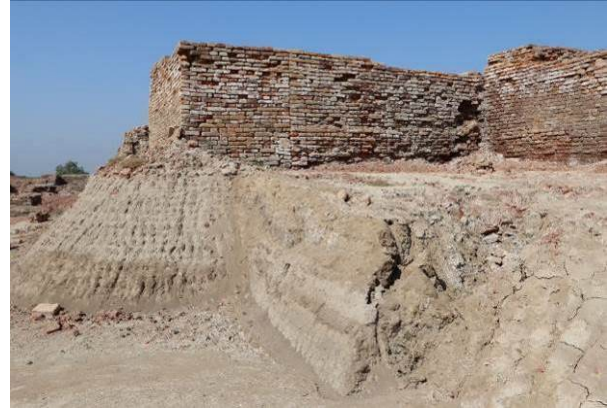
One should note that the system used at Moenjodaro for the treatment of the floors (sundried mud bricks laid on a layer of sand) though giving satisfaction for draining water flows in regular raining circumstances, has proved ineffective (if not dangerous) when run-off is higher, infiltrates under the brick layer, resulting in washing of the sand layer and further, acceleration of the erosion process of gully formation.

Gaps left by eroded sand under mud brick floor SV area Pushta protection affected by water infiltration HR area

1. Replace the sand layer of the pavement technique by mud mortar
2. Use of drainage pits at the center of the rooms where it appears impossible to install exhaust pipes
3. Use of wells for drainage when existing / possible (HR area)
4. Modify pavement slopes when they drive runoff towards wall basis (L area)

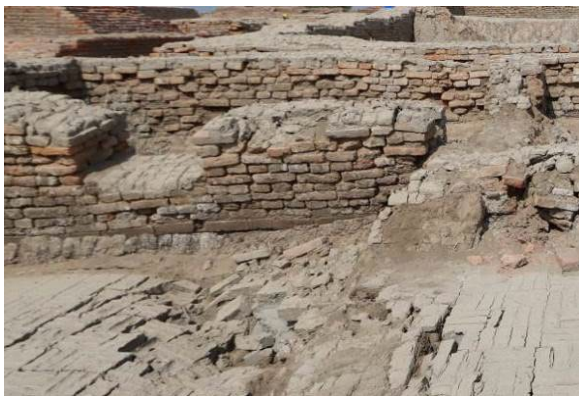
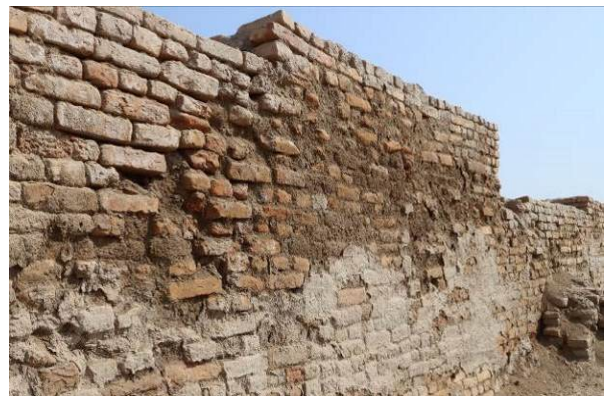
Besides that, this system is allowing water infiltration through the bricks and then through the layer of sand down to the original fabric. The resulting issue is that this humidity is like trapped under this layer of sand with the only potential of being evaporated through wall structures, at times above ground level, but also when structures are forming terraces (more specifically the case of the stupa zone, but not only), and as such, increasing the potential of crystallisation of salts on their surfaces (see next chapter).

Traces of high humidity content under floor SD area Traces of high humidity on retaining wall. SD area

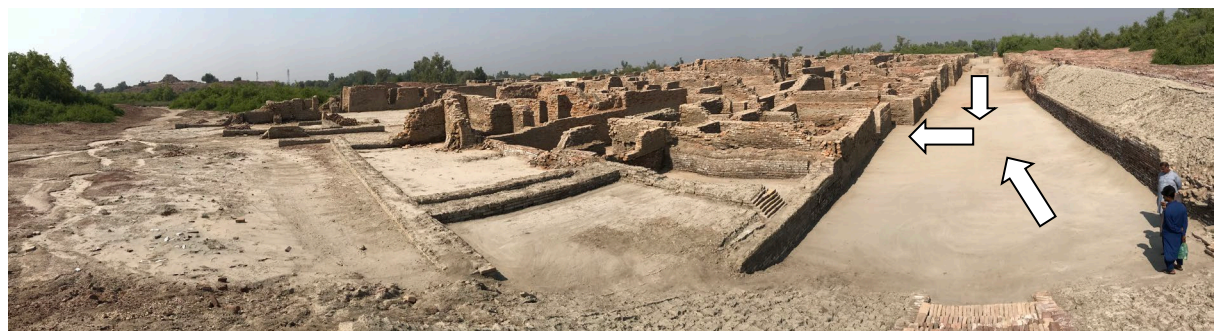
The levelling of the large street east of DK south area drives runoff towards the built structures at its western side

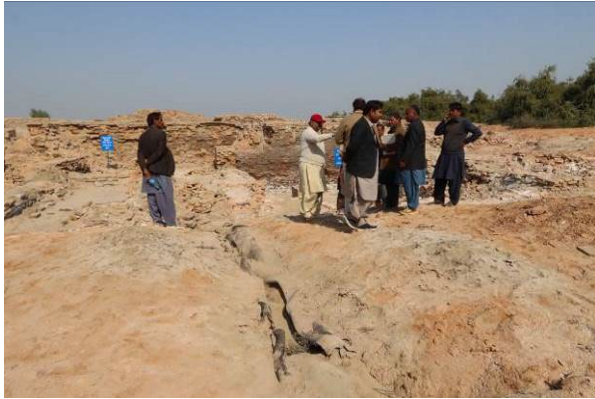
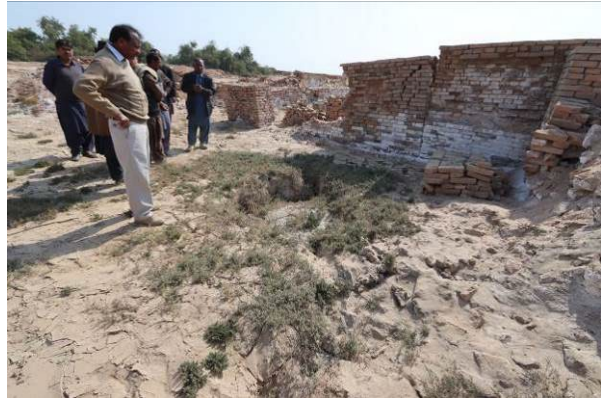
Two specific cases that were discussed in HR area.

Left: need to open canal from temple room; In-depth observation has led to understand that there was a need to consider both western and upper zones (above temple itself) to ensure that less runoff would be driven to temple. It was also decided that a shallow drain be installed at the eastern side,

Right: depression in a courtyard. Alerted by Ali Gul, foreman, this huge depression in the ground was studied. The observation of the topography led to deciding that a drainage pit (the only possible solution) should be provided. As a follow-up, a sketch and a rate analysis sheet were prepared.

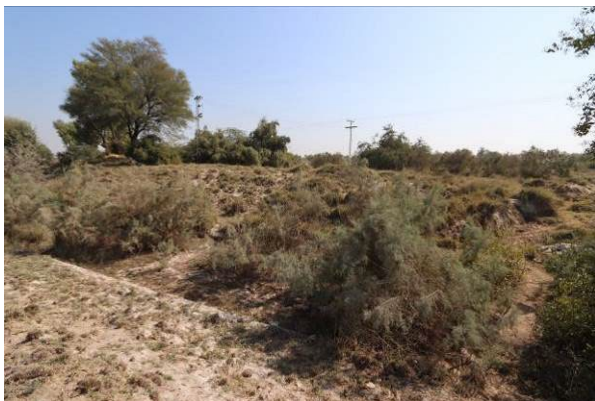
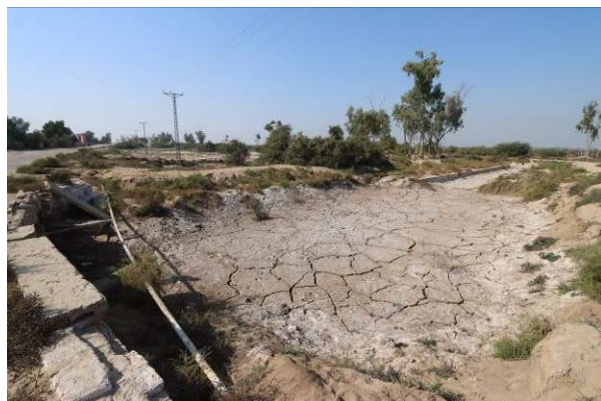
Inspection of circular canal – northern zone.

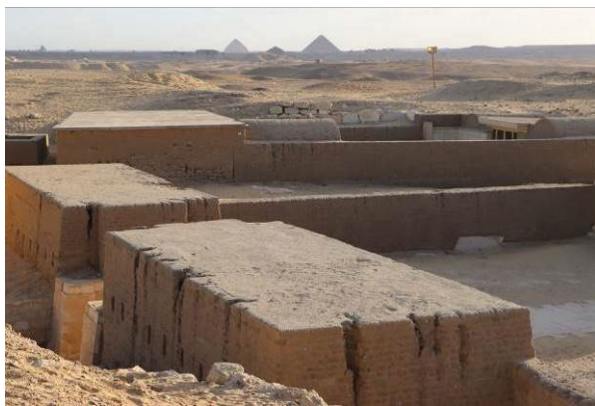
Left: Typical degradation process (formation of gullies) at Saqqara

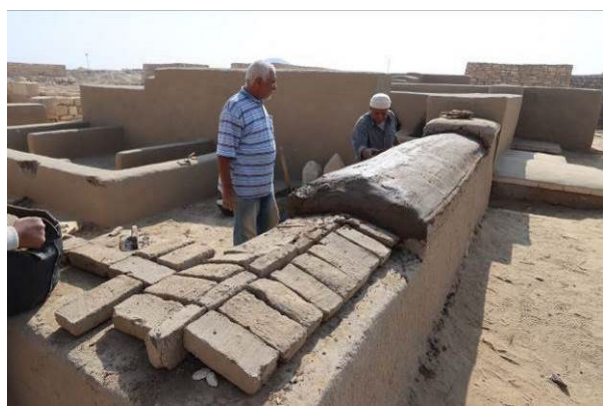
Right : proposed solution for capping (Pepy 1st site)

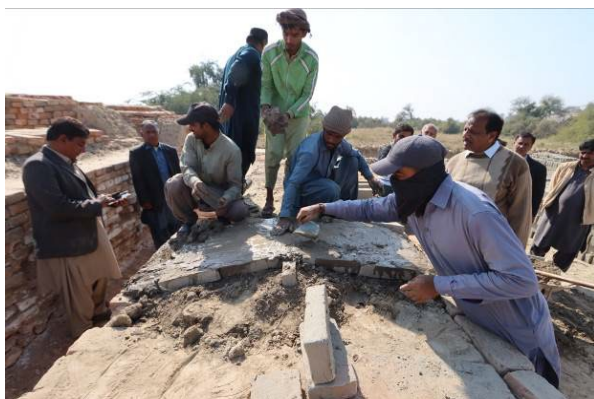
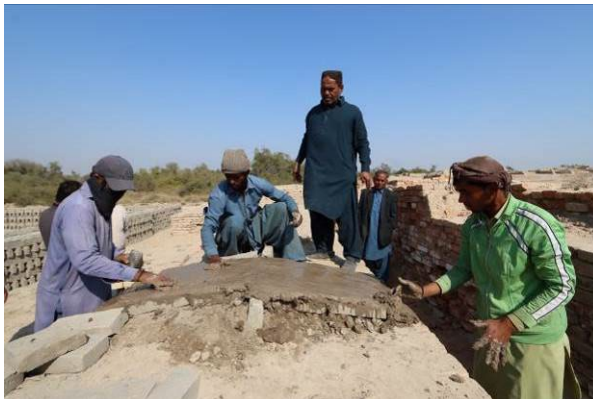
Second was devoted to the preparation of a sample of capping with a rounded shape. It was organised at DK areas entrance where brick making is on-going. The team did show capacity to easily undertake this type of work, while the appearance of cracks in the mortar led to sensitize to the need to take care to the quality of the mix used which do need addition of sand, long chopped straw for the core of the shape and short chopped straw for the final plastering layer.

Rounded shape capping sample being prepared during field session

2. For better protection and longer duration,
 - a. Add two brick layers (instead of one only) above burnt bricks before rounded shape;
 - b. First prepare the round shape with bricks and then add first mortar / plaster layer to form the final shape (half inch should be left at the sides for flush finishing of final layer)

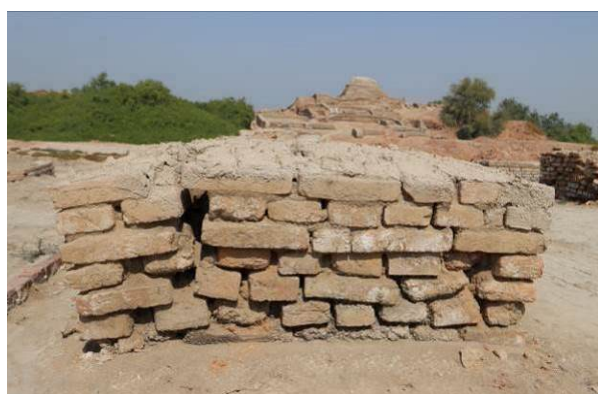
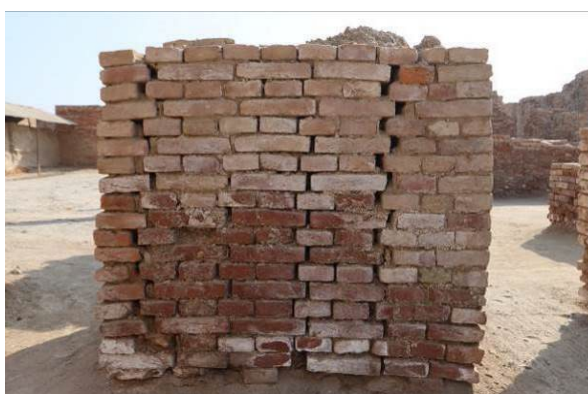
Two column types of wall (L and DKG areas) illustrating well the typical collapse process starting from the base

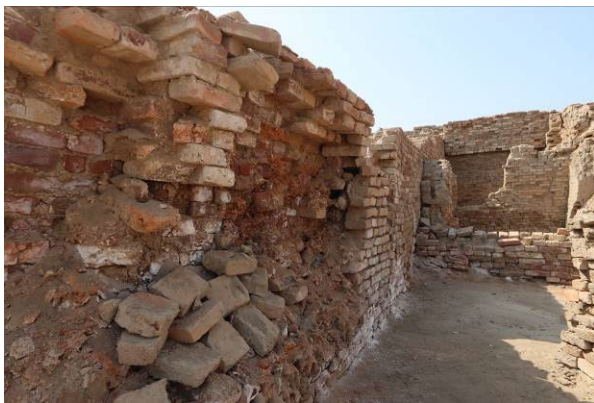
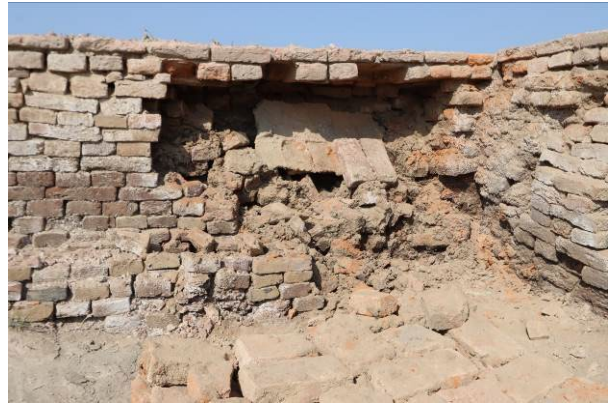
Wall collapses where salt attack has played a strong role at DKG (left) and HR (right) areas.

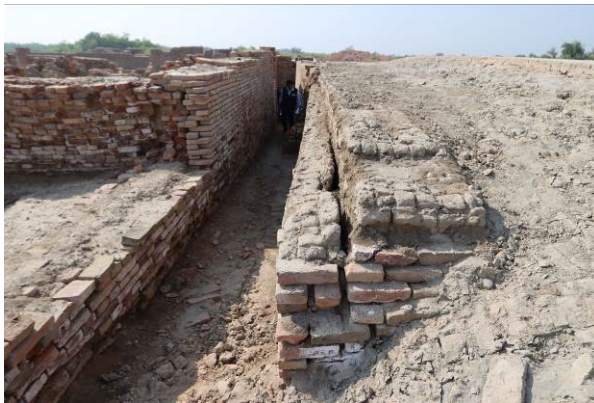
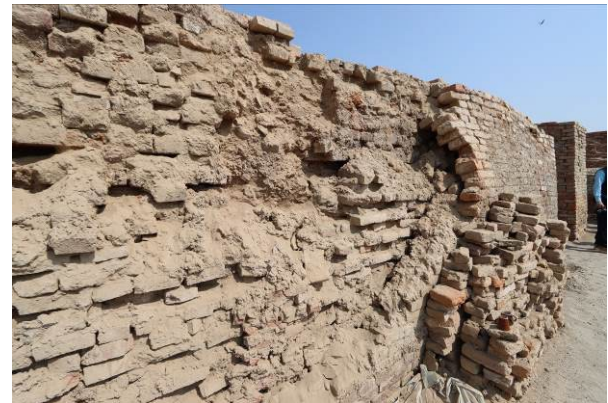
Two stages of the process of separation between the new and the old parts of walls, DKG area.

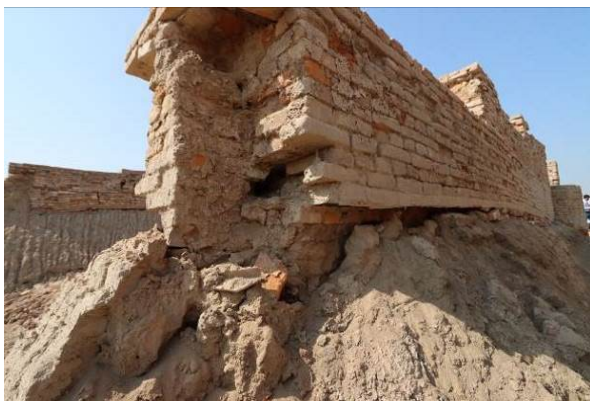
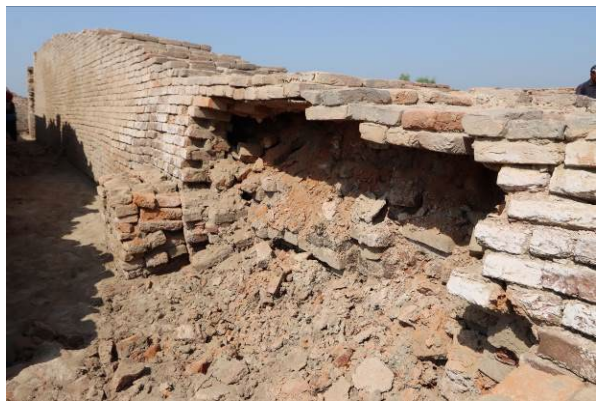
Damp proof course at DKG partly efficient

Concrete layer between the two last brick courses at HR

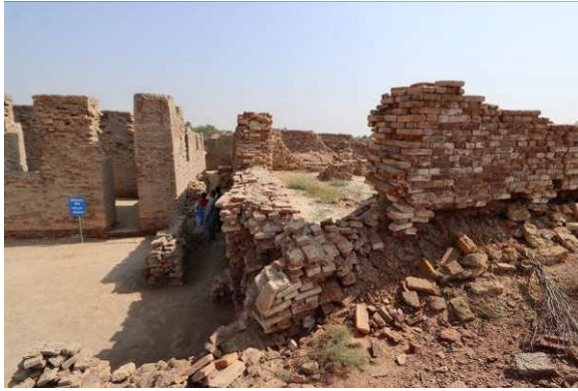
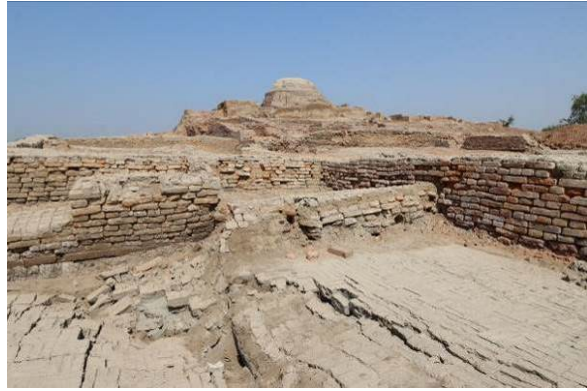
Pressure against walls by backfilling of platforms / rooms floors, DKG area (left) and SD area (right)

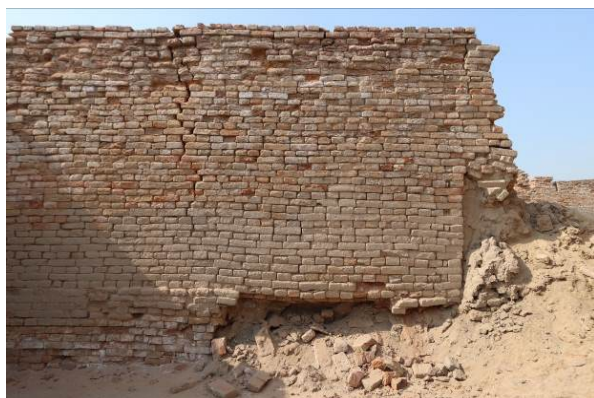
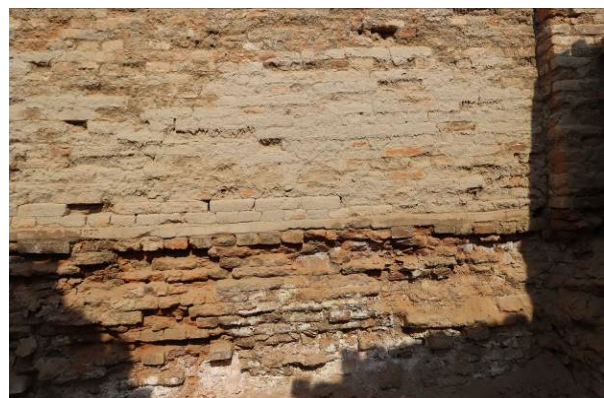
To address the priority discussed (see above), it was decided that the site visit should be organized at DKG south where numerous cases of wall basis decay can be observed, some affecting very high structures which require specific care. That has led to discuss what would be the best methodology of intervention with giving specific attention to security measures prior to intervention. That led to recommend:

Wall seriously affected where most of the field discussion occurred (DKG south area)

- . provision of security equipment for the workers : helmets, security shoes;
- . detailed observation / understanding of the weaknesses and risks linked (more specifically when wall base is attacked on both sides);
- . definition of an intervention strategy, starting with the easiest part to be treated (often at the ends of the “destructive furrow” and further possibly portion by portion);
- . strutting with wooden structures if felt necessary for safety;
- . strutting with truck jack(s);
- . cleaning the gap to be treated (if presence of salt, possibly applying mud mortar for absorption);
- . possibly removing some bricks or parts of bricks so as to be able to accommodate full size new bricks (half or full / stretcher or header);
- . intervention with ensuring proper bonding / proper filling with mortar to avoid evaporation inside the wall and thus salt accumulation.

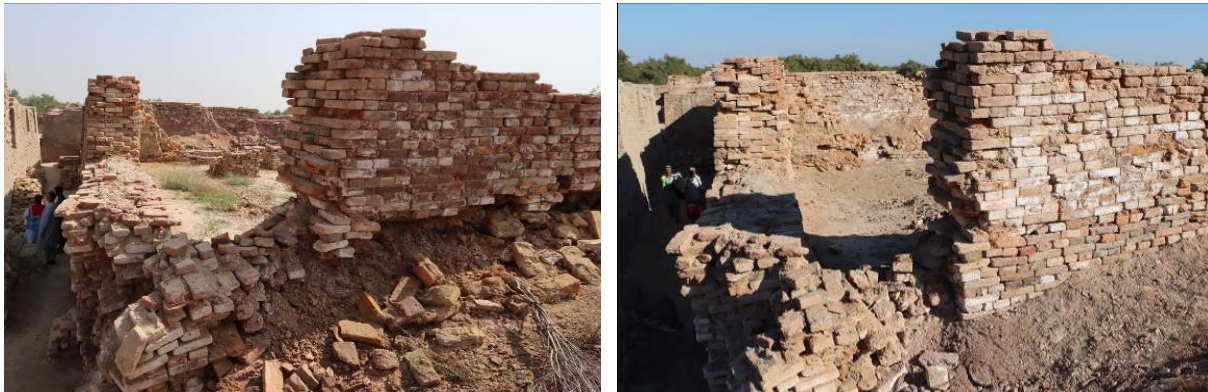
Another potential practice has been discussed and approved, that of temporary dry masonry supporting structure, leading to a demonstration being made at one of the most affected wall

in DKG area (see pictures below). It was however concluded that such measures should not be kept for long periods as on the long run this solution may favor crystallization of salts between the original and dry masonry.

Demonstration of wall base treated temporarily with dry brick wall (without mortar)

- 7. Temporary measures:
 - a. Temporary measures with piles of dry burnt bricks masonry is to be applied when work on a structure in danger cannot be treated immediately.

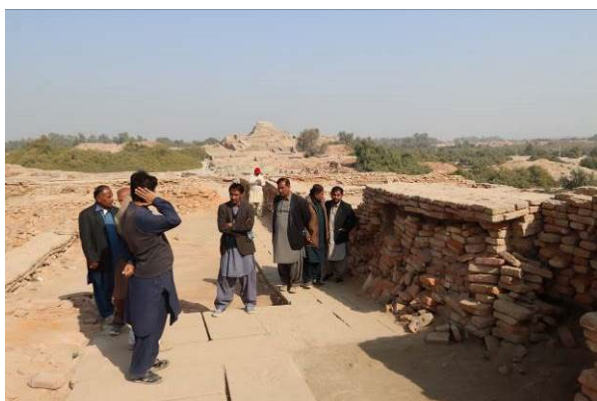
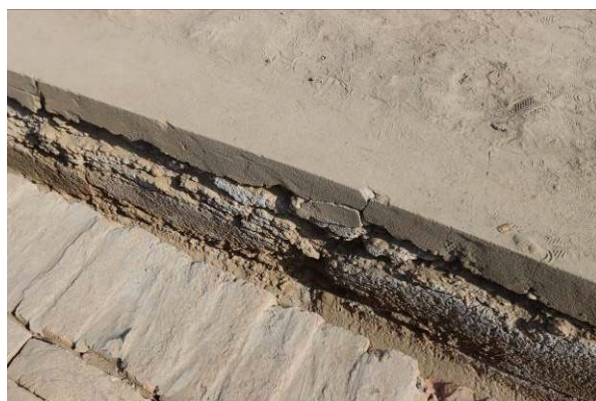
Discussion on the negative impact of path on a wall at L area

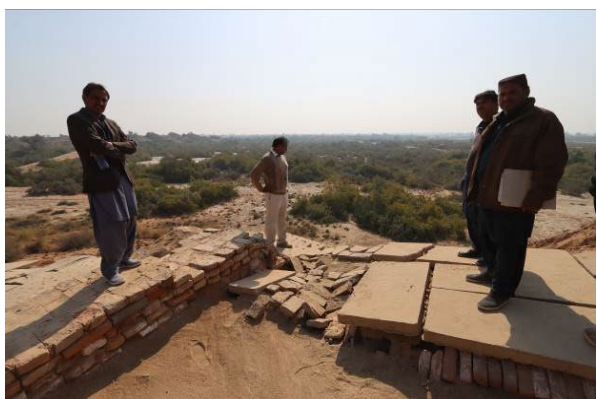
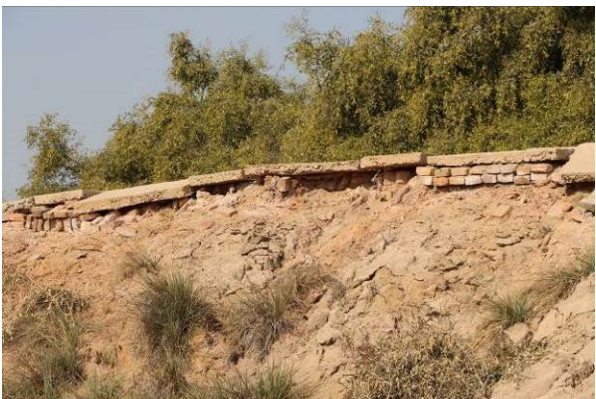
Observation of the decay of a concrete slab path and taking stock of its dangerousness, leading to the recommendation of closing this path to the public.

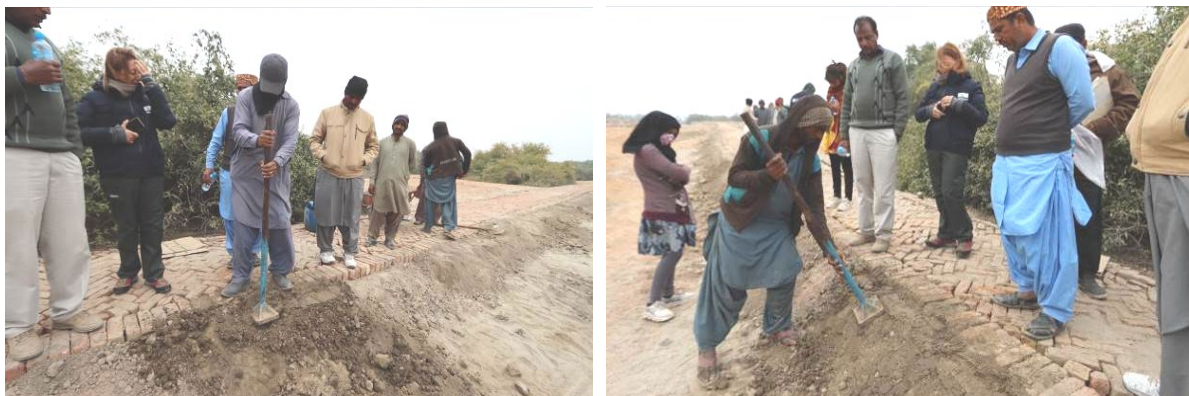
Demonstration of the rammed earth technique adapted to the construction of “high resistant shoulders” for ensuring long term durability of all types of paths (avoiding erosion at the sides), path under repair at the south east of DKG south area.

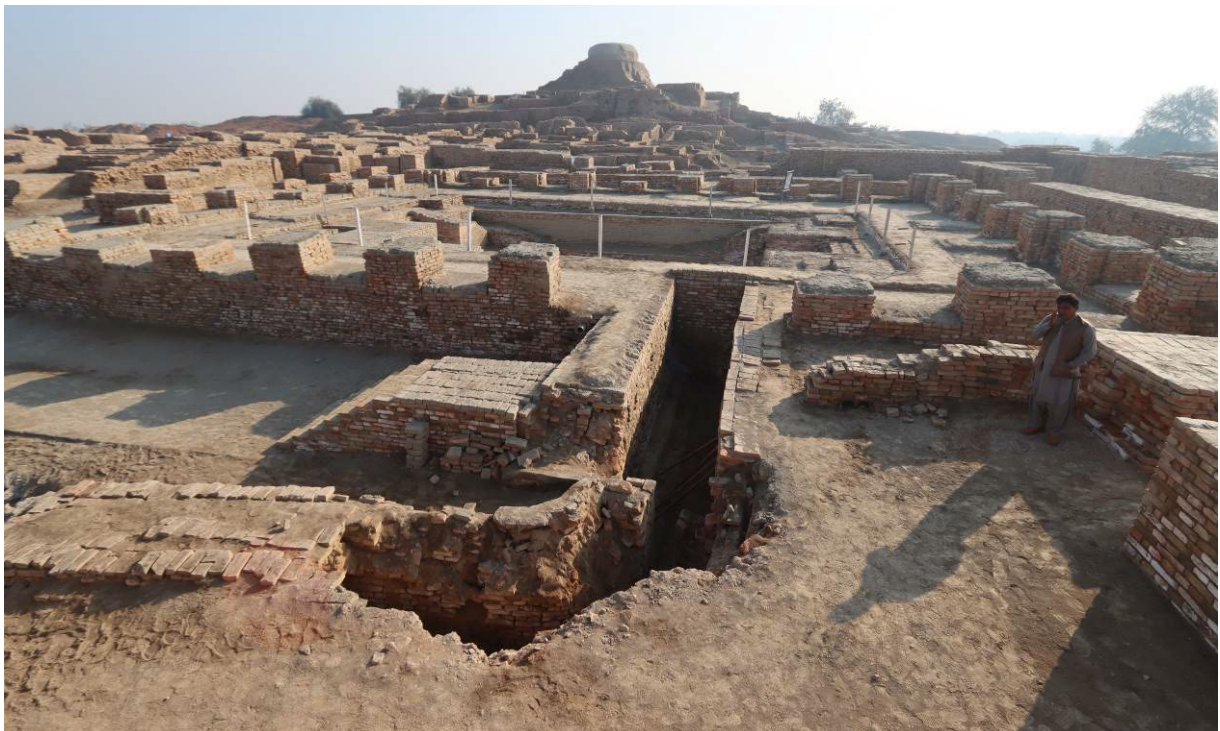
Bath canal at SD area

The inspection made by the workshop participants revealed that the cause of decay was not the canal itself (the canal from the bath was obstructed, that was probably the cause of decays in the bath pool walls, already repaired). The cause was rather the water runoff which after careful observation of slopes started to form on the other side of the pool itself (more than 60 m away).

That established, the restauration was discussed but which led to a very specific question that of the reconstruction of a corbelled vault, which would not be too difficult, but in the case of this canal which is forming a turn (about 110°). What could be the bounding for that? As

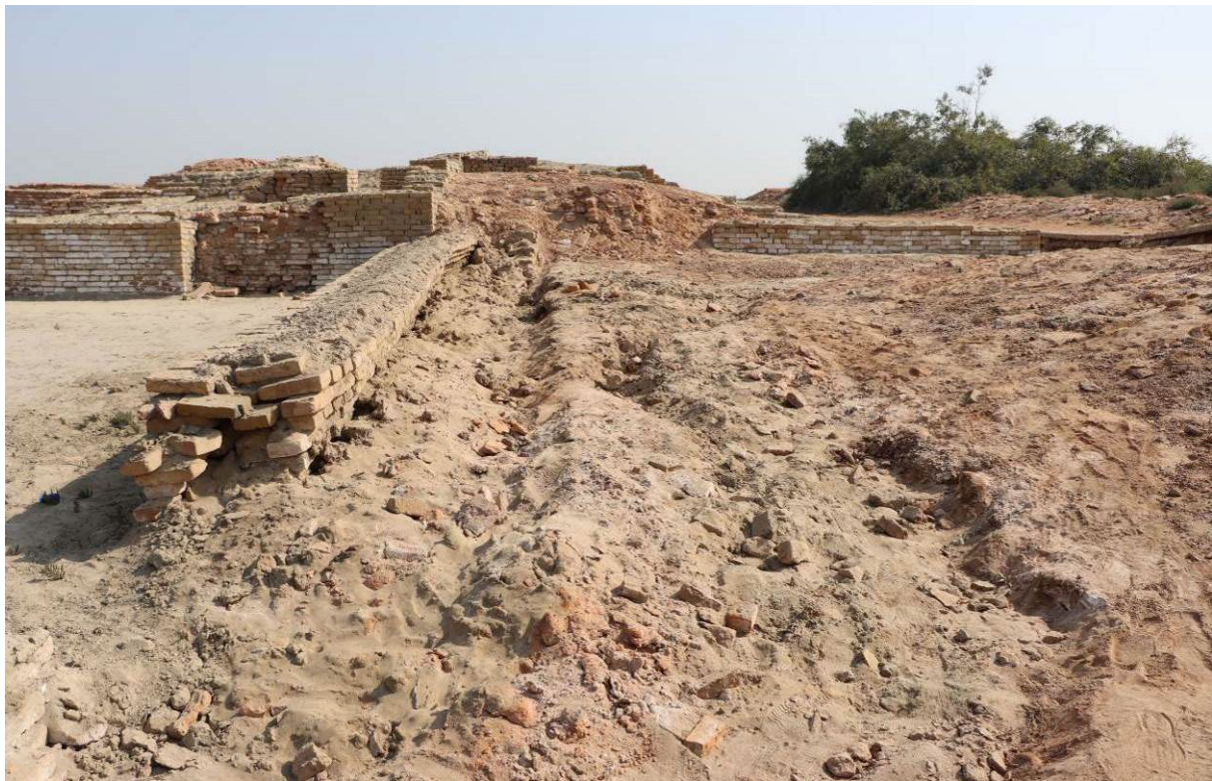
Baths canal at HR area :

Similarly to what has been observed for the bath canal at SD area, the diagnosis at HR area for the two covered canal concerned was that the destruction (partial) was not linked to the presence of the canal, but being the result of water runoff too close to the external wall.

Risk of further collapse are now quite limited and as there are many other works to be done elsewhere, it was decided that rather than launching a restoration process, a preventative measure should be taken, that of releveling the ground at the side of the canal so as to make sure that water runoff would be at least 3 m away on the south side.

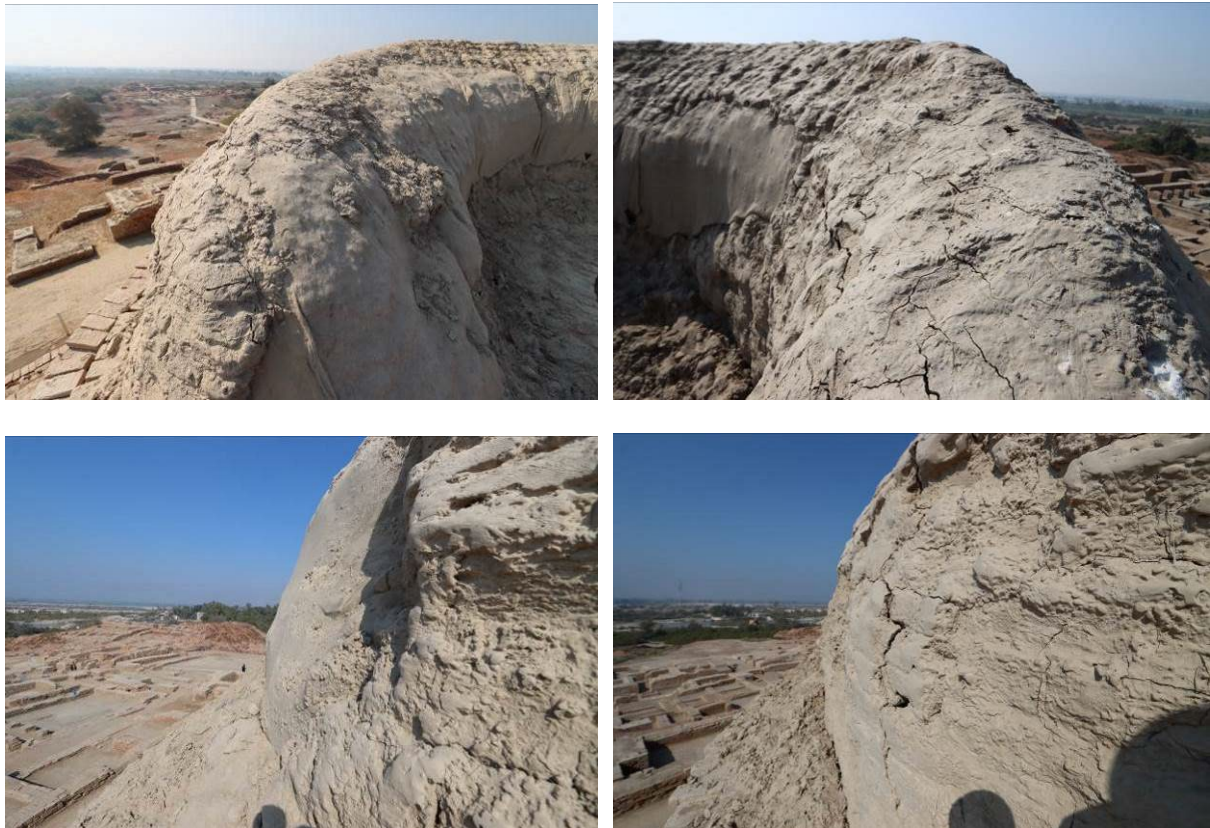
managed to climb up and go round the stupa base. That inspection led to the understanding of a much more difficult situation with several cracks showing that in addition to fallen parts, other remaining ones were not very stable. Moreover cracks at the top and at the sides would 1) offer the possibility to let rainwater penetrate in between the external protective layer and the geotextile and 2) make it difficult to find a strong base on which reconstruction of the protective layer be made.

As the presence of such situation was also visible inside the stupa (a more accessible place) the discussion on “what to do” was organised there. It was commonly agreed that the best solution would be to remove the protective coat and the debris and rebuilt them. On the other hand it was suggested that the protective geotextile be left in place.

Concerning the reconstruction, the masons were asked their opinion. Actually one of them participated in the process some 30 years ago and was fully able to explain how it had been done, making everyone confident that he could do that work (and train younger masons) without needing too much guidance.

Finally it was also agreed upon that the reconstruction process should follow similar specifications as the one for underpinning, with slow progress of the work to be established (no more than three layers of bricks everyday) for ensuring best connection between the old and new part (through avoiding large settlements due to mortar shrinkage and compaction).

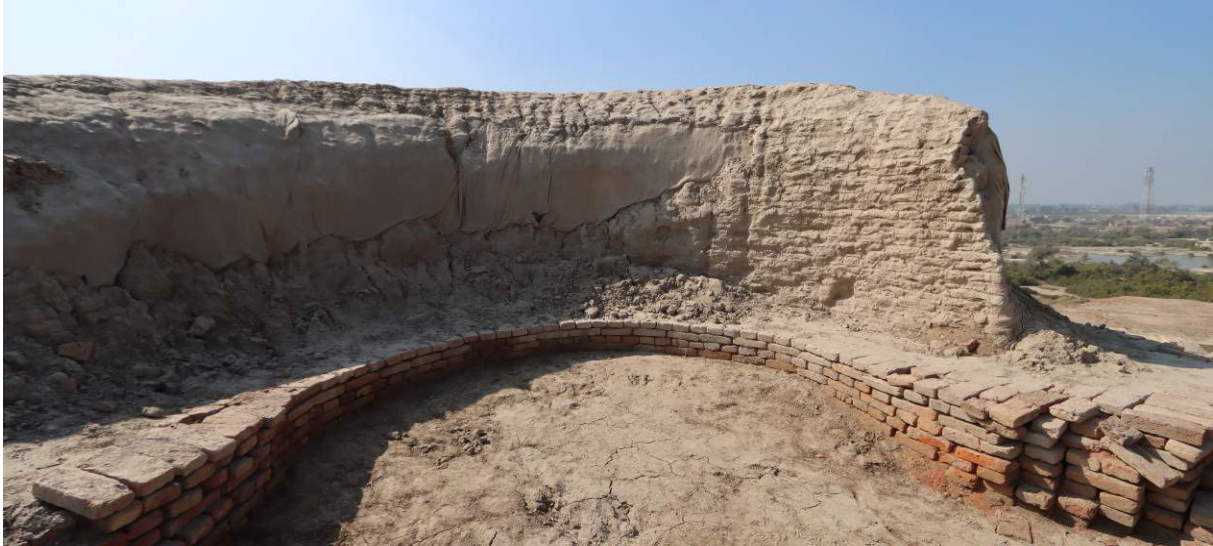
Inside the stupa, much more accessible than its outside elevation

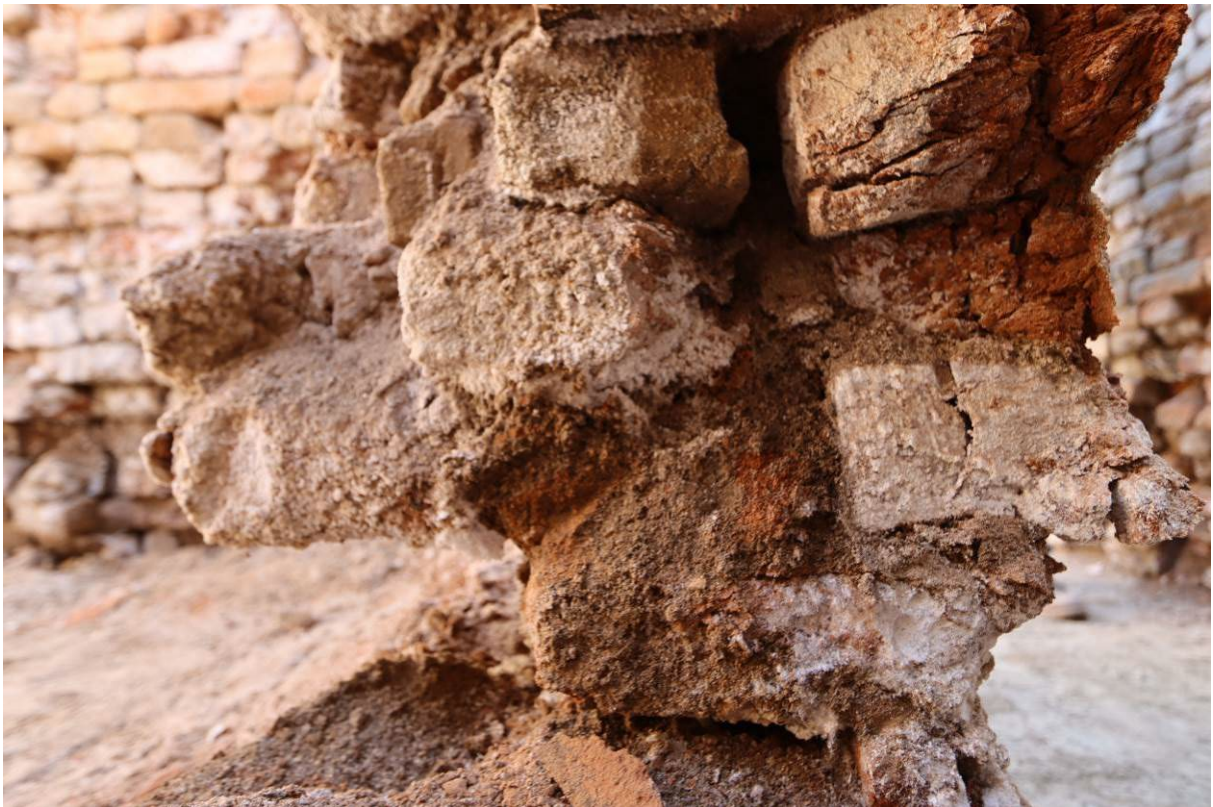
Well preserved house (DKG south)

The well preserved house has been seriously affected during the August 2022 rains. There are several walls that have suffered erosion at their base, on the two sides (mainly inside partition walls). The inspection has revealed that some of the walls have their stability endangered (see picture above).

Thus, the recommendations made for underpinning fully apply here (see page 21), to be implemented with maximum care for ensuring safety of the workers and structures.

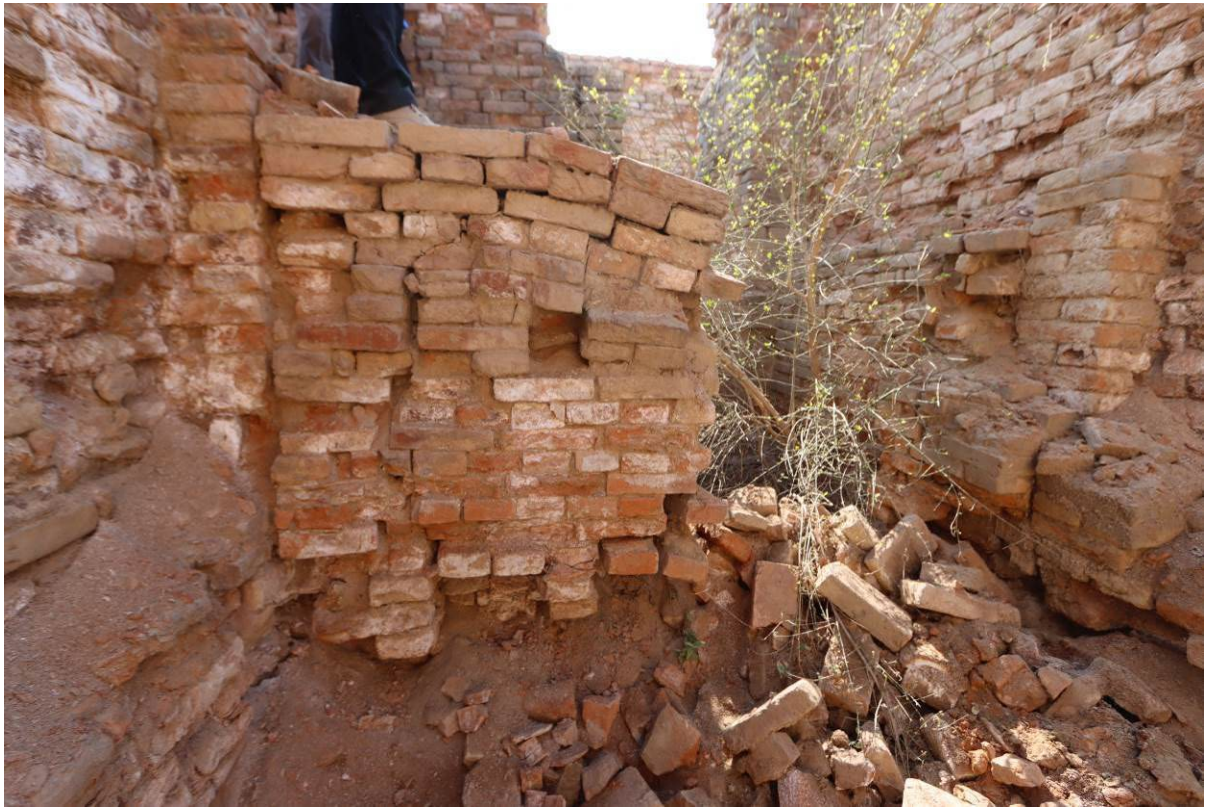
House without door (DKG south)

Current situation found at House with no door:

Two rooms without openings in this house are filled with debris on about 1,5 m high. The southern room has the top of this debris leaning towards west while the northern room is leaning towards east. And a tree is growing in the southern room. The slopes of the debris are guiding rain water towards walls and as such there are degradations on the opposite face of the walls concerned.

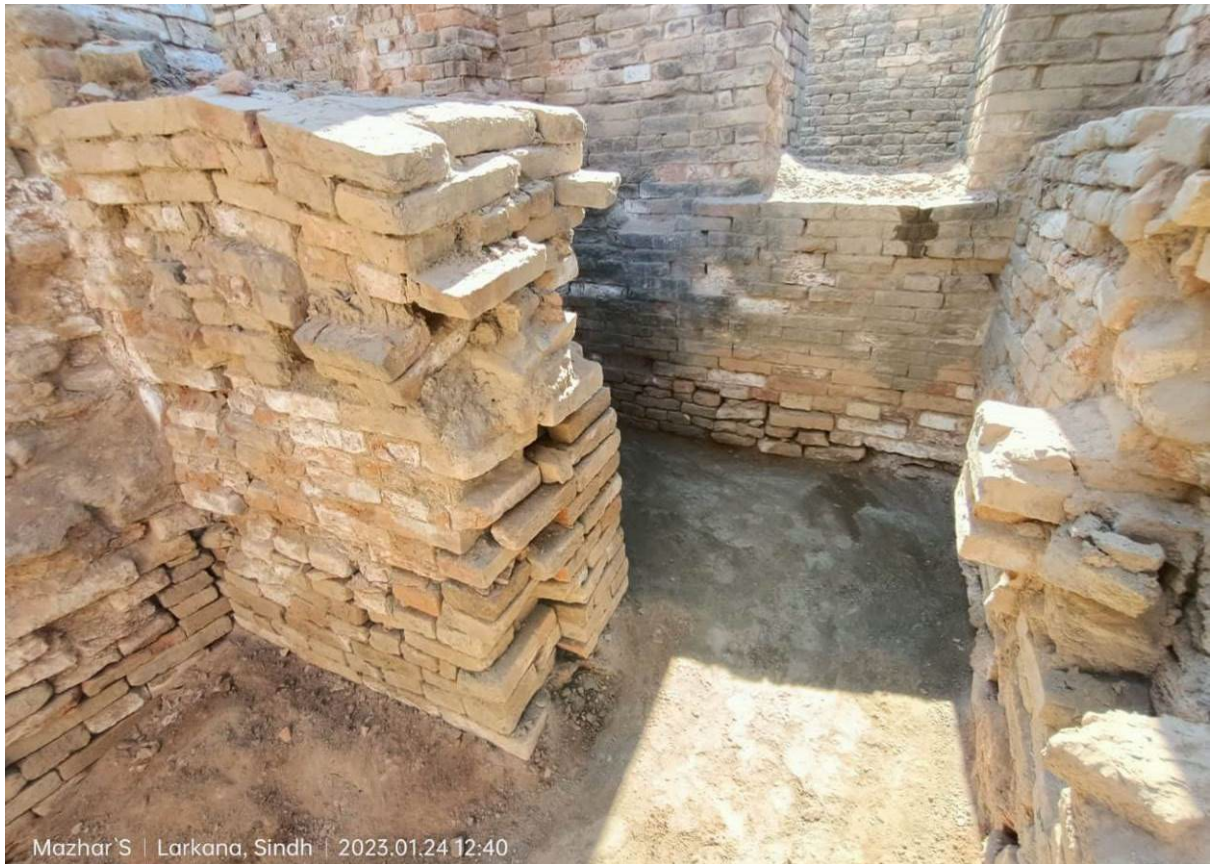
No name street has been temporarily given to that street as it has never received any name ! It is also in a part of SD area which could not be given sufficient attention these last years. As a result of limited attention and no monitoring some erosion has taken place that has probably much increased during the heavy rains of august 2022. As it is a typical situation which do need to be addressed in emergency, it was also taken as one the studied case study.

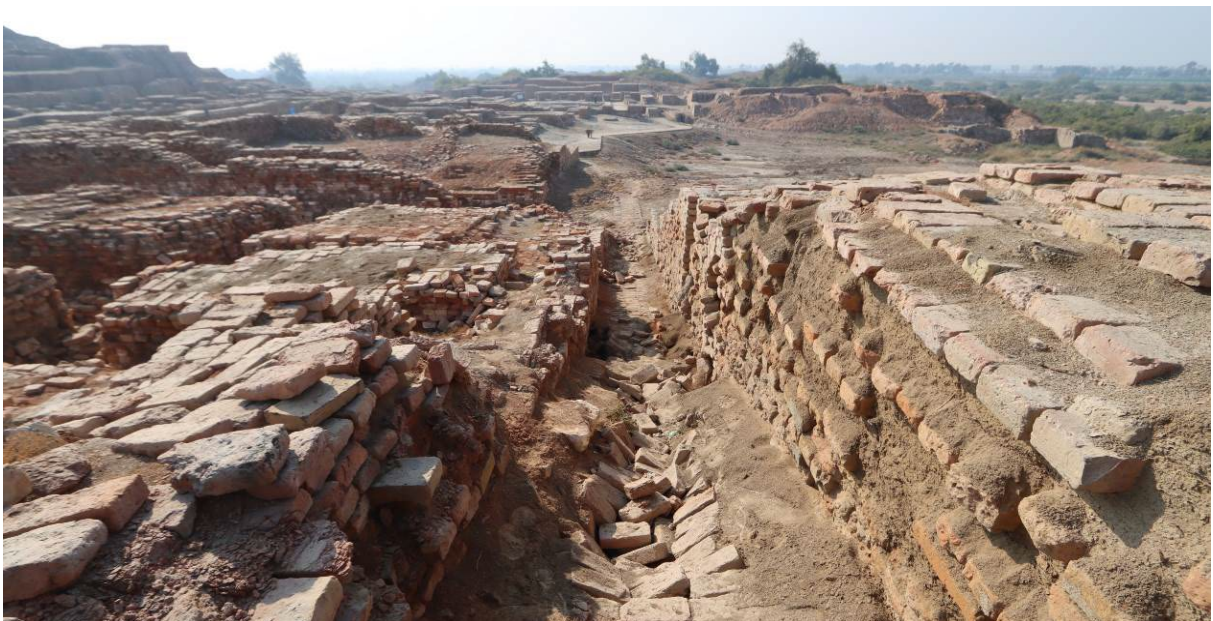
As it can be seen on the picture above (p. 33), the weakness here has probably its origin from a base insufficiently compacted for the shallow drain that was rightly installed to properly drain this sloppy street. That has led to infiltration and erosion under this pavement which now evolves towards presenting risks for the walls at its both sides.

This diagnosis has led to recommend that the path be removed and redone making sure that its base be seriously compacted and to lay the burnt brick shallow drain on mud mortar rather than on sand.

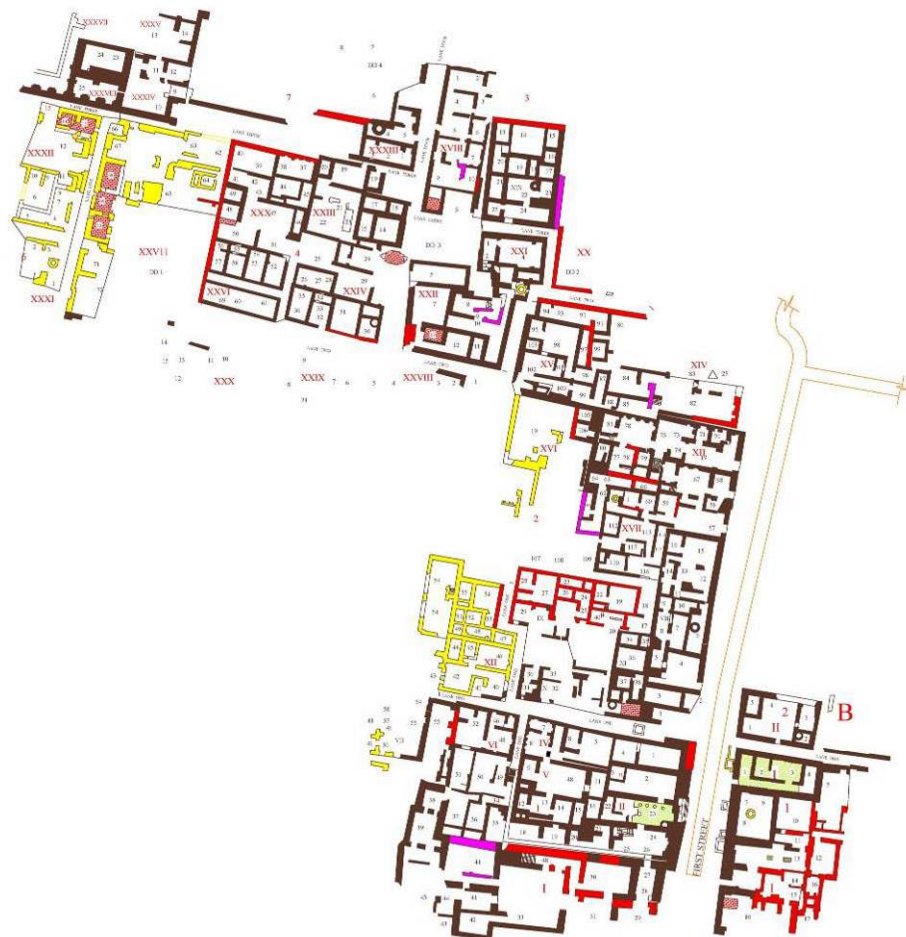
V-S AREA

- Good Condition
- Underpinning
- Destroyed and need full reconstruction (or reconsideration)
- Structures disappeared due to passage of time
