Moenjodaro UNESCO Emergency Mission Following Disastrous Rainfall in 2022: Intermediate Progress report

UNESCO Emergency Mission Following Disastrous Rainfall in 2022

Intermediate Progress report

April 2023

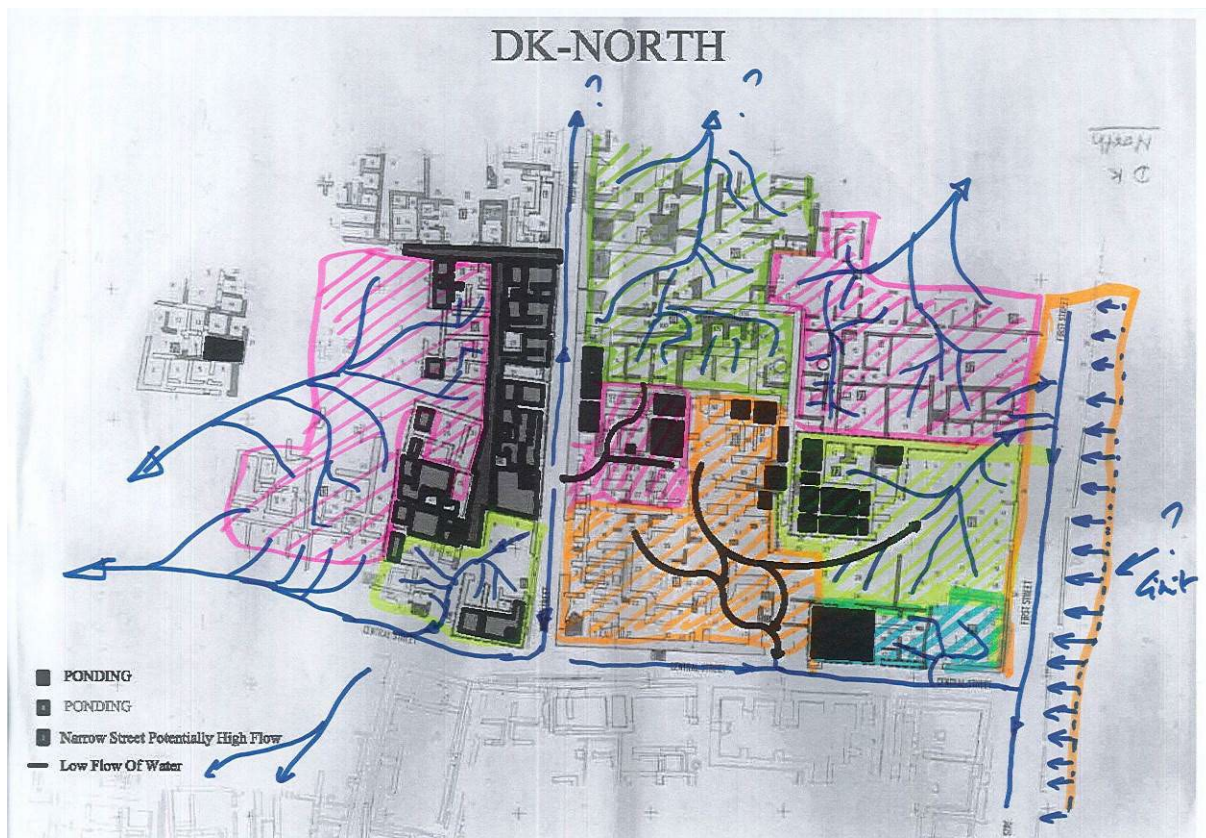
H-R AREA

Example of plan provided to illustrate comments made during zoom meeting to MCO team for improving the clarity / pertinence of their production

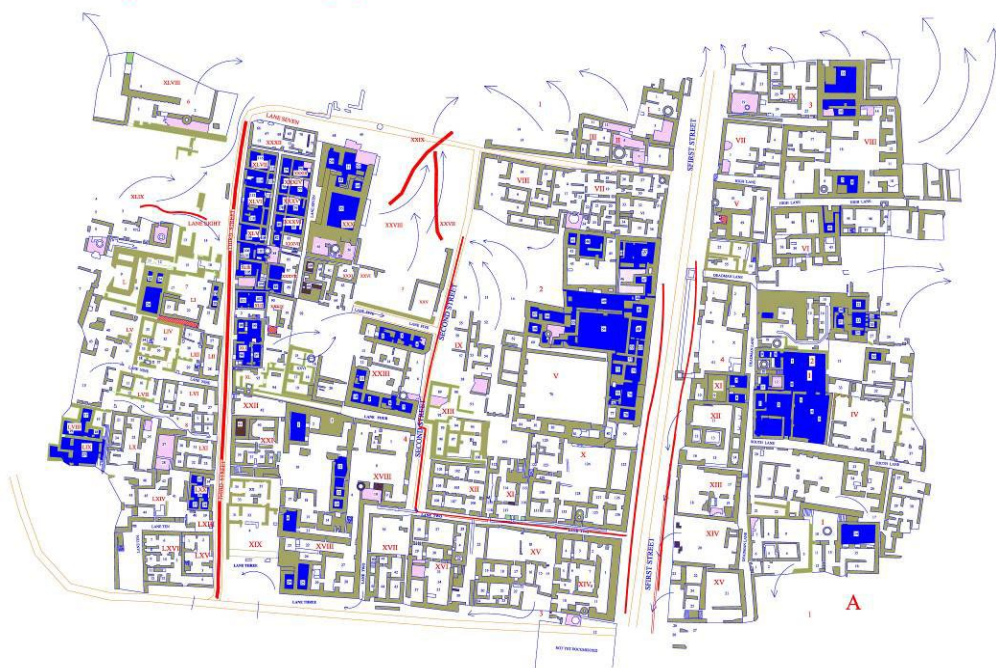
- Rooms (or courtyards)without water flows outlet
- Paths floors endangering the walls structures (concrete slabs precast slab with slopes leaning towards walls)
- flow of water
- Narrow streets with potentially high flows
- Gullies appeared due to weak drainage system
