# Moenjodaro UNESCO Emergency Mission Following Disastrous Rainfall in 2022: Intermediate Progress report

## UNESCO Emergency Mission Following Disastrous Rainfall in 2022

**Intermediate Progress report**

**April 2023**

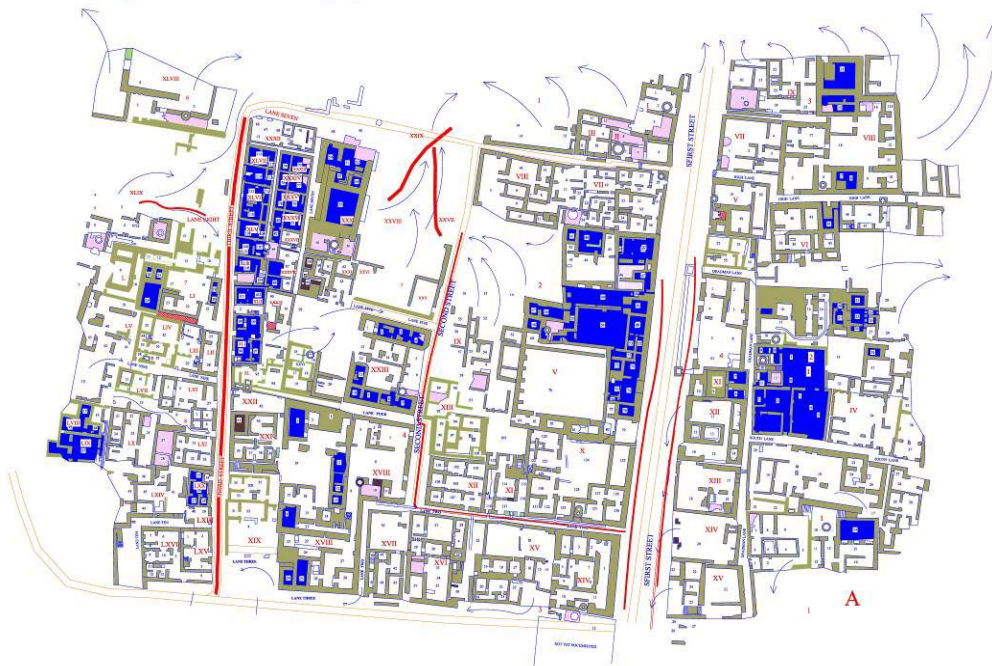
## H-R AREA

- Rooms (or courtyards )without water flows outlet
- Paths floors endangering the walls structures (concrete slabs precast slab with slopes leaning towards walls)
- flow of water
- Narrow streets with potentially high flows
- Gullies appeared due to weak drainage system

Example of plan produced by Moenjodaro team after the 1st UNESCO expert mission which were presented and discussed during zoom meetings. Drainage issues at HR area, December 2022.

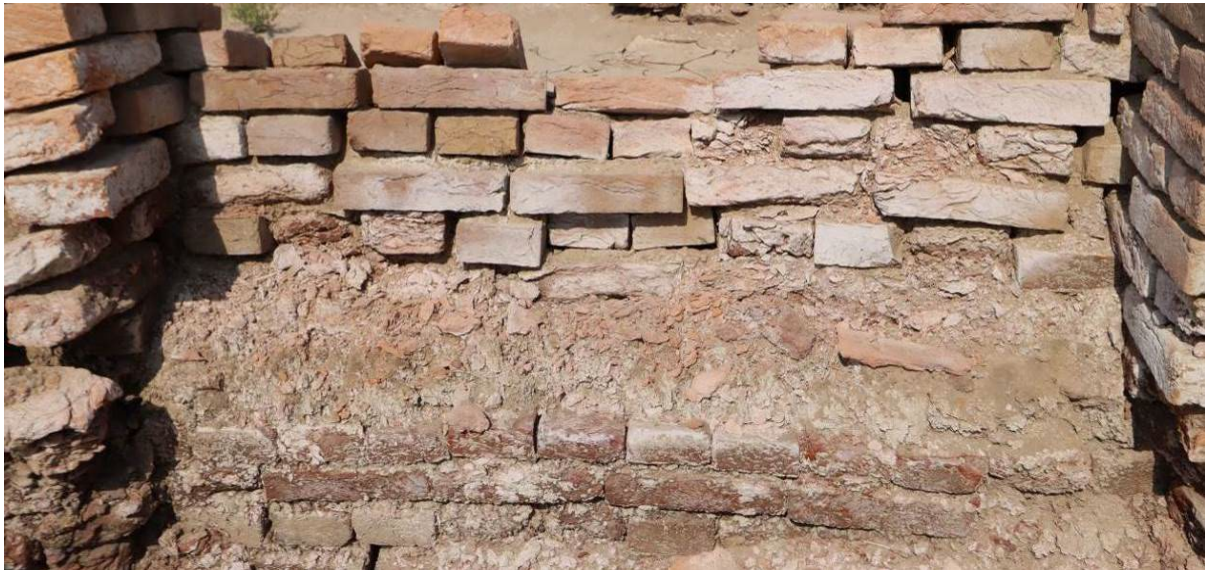
Actually, there exists much evidence that there are substantial differences in their capacity to resist to regular stresses as even at same locations, the state of conservation is very different. The case of the burnt bricks is particularly illustrating that with in the presence of salts bricks in the same course can be in perfect state while another besides it is almost fully disintegrated.

*One of the examples discussed: the variety of quality of burnt bricks is very visible on this wall at DKG area, very good state at the base, almost fully disintegrated in the middle, acceptable at the top*

This calls for launching a process for re-installing a more systematic process for the quality of the materials being used at Moenjodaro, both for the earth and for the burnt bricks:

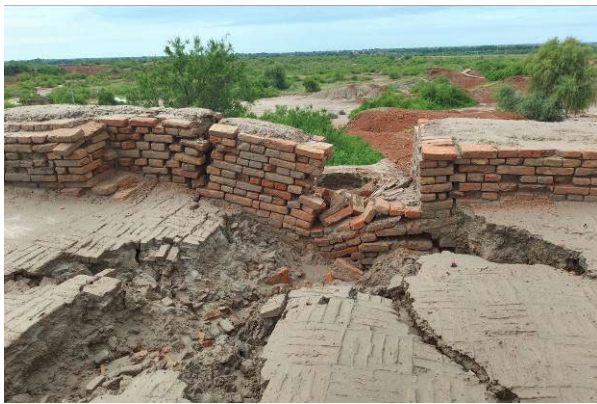
*Failure of drainage system at SD area © N. A. Sangha:*

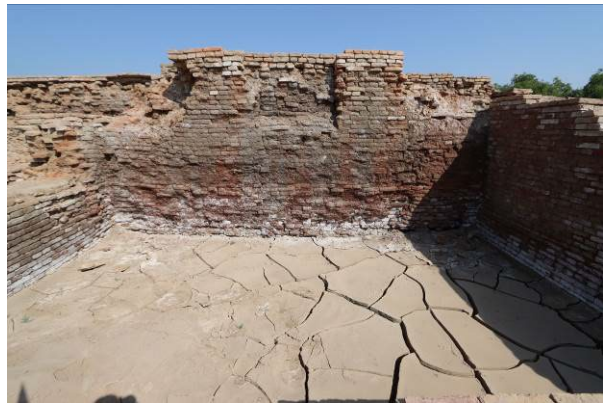
*Temple at HR area, with traces of high water level*

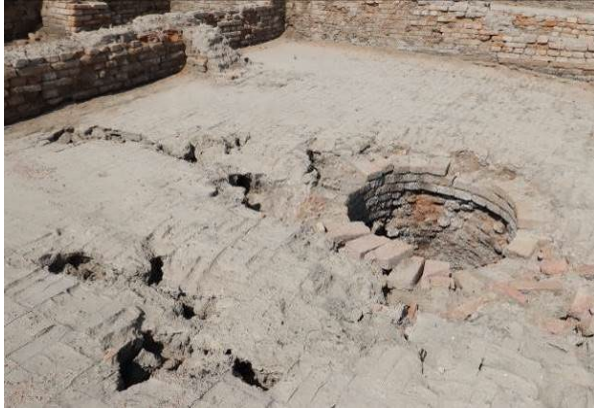
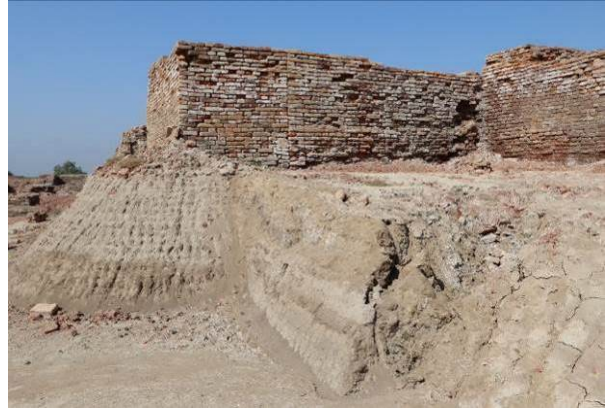
One should note that the system used at Moenjodaro for the treatment of the floors (sundried mud bricks laid on a layer of sand) though giving satisfaction for draining water flows in regular raining circumstances, has proved ineffective (if not dangerous) when run-off is higher, infiltrates under the brick layer, resulting in washing of the sand layer and further, acceleration of the erosion process of gully formation.

*Gaps left by eroded sand under mud brick floor SV area Pushta protection affected by water infiltration HR area*

1. Replace the sand layer of the pavement technique by mud mortar
2. Use of drainage pits at the center of the rooms where it appears impossible to install exhaust pipes
3. Use of wells for drainage when existing / possible (HR area)
4. Modify pavement slopes when they drive runoff towards wall basis (L area)

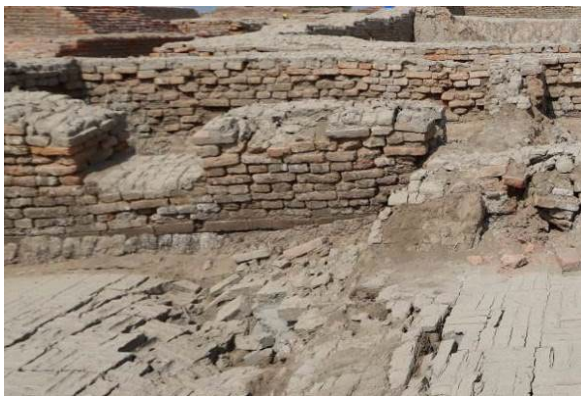
Besides that, this system is allowing water infiltration through the bricks and then through the layer of sand down to the original fabric. The resulting issue is that this humidity is like trapped under this layer of sand with the only potential of being evaporated through wall structures, at times above ground level, but also when structures are forming terraces (more specifically the case of the stupa zone, but not only), and as such, increasing the potential of crystallisation of salts on their surfaces (see next chapter).

*Traces of high humidity content under floor SD area Traces of high humidity on retaining wall. SD area*

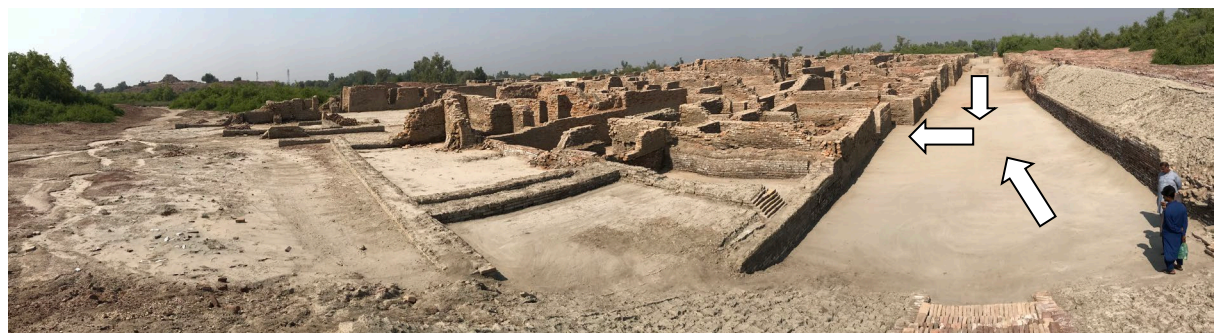
At a larger scale, it was noted that the overall drainage system sometimes involves collection of rainwater from large areas and instead of driving the run-off far from the archaeological remains, drives it inside narrow streets. This is the case more specifically at DK area where the large street at the eastern side drives water towards south but as it is blocked by archaeological debris mounds turns right inside the old city fabric, to finally be drained towards the western canal (see picture below with arrows indicating flows directions. But there are many other similar situations where high run-off is guided towards archaeological remains instead of “to safe discharge areas”.

*The levelling of the large street east of DK south area drives runoff towards the built structures at its western side*

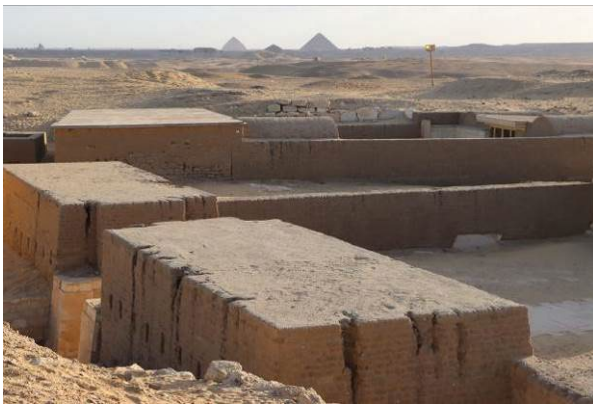
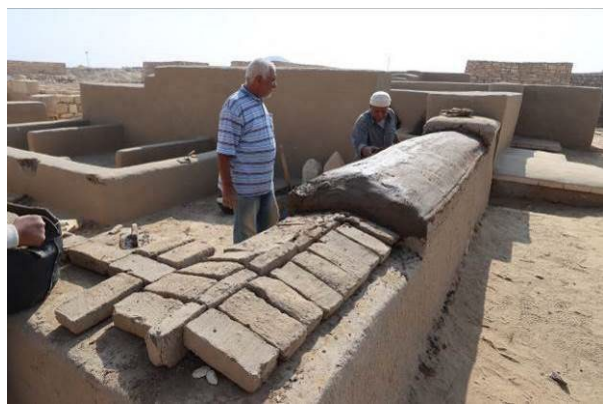
Observing the variety of solutions that had been developed in the past at several individual sites it was observed that rounded shapes were behaving better, allowing for better repartition of the flows of water and so avoiding formation of gullies.

*Left: Typical degradation process (formation of gullies) at Saqqara  
Right : proposed solution for capping (Pepy 1st site)*

This presentation was followed by revising the indications in the conservation manuals while also using some of the recent reports of works undertaken. It was realised that rounded shapes were already quoted as a best solution, though had not been set as compulsory, thus had not been applied for many years. When looking at new risks linked to climate change, it was decided that the adoption of rounded shape of wall capping should now be the rule.

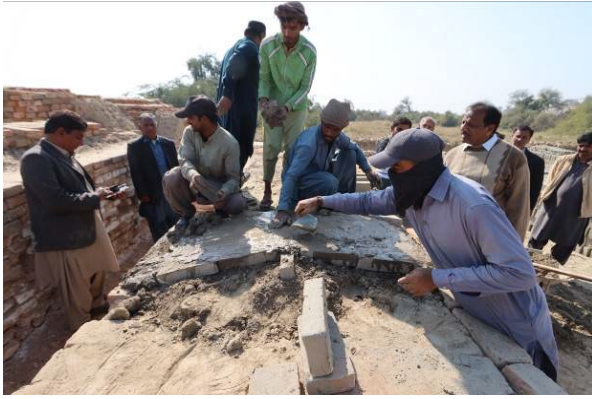
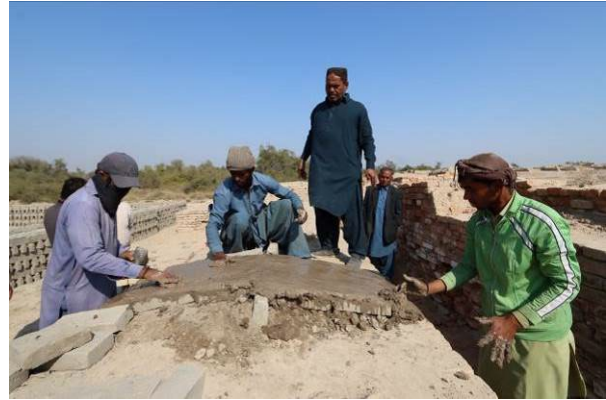
Second was devoted to the preparation of a sample of capping with a rounded shape. It was organised at DK areas entrance where brick making is on-going. The team did show capacity to easily undertake this type of work, while the appearance of cracks in the mortar led to sensitize to the need to take care to the quality of the mix used which do need addition of sand, long chopped straw for the core of the shape and short chopped straw for the final plastering layer.

*Rounded shape capping sample being prepared during field session*

2. For better protection and longer duration,
  - a. Add two brick layers (instead of one only) above burnt bricks before rounded shape;
  - b. First prepare the round shape with bricks and then add first mortar / plaster layer to form the final shape (half inch should be left at the sides for flush finishing of final layer)

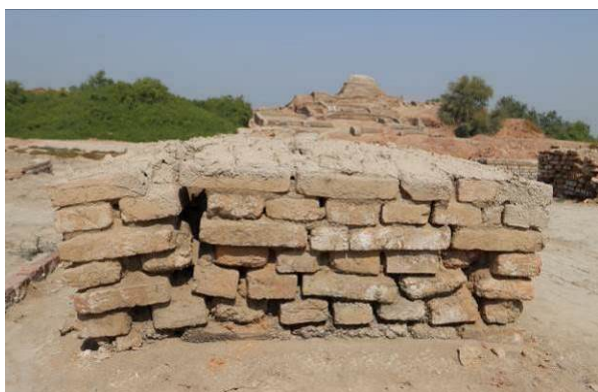
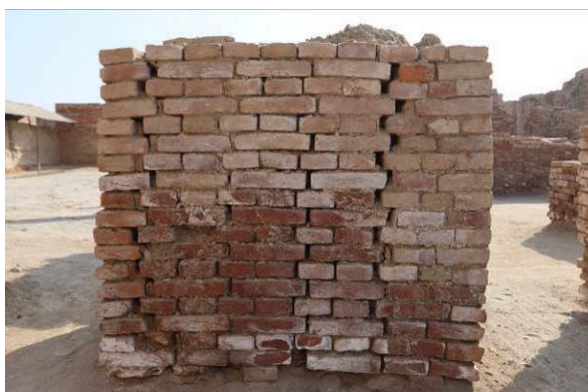
*Two column types of wall (L and DKG areas) illustrating well the typical collapse process starting from the base*

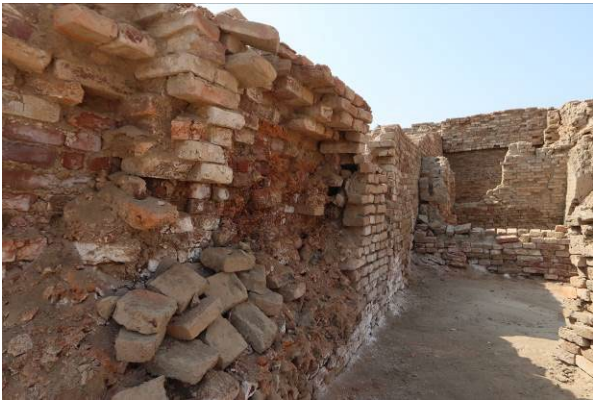
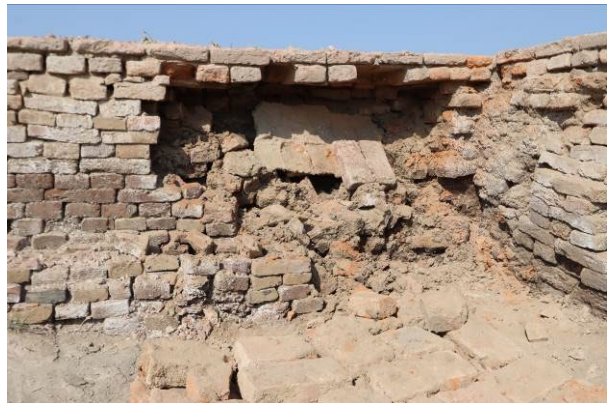
*Wall collapses where salt attack has played a strong role at DKG (left) and HR (right) areas.*

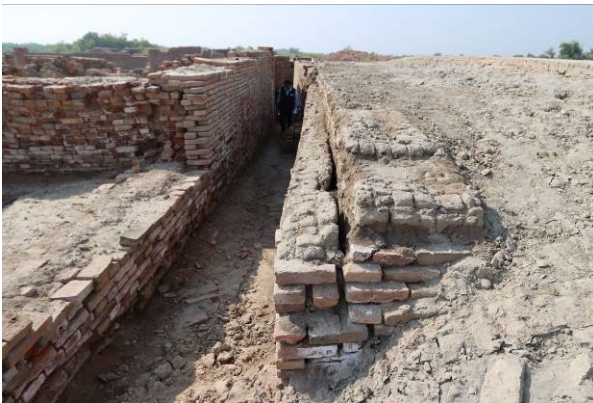
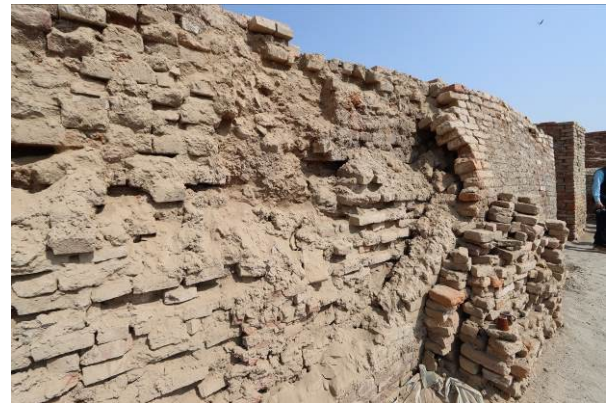
*Two stages of the process of separation between the new and the old parts of walls, DKG area.*

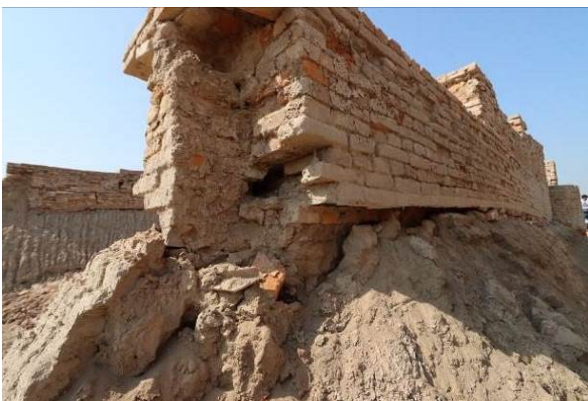
*Damp proof course at DKG partly efficient*

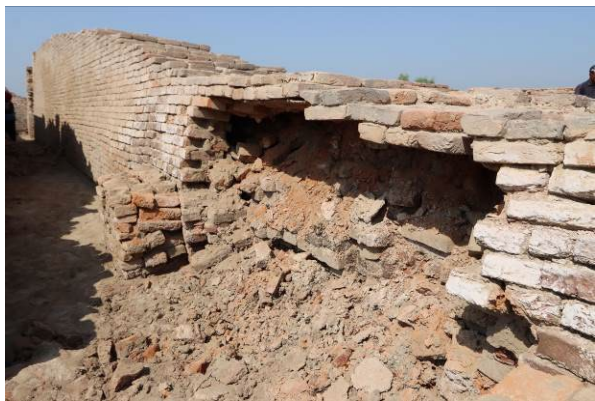
*Concrete layer between the two last brick courses at HR*

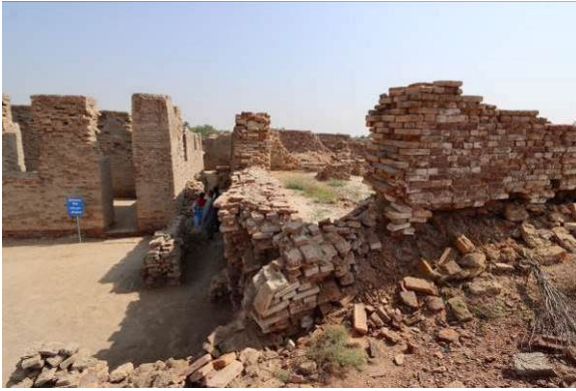
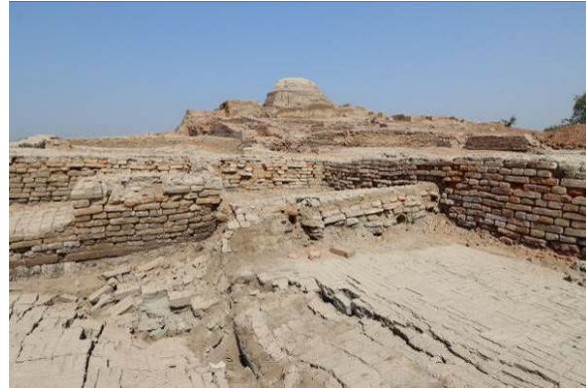
*Pressure against walls by backfilling of platforms / rooms floors, DKG area (left) and SD area (right)*

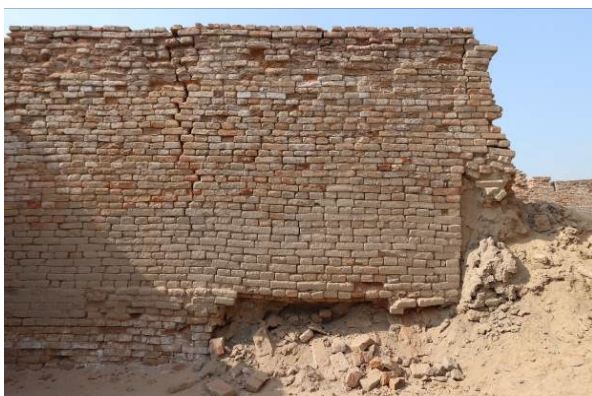
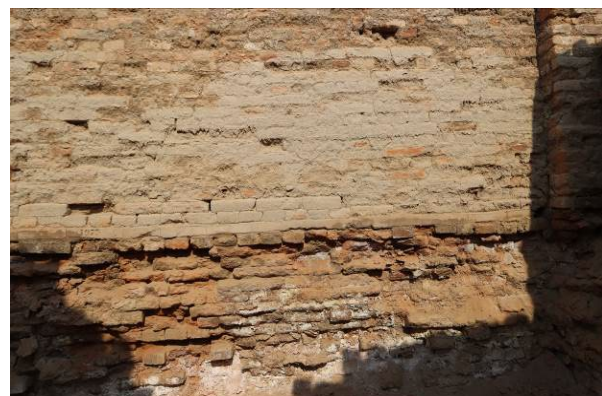
To address the priority discussed (see above), it was decided that the site visit should be organized at DKG south where numerous cases of wall basis decay can be observed, some affecting very high structures which require specific care. That has led to discuss what would be the best methodology of intervention with giving specific attention to security measures prior to intervention. That led to recommend:

*Wall seriously affected where most of the field discussion occurred (DKG south area)*

- . provision of security equipment for the workers : helmets, security shoes;
- . detailed observation / understanding of the weaknesses and risks linked (more specifically when wall base is attacked on both sides);
- . definition of an intervention strategy, starting with the easiest part to be treated (often at the ends of the “destructive furrow” and further possibly portion by portion);
- . strutting with wooden structures if felt necessary for safety;
- . strutting with truck jack(s);
- . cleaning the gap to be treated (if presence of salt, possibly applying mud mortar for absorption);
- . possibly removing some bricks or parts of bricks so as to be able to accommodate full size new bricks (half or full / stretcher or header);
- . intervention with ensuring proper bonding / proper filling with mortar to avoid evaporation inside the wall and thus salt accumulation.

5. Repair should follow the following rules:
  - a. Work slowly : not more than 3 layers of bricks laid every day so as to ensure that there is minimum settlement of the new masonry and thus best liaison with the old one

- d. When the repair reaches the top of the gap, wait for the new masonry to settle, (at least three days) before filling the last mortar joint. The mortar joint is to be hammered so as to get maximum compaction and best connection between the repair and the upper part of the wall;

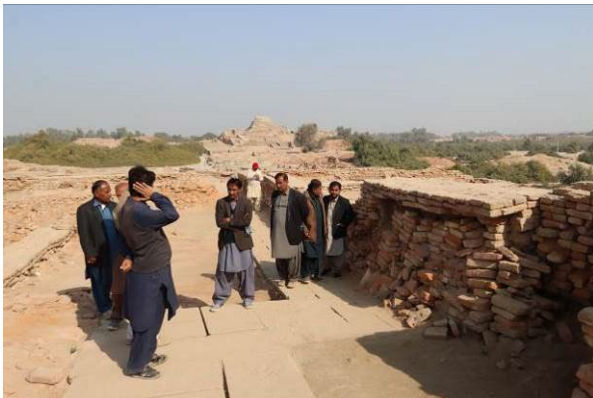
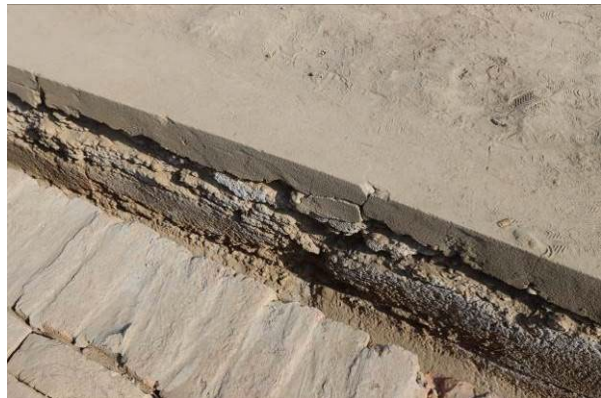
*Discussion on the negative impact of path on a wall at L area*

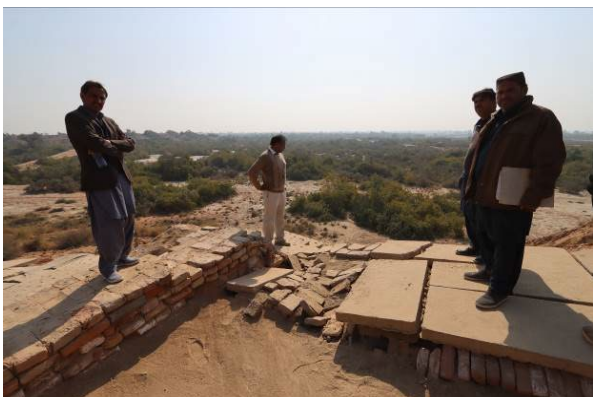
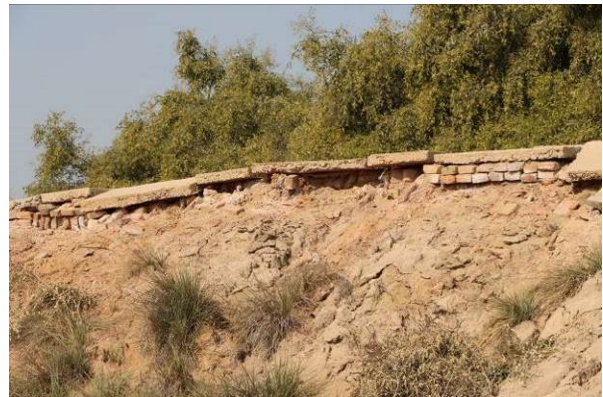
*Observation of the decay of a concrete slab path and taking stock of its dangerousness, leading to the recommendation of closing this path to the public.*

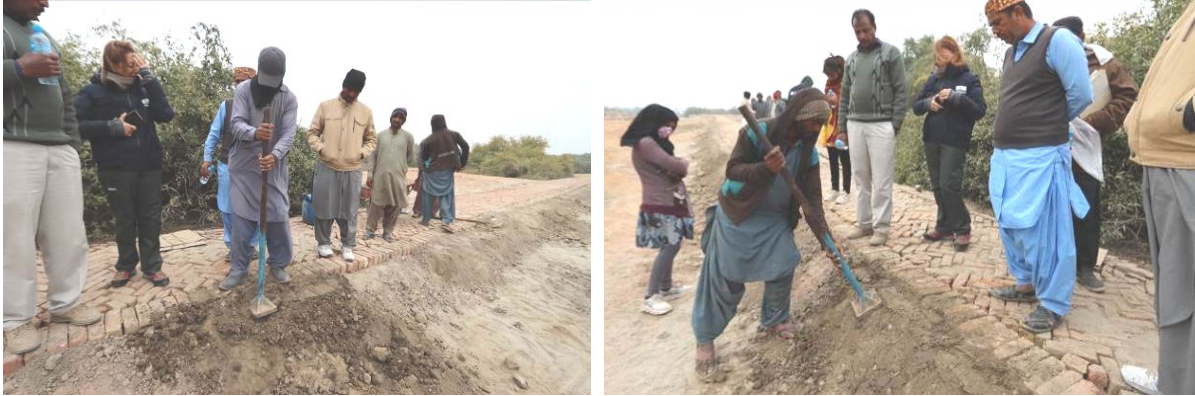
*Demonstration of the rammed earth technique adapted to the construction of “high resistant shoulders” for ensuring long term durability of all types of paths (avoiding erosion at the sides), path under repair at the south east of DKG south area.*

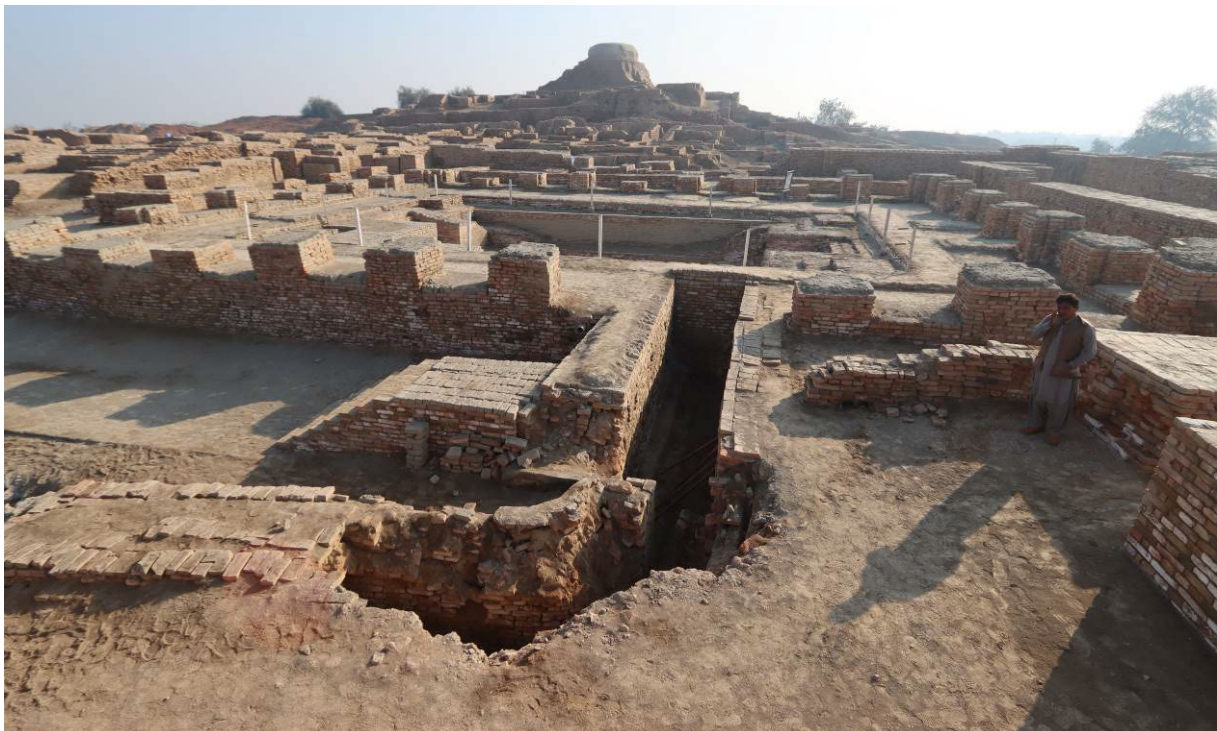
### Bath canal at SD area

The inspection made by the workshop participants revealed that the cause of decay was not the canal itself (the canal from the bath was obstructed, that was probably the cause of decays in the bath pool walls, already repaired). The cause was rather the water runoff which after careful observation of slopes started to form on the other side of the pool itself (more than 60 m away).

That established, the restoration was discussed but which led to a very specific question that of the reconstruction of a corbelled vault, which would not be too difficult, but in the case of this canal which is forming a turn (about 110°). What could be the bounding for that? As

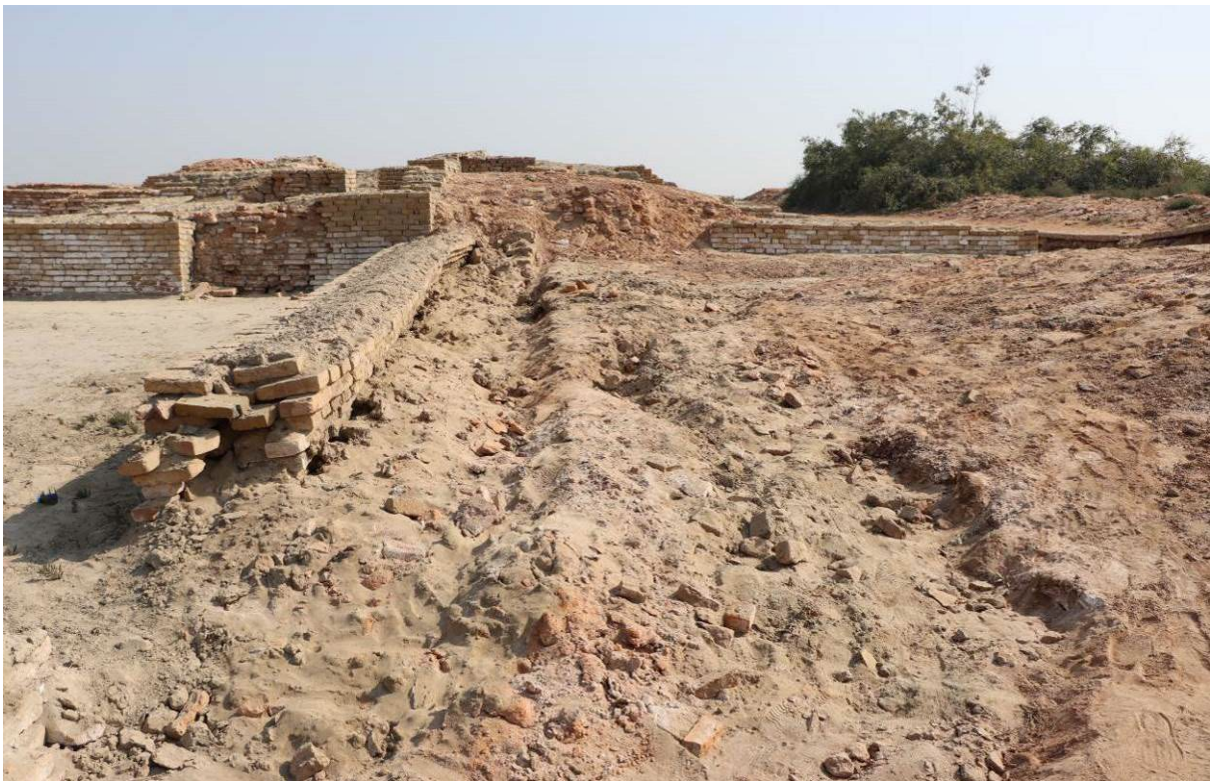
### **Baths canal at HR area :**

Similarly to what has been observed for the bath canal at SD area, the diagnosis at HR area for the two covered canal concerned was that the destruction (partial) was not linked to the presence of the canal, but being the result of water runoff too close to the external wall.

Risk of further collapse are now quite limited and as there are many other works to be done elsewhere, it was decided that rather than launching a restoration process, a preventative measure should be taken, that of releveling the ground at the side of the canal so as to make sure that water runoff would be at least 3 m away on the south side.

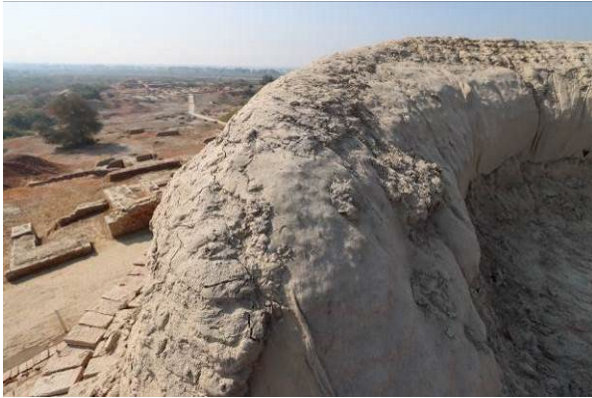
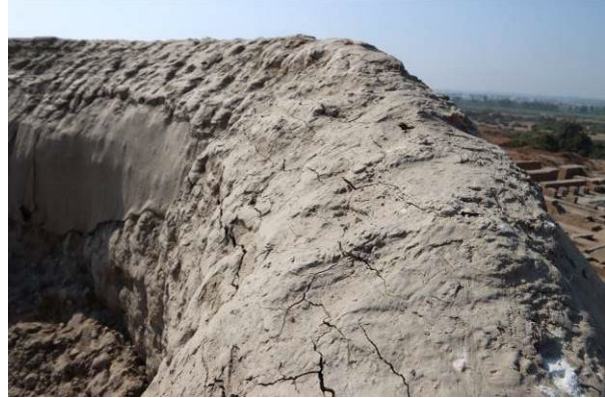
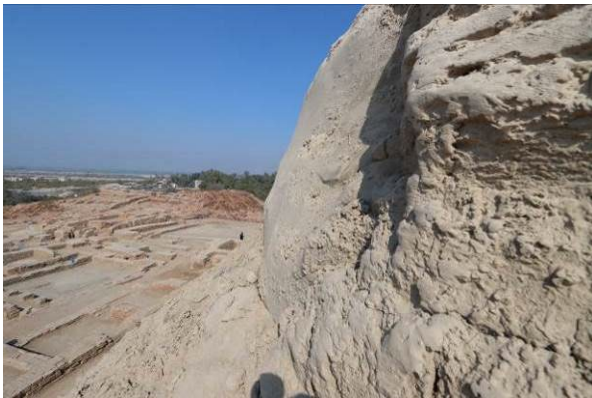
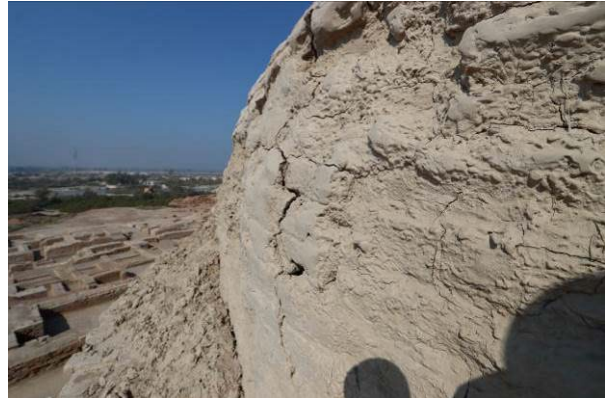
managed to climb up and go round the stupa base. That inspection led to the understanding of a much more difficult situation with several cracks showing that in addition to fallen parts, other remaining ones were not very stable. Moreover cracks at the top and at the sides would 1) offer the possibility to let rainwater penetrate in between the external protective layer and the geotextile and 2) make it difficult to find a strong base on which reconstruction of the protective layer be made.

As the presence of such situation was also visible inside the stupa (a more accessible place) the discussion on “what to do” was organised there. It was commonly agreed that the best solution would be to remove the protective coat and the debris and rebuilt them. On the other hand it was suggested that the protective geotextile be left in place.

Concerning the reconstruction, the masons were asked their opinion. Actually one of them participated in the process some 30 years ago and was fully able to explain how it had been done, making everyone confident that he could do that work (and train younger masons) without needing too much guidance.

Finally it was also agreed upon that the reconstruction process should follow similar specifications as the one for underpinning, with slow progress of the work to be established (no more than three layers of bricks everyday) for ensuring best connection between the old and new part (through avoiding large settlements due to mortar shrinkage and compaction).

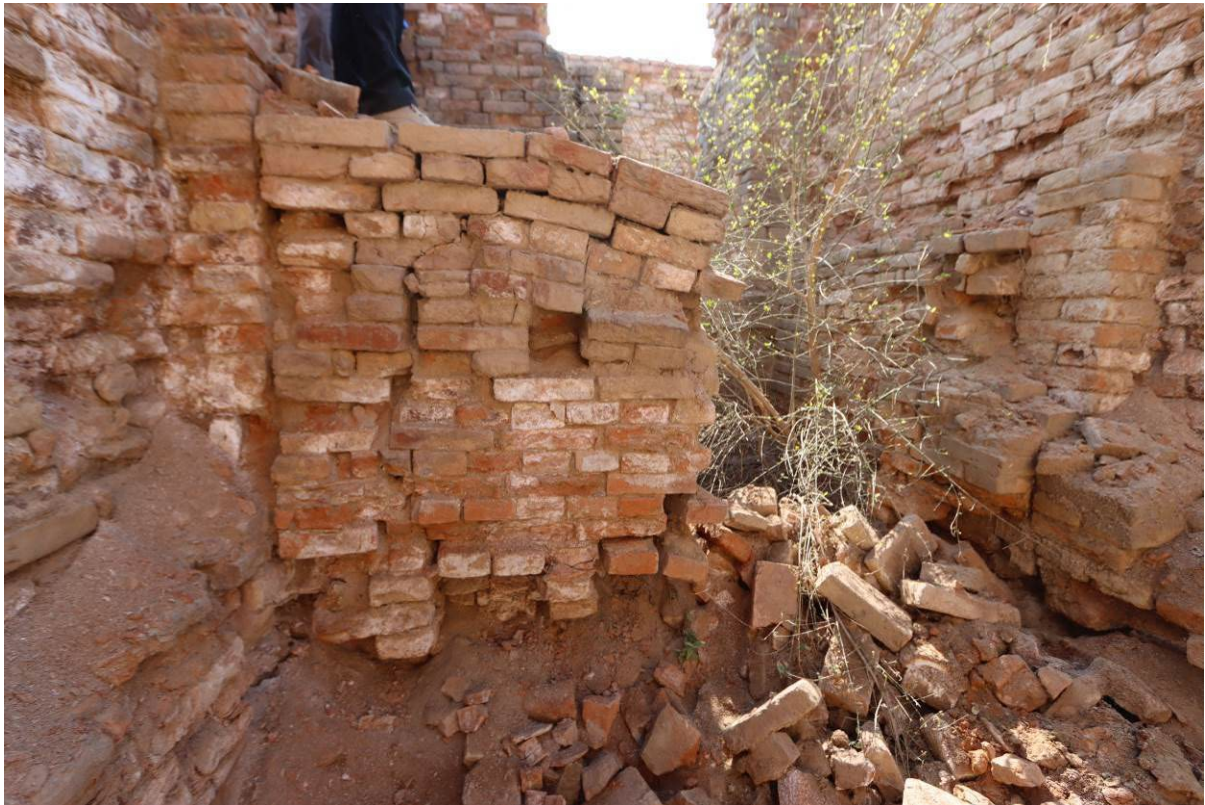
## House without door (DKG south)

Current situation found at House with no door:

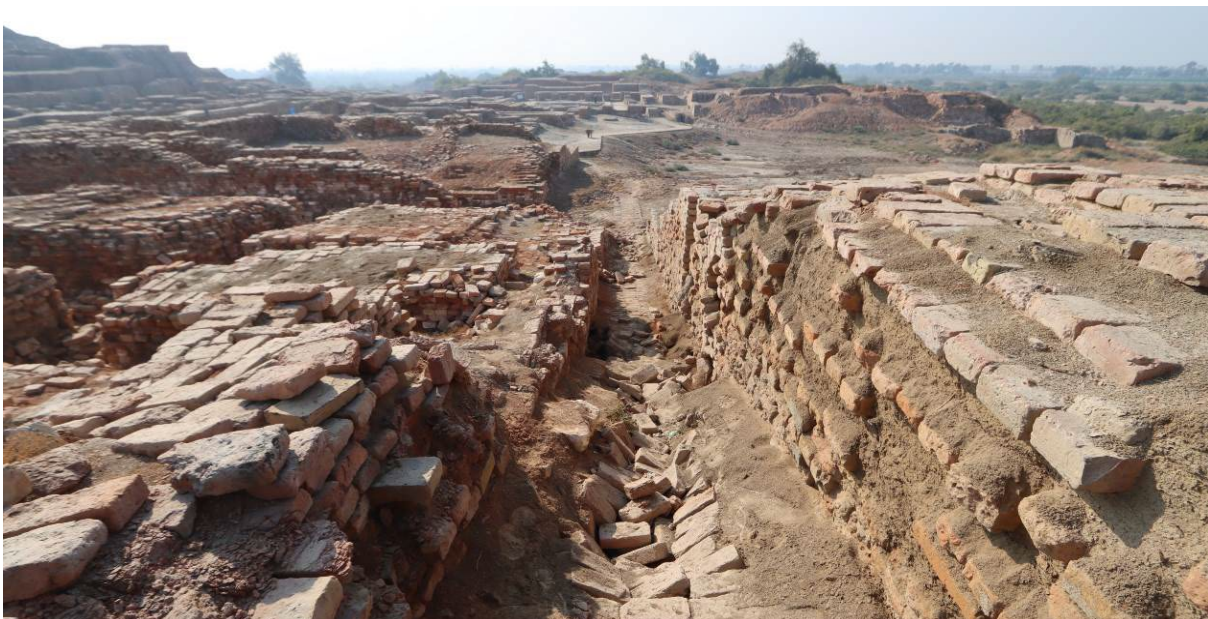
### **No name street**

No name street has been temporarily given to that street as it has never received any name ! It is also in a part of SD area which could not be given sufficient attention these last years. As a result of limited attention and no monitoring some erosion has taken place that has probably much increased during the heavy rains of august 2022. As it is a typical situation which do need to be addressed in emergency, it was also taken as one the studied case study.

As it can be seen on the picture above (p. 33), the weakness here has probably its origin from a base insufficiently compacted for the shallow drain that was rightly installed to properly drain this sloppy street. That has led to infiltration and erosion under this pavement which now evolves towards presenting risks for the walls at its both sides.

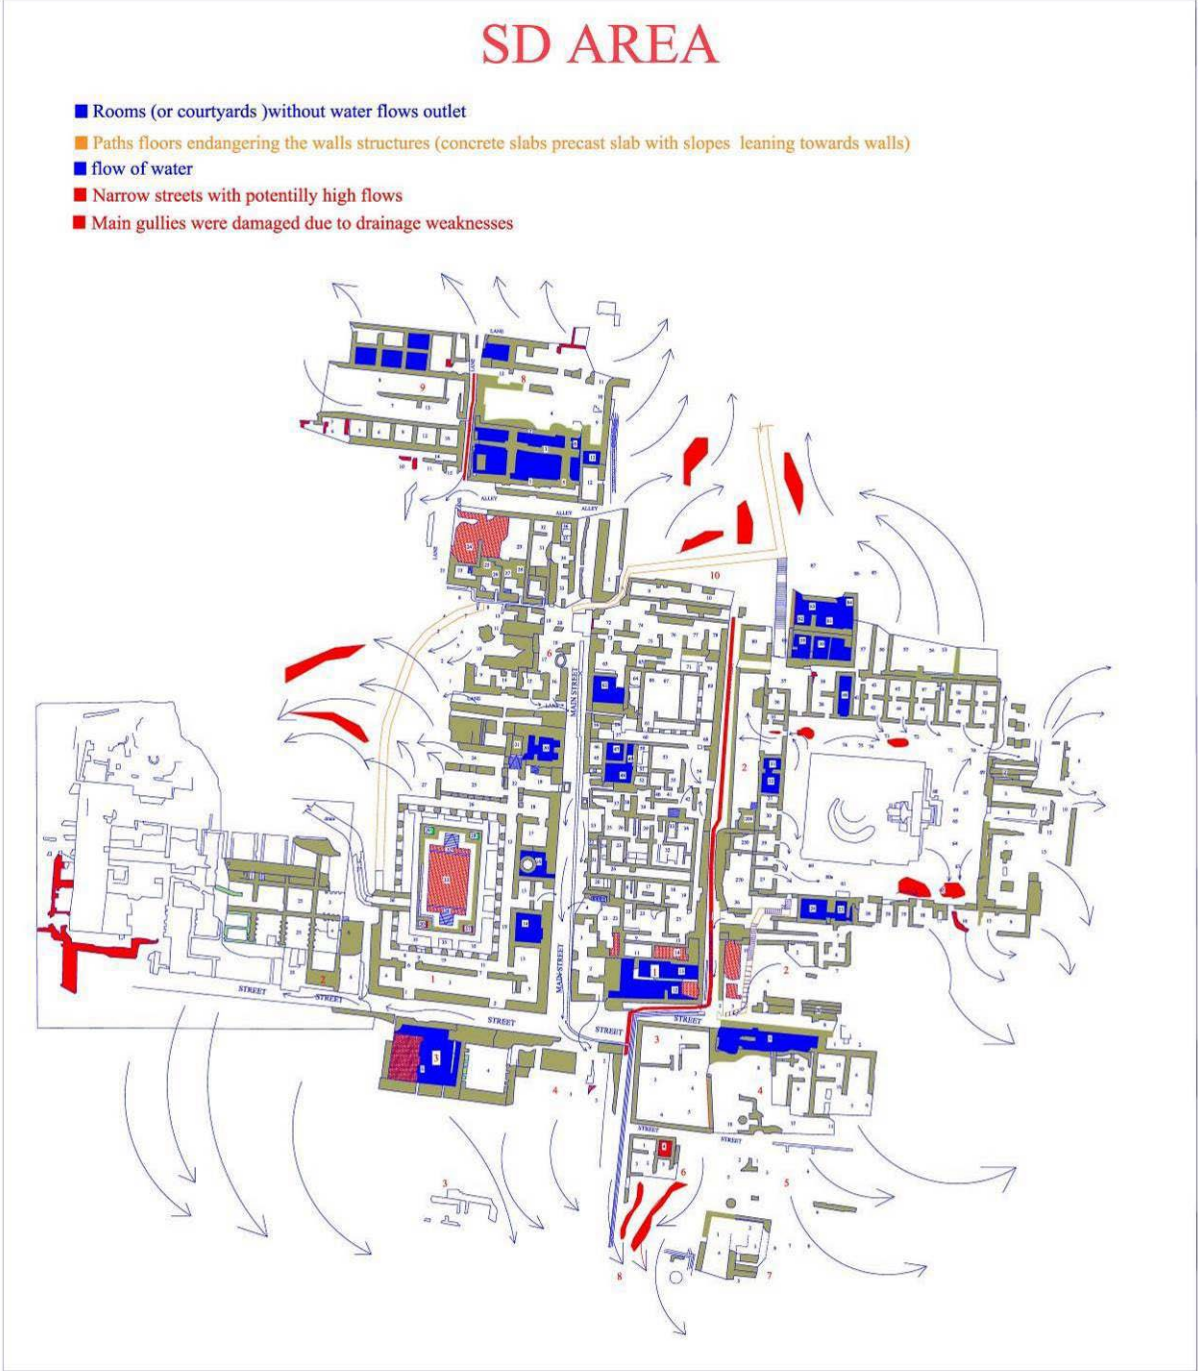
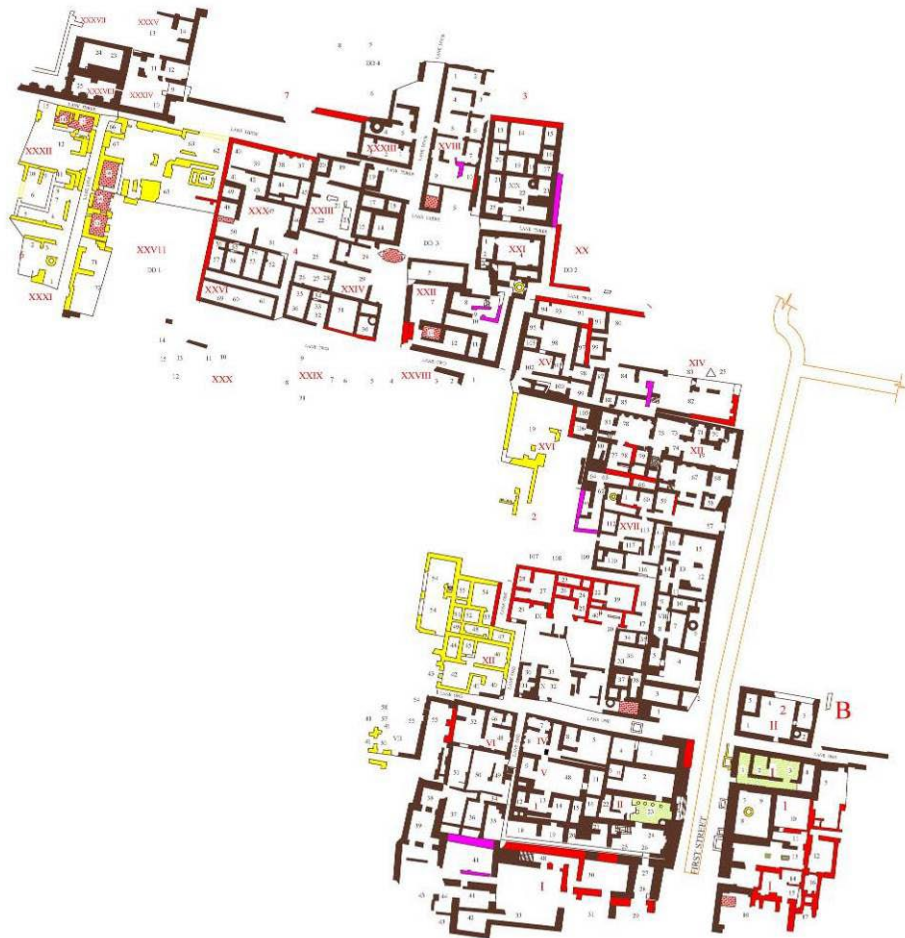
# V-S AREA

- Good Condition
- Underpinning
- Destroyed and need full reconstruction (or reconsideration)
- Structures disappeared due to passage of time

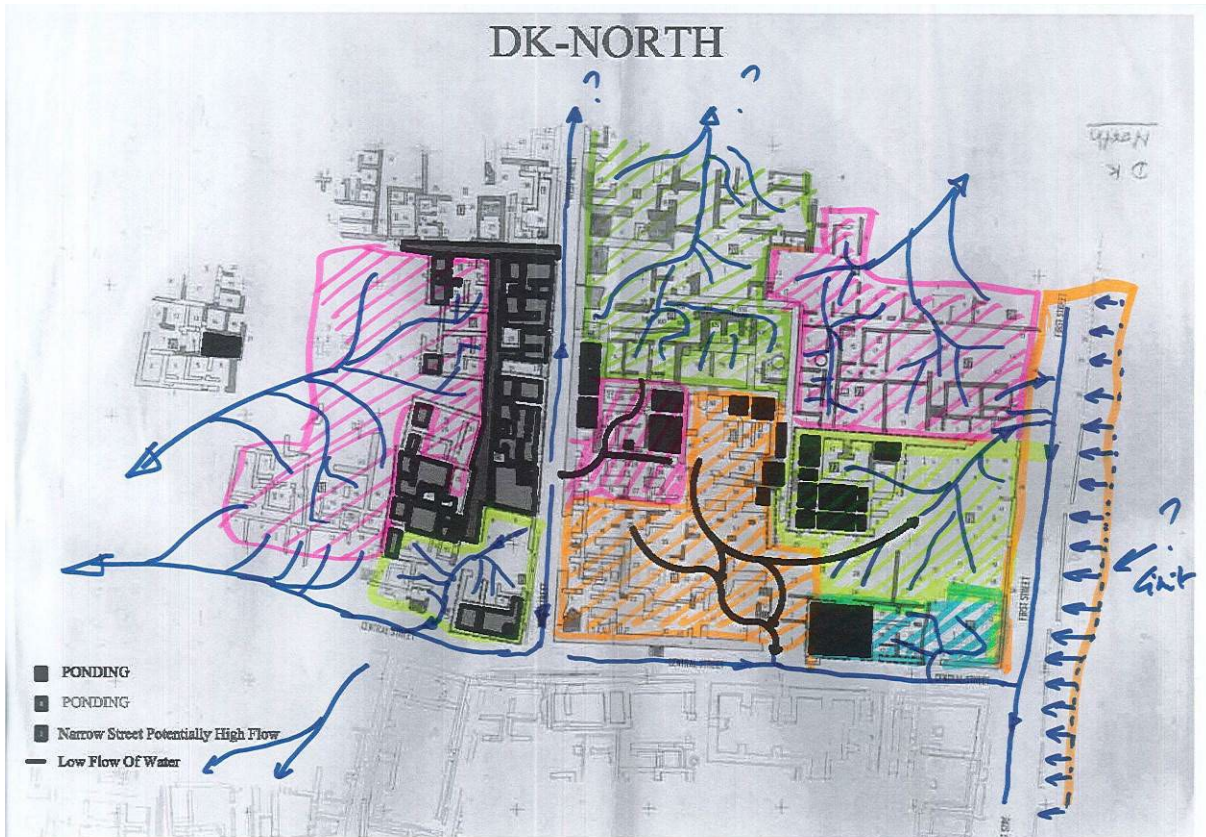
Example of plan provided to illustrate comments made during zoom meeting to MCO team for improving the clarity / pertinence of their production

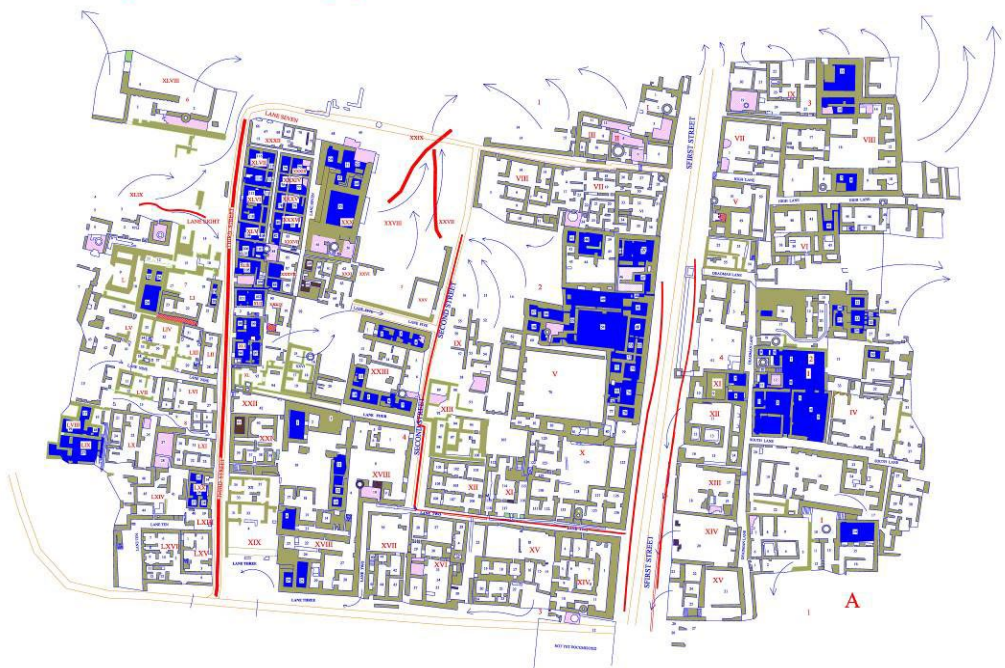
### H-R AREA

- Rooms (or courtyards) without water flows outlet
- Paths floors endangering the walls structures (concrete slabs precast slab with slopes leaning towards walls)
- flow of water
- Narrow streets with potentially high flows
- Gullies appeared due to weak drainage system

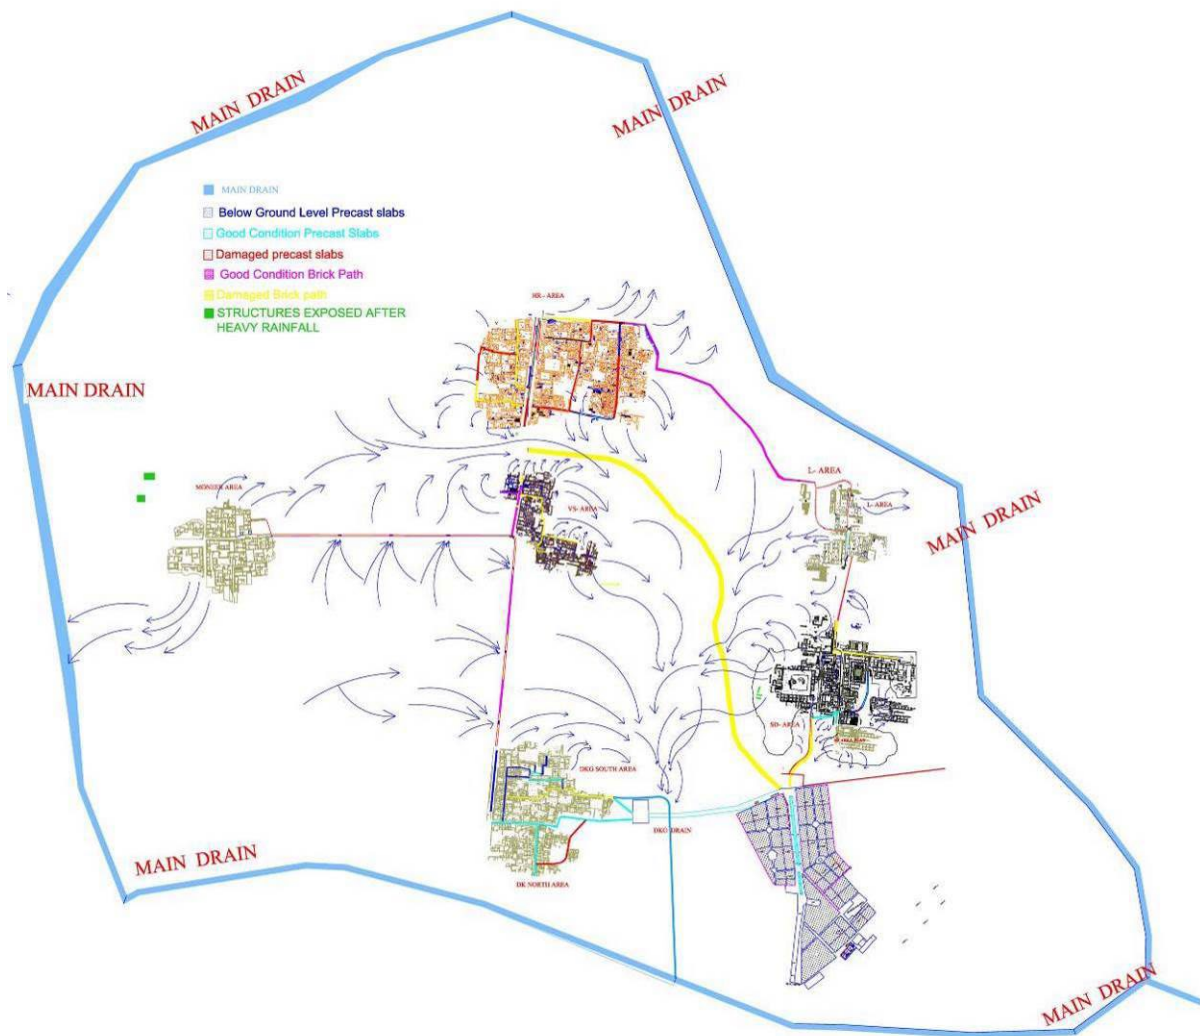
Plan of the overall site showing paths and main drainage slopes / canals
