# Experimental Analysis of Unreinforced Masonry Buildings Through the Quasi-Static Test: A Half-Scale Two-Story Modern Masonry Building

# Experimental analysis of unreinforced masonry buildings through the quasi-static test: A half-scale two-story modern masonry building

## **Abstract:**

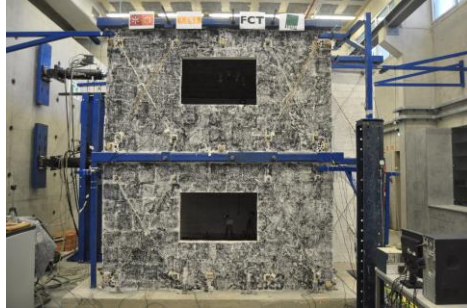
DIC has become widely used in engineering to monitor material and structural response because of its inexpensive equipment needs, wide full-field measurement, and ease of use. Several studies on masonry, such as Ghiassi et al. (2013), Ghorbani et al. (2015), and Rajaram et al. (2017), used the DIC method to acquire full-field information on displacement, deformation, and crack propagation and demonstrated its potential for providing valuable results. Thus, the North façade, where the first cracks were expected, has been monitored through the DIC technique. Firstly, a random pattern of dots has been sprayed with black paint on the façade, preliminarily painted in white to improve the contrast (Figure 5). Then, a unique camera was located approximately four meters in front of the façade to ensure that the camera captured the entire

building. A Sony DSC-RX100M7 camera of 20 Megapixels (5472x3648) using the manual focus has been fixed on a tripod: the diaphragm opening, shutter speed, and ISO value have then been optimized to obtain enough contrast and light in the pictures. Finally, the pictures have been recorded with a constant frequency of 0.125 Hz (i.e. one picture every eight seconds).

**Figure 5.** Building façade that DIC was applied
