Rogers Langat, Emmanuel de Luycker, Arthur Cantarel, Micky Rakotondrabe

# Integration Technology with Thin Films Co-Fabricated in Laminated Composite Structures for Defect Detection and Damage Monitoring

**Abstract:** Despite the well-established nature of non-destructive testing (NDT) technologies, autonomous monitoring systems are still in high demand. The solution lies in harnessing the potential of intelligent structures, particularly in industries like aeronautics. Substantial downtime occurs due to routine maintenance, leading to lost revenue when aircraft are grounded for inspection and repairs. This article explores an innovative approach using intelligent materials to enhance condition-based maintenance, ultimately cutting life-cycle costs. The study emphasizes a paradigm shift toward structural health monitoring (SHM), utilizing embedded sensors for real-time monitoring. Active thin film piezoelectric materials are proposed for their integration into composite structures. The work evaluates passive sensing through acoustic emission (AE) signals and active sensing using Lamb wave propagation, presenting amplitude-based and frequency domain approaches for damage detection

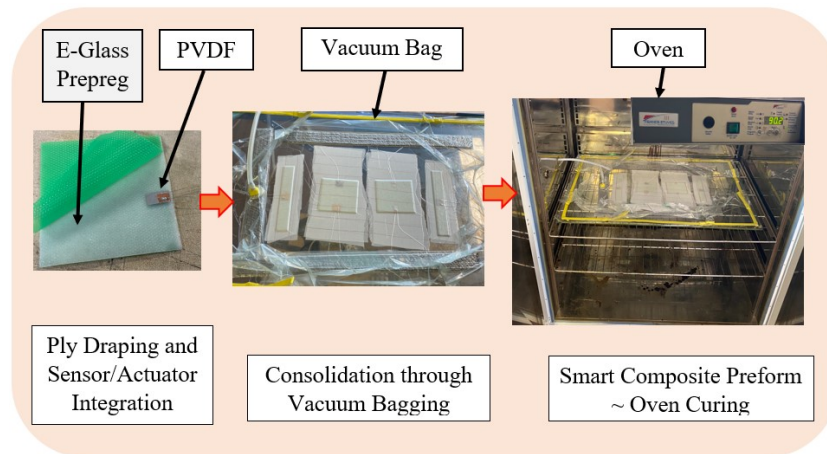
**Figure 1.** Samples' fabrication process through consolidation molding with a curing temperature of 90 °C for 90 min.

Following a vacuum-assisted consolidation molding process, depicted in Figure 1, smart composite samples of varying sizes were fabricated by an embedding technique. The approach employed aligns with the design and fabrication processes detailed by Langat et al. [8]; nonetheless, in the present study, distinct materials and a unique wiring procedure for the active elements were utilized.

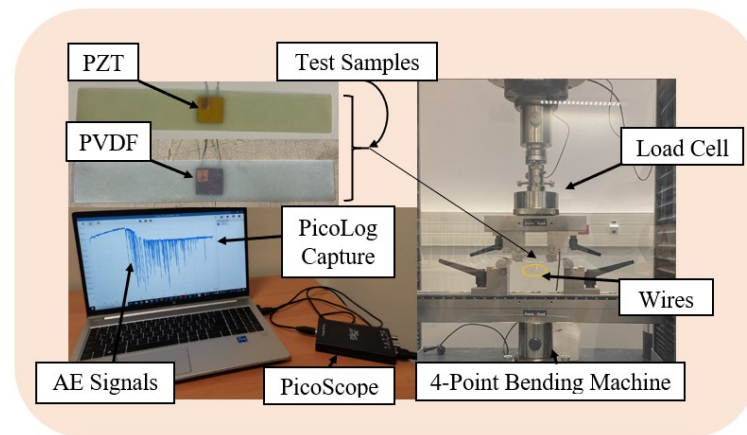
**Figure 2.** Four point bending test of the fabricated smart composite plates featuring embedded PVDF and PZT sensors to investigate passive sensing approach through acoustic emissions (AE).

The experimental setup for the analysis of the potential of the embedded PZT and PVDF patches to detect faults within fiber-reinforced composites in real time while in passive mode is shown in Figure 2. The 200 mm × 30 mm × 1.7 mm smart composite beams presented in the figure below were subjected to a 4-point bending test on the Zwick Roell Z100 material testing equipment, manufactured by ZwickRoell (Ulm, Germany) to facilitate this evaluation. The loading span was set to half of the support span, following the ASTM D6272 standard [40]. The test sample was preloaded to 1N and continually deflected with a 5 mm/min cross-head speed until it failed.

Concurrently, after reaching the preload value, PicoLog 7, a data logging software in streaming mode, was set to collect real-time data from the embedded sensor and display the response, which relied on the PicoScope 2000 series (2204A) for data acquisition. This recording provided relevant information for the SHM evaluation, including the time of material failure and the maximum flexural strength that it could withstand shortly before damage propagation. In contrast to other studies within the same framework, such as those conducted by Lampani et al. [30] and Tuloup et al. [41], which solely rely on the evolution of electrical capacitance to evaluate damage, our current work captured acoustic signals. This approach was employed to assess the suitability of both PVDF and PZT materials in detecting damage initiation. Furthermore, it was extended to verify the influence of integrating both materials into fiber-reinforced composite structures.

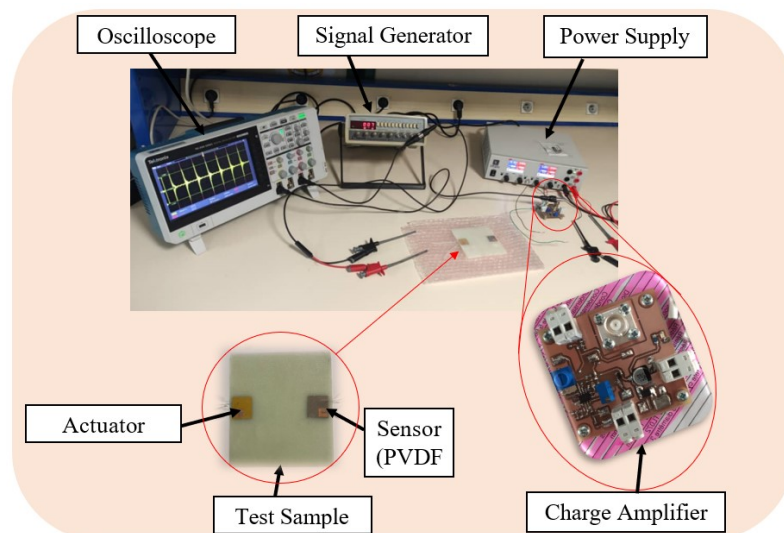
**Figure 3.** Investigation of the active sensing approach through actuator–sensor configuration (pitch-catch) based on Lamb wave propagation. A rectangular waveform with an amplitude of 31.75 V was applied to the PZT at a frequency of 6 Hz.

Figure 3 illustrates the experimental setup utilized in the active sensing approach. A  $100\text{ mm} \times 100\text{ mm} \times 1.7\text{ mm}$  plate with a single pair of actuator sensors underwent testing using the pitch-catch method described in [38,42,43]. Leveraging the sensitivity of Lamb waves to structural damages like cracks, this SHM test employed an embedded PZT to generate Lamb waves. These waves were transmitted across the plate and captured by a passive PVDF sensor. The received signal served as the baseline for an undamaged structure, referred to as “Healthy” in this study. Subsequently, artificial damage in the form of a through-hole was induced, and signal responses from various damage sizes were collected. These data were then compared with the baseline of the undamaged structure, aiming to verify potential variations and assess the feasibility of the active sensing approach for SHM.

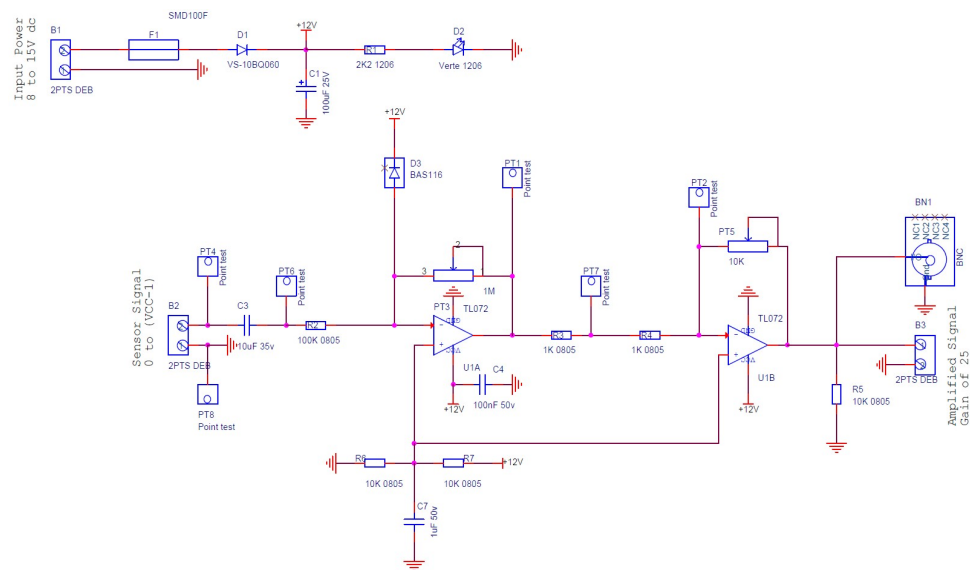
Figure 4. A schematic of the charge/voltage amplifier designed and manufactured to amplify the magnitude of the sensor signal.

Figure 4 illustrates the circuit of the amplifier specifically designed and manufactured for this study. The configuration consists of two cascaded operational amplifiers operating in closed-loop mode with negative feedback. This design ensures that the operational amplifier (OP-Amp) does not reach saturation and functions in the linear mode. At the input of the sensor signal, a capacitor is incorporated to eliminate any DC signal, allowing only the preservation of the AC signal response generated by the Lamb wave. Following the gain formula of the inverting amplifier ( $-R_f/R_{in}$ ) and utilizing the given parameters, the voltage gain was determined to be 25. A simulation was conducted to determine the amplifier’s bandwidth. Figure 5 depicts the simulation results, revealing the  $-3$  dB frequency point at 374 kHz.

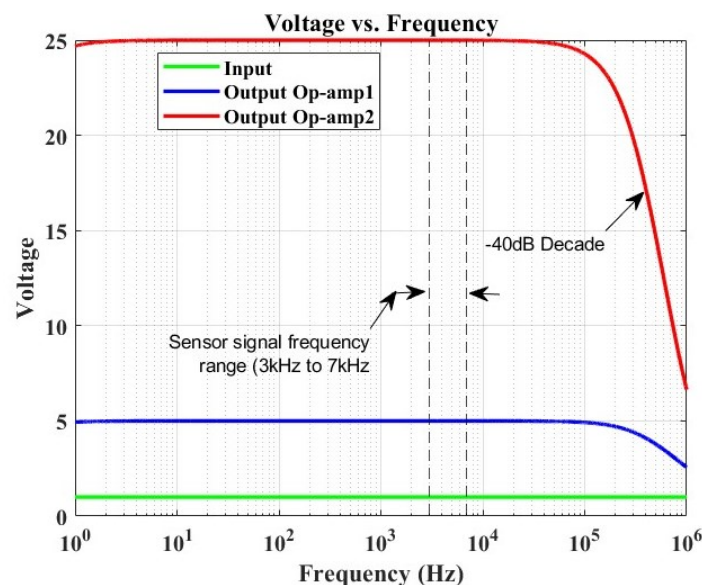
Figure 5. Frequency response simulation of an OrCAD-based amplifier, illustrating a voltage gain of 25 and a  $-3$  dB frequency point at approximately 374 kHz. The sensor signal frequency range demonstrates a constant gain without any filter interference.

The primary concern lies in evaluating the impact of the amplifier on the recorded sensor signal. The sensor signal frequencies were analyzed, indicating a frequency range of 3–7 kHz. It was observed that the amplifier did not adversely affect the signal response, as the range remained consistent throughout the frequency response evaluation of the amplifier, with no filter interference. Consequently, the amplified signal was deemed suitable for SHM investigation within the scope of this study.

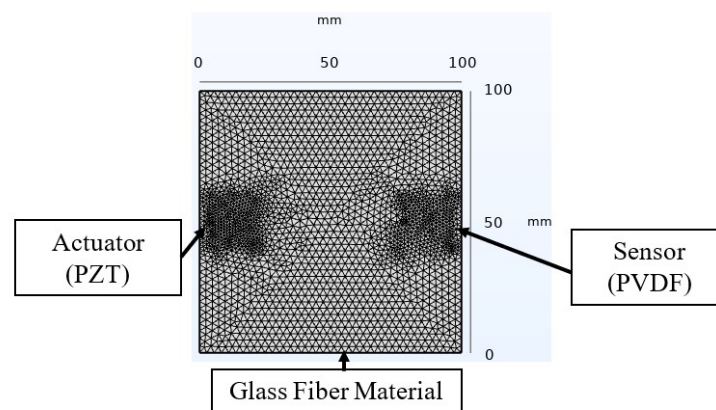
**Figure 6.** Finite element modeling of the Lamb wave propagation technique for SHM based on COMSOL Multiphysics software.

A finite element analysis based on the COMSOL Multiphysics software's solid mechanics module was implemented to complement and validate the experimental data in the study of the active sensing SHM approach. The developed model, illustrated in Figure 6 with the associated dimensions, included defined material properties for the glass fiber (refer to Table 1). For the piezoelectric elements, materials were selected from COMSOL's material library. The analysis assumed perfect bonding at the material interfaces in the smart composite throughout the test, ensuring that no slippage occurred between different layers [44]. In this approach, a step signal was applied to the PZT, and a domain probe captured the transient response from the PVDF sensor. The model utilized a free tetrahedral mesh with a normal density to optimize the computation time, selected after a mesh refinement approach, which showed a negligible impact on the received signal. The study, executed in the time domain, employed a fixed time step of  $3.2 \times 10^{-6}$  s, matching the acquisition period in the experiment. Similar damages to those induced in the experiment were investigated to analyze the variability.

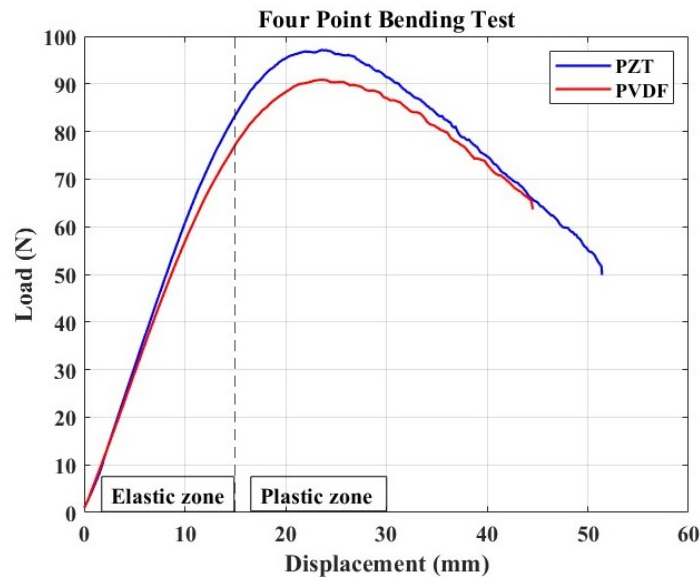
**Figure 7.** Load–displacement curve resulting from the 4-point bending test with noticeable linear (elastic) and non-linear (plastic) zone. Maximum load attained by a sample with PZT is 97.1214 N, and it is 90.8469 N for that with an embedded PVDF patch.

The load–displacement curve from the four-point bending test of the specimens with PZT and PVDF embedded is shown in Figure 7. This test was carried out solely to determine the mechanical behavior of smart composite materials when these two different types of piezoelectric materials are embedded, as well as to conclude their suitability to act as passive sensors while selecting the best that can capture the AE signal for continuous damage monitoring. This study is necessary since the literature has supported the embedding technique with the aim of protecting sensors from their surrounding environment, while

The loaded samples show two domains in the load–displacement curve: a linear elastic deformation zone followed by a plastic deformation zone with a non-linear displacement. This observation is consistent with the findings of Lampani et al.’s [30] investigation. Indeed, at the start of the test, the specimen bent without slipping on the bottom fixture. Still, as time passed, after the material’s yield strength was reached, significant slippage was observed, with the deflection curvature increasing between the two fixtures, resulting in the non-linear zone depicted in the figure. This result could also be related to the fact that, in the case of four-point bending tests of flexible materials, a zone with a rapid rupture is rarely observed since the material may fail by folding without noticeable cracks.

It is also critical to note the smoothness of the curve shortly after the ultimate strength point. The response becomes non-smooth at this point in the load–displacement curve, which could indicate the onset of BVID in the form of microcracks. This decision is intended to be made based on the signal acquired continually in this setup, as these damages are

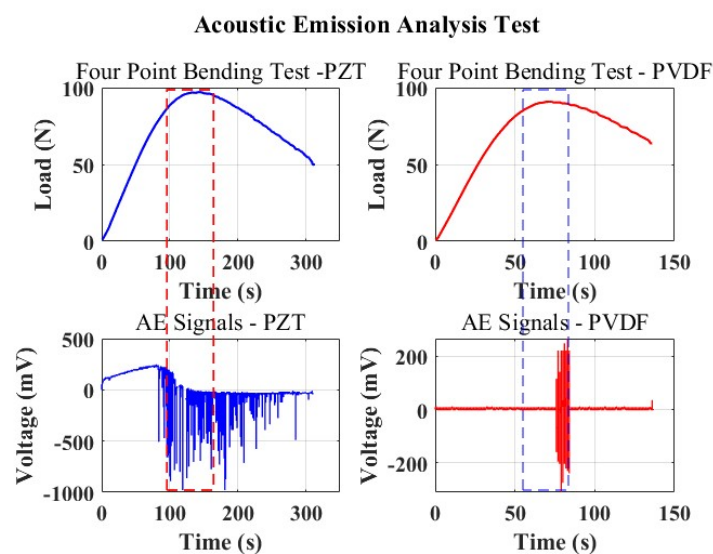
**Figure 8.** Acoustic emissions generated from the micro fractures in the loaded smart composite beam alongside the load–time curves.

Figure 8 depicts the signals of AE events recorded during the bending test, alongside the load curves plotted against time. This presentation aims to visually capture the evolution of the AE responses with reference to the mechanical behavior of the material subjected to the test.

The first curve in blue corresponds to the responses of the samples bearing PZT as a sensor. It can be seen that within the linear domain, where the beam experiences compression from the loading points with a linear displacement, the PZT experiences tension and yields a slightly linear positive response, as can be observed from the AE events captured. This could be explained by the fact that, at this point, the PZT remains compliant with the bending of the host structure. Immediately, the yield strength of the material is reached at the 90 s point, the interlaminar stresses become significant, and the displacement at this point is close to 10 mm, where the material starts to slip, beginning to create a large curvature and non-uniform displacement, leading to the bending of the PZT material as it nears the yield strength; this explains the sudden change in voltage to negative.

Realizing the nature of ceramics to be brittle, a clicking sound from the cracking PZT could be heard as the bending progressed. Despite this, the sensor remained stable, consistently capturing AE events. The commencement of damage elevated the compression forces on the PZT at the material's maximum yield strength, resulting in peak responses. Indeed, as the bending strains weakened the beam's mechanical performance, the sensor constantly detected AE hits. The cracking sensors suggest that the origin of microcracks within the material aligns with the embedded sensor region. This event causes a concentrated concentration of stresses, which may help to explain the unpredictable signal recorded by the PZT.

In contrast, the smart composite beam with a PVDF sensor, unlike the former, remains compliant with the loading due to its flexibility and tracks the bending of the structure while remaining sensitive to any damage. The PVDF sensor records an acoustic signal and continuously registers this signal until the load is no longer increasing as a result of the failed structure and continuous slippage of the beam. In Figure 8, it is evident that the responses from the PVDF (depicted by the red plots) exclusively capture the signals as the material surpasses its ultimate strength. This observation signifies the detection of AE signals, indicating the occurrence of actual damage to the structure.

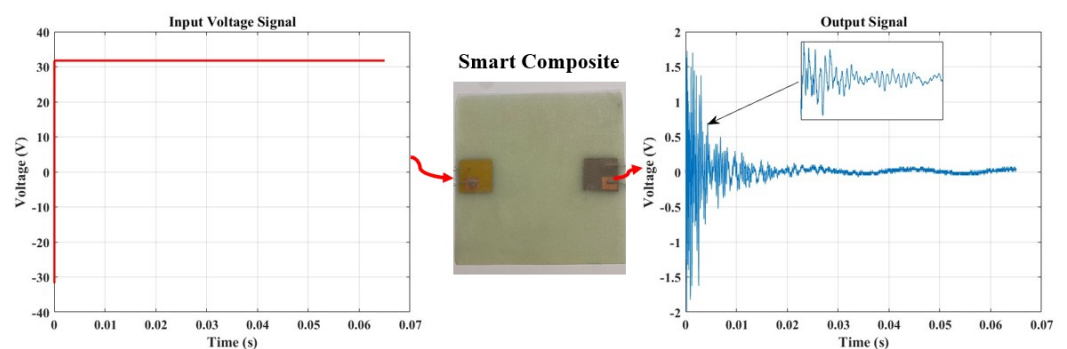
**Figure 9.** A single actuator sensor path illustrating the pitch-catch approach for damage diagnosis and monitoring, with an input signal deployed at a fixed frequency of 6 Hz.

In contrast to the passive method discussed earlier, which relies on damage-dependent signal responses for acoustic wave generation in damage monitoring and severity determination, the active sensing approach involves the continuous generation of elastic waves traveling through a material. Figure 9 illustrates our testing approach, utilizing a pitch-catch technique with a single actuator sensor configuration. In this setup, PZT generates signals by applying a step input signal, as depicted in the figure. Subsequently, a PVDF sensor receives the signals on the opposite end of the plate. The findings given in the preceding section partially influenced the selection of these components.

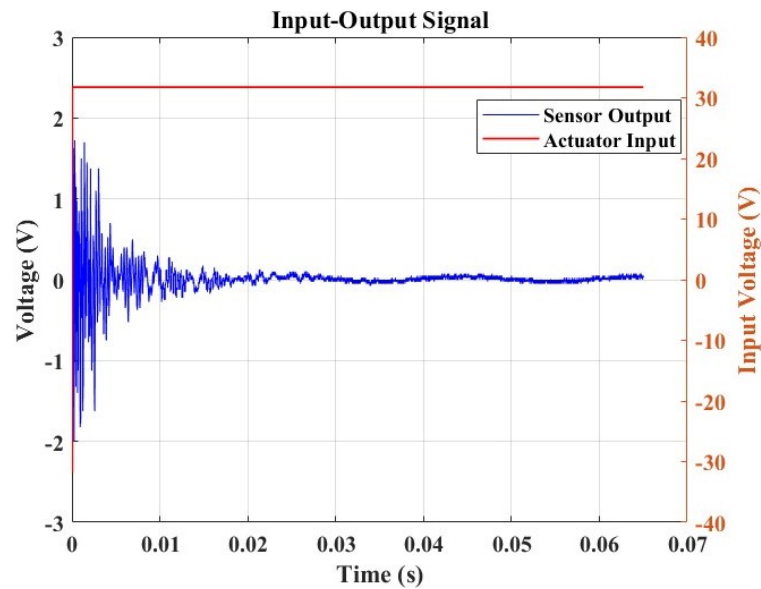
Figure 10. A step response from the pristine sample.

Figure 10 presents this study's step response output signal, which will be utilized in the measurement to validate the feasibility of conducting SHM within this framework.

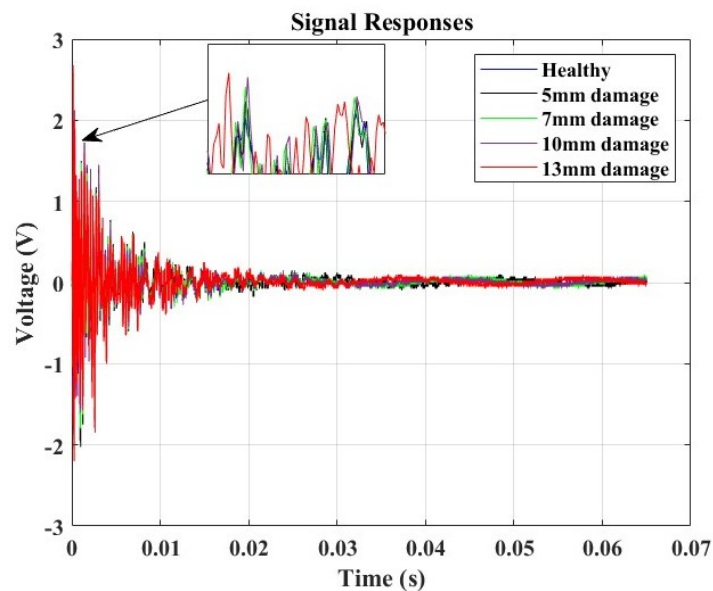
Figure 11. Amplitude response analysis for damage detection and correlation analysis.

Figure 11 illustrates the amplitude-based damage diagnosis approach. The collected data revealed distinct variations in peak amplitude corresponding to the different hole sizes introduced into the structure. Notably, the baseline measurement from the undamaged, healthy structure exhibited a peak amplitude of 2 V. Utilizing a relative difference metric

calculated concerning this baseline, we observed a clear correlation between increasing hole sizes and higher relative differences. The peak amplitudes rose from 2.05 V for a 5 mm hole to 2.675 V for a 13 mm hole, with corresponding relative differences ranging from 0.025 to 0.3375, as illustrated in Table 3. This trend underscores the sensitivity of the monitoring system to structural changes, with larger hole sizes resulting in more pronounced deviations from the healthy baseline. The findings emphasize the efficacy of Lamb wave monitoring in detecting and quantifying structural damages, providing valuable insights for real-time structural health monitoring applications.

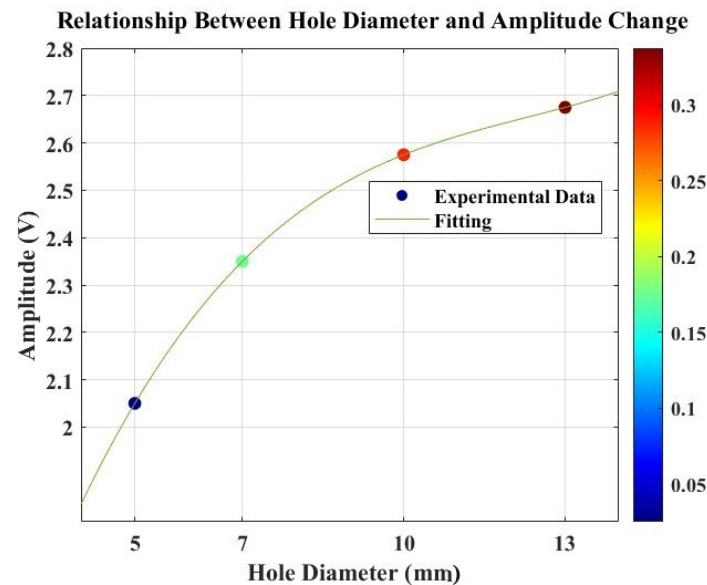
**Figure 12.** Relationship between hole diameter and amplitude responses alongside their relative differences from the baseline signal for damage diagnosis, exhibiting a non-linear relation where the amplitude of the response is influenced by the cubic power of the hole size.

Figure 12 displays the relationship between the amplitude and damage size (hole size). The plot illustrates a correlation between these variables in the structure. The observation reveals that the response amplitude follows a cubic function when a hole is introduced during the SHM test utilizing Lamb waves. This increase in amplitude can be attributed to the altered structural stiffness resulting from the introduced hole damage, facilitating easier wave propagation. To further understand this correlation, a polynomial interpolation approach was employed to fit the response ( $R^2 = 1$ ). The resulting correlation function is presented in Equation (2), highlighting a non-linear relationship between the amplitude and hole size.

$$A = 0.001\lambda^3 - 0.037\lambda^2 + 0.486\lambda + 0.423 \quad (2)$$

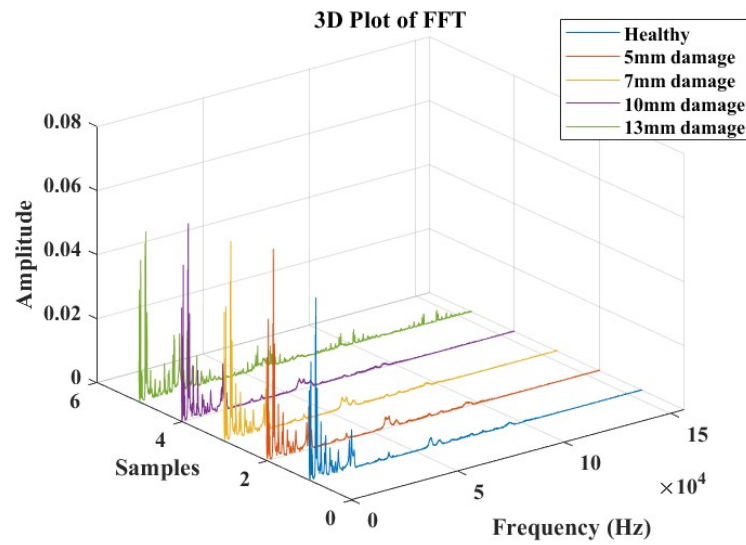
Figure 13. Fast Fourier Transform response analysis for damage detection and severity identification.

In the frequency domain, Lamb wave signals were analyzed using Fast Fourier Transforms, as illustrated in Figure 13. The time domain signals were transformed, considering a data acquisition frequency of 312 kHz. The objective of this analysis was to identify a combination of parameters that could offer an indicative correlation to the response corresponding to the presence of damage. Based on observations from these plots, a specific frequency range between 8 kHz and 20 KHz was extracted (as depicted in Figure 14), where the influence of the introduced damage on the structure appeared to be significant. This extraction was undertaken to streamline the evaluation of pertinent parameters that could offer a reliable damage index for the SHM study.

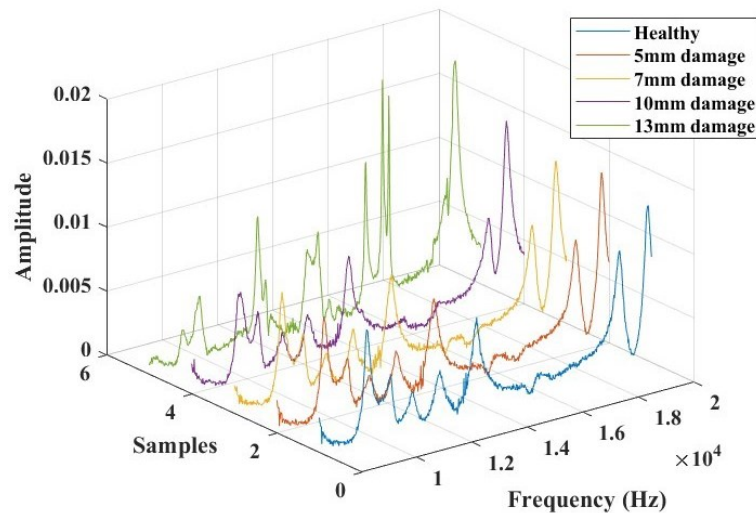
Figure 14. The selected frequency range (8000 Hz to 20,000 Hz) for damage identification feature extractions and analysis.

Table 4 summarizes the extracted parameters, including peak frequency values, the area under the curve, and the centroid frequency. Each of these three parameters displayed an increasing trend with the magnitude of the damage within the selected frequency range. Subsequently, the relative differences in their evolution were computed. This led to

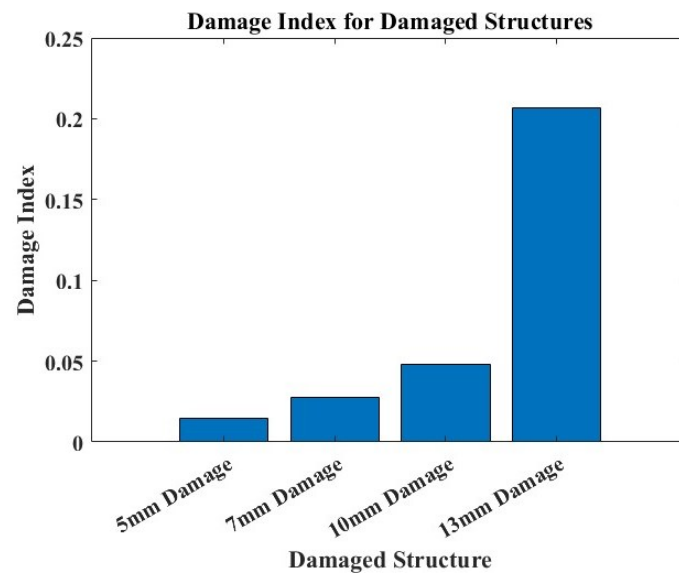
**Figure 15.** A damage index plot of the damaged structure cases.

A damage index plot against damaged structures in SHM is shown in Figure 15. The plot illustrates the variations in damage indices across different structures, highlighting the increasing trend with an increased damage size. The damage indices serve as a crucial indicator of structural health, facilitating the identification of deteriorating conditions that require attention. This analysis supports the implementation of condition-based maintenance strategies in aerospace structural systems.

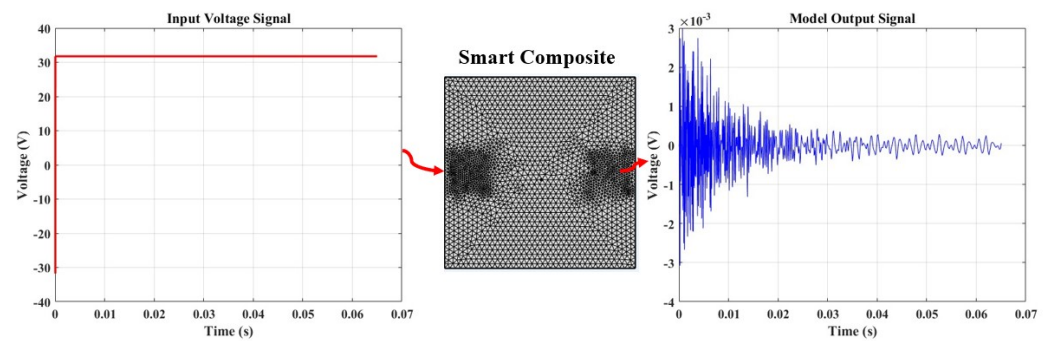
**Figure 16.** The numerical model simulation involving a step voltage input with an amplitude of 31.75 V and a fixed time step of  $3.2 \times 10^{-6}$  s.

Figure 16 displays the outcomes of the finite element method analysis using the pitch-catch sensing approach implemented in COMSOL. The results exhibit a transient response similar in form to the one obtained from the experimental data presented in Figure 9. A similar attenuation trend is seen in the simulation's Lamb wave signal, which converges with the experiment's observed period. These findings complement and validate the experimental study conducted within the framework of active sensing in this work.

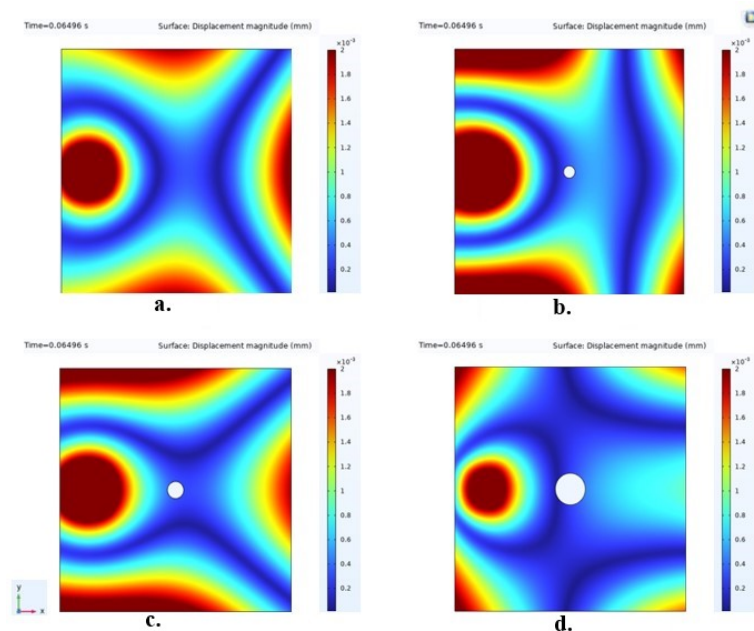
**Figure 17.** The surface plots of the analyzed sample cases displaying the displacement magnitude for visualization of the disturbance created by damage on the Lamb waves. In these representations, (a) illustrates the healthy structure in its intact state, (b) shows a structure with 5 mm hole damage, (c) demonstrates a structure with 7 mm hole damage, and (d) displays a structure with 13 mm hole damage.

The surface plots in Figure 17 illustrate displacement magnitudes with varying damage sizes. An observation reveals that, due to changes in material properties induced by damage, the Lamb wave traveling through this region undergoes scattering in multiple directions—notably, the degree of spreading increases with the severity of the impact on the structure. The signals obtained from this damage diagnosis approach are thus deemed reliable for application in implementing SHM.

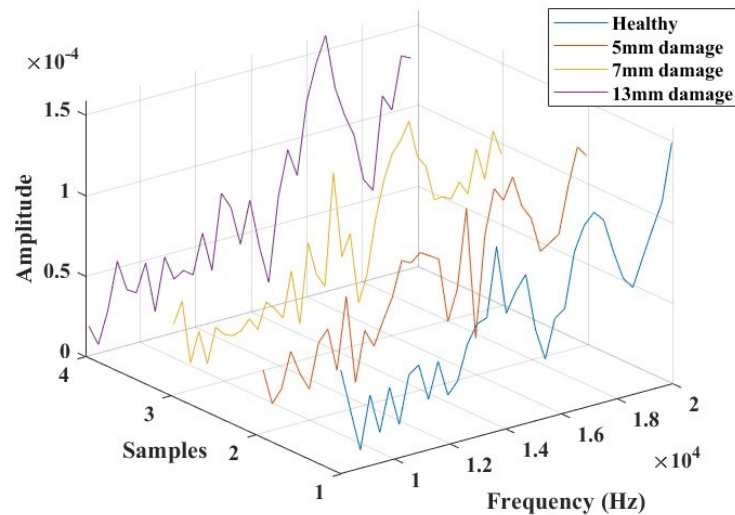
**Figure 18.** The selected frequency range for damage identification feature extractions and analysis for the simulated plate in COMSOL.

Figure 18 shows the resulting plots for this frequency window. The centroid frequency feature, the center of mass of the frequency distribution, which has found interest in the study of AE signals for damage assessment [45] and structural health monitoring, was extracted as a parameter of interest. The results revealed an increasing trend in this characteristic parameter, indicating changes in structural properties.
