Article

Integration Technology with Thin Films Co-Fabricated in Laminated Composite Structures for Defect Detection and Damage Monitoring

Rogers K. Langat ^{1,2}

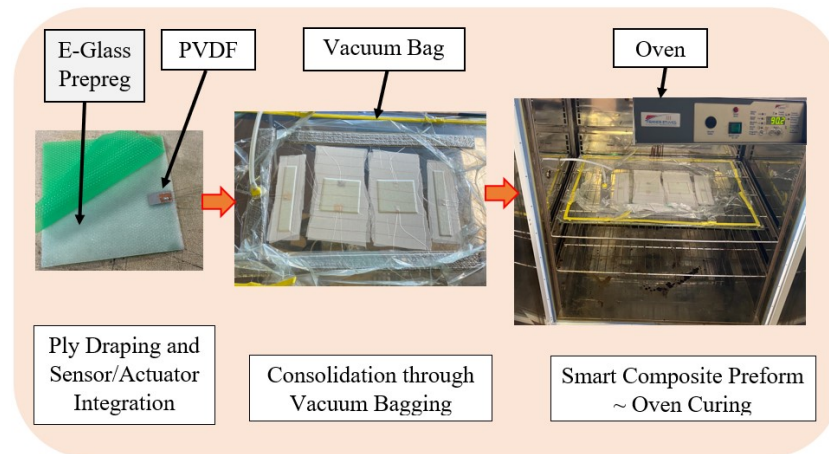
Figure 1. Samples' fabrication process through consolidation molding with a curing temperature of 90 °C for 90 min.

Following a vacuum-assisted consolidation molding process, depicted in Figure 1, smart composite samples of varying sizes were fabricated by an embedding technique. The approach employed aligns with the design and fabrication processes detailed by Langat et al. [8]; nonetheless, in the present study, distinct materials and a unique wiring procedure for the active elements were utilized.

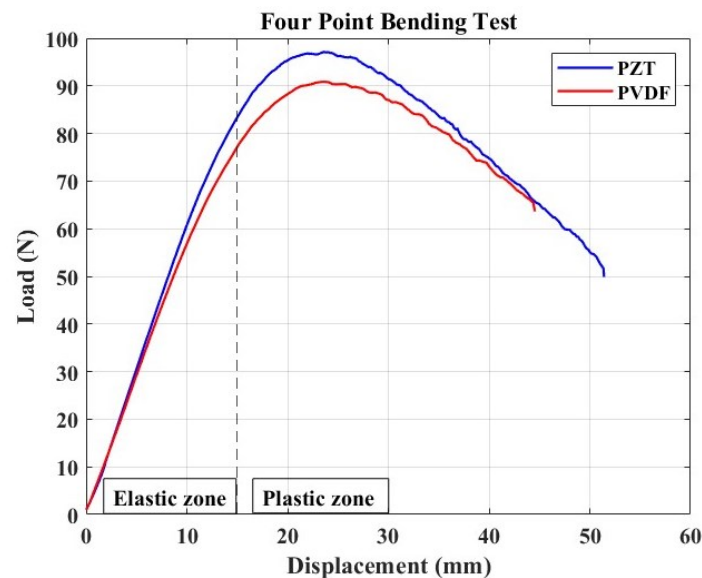
Figure 7. Load–displacement curve resulting from the 4-point bending test with noticeable linear (elastic) and non-linear (plastic) zone. Maximum load attained by a sample with PZT is 97.1214 N, and it is 90.8469 N for that with an embedded PVDF patch.

The load–displacement curve from the four-point bending test of the specimens with PZT and PVDF embedded is shown in Figure 7. This test was carried out solely to determine the mechanical behavior of smart composite materials when these two different types of piezoelectric materials are embedded, as well as to conclude their suitability to act as passive sensors while selecting the best that can capture the AE signal for continuous damage monitoring. This study is necessary since the literature has supported the embedding technique with the aim of protecting sensors from their surrounding environment, while

The loaded samples show two domains in the load–displacement curve: a linear elastic deformation zone followed by a plastic deformation zone with a non-linear displacement. This observation is consistent with the findings of Lampani et al.'s [30] investigation. Indeed, at the start of the test, the specimen bent without slipping on the bottom fixture. Still, as time passed, after the material's yield strength was reached, significant slippage was observed, with the deflection curvature increasing between the two fixtures, resulting in the non-linear zone depicted in the figure. This result could also be related to the fact that, in the case of four-point bending tests of flexible materials, a zone with a rapid rupture is rarely observed since the material may fail by folding without noticeable cracks.

It is also critical to note the smoothness of the curve shortly after the ultimate strength point. The response becomes non-smooth at this point in the load–displacement curve, which could indicate the onset of BVID in the form of microcracks. This decision is intended to be made based on the signal acquired continually in this setup, as these damages are

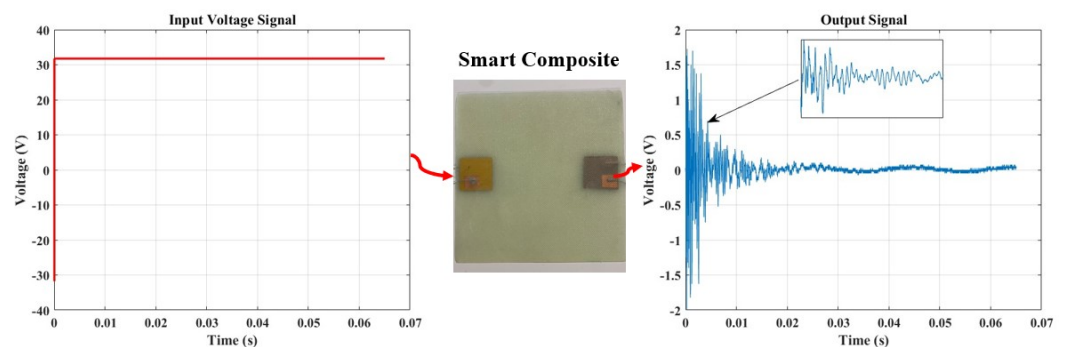
Figure 9. A single actuator sensor path illustrating the pitch-catch approach for damage diagnosis and monitoring, with an input signal deployed at a fixed frequency of 6 Hz.

In contrast to the passive method discussed earlier, which relies on damage-dependent signal responses for acoustic wave generation in damage monitoring and severity determination, the active sensing approach involves the continuous generation of elastic waves traveling through a material. Figure 9 illustrates our testing approach, utilizing a pitch-catch technique with a single actuator sensor configuration. In this setup, PZT generates signals by applying a step input signal, as depicted in the figure. Subsequently, a PVDF sensor receives the signals on the opposite end of the plate. The findings given in the preceding section partially influenced the selection of these components.

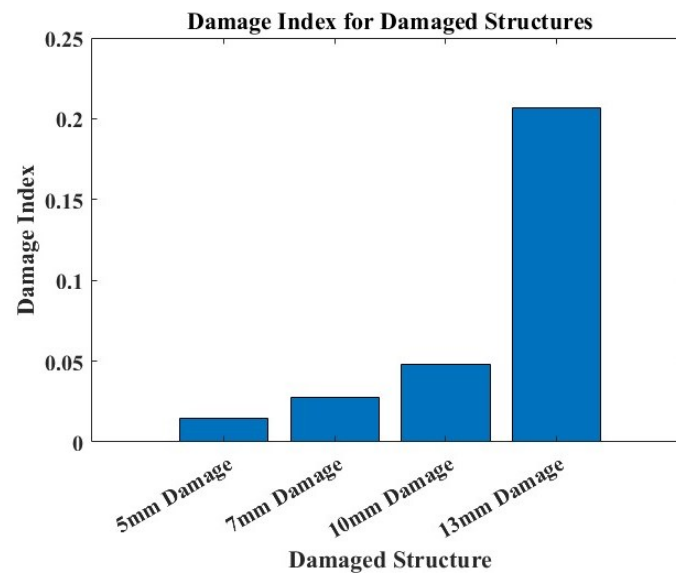
Figure 15. A damage index plot of the damaged structure cases.

A damage index plot against damaged structures in SHM is shown in Figure 15. The plot illustrates the variations in damage indices across different structures, highlighting the increasing trend with an increased damage size. The damage indices serve as a crucial indicator of structural health, facilitating the identification of deteriorating conditions that require attention. This analysis supports the implementation of condition-based maintenance strategies in aerospace structural systems.

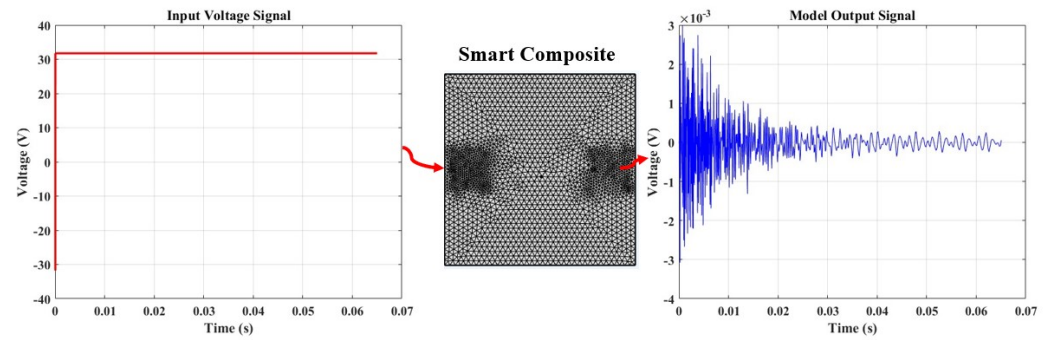
Figure 16. The numerical model simulation involving a step voltage input with an amplitude of 31.75 V and a fixed time step of 3.2×10^{-6} s.

Figure 16 displays the outcomes of the finite element method analysis using the pitch-catch sensing approach implemented in COMSOL. The results exhibit a transient response similar in form to the one obtained from the experimental data presented in Figure 9. A similar attenuation trend is seen in the simulation's Lamb wave signal, which converges with the experiment's observed period. These findings complement and validate the experimental study conducted within the framework of active sensing in this work.

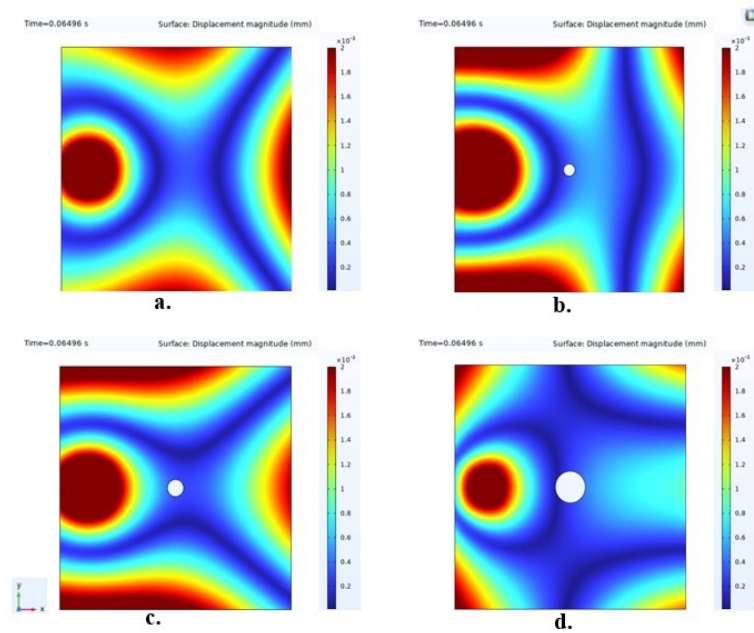
Figure 17. The surface plots of the analyzed sample cases displaying the displacement magnitude for visualization of the disturbance created by damage on the Lamb waves. In these representations, (a) illustrates the healthy structure in its intact state, (b) shows a structure with 5 mm hole damage, (c) demonstrates a structure with 7 mm hole damage, and (d) displays a structure with 13 mm hole damage.

The surface plots in Figure 17 illustrate displacement magnitudes with varying damage sizes. An observation reveals that, due to changes in material properties induced by damage, the Lamb wave traveling through this region undergoes scattering in multiple directions—notably, the degree of spreading increases with the severity of the impact on the structure. The signals obtained from this damage diagnosis approach are thus deemed reliable for application in implementing SHM.
