# NILE'S EARTH 2023

STUDY AND CONSERVATION OF  
EARTHEN ARCHAEOLOGICAL SITES  
IN ANCIENT EGYPT AND SUDAN

PROCEEDINGS - MARCH 2024

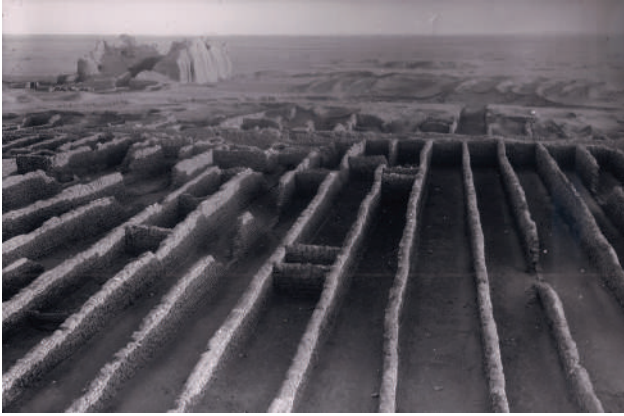
Figure 1: The Tumulus K III at Kerma looking towards the funerary Chapel K II.  
© Photograph courtesy Museum of Fine Arts Boston

At Kerma, located along the Dongola Reach of Upper Nubia, a pattern of internal buttressing walls developed in the great funerary tumuli constructed at the end of the Classic phase of the civilization coeval with the late Second Intermediate Period in Egypt. The North Palace at Deir el-Ballas in Upper Egypt, which is contemporary with these last tumuli at Kerma, is the earliest example of a true casemate foundation in Egypt. The casemates employed there, very long narrow chambers filled in with earth and gravel and capped with a pavement of mud brick one course thick, is exactly the same as in the tumuli. Indeed, the very design of the casemate walls is the same, usually two and one half bricks thick, spaced out between 205-250 centimeters wide, and paved over with a single layer of brick. This pattern is not followed by any of the Near Eastern or purported Egyptian parallels that have previously been suggested as antecedents for this construction technique.

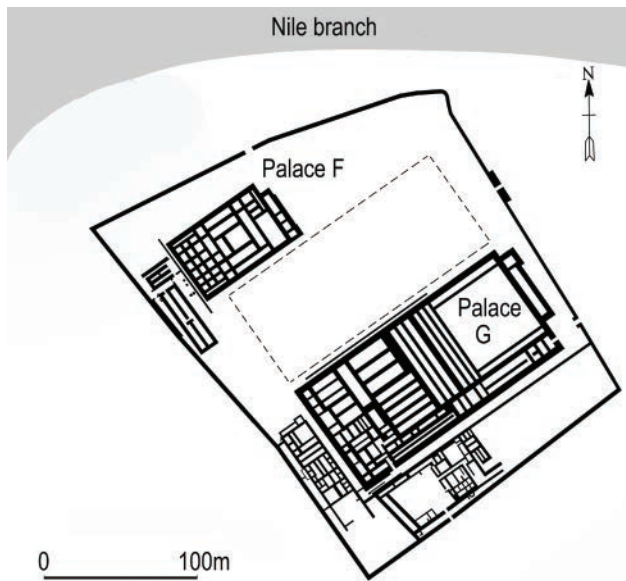
Figure 9: Palaces F and G at Ezbet Helmi.  
© Drawing by A. Boyce

On the other hand, Palace G is larger, measuring 168 x 78.75 meters and is composed of long, narrow casemates set perpendicular and fronting a large square open court, just like the North Palace at Deir el-Ballas. While the exact extent of the core plan of the North Palace is unclear, the traces suggest an approximately similar size. Other than in replicating the pattern found at Deir el-Ballas, there would seem to be no reason why the construction methods used in these two ‘palaces’ in the Delta would be so different. This correspondence also underscores the earlier date proposed for the Ezbet Helmi structures.<sup>26</sup> It should also be noted that the pattern of long, narrow casemates derived from the Kerma tumuli and used in the North Palace at Deir el-Ballas and Palace G is no longer used and a more regularized pattern of squared casemates developed at the “South Palace” becomes the standard for all later casemate platforms.

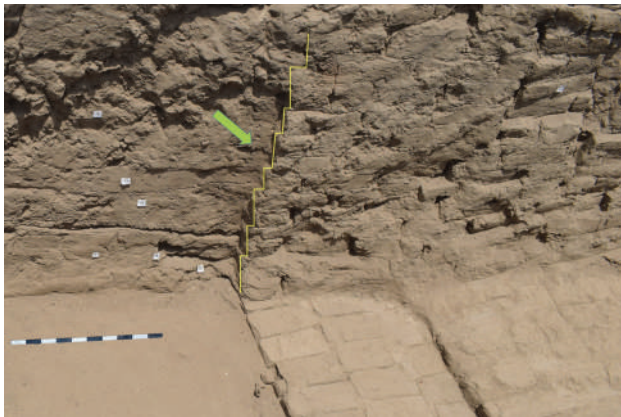
Figure 5: Wall's face slope, which produced by laid the bricks stepping each layer of bricks back slightly.

Fifteen courses survived from the thick wall (Fig. 5), following the standard Egyptian way for constructing the enclosure walls.<sup>10</sup> The wall consists of a central mass entirely of headers, whilst the outer faces exhibit alternate courses of headers and stretchers with carefully pointed joints, which would considerably speed up the process of construction.<sup>11</sup>

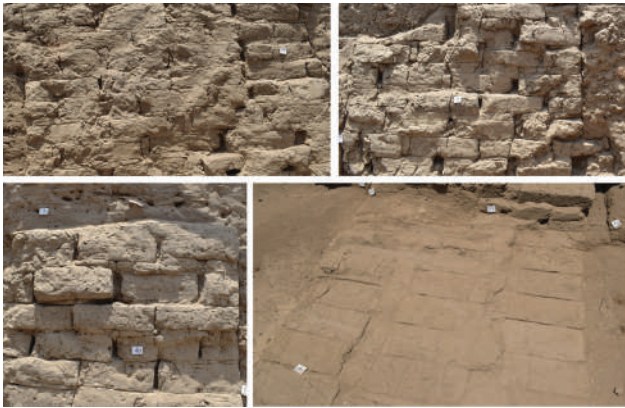
Figure 8: Mortar, bricks composition and size with details of the vertical and horizontal beds.  
© A. Altaher

The mortar was typical for all five walls, being composed of light brownish grey clayey silty mixed with Nile sand. Straw is occasionally found and inclusions, such as small pebbles and ceramics, can be detected as well.<sup>18</sup> The mortar normally forms a bed beneath each new course of bricks and between each brick. On the thick wall, the size of the vertical bed ranged between 0.01-0.04 meters while the horizontal bed ranged between 0.02-0.05 meters (Fig. 8).

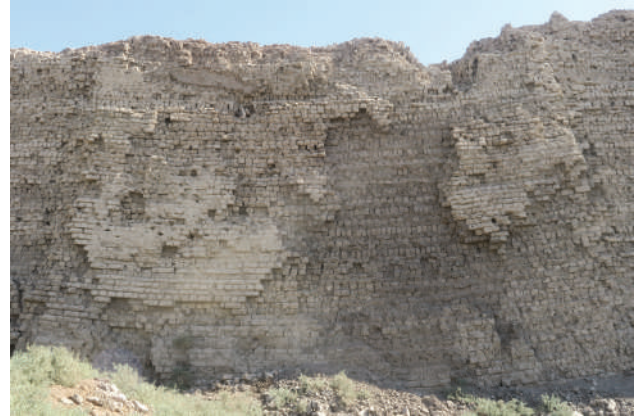
Figure 5: View of one of the wall sections nearby the eastern gate. The facing is damaged and shows layers of mud bricks on edge.

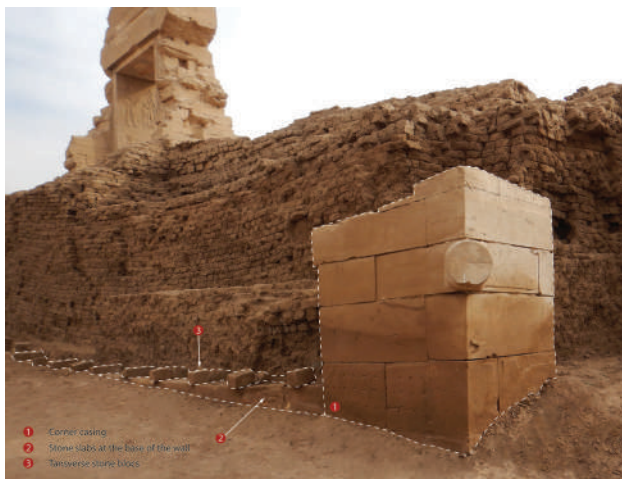
Figure 10: Stone reinforcements in the wall.  
© M. Vanpeene

The most imposing and distinctive of these is the one protecting the western corner of the wall (Fig. 10 feature 1)<sup>25</sup>. In plan, this element forms an L-shaped casing measuring 1.84 m by 1.30 m and varying in thickness from 0.42 m to 0.46 m. Its maximum preserved height is 2.23 m. The presence of dressed *joint surfaces* (with *anathyrosis*) against the mud brick masonry suggests that at least some of the blocks come from an earlier structure and have been reused.

One row of stone blocks immediately above the stone slabs is also of note (Fig. 10 feature 3). Each has an almost square section – 14 to 18 cm – and measure approximately 50 cm in length. Most of them are fractured and some have been restored by inserting cement-sealed metal pins. These interventions are obviously modern, implying that the blocks are probably not exactly *in situ*. However, archival photos (Fig. 11) found in the *Centre Franco-Égyptien d'Étude des Temples de Karnak* (CFEETK)<sup>28</sup> collections confirm that these elements were already present at the time of the first conservation work in the early 20<sup>th</sup> century. They were therefore part of the ancient structure before this intervention, which only slightly altered their position.

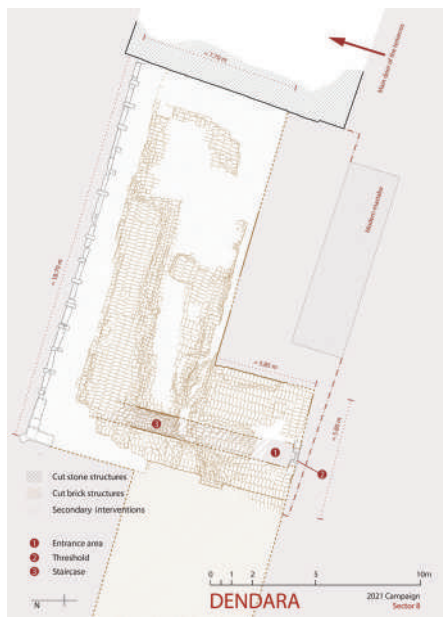
Figure 12: Plan of the newly discovered spaces of the enclosure wall.

Although they were badly damaged, these new spaces may be interpreted as an entrance area associated with a staircase providing access to a higher level of the enclosure wall, which has now disappeared<sup>31</sup> (Fig. 12).

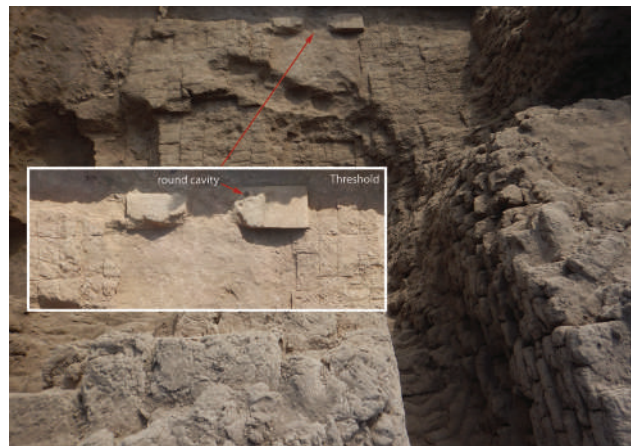
Figure 13: Threshold of the staircase.

The preserved part of the entrance opens onto the interior of the precinct through a doorway at the south-west side of the main door. Its position is marked by a sandstone threshold 0.37 m wide and 1.61 m long (Fig. 12 feature 2, Fig. 13). This formed a 6 cm high step that was worn in the middle, as a result of intensive use over a long period. The structure of the doorway is lost, but the threshold surface shows the negative of the jambs. Incised lines could indicate the position of a lost stone doorframe. They allow the width of the doorway to be reconstructed as 0.81 m – its original height remains unknown. A circular depression on the west side of the block could indicate the presence of a door, but its position, against the frame, points to a secondary rearrangement of the feature. A space 1.25 m wide and 1.14 m long was accessed through this doorway. It was floored with pure clay *mouina*. Although the side walls are only partially preserved, their position could be reconstructed thanks to the layout of the bricks in the masonry. To the north, a large pit has obliterated the plan of the entrance area and its junction with the staircase.

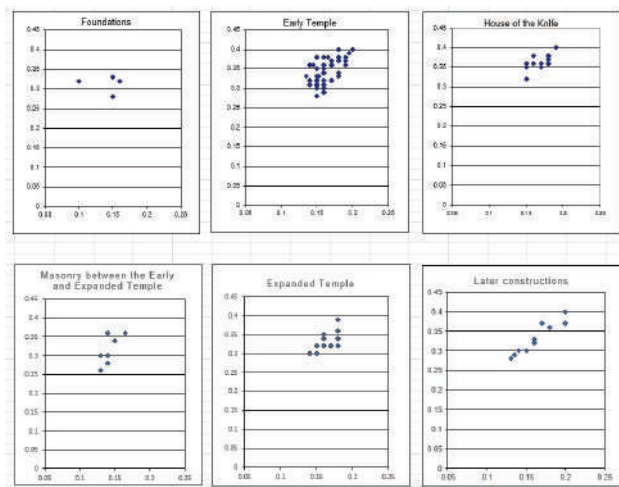
Figure 3: Formats of mud bricks used in individual building stages of the temple as well as in foundations.  
© J. Krejčí, Archives of CIE FA CU

be built thoroughly, levelling layers of edgers were used in the wall. The entrance and central part of the Early Temple played an essential communication role in the framework of the entire mortuary temple. The mud-brick masonry of its rooms was worn out by intensive temple operations connected with Raneferef's mortuary cult. This initiated their rather frequent restoration and modifications. Therefore, the ground plan of this temple part is rather complicated and includes many additional walls, bricking ups, etc. This situation makes the study of earthen masonry and construction joins rather difficult. Typical for this part of the temple is the frequent use of levelling layers – in most cases consisting of edgers and thick mortar layers. On the other hand, the faces of the store-room partitions show only basic brick bonding – A3 or A2.

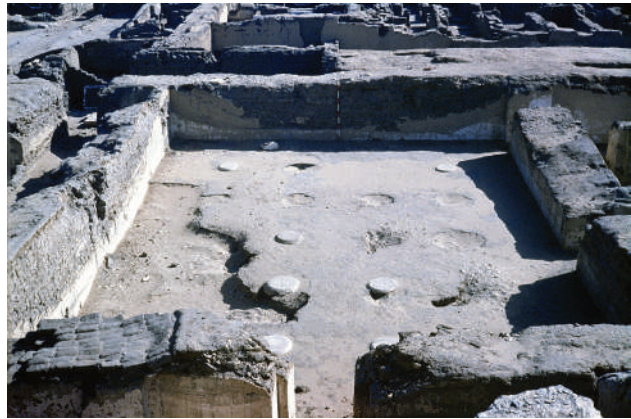
Figure 4: Hypostyle hall from the north.  
© J. Grabmüller, Archives of CIE FA CU

In the case of the masonry of the hypostyle hall (Fig. 4), bricks of similar dimensions but made of rather different materials were used in its individual side walls. Does this prove the progress of the work, or adobes used here were made by two brickmakers using the same mould format or is it just a coincidence? More proof of these technological procedures is apparently documented by a bricked-up entrance located in the axis of the northern wall of the hypostyle. This aperture had not been made by the dismantling of this part of the wall; it was left when the wall was being erected. It is highly probable that this aperture was used during the construction of the columned hall for transportation of needed building materials – bricks, wooden columns or beams for the ceiling construction, etc., to the hall and other rooms. After the end of its use, the auxiliary entrance was bricked up with mud bricks of two formats (0.31–0.32×0.15–0.17×0.10–0.12 and ?×0.19×0.12 m). These brick formats did not depart very much from the brick formats used in the walls of the southern part of the Early Temple. This means that the entranceway was bricked up already during the construction of other parts of this temple sector.

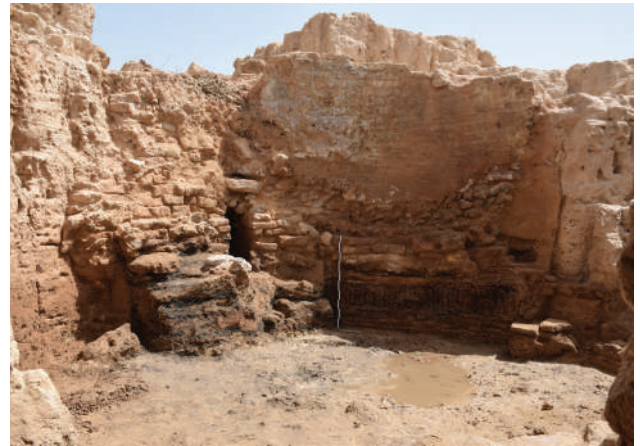
Figure 2: The remnants of kiln A. View from the west.

Kiln A was badly destroyed, but its outline was determined by the circular foundation cut into the bedrock. Fortunately, a section of the kiln wall on eastern side (#13) was preserved (Fig. 2); and was excavated to its foundation courses, at the base of the kiln. This wall is 4.50 m in length from north to south and 0.15 m in width, with 3 m of its height is remaining. The remaining parts of the wall demonstrate how it was constructed over the bedrock. The edges of the cut in the bedrock were first refined, then padded with mud, before constructing the wall of *tafla*/clay bricks, arranged horizontally. These bricks have been significantly reddened by heat from the kiln, particularly in the foundation courses closest to the heat source. The bricks measure 25 × 25 × 8 cm and *tafla* was again used as mortar to fill the gap of approximately 0.50 cm in the vertical and horizontal joints. The arrangement of the bricks varied in different parts of the structure. The eight foundation courses, which are part of the firebox, are thicker with the four lower courses laid as stretchers and the fifth with the bricks set upright (soldier courses), followed by two more stretcher courses. *Tafla* was again used as mortar. A gypsum layer was used to line the floor of the firebox. The upper part of the wall

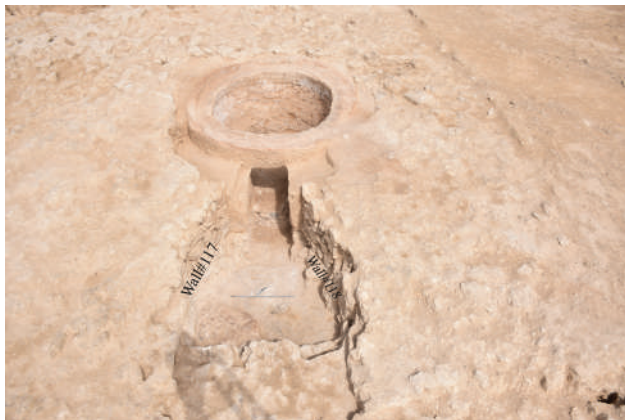
Figure 7: Kiln C. View from the south.  
© Mohga Abd El-Kawy

The brickwork consisted of *tafla* bricks arranged horizontally, which have been significantly reddened by heat, especially in the lower course. The bricks measured 25 × 25 × 8 cm, and *tafla* mortar was used to fill the gap of approximately 2.50 cm in the horizontal joints, but more carelessly in the vertical ones. There are remains of mud plaster on the inner side of the wall and the floor of the kiln was lined with a gypsum layer that directly overlaid the bedrock.

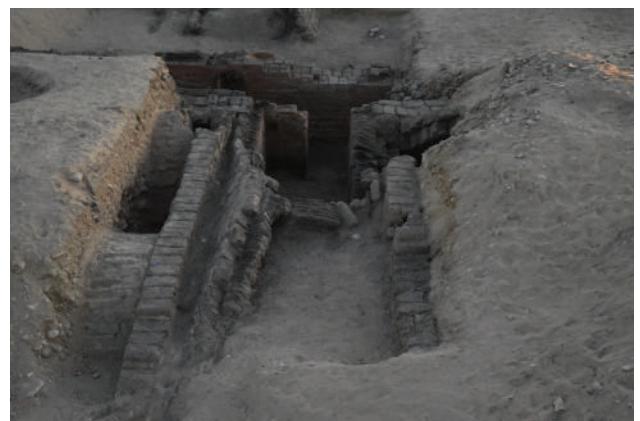
Figure 6: General view of corridor 2, from North.  
© S. Dhennin

Corridor 2 was cleared by only 2m to the north, in order to expose the entrance to galleries 10 and 11 and avoid backfilling the excavated corridor 1. Its construction method is similar to that of corridor 1, as is its width (1.20m). The load-bearing walls (walls 6 and 8) are built in a similar way to walls 4 and 5. They were plastered with a mud mortar, of which only a few traces remain on the top of wall 11. The foundations of the vault are both made of rowlock. The vault was framed by two parallel walls (walls 7 and 9), whose technique has not been fully clarified: they are probably an extension of the elevation of walls 6 and 8, reduced to half their thickness to frame the vault and serve as buttress walls. Half the thickness of the walls (towards the interior of the corridor) thus forms the load-bearing walls, while the other half of their thickness rises higher, at least up to the extrados of the side gallery vaults, to close the opening and serve as a gable wall (Fig. 6). These walls were also designed to contain the backfill that covered the flanks of the vault, loading it and making the structure underground. This vault (vault 2), partially preserved on the north of the corridor, is a two-course vault with a parabolic arch. The bricks used for this vault are of different modulus for the two courses. The lower course is made up of long, thin, slightly leaning bricks with wide finger marks on the sides. Ceramic sherds are interspersed between these bricks, in a non-regular pattern. The type thus corresponds to a ‘Nubian’ vault. The upper course is made of the same bricks as the walls, placed perpendicular to the first course. So far, all the vaults observed in the catacombs, both for the galleries and the corridors, have been built using to the same technique.

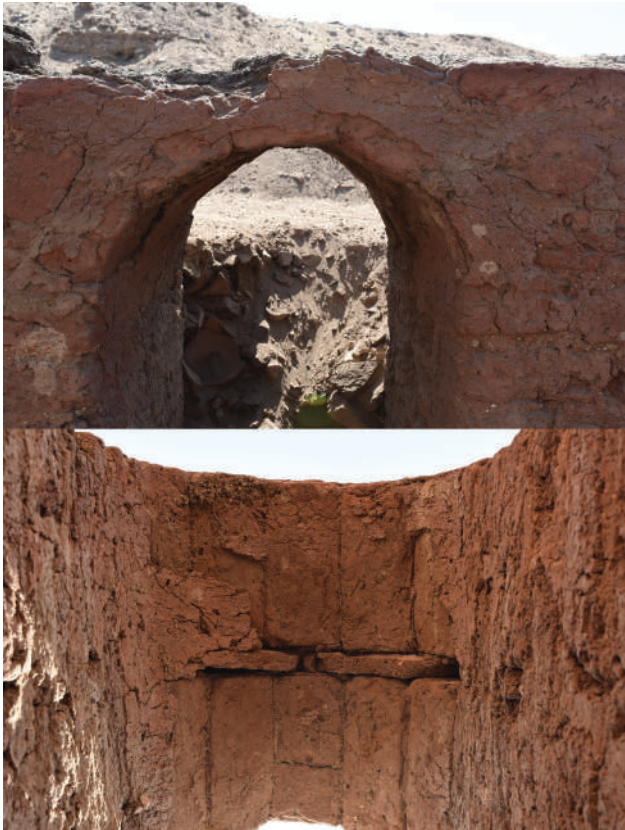
Figure 7: Doorway 6, from North and from below.  
© S. Dhennin

The entrances to the galleries distributed by the corridors were provided by low and narrow doors. Door 6, for example, which opens onto gallery 6, is 1.50 m high at the arch and 60 cm wide. Its arch is positioned on the eleventh course of wall 4. Its lower course is composed of two series of five headers, separated by two thin bricks (Fig. 7). The whole was mortar-bounded and covered with a thick plaster. The upper course, partially preserved and hidden by mortar remains, had a similar layout. No door-closing system was observed, nor any blocking that might correspond to the closing of the galleries after their filling, was observed.

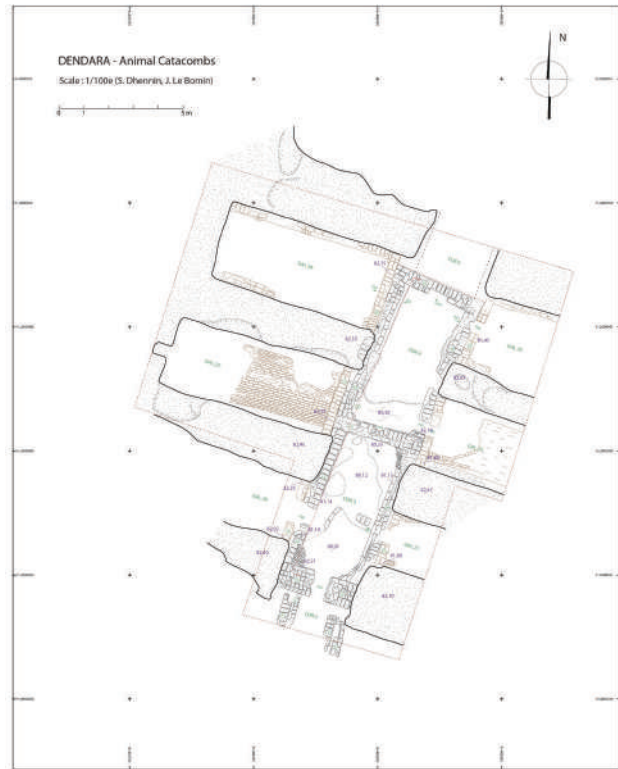
Figure 8: Top view of corridors 3, 4 and side galleries.  
© S. Dhennin, J. Le Bomin

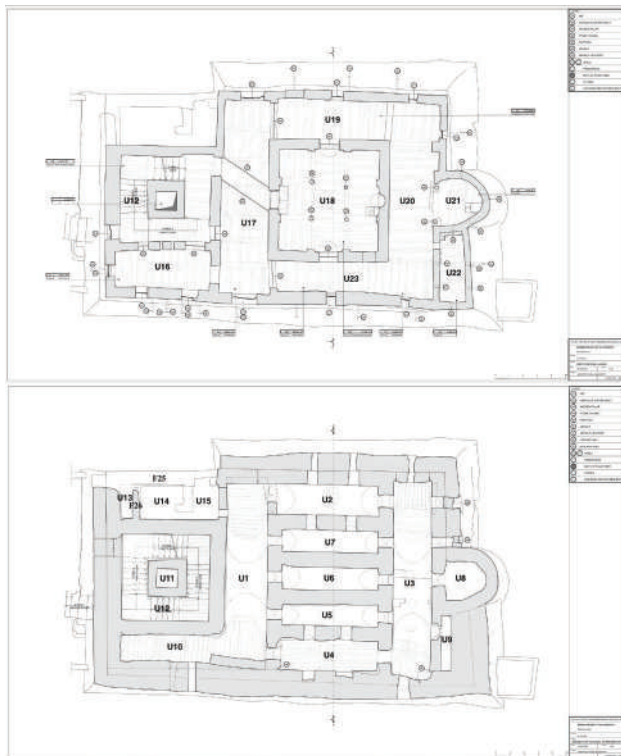
Figure 5: The plans of the mosque; the ground floor at the window level (below), the first floor (above).

a traditional roofing structure that uses *jarid* (palm fronds), *zibāla*, and *birsh* (mat made of palm leaves), supported by wooden beams and the floor supported by doum palm trunks. The roof and some parts of the floor are the most intensively repaired areas in the building in modern times. The walls of the central hall on the upper floor and some parts of the staircase preserves polychrome paintings depicting biblical scenes, Archangel Michael, saints and royal and ecclesiastic figures.<sup>12</sup> These paintings were covered by plaster layers and have been removed in the past hundred years. Sandstone blocks were applied in some parts of the building, such as at corners and the bottom of the building, thresholds, lintels, door jambs, column bases, steps, and flooring on the first floor.<sup>13</sup>

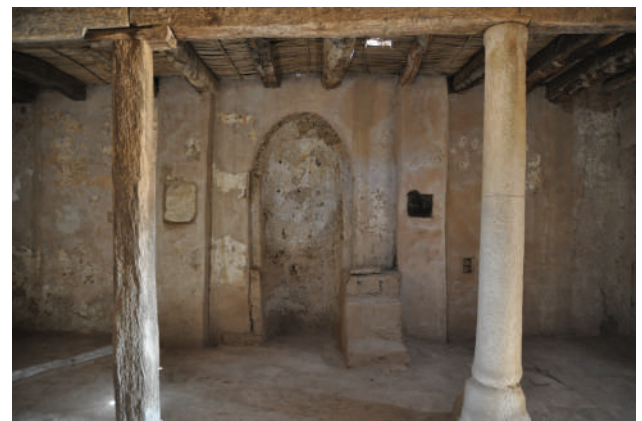
Figure 6: The central hall.

After the conversion of the building to a mosque, the most notable features of change were the additions of a *minbar* and *mihrab* in the central hall (Fig. 6), placement of a stone stela that records the conversion, and the wall paintings being covered with plaster. An Arabic inscription was left near the

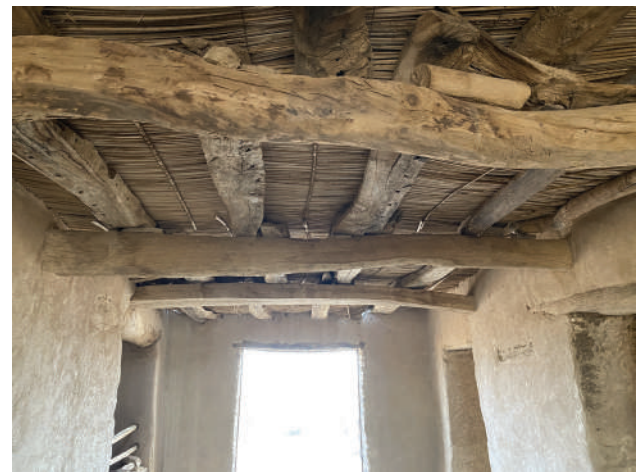
Figure 8: Reuse of a wooden boat as a roofing material.  
© PCMA, UW, T. Fushiya

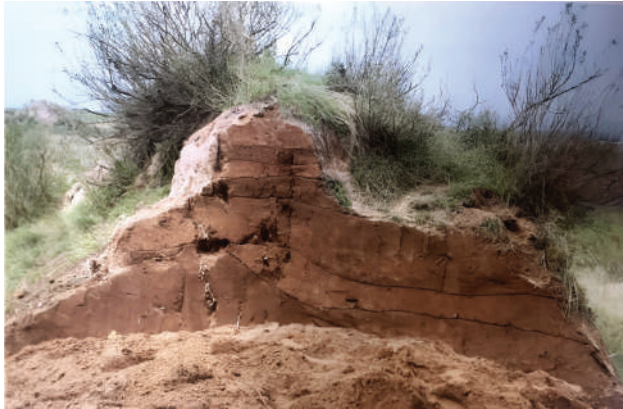
Figure 4: Stacking Earth Great Wall.  
© C. Xue, "Research on Construction Technology of the Great Wall in China", PhD Thesis, Northwestern University, 2018

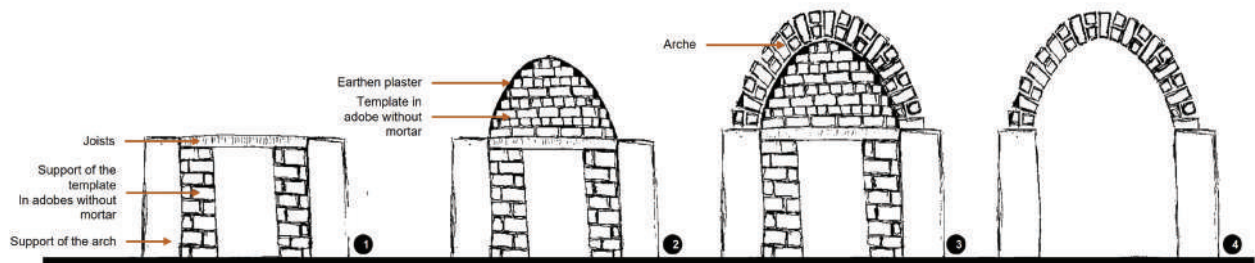
Figure 8: Traditional arches construction in the Ksar of Timimoun. © H. Ben Charif

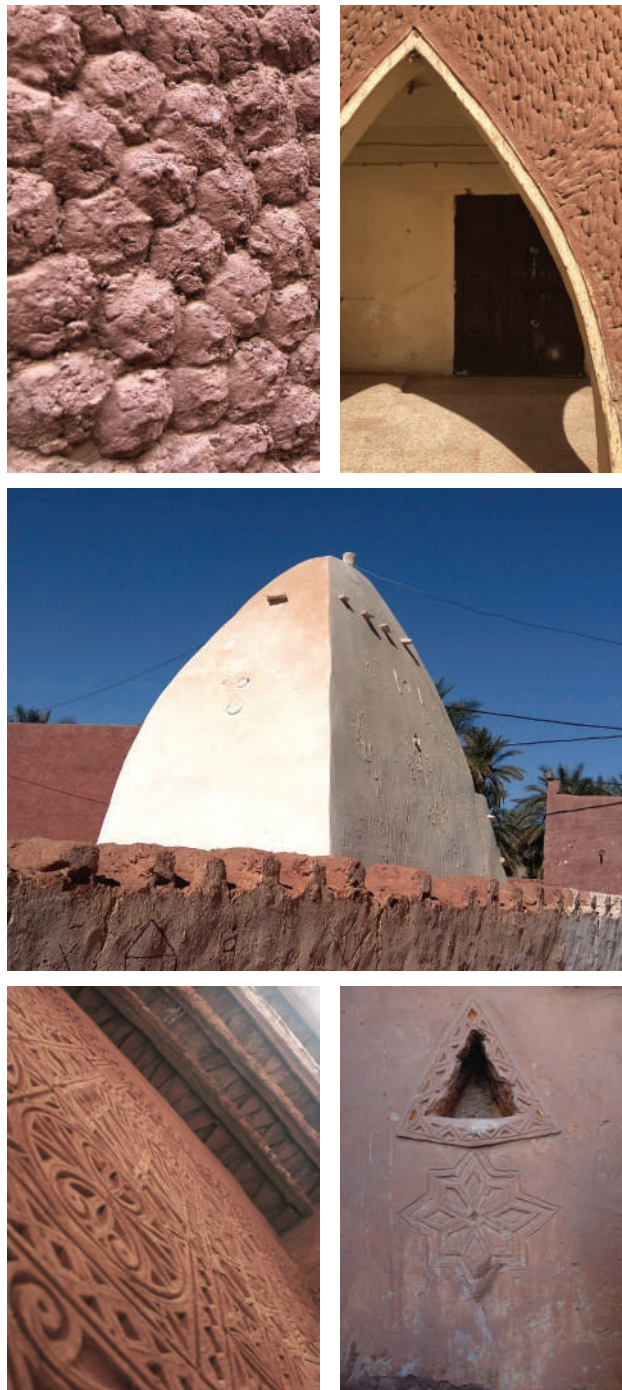
Figure 10: Exterior earthen and lime plastering (on top). Decoration techniques found in Timimoun (on bottom).

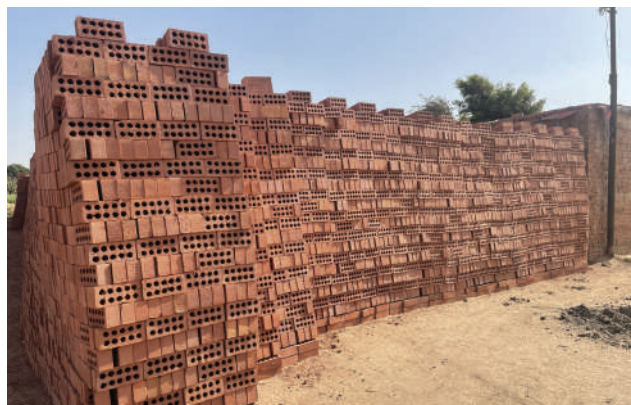
Figure 5: The classic alveolar bricks in al-Qaliubya governorate (Egypt)  
© C. Pérez-Houis, May 2022

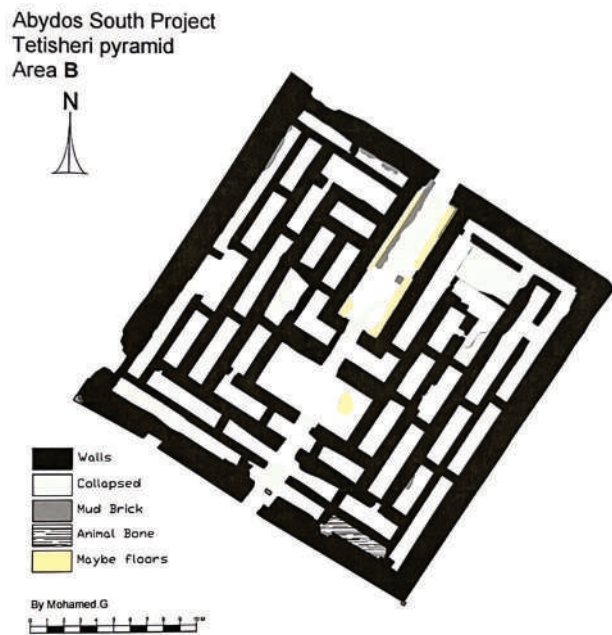
Figure 1: Plan of the Tetisheri Pyramid.  
© Mohamed G.

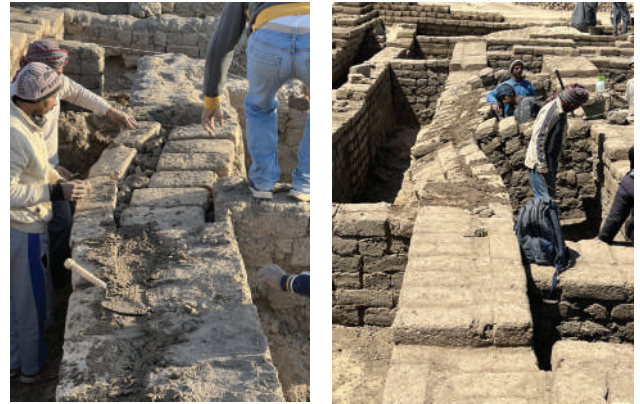
Figure 3: Two deformed walls stabilized with the existing characteristics.  
© A. Crosby

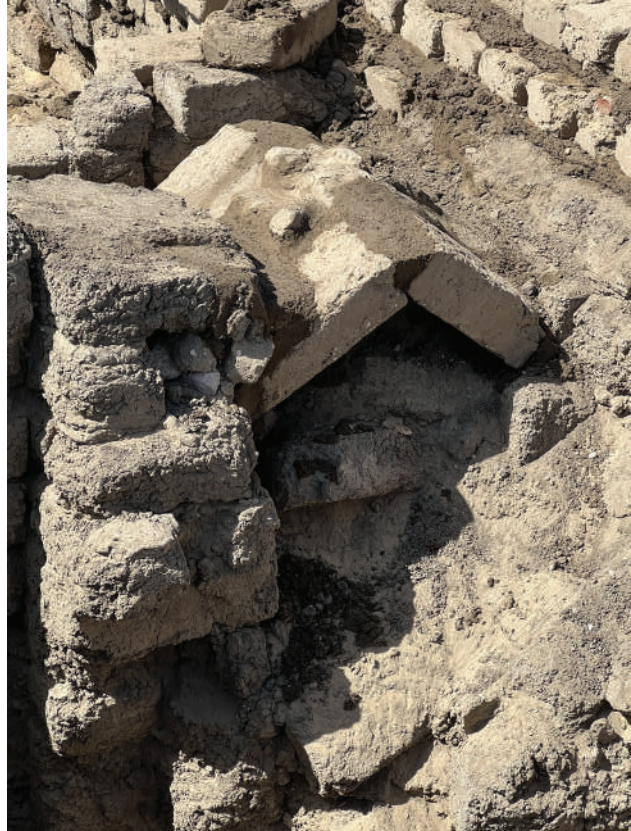
Figure 5: A feature spanning a cell that was stabilized.

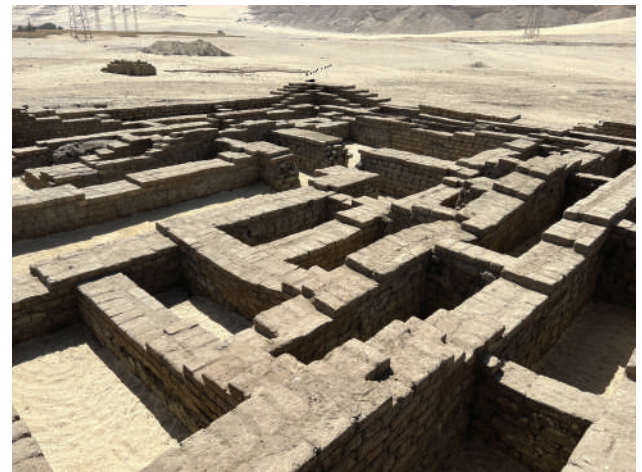
Figure 6: Existing walls, stabilized walls, and restored walls in the north section of the Pyramid.

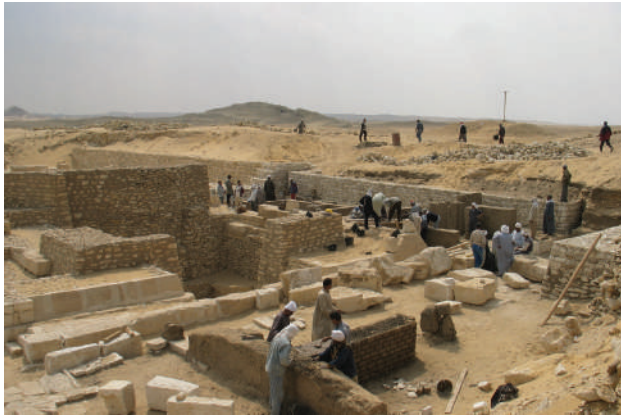
Figure 5: Conservation works on the mudbrick structures (methods A and B).

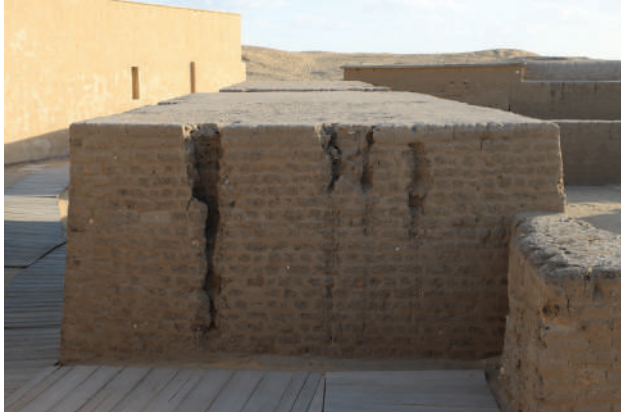
Figure 8: Gullies formed on a recently partially reconstructed entry pylon of one of the tombs of the New Kingdom necropolis at Saqqara.

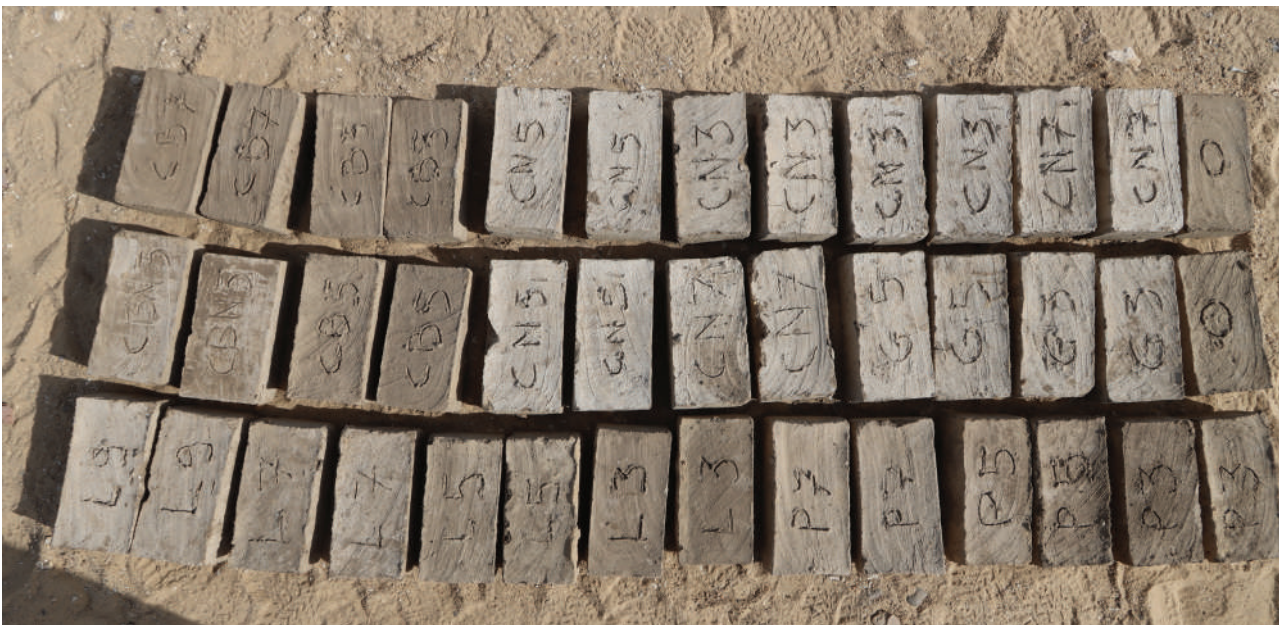
Figure 11: Samples of bricks prepared using a variety of stabilizers and dosages.

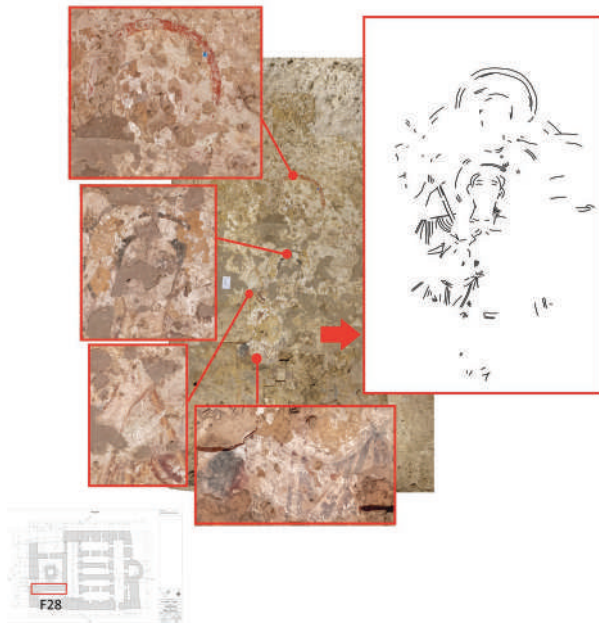
Figure 3: F28 wall. Result of the stratigraphic test.  
© PCMA, University of Warsaw, A. Chlebowski, M. Skarżyńska

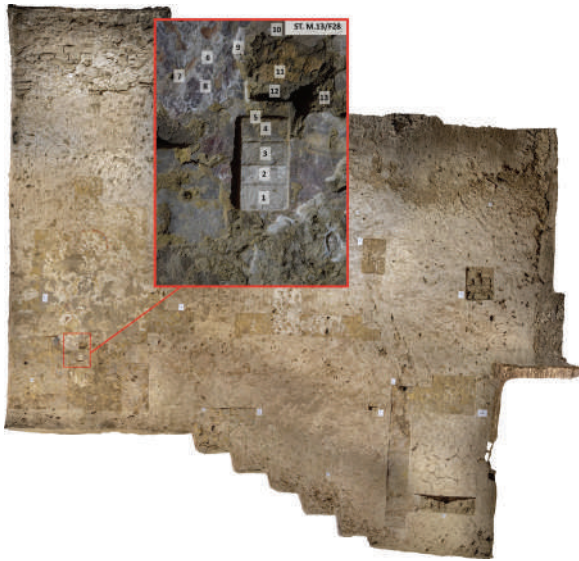
Figure 7: Stratigraphic test ST.M.13/F28.

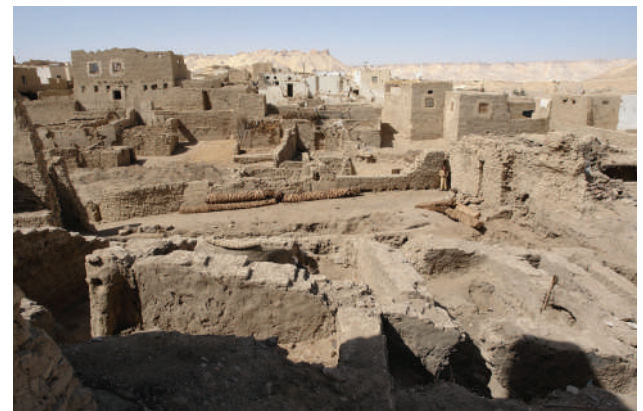
Figure 5: Severe structural degradation.  
© M. Mohamed

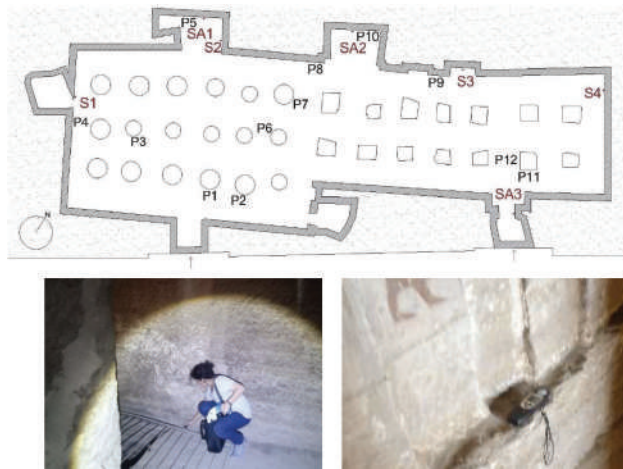
Figure 4: Layout of the tomb and location of the measurement points (S), painting location (P).  
© L. Joyanes Díaz

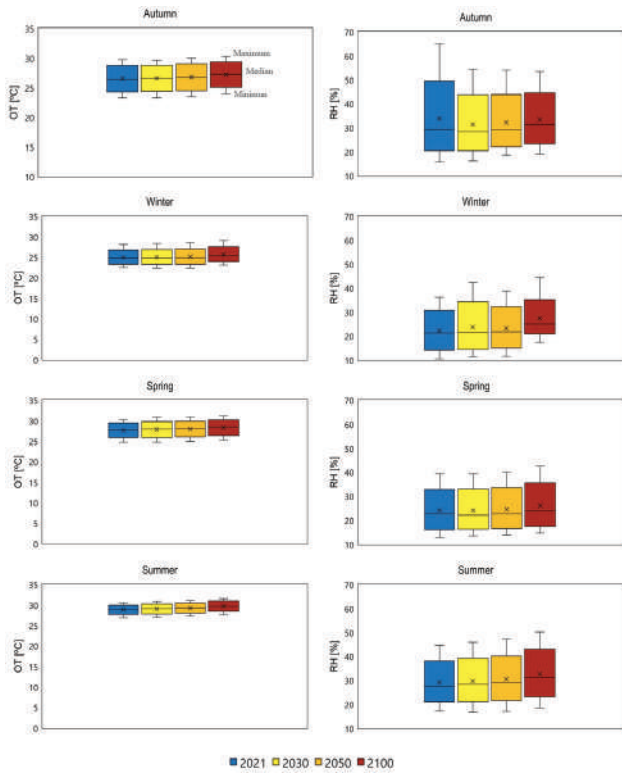
Figure 6: Statistics, the quartile, median, maximum and minimum T and RH.  
 © L. Joyanes Díaz, C. M. Muñoz González

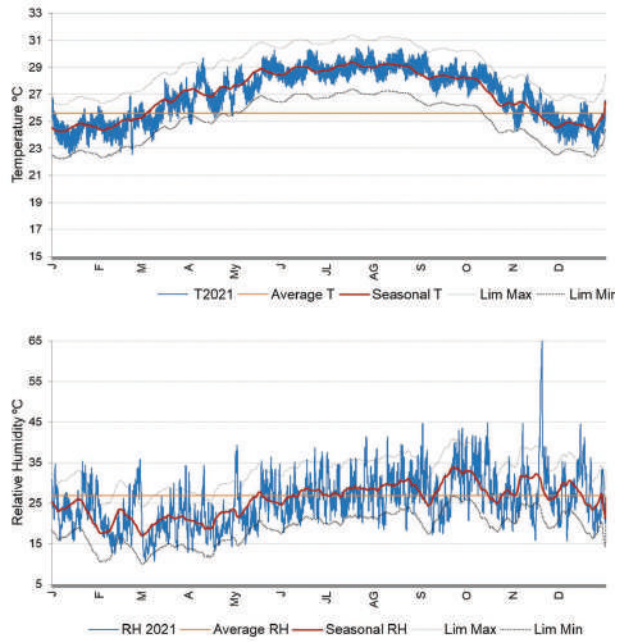
Figure 7: Monitored average T and RH and seasonal average limited.  
 © C. M. Muñoz González

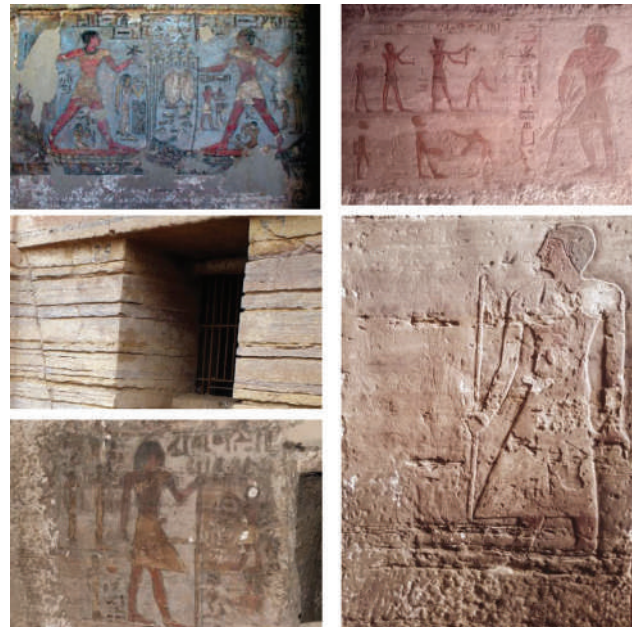
Figure 8: Deterioration of painting inside QH25 and QH26.  
 © L. Joyanes Díaz

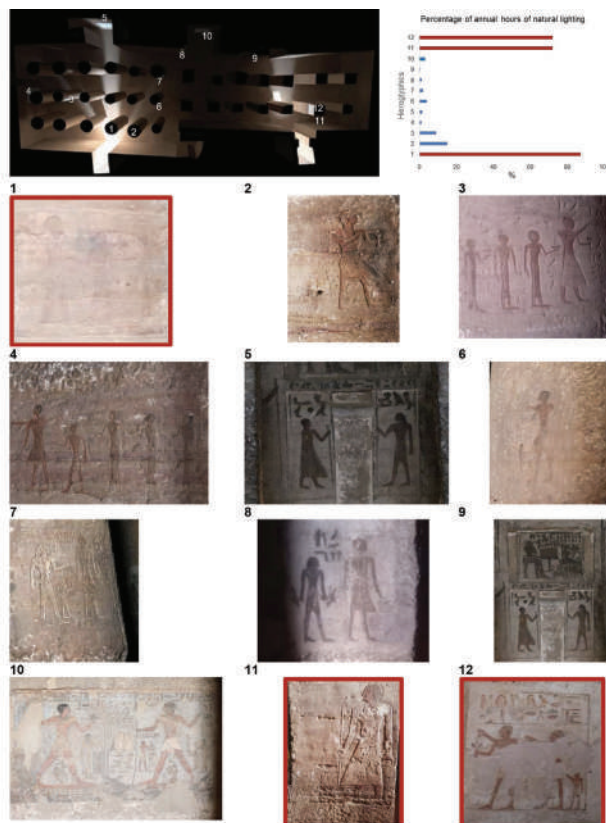
Figure 10: Percentage of annual hours of natural lighting on hieroglyphics.  
© L. Joyanes Díaz, C. M. Muñoz González

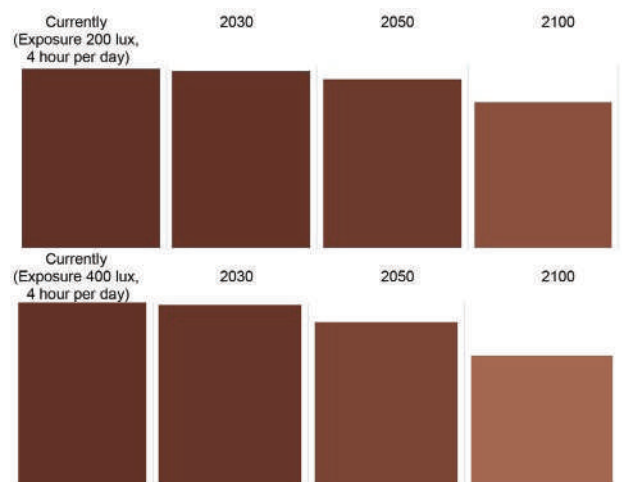
Figure 11: Fading of a single colour in three different scenarios.  
© L. Joyanes Díaz, C. M. Muñoz González

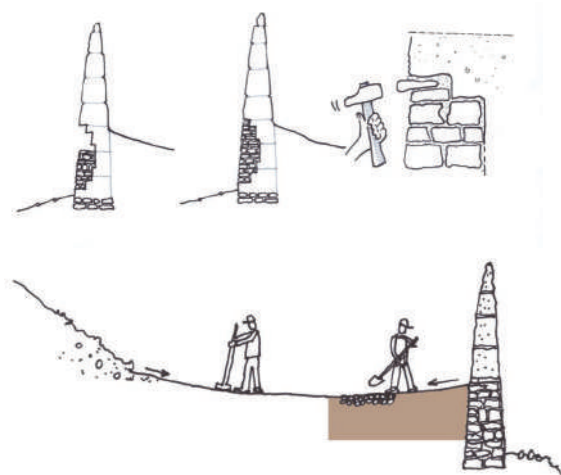
Figure 7: Realization of drainage slope and resumption of damage to the basement and the wall.

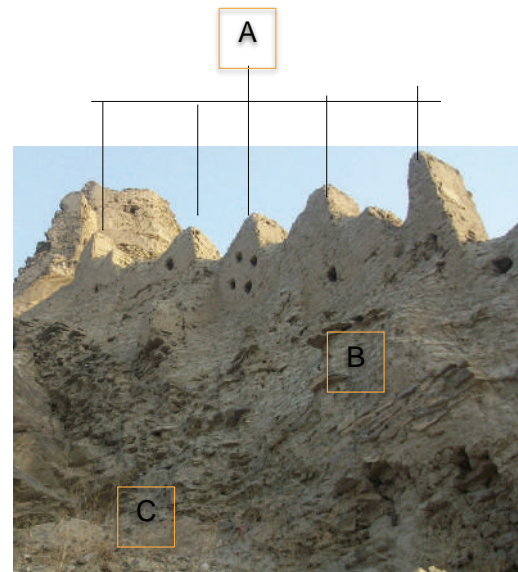
Figure 11: Detail of intervention for the part of the wall built in adobe.  
© S.M. Khalili

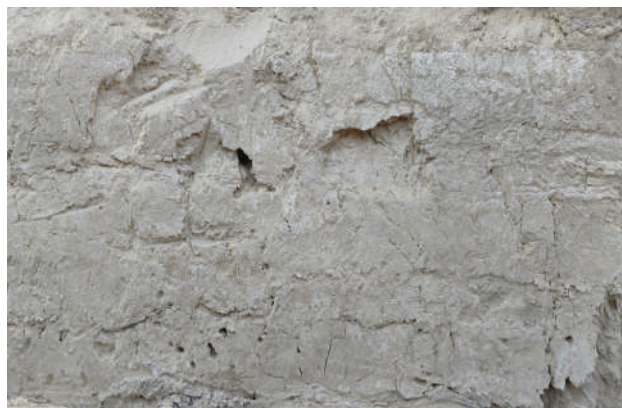
Figure 3: Babylon Ninmakh temple. Lime plaster.  
© A. Al Taei

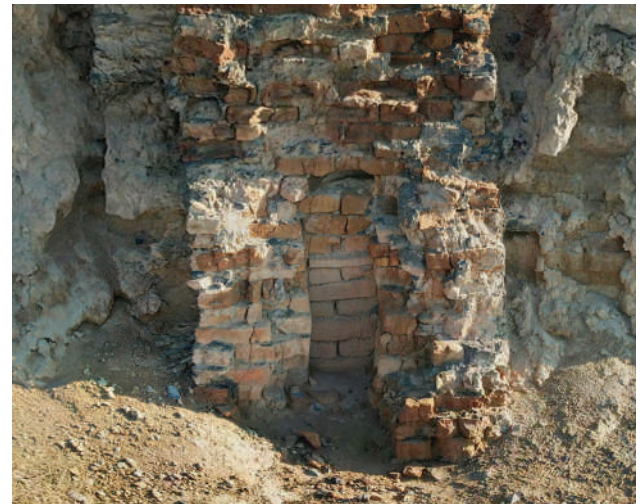
Figure 4: Water drainage in the Ezida Temple.

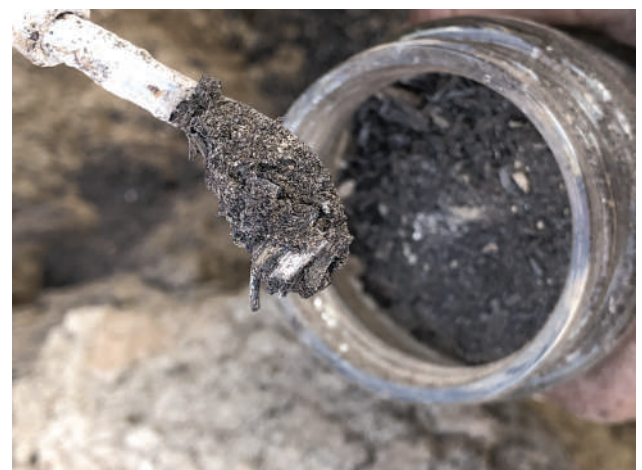
Figure 5: Bitumen mix found in Ezida Temple.
