## Storm Alex: lessons learnt from the debris flood that occurred on October 2nd 2020 in the French Maritim Alps

Céline Martins, Damien Kuss, Cécile Guitet, Simon Carladous, Yannick Robert, Nathalie Andréis, Guillaume Piton, Frédéric Liébault, Myriam Flipo, Margot Chapuis, et al.

Céline Martins, Damien Kuss, Cécile Guitet, Simon Carladous, Yannick Robert, et al.. Storm Alex : lessons learnt from the debris flood that occurred on October 2nd 2020 in the French Maritim Alps. Interpraevent 2024, Jun 2024, Vienna, Austria. pp.680-684. hal-04680214

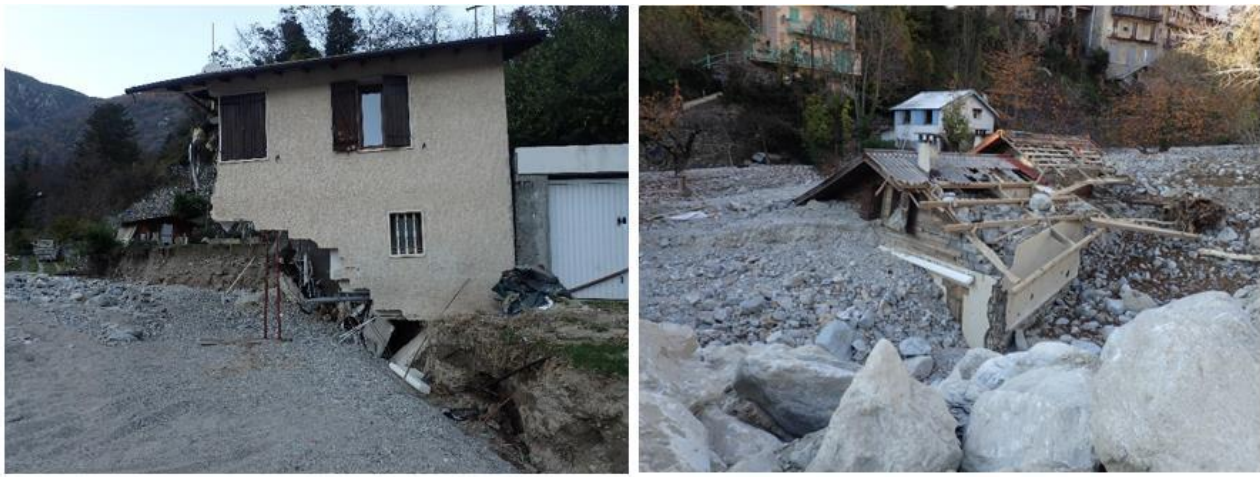
Figure 3 : Post-event photos of the field: (left) St Dalmas de Tende, damage caused by scouring of foundations (Source: ONF-RTM); (right) St Martin Vesubie, damage caused by massive deposition (Source: ONF-RTM).

- Considerable damage exacerbated by the debris flood process: the material toll following flood Alex is high, with extensive damage to infrastructure and buildings. The back analysis provided an opportunity to analyse the links between the nature of the damage, its extent and the intensity of the torrential phenomena. Over the two valleys, more than 400 buildings were affected, including 171 that were totally destroyed, 52 that were threatened with ruin and 203 with various types of damage. The results also show that the buildings were damaged in different ways: by flooding/submergence (by liquid water with a low sediment content), by filling with bedload transport (Figure 3 right), or by scouring of the foundations, (Figure 3 left). The main cause of structural damage to buildings is scouring of the foundations, with the rate of damage increasing sharply when the foundations become locally and then generally undermined.
