Storm Alex : lessons learnt from the debris flood that occurred on October 2nd 2020 in the French Maritim Alps

Céline Martins, Damien Kuss, Cécile Guitet, Simon Carladous, Yannick Robert, et al.. Storm Alex : lessons learnt from the debris flood that occurred on October 2nd 2020 in the French Maritim Alps. Interpraevent 2024, Jun 2024, Vienna, Austria. pp.680-684. hal-04680214

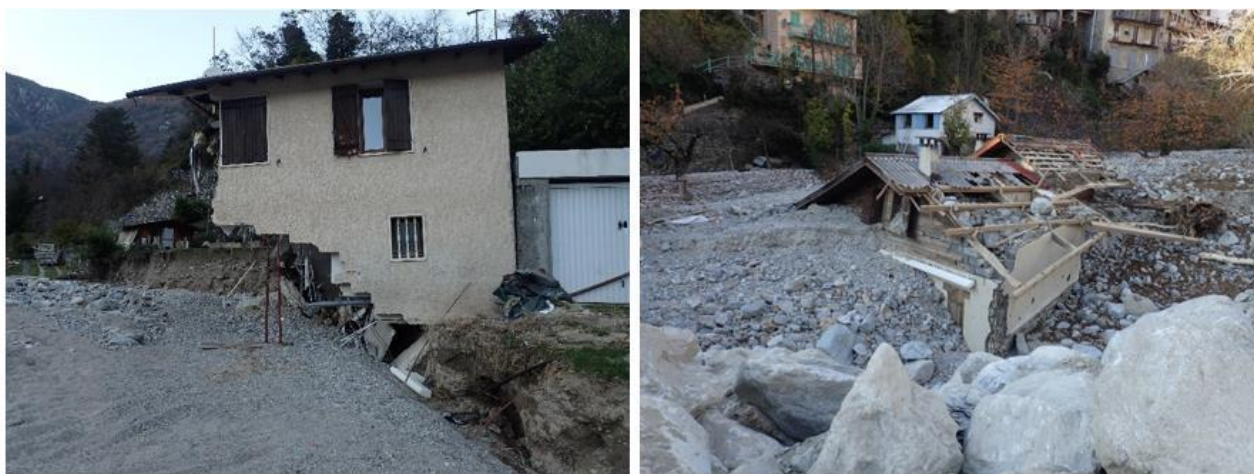
Figure 3 : Post-event photos of the field: (left) St Dalmas de Tende, damage caused by scouring of foundations (Source: ONF-RTM); (right) St Martin Vesubie, damage caused by massive deposition (Source: ONF-RTM).

- Considerable damage exacerbated by the debris flood process: the material toll following flood Alex is high, with extensive damage to infrastructure and buildings. The back analysis provided an opportunity to analyse the links between the nature of the damage, its extent and the intensity of the torrential phenomena. Over the two valleys, more than 400 buildings were affected, including 171 that were totally destroyed, 52 that were threatened with ruin and 203 with various types of damage. The results also show that the buildings were damaged in different ways: by flooding/submergence (by liquid water with a low sediment content), by filling with bedload transport (Figure 3 right), or by scouring of the foundations, (Figure 3 left). The main cause of structural damage to buildings is scouring of the foundations, with the rate of damage increasing sharply when the foundations become locally and then generally undermined.
