Insight into the fracture behaviour and mechanical response of ECAP processed cast and LPBF AlSi10Mg alloy

Abstract

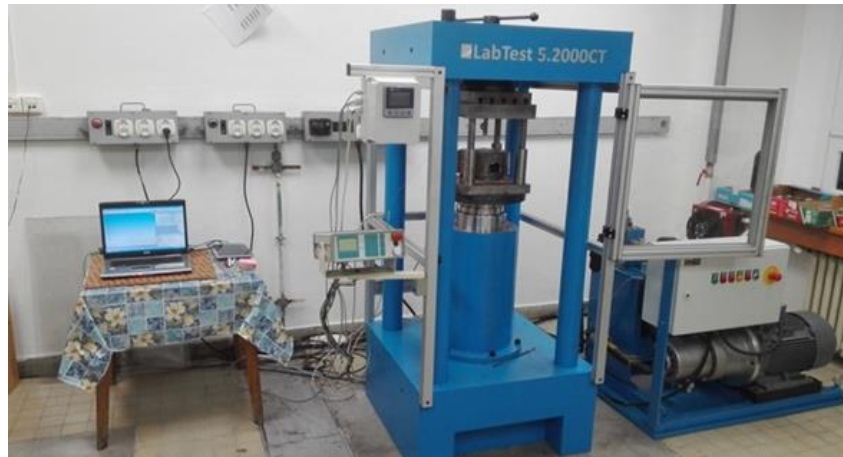
Fig. 3. View of the workplace for material forming using the ECAP method.

The ECAP experiment was performed using the LabTest 5.2000CT hydraulic press (depicted in Figure 3) controlled by Test Emotion software, which allowed the measurement of force values as a function of deformation resistance (σ) versus displacement (Δh).

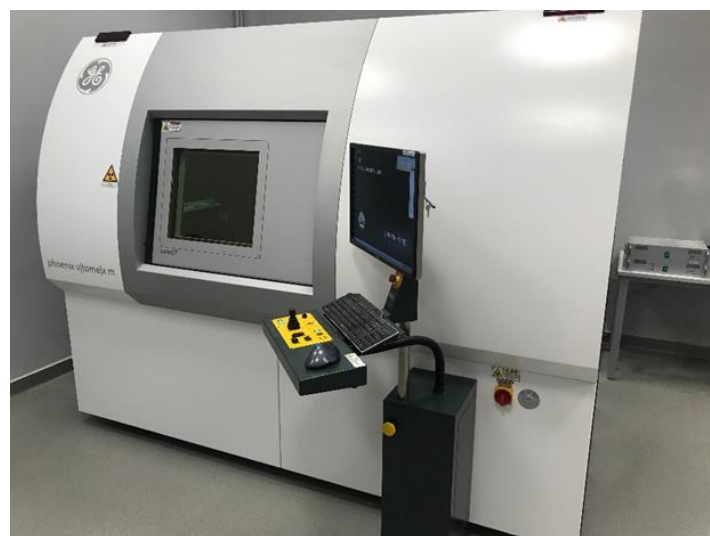
Fig. 6. Phoenix v|tomex m300 with DEBEN CT5000TEC control module.

The μ CT measurements were made on a Phoenix v | tomex m300 device (Fig. 6) using a microfocus lamp. The tested material was characterized by a similar absorption of X-ray waves, which means that from the point of tomographic examination two groups of elements can be distinguished:

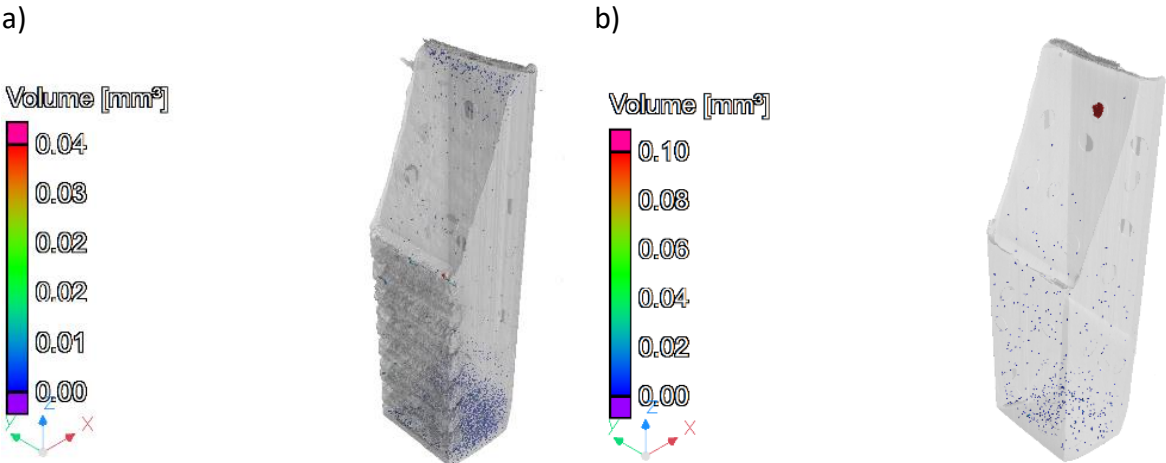
Fig. 13. The results of the porosity measurement a) ECAP-processed cast specimen, b) ECAP-processed SLM specimen.

Figure 13 presents the results of the porosity analysis. The accompanying images show a view of the reconstructed 3D object accompanied by a translucent image highlighting the results of the porosity analysis. The analysis focuses primarily on assessing pore size. Each identified defect is assigned a specific colour based on a predefined scale, which can be used to determine its size.

In Figure 13(a), it is evident that the ECAP-processed cast specimen has a higher number of uniformly distributed defects. The total porosity is determined to be 0.11%, corresponding to approximately 7000 pores. These defects have high sphericity and are predominantly visible at a distance of about 2 mm from the front edge of the ECAP-processed specimen (which experienced less deformation). The μ CT scan confirms that the residual pores formed during casting were not completely closed by the ECAP processing (see Supplementary Figure S2).

The ECAP-processed SLM specimen shows a lower porosity compared to its ECAP-processed cast counterpart. It is noticeable that defects are uniformly distributed throughout the specimen. The total porosity is determined to be 0.01%, corresponding to approximately 500 pores.

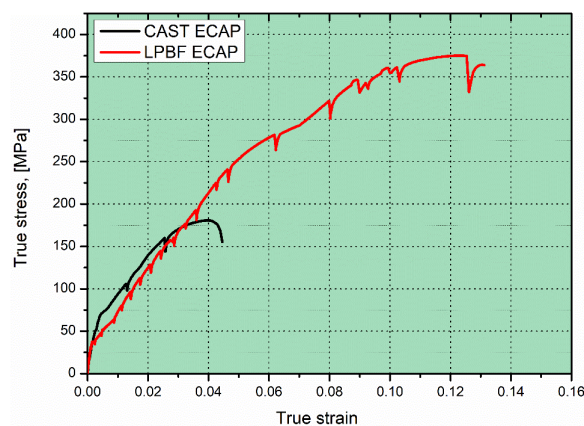
Fig. 14. Stress-strain curve registered during an in-situ μCT analysis.

In the subsequent phase of our investigation, we conducted in-situ tensile μ CT analysis to examine the fracture and mechanical behaviour of both ECAP-processed specimens. For this analysis, we carefully cut specimens from the midsection of the extruded ECAP billet, which displayed a relatively uniform distribution of porosity. The test involved performing scans at a tensile force loads corresponding to the characteristic stress drops observed on the stress-strain curve, Fig. 14.

As can be seen, the microstructural changes (discussed in Subchapter 3.1) have a significant impact on the mechanical performance. The most remarkable observation is the substantial increase in tensile strength achieved through the ECAP process. Specifically, the ECAP-processed cast specimen fractures at approximately 175 MPa and true strain of ~ 0.04 , whereas the ECAP-processed SLM specimen fractures at around 370 MPa. Additionally, the SLM specimen fractures at significantly higher true strain value of ~ 0.12 . These findings are noteworthy because such microstructural changes (reduction in grain size) typically result in improved strength, as predicted by the Hall-Petch relationship, which is often achieved at the expense of ductility. Referring to the ECAP-processed SLM alloy, the increased ductility can be attributed to two main microstructural features. The first is the unique multi-level heterogeneous microstructure, which contributes to exceptional mechanical properties, in particular improved work hardening capability. The second is the Si morphology. As can be
