Sustainable Construction through Tradition: Inventory of Cob Buildings in the Guérande Peninsula (France)

Keywords: heritage; earth construction; cob; Guérande peninsula

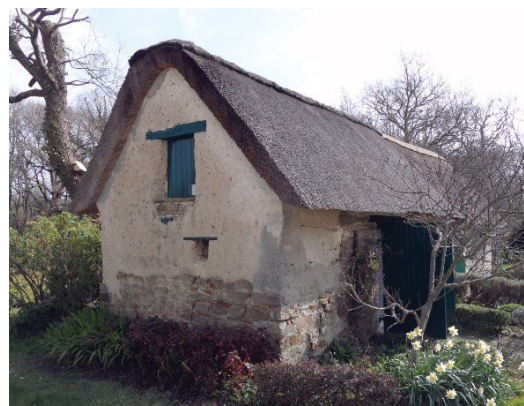
Figure 1. A cob outbuilding at Kerhebé, dating from the mid-19th century [15].

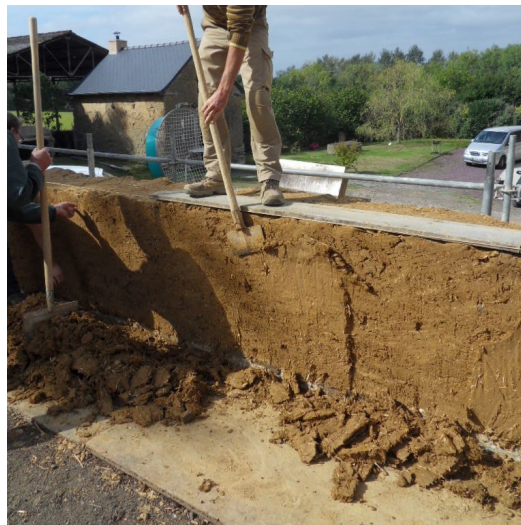
Figure 6. A cob wall in modern construction [33].

According to Hamard et al. [8], the cob technique consists of stacking clods, or cakes, of a wet raw earth mixture of fairly stiff consistency to form a monolithic, load-bearing, or free-standing wall (see Figure 6). The earth is excavated on site or nearby and may be mixed with natural fiber additives such as straw, reed, or hay. A cob wall is built in layers, known as ‘lifts’, because each layer of fresh, wet material must dry sufficiently to support the mechanical load of the upper layers before another lift can be applied. A cob building also usually has a stone foundation plinth to protect the walls and floors from water damage caused by capillary rise and splashing from rain hitting the ground [8].
