Sustainable Construction through Tradition: Inventory of Cob Buildings in the Guérande Peninsula (France)

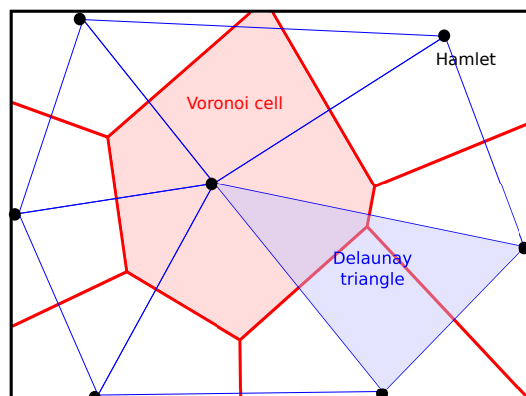
In order to identify the cob buildings on the Guérande Peninsula, we combined several sources of information and open-source digital tools. The first step was to demarcate sub-zones for investigation. To do so, we imported the digital map of the region from Géoportail [34], a government website, into the geographic information system software QGIS 3.34.10-Prizren [35]. Each place (such as hamlet, village, district, and so forth) is already assigned a location and a name on the Geoportail map. These locations were used as nodes to perform a Delaunay triangulation, from which we obtained Voronoi cells. The Delaunay triangulation is an optimized method for joining the nearest nodes and creating a triangular mesh (see Figure 7). The Voronoi tessellation method allows for the generation of a tiled partition of the surface, wherein each vertex of a given polygonal Voronoi cell is positioned at the same distance from the vertices of the Delaunay triangle to which it

Figure 7. Delaunay triangulation and Voronoi diagram used to define the investigation zones.
