Sustainable Construction through Tradition: Inventory of Cob Buildings in the Guérande Peninsula (France)

Abstract: This paper delves into the investigation and inventory of cob buildings within the Guérande Peninsula, employing an interdisciplinary framework merging academic inquiry, fieldwork, and digital cartographic methodologies. Against the backdrop of escalating environmental concerns within the construction sector, raw earth construction emerges as a compelling avenue for sustainable building practices due to its low embodied energy and reversible characteristics. Despite historical prevalence in regions such as northwest France, traditional earth-building techniques have experienced waning prominence with the advent of industrial materials. However, the resurgence of interest in raw earth's minimal carbon footprint has catalyzed renewed attention towards earth-building methods. Through a meticulous investigation methodology, this study identifies and analyzes 802 potentially old cob buildings, with 46 structures confirmed as cob constructions. Employing statistical analyses of building characteristics, including wall and lift heights, preservation states, and geographical

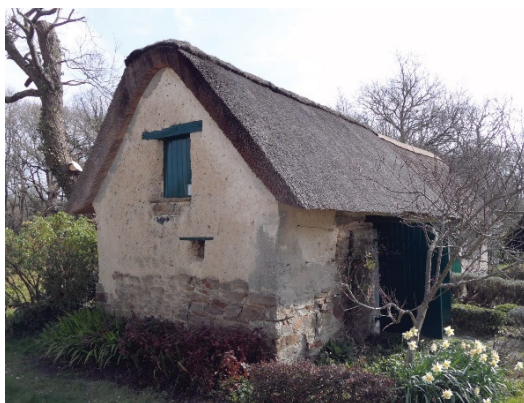
Figure 1. A cob outbuilding at Kerhebé, dating from the mid-19th century [15].

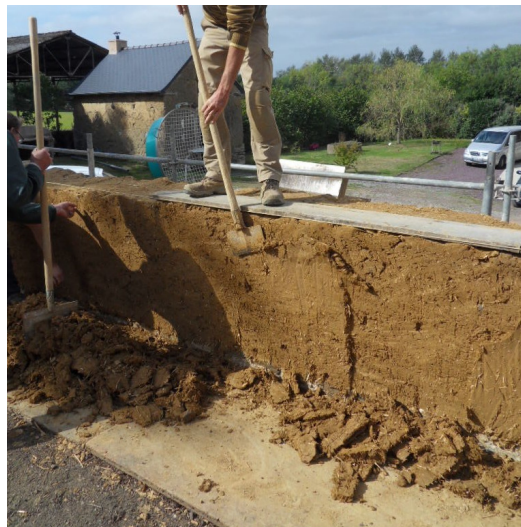
According to Hamard et al. [8], the cob technique consists of stacking clods, or cakes, of a wet raw earth mixture of fairly stiff consistency to form a monolithic, load-bearing, or free-standing wall (see Figure 6). The earth is excavated on site or nearby and may be mixed with natural fiber additives such as straw, reed, or hay. A cob wall is built in layers, known as ‘lifts’, because each layer of fresh, wet material must dry sufficiently to support the mechanical load of the upper layers before another lift can be applied. A cob building also usually has a stone foundation plinth to protect the walls and floors from water damage caused by capillary rise and splashing from rain hitting the ground [8].

Figure 6. A cob wall in modern construction [33].
