# First predictive measurements of endodontic mechanical damage through photoelastic analysis and acoustic emission descriptors

Jeanne Davril, Romain Hocquel, Marin Vincent, Éric Mortier, Nicolas Rauber, Adrien Baldit, Rachid Rahouadj

Preprint submitted on 15 Oct 2024

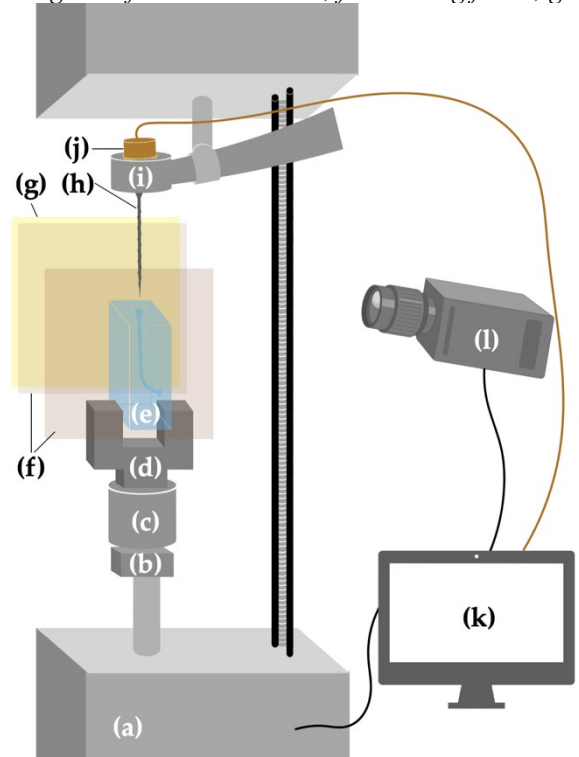
Figure 1: a Tensile machine; b Load cell; c Torque cell; d Clamping; e geometry and the different regions of the PMMA block; f Polarizing filters; g

Light source; h File; i Motor; j Acoustic sensor; k Computer with softwares; l HD camera.

The study consists of a campaign in which each multiphysic test is designed to reproduce the fracture of a continuously rotating endodontic file within a canal (Fig. 1).

The analog tooth model was a block of PMMA containing a curved canal. As PMMA is birefringent, polarizers were placed on either side of the block to reveal isochromatics that reflect the existence of stress fields. Qualitative analysis of the isochromatics makes it possible to locate areas of high stress concentration in the tooth canal around the file. The endodontic files used (One Curve, MicroMega SA) were mounted on a Dual Move endodontic motor (MicroMega SA) and rotated at a speed of 500 rpm, with a safety torque of 4 N.cm. The motor was fixed to workbench throughout the experimental campaign. The PMMA blocks were attached to the mobile crosshead of the tension-compression machine (Ametek Lloyd LS1), fitted with force (50 N) and torque (0.3 Nm) transducers. The block moved 20 mm in the direction of the file at a speed of 1 mm/s and returned under the same conditions. The AE chain comprises a miniature

transducer linked by a cable to a preamplifier and a data acquisition chain (Mistras). The ultrasonic transducer (200-750 kHz) was coupled to the endodontic motor head. Force and torque values were processed simultaneously with AE descriptors, which were collected and analyzed using AEWIN software. Tests were repeated on the same file until breakage, each block being reamed only once. After each test leading to fracture, the files and instrumental breaks within the blocks were examined and analyzed on a profilometer.

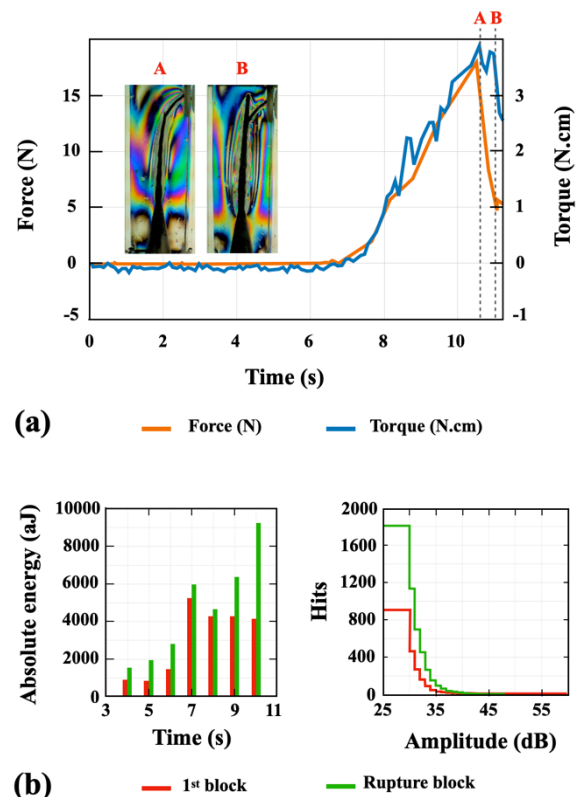
**Figure 2. (a)** Illustration of file breakage and bifurcation of the machined canal, and associated

force and torque responses versus time during a rupture test (b) Comparison of acoustic emission descriptors of a representative file for the first and the rupture block: on the left, absolute energy (aJ) versus time (s); on the right, distribution of hits by amplitude (dB). Credit: J Davril

A total of 10 files were tested to failure, corresponding to 34 blocks. Real-time isochromatic analysis revealed a high concentration of stresses around the file, particularly in the "working" areas of the file (Fig. 2a). On the other hand, we observed residual stresses persisting in the blocks, even after the file had been removed, particularly at the root canal walls and around the embedded instrumental break. An inversion of the file pitch is visible on every broken file, and the fracture surface is helical in shape but slightly different from 45°, meaning that the file has mainly broken in torsion, with its tip embedded in the apical zone. Finally, after breaking (point A in Fig 2a), the file continues its movement prescribed by the choice of loading path, creating a block. new path, or bifurcation (point B in Fig.2a), along the long axis of the block.

Force and torque values increase during machining (Fig. 2a). In the various tests, the force reached maximum values of around 15 to 30 N and the torque of 3 to 4 N.cm. In tests where breakage occurred, the force decreased immediately after breakage, while the torque decreased once the return movement has been initiated. With regard to acoustic emission signals, we present in this summary, by way of example, the evolution of absolute energy (aJ) as a function of machining time and the distribution of hits as a function of their amplitude (dB) (Fig. 2b). This subfigure compares the results for the first resin block and the one during which the file break occurred. Absolute energy values were higher during the rupture test than during the first test, particularly just before rupture (at time 10.5 seconds in figure 2b). In terms of signal amplitude and distribution (hits), for all tests, there were many low-amplitude events and few high-amplitude events. Compared with the first block test, the rupture test showed lower signal amplitudes but a greater number of hits. On the other hand, the maximum amplitude reached was lower and high-amplitude signals were rarer. The increase in absolute energy and number of hits reflects an increase in the number of microstructural events leading to fracture (Nataf *et al.*, 2020).
