Triggering and runout conditions of two rock slope failures in the French Alps: Vallon d'Étache and Crête des Grangettes

Triggering and runout conditions for the little rock avalanche of June 2020 in Vallon d'Étache (Savoy, France).

An approach combining various cutting-edge methods.

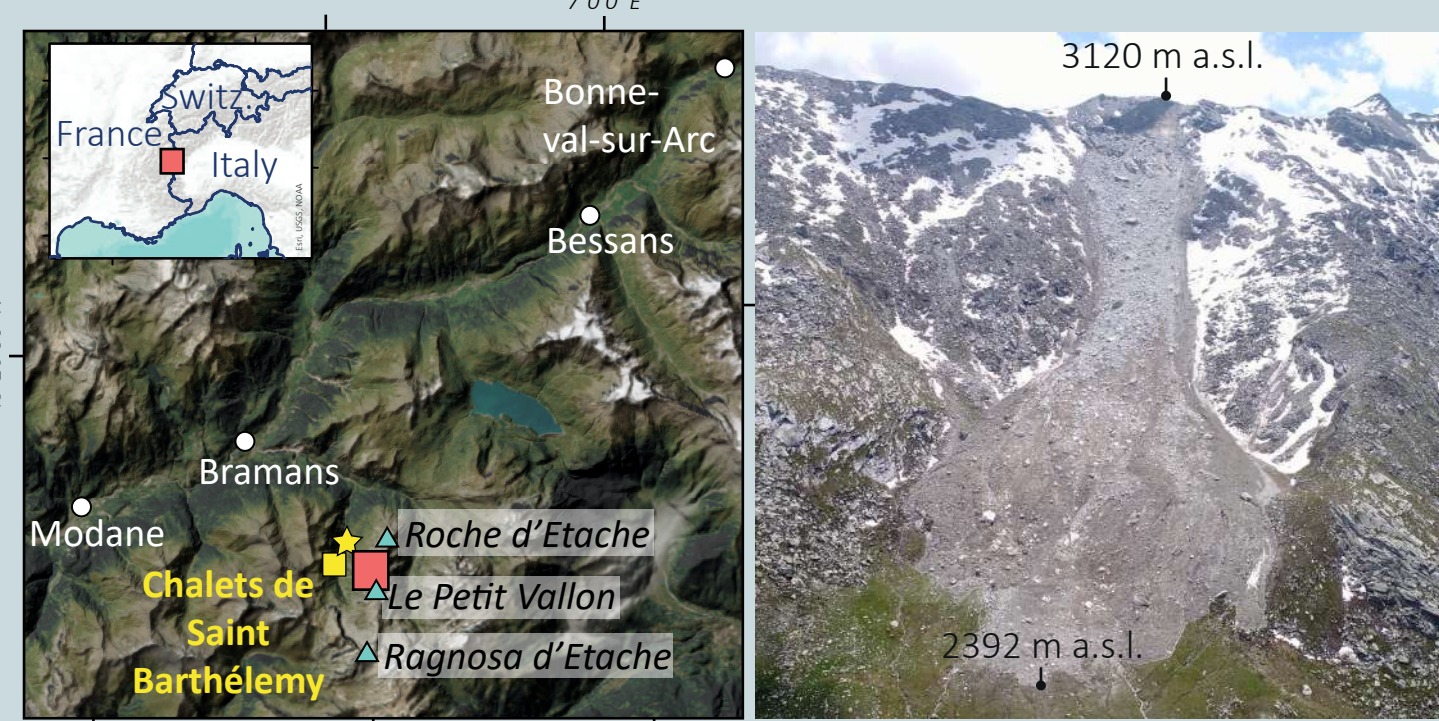
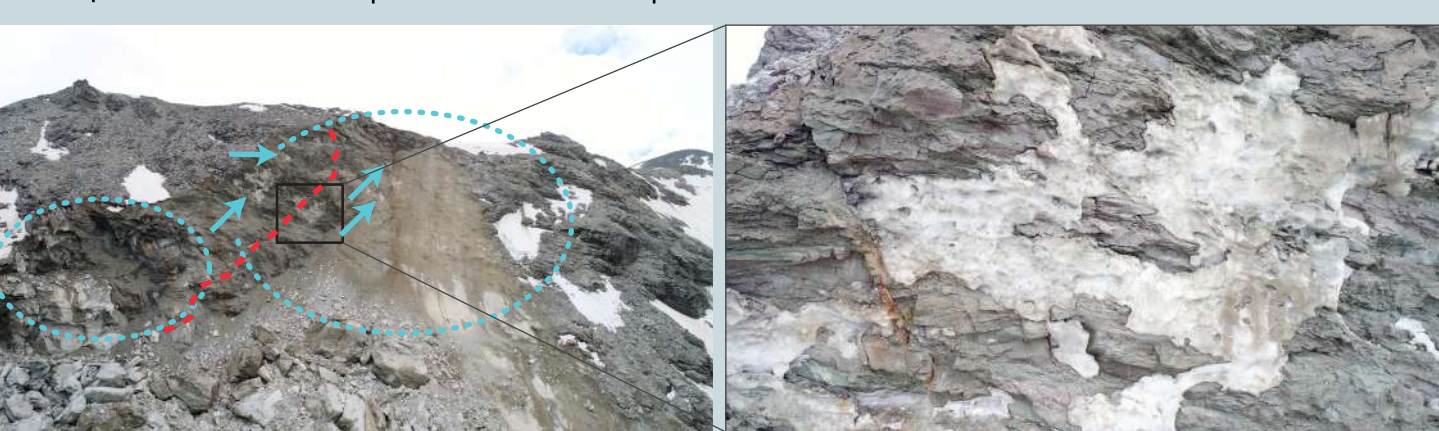
The rock avalanche occurred on June 18, 2020, from the crest line (3126 m) in Etache Valley. The deposit extends 600 m above the farm, the parking area, and the hiking trails. **Ice in the rockfall scars** suggests the presence of permafrost, but its local distribution remains to be confirmed.

- Building
- Visible fracture
- Study area
- Visible ice coating
- Parking
- Liquid water

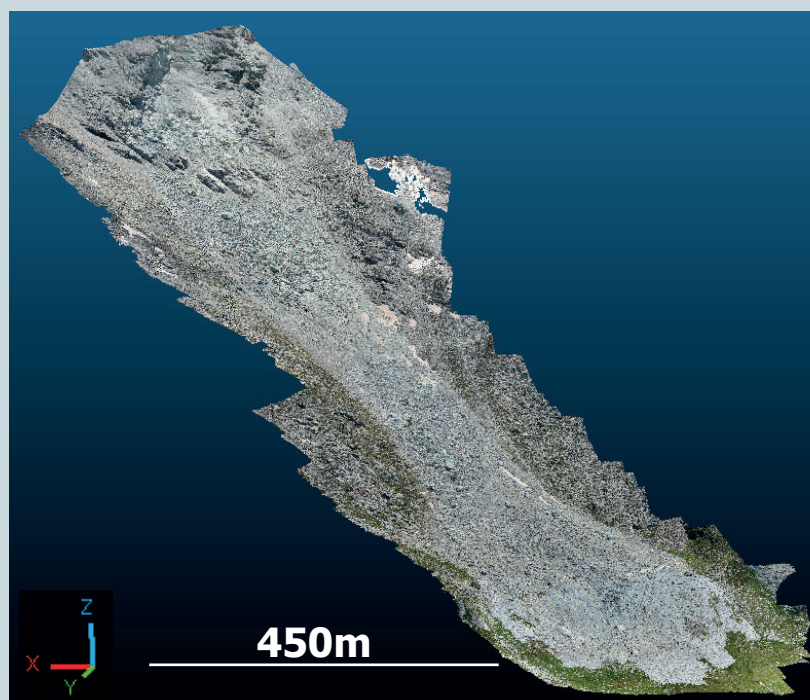
VOLUMES : 3D RECONSTRUCTION

The scar :

- Width: 180 m
- Max depth: 46.5 m
- Average depth: 14.7 m.

Estimated volume:
221,000-229,000 m³

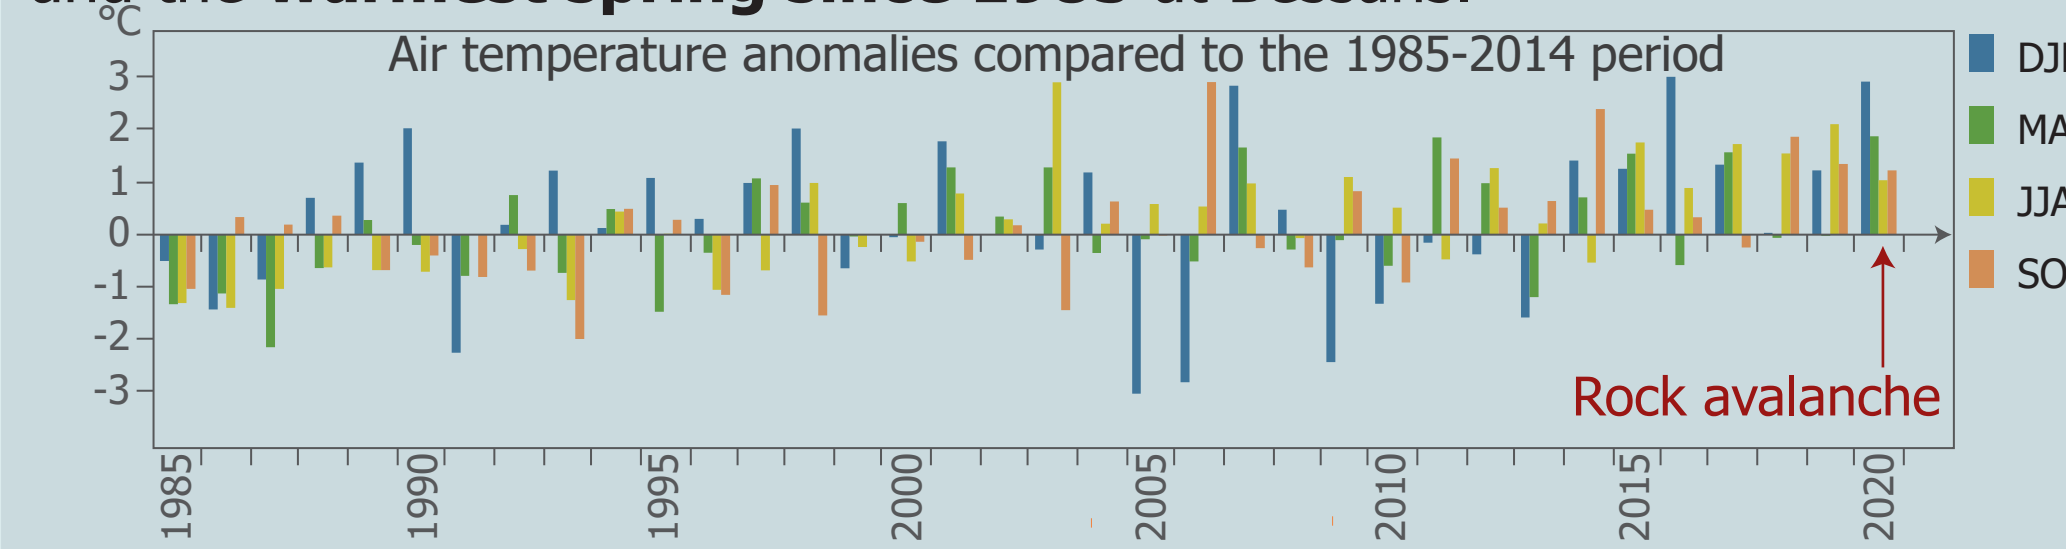
Air temperature anomalies:

- 2020 annual average air temperature: **the warmest in the 1985-2014 period.**
- The 6 month period prior to the event: the **second warmest winter and the warmest spring since 1985** at Bessans.

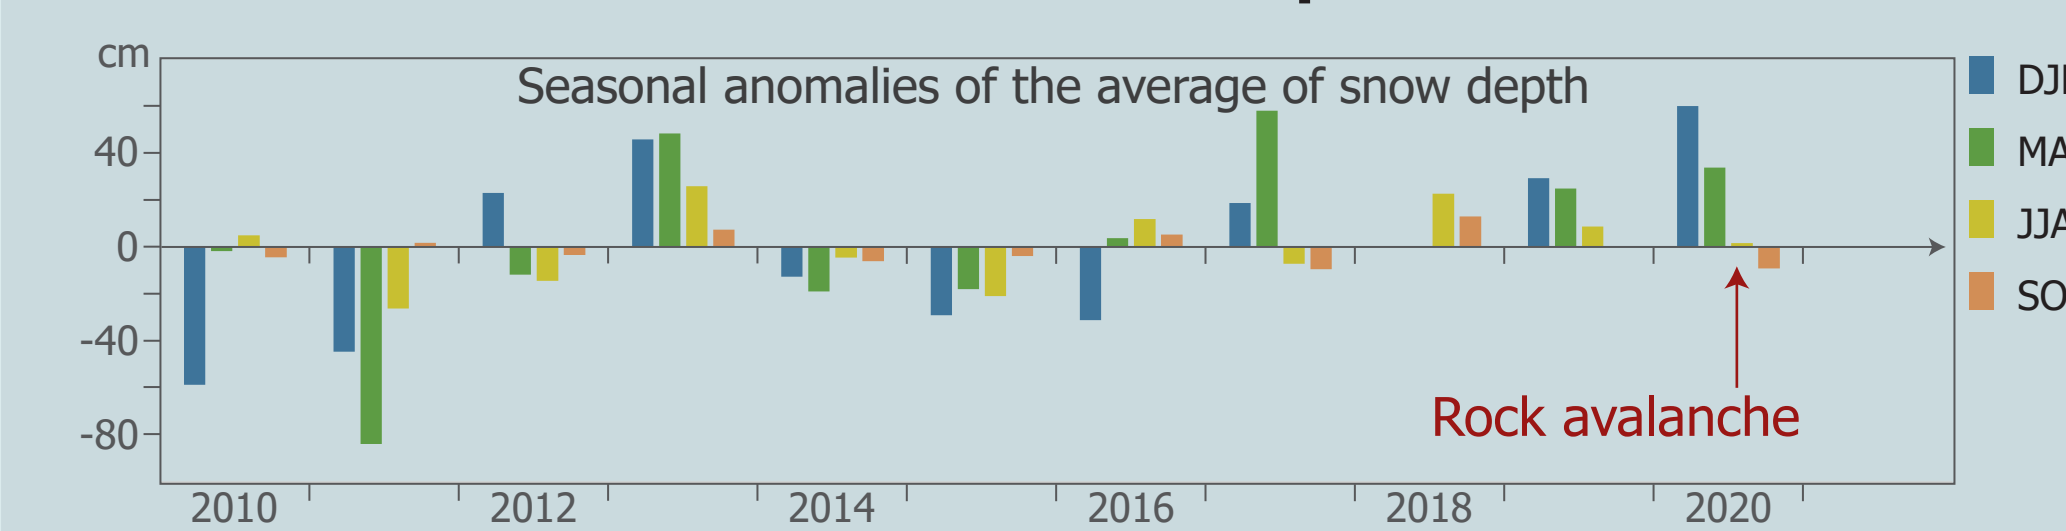
Snow anomalies:

- Average snow depth over the winter period: 186 cm = **48% (60 cm) more snow than the 2010-2019 winter periods** at Bonneval-sur-Arc.

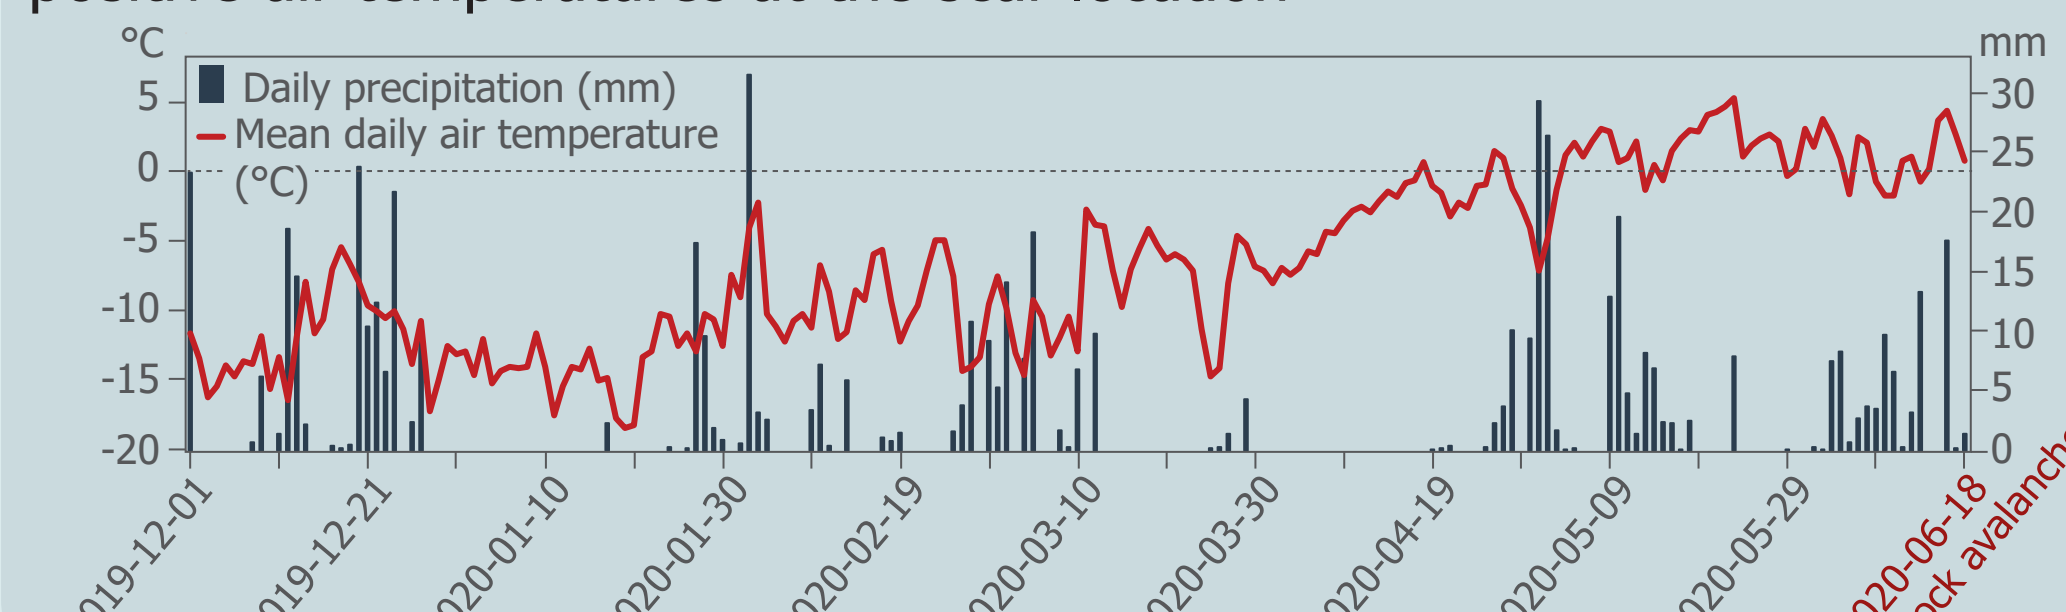
Precipitation prior to the rock avalanche:

- **Significant rainfall** the week prior to the event (15 % of the spring 2020 rainfall in Bessans).
- **Significant input of water (snow melt and rainfall)** suggested by positive air temperatures at the scar location

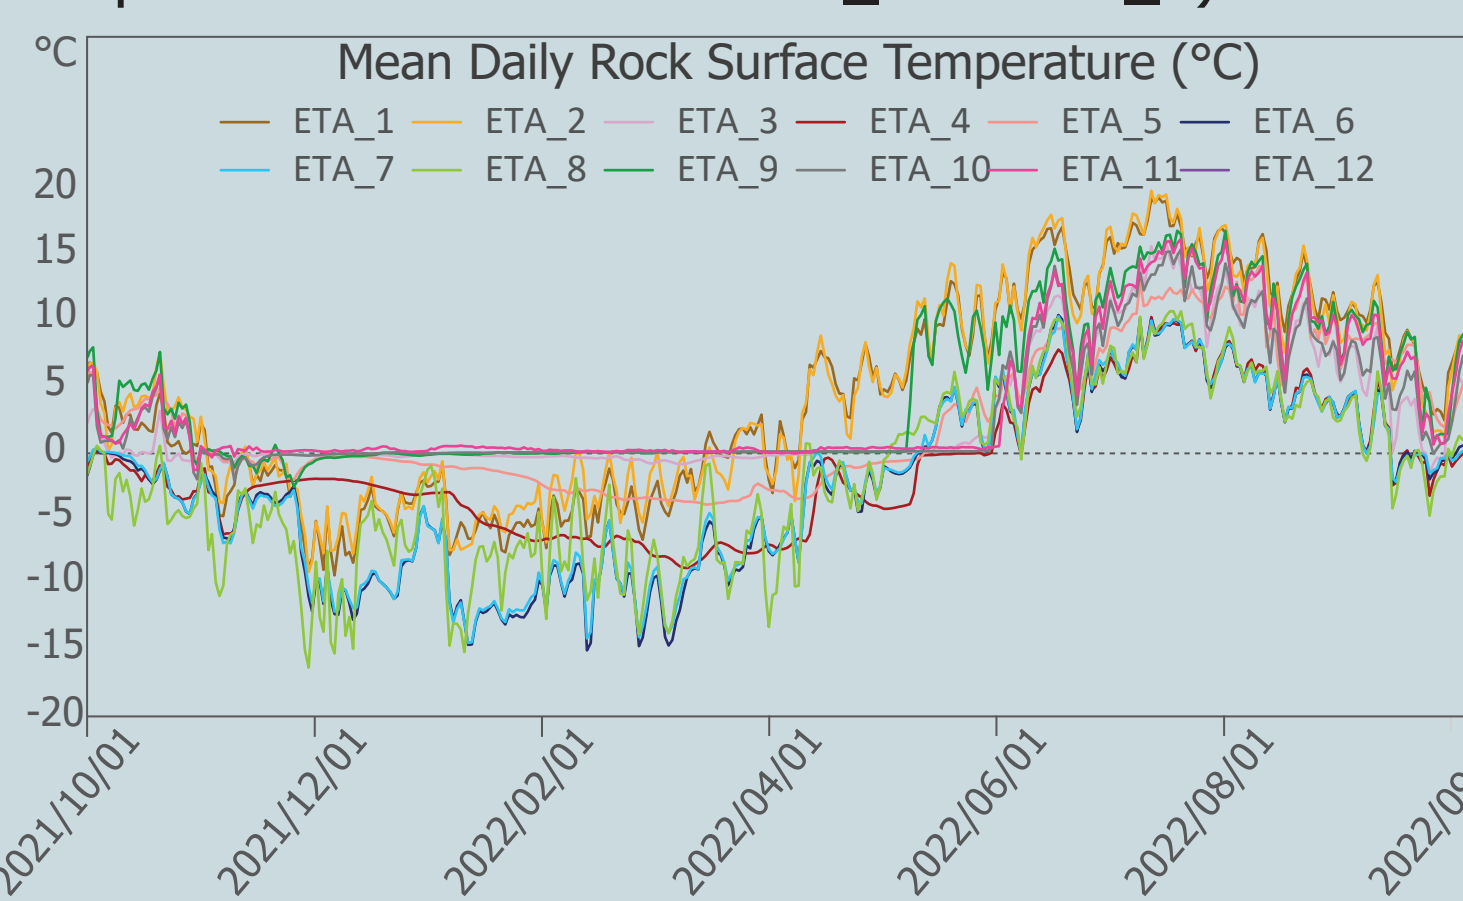
- **12 loggers installed** (c. 10 cm below the surface)
 - elevation range from 2675 m to 3116 m asl.
 - different ground conditions and sun-exposure.
 - data recorded from 2021/10/01 to 2022/09/30.
- **MAGST***1: ranges from -2.3 to 6.1°C
- **Sensors affected by snow** (dampened daily oscillation and persistent sub-zero temperature in winter and spring).
- **Effect of permafrost at depth** (suggested by low temperature in winter for ETA_4 & ETA_5)

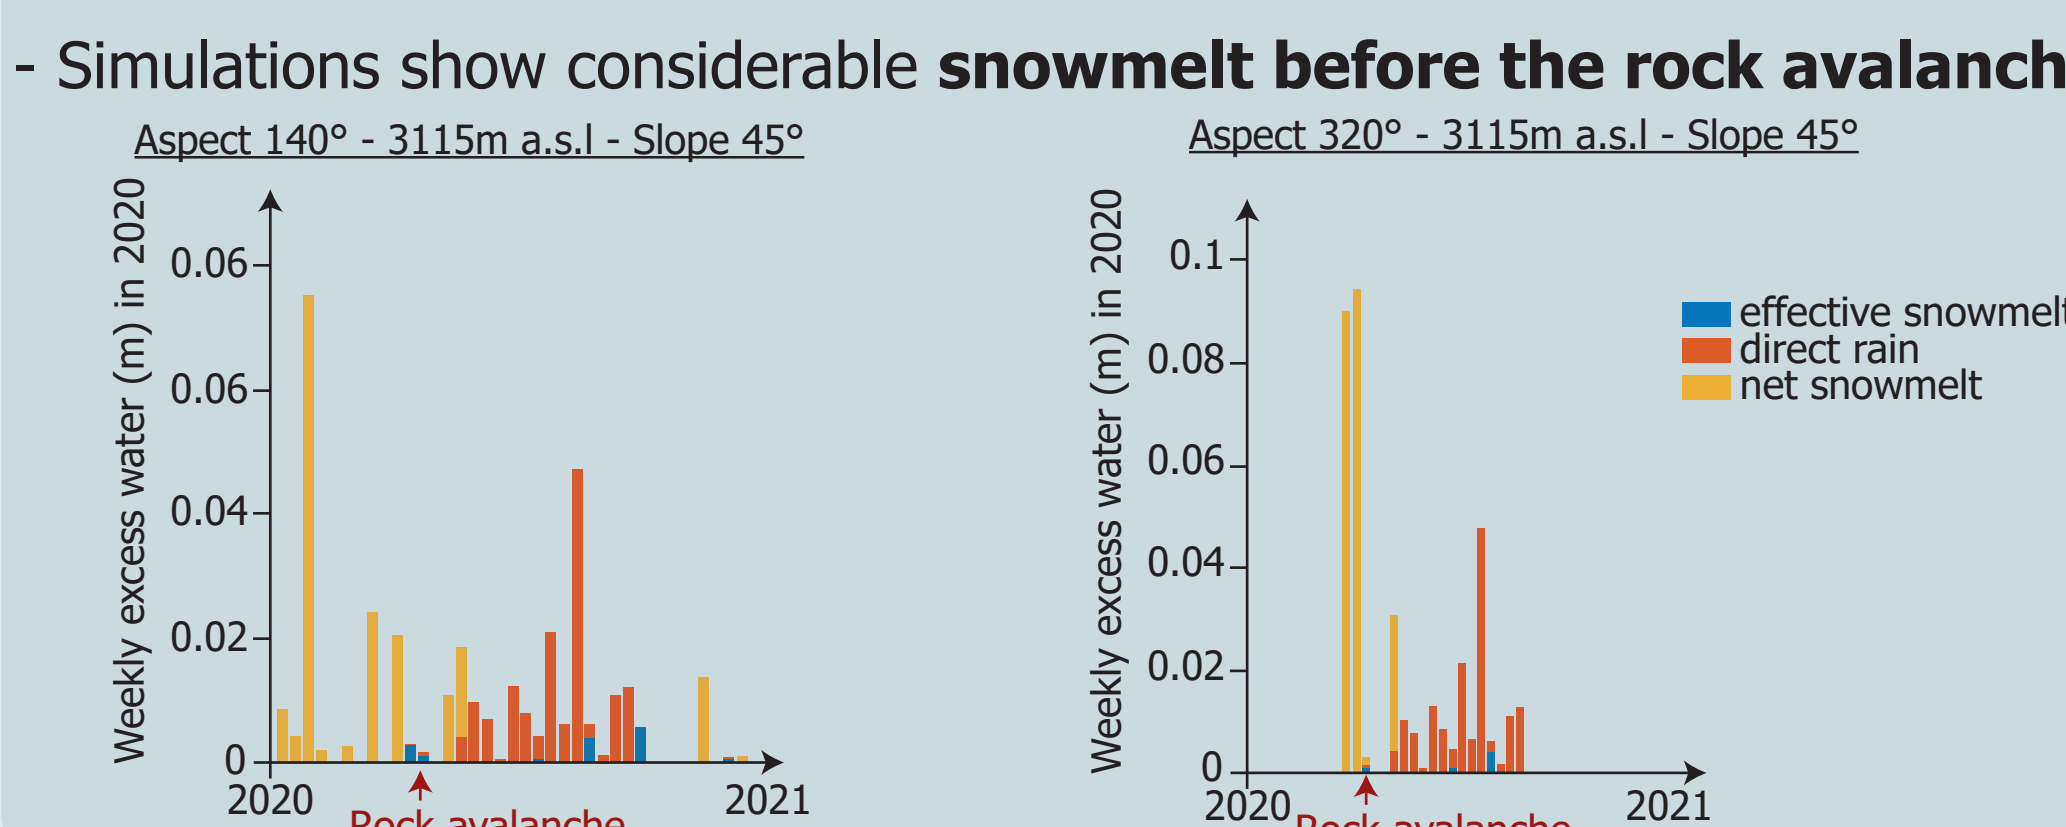
- The **CryoGrid** model (Westermann et al., 2022) was used to simulate the **energy and water mass balances and estimate rock surface temperature and water fluxes from snowmelt and rainfall.**

- Energy balance model (CryoGrid) show that **water input from precipitation and snowmelt are consistent** in the weeks before the rock avalanche is triggered.

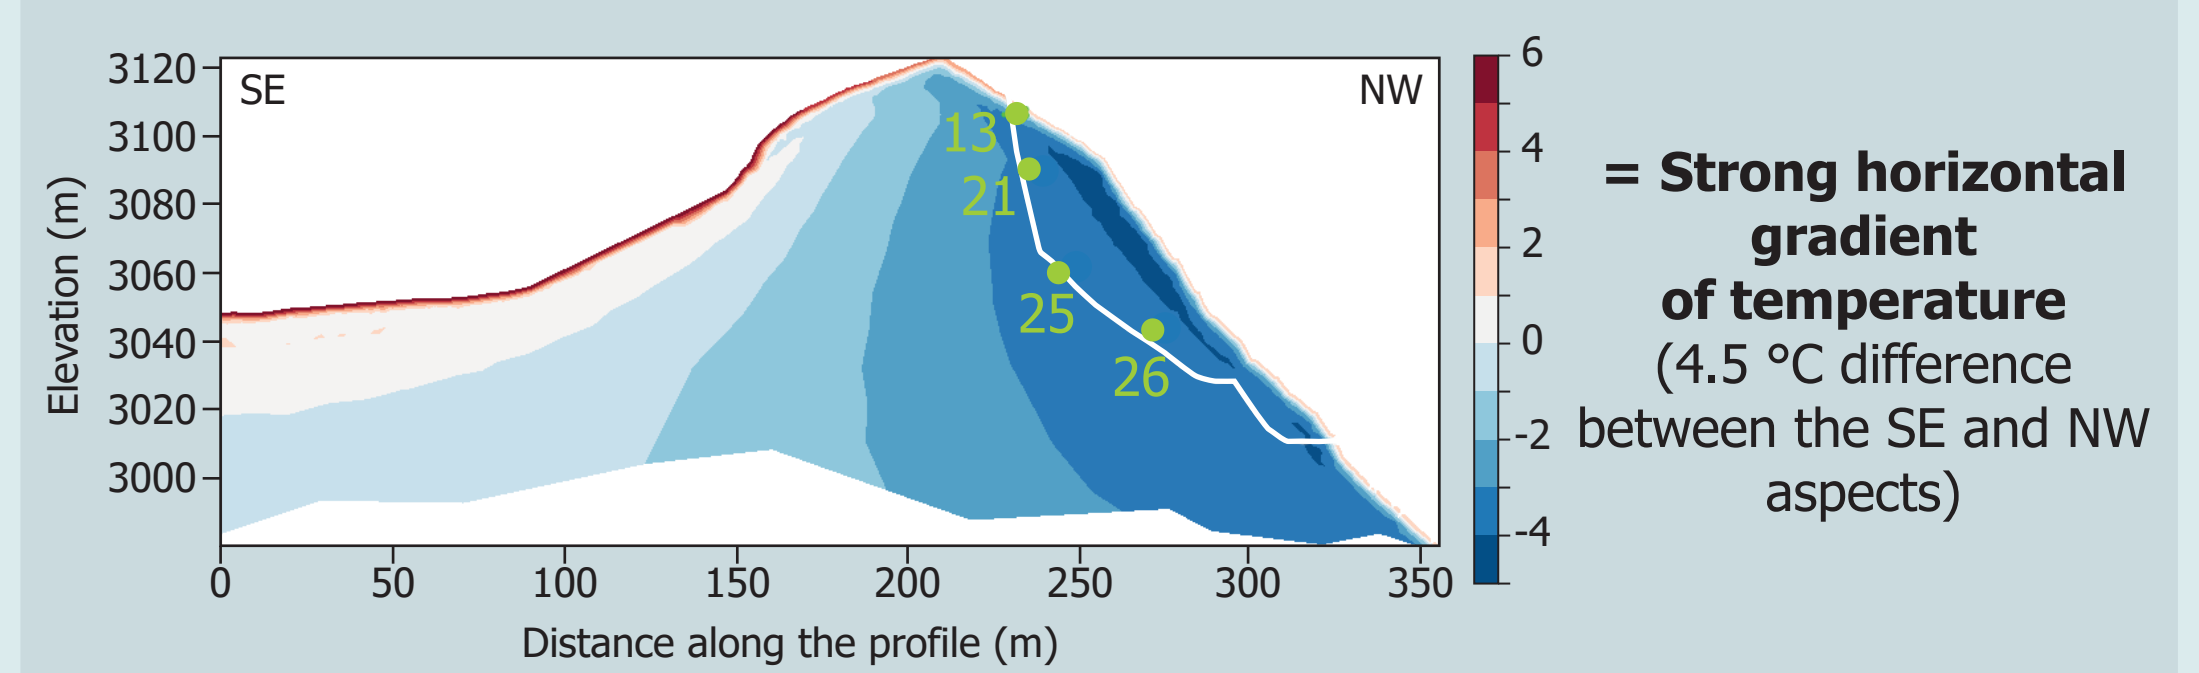
In order to estimate **the thermal state of the release area** when the rockfall happened we performed two simulations with FEFLOW.

Simulation 1*2: Forced with rock surface temperature deduced from air temperature (does not account for the presence of snow.)

- Permafrost modelling results (Feflow) strongly support **the hypothesis of a rockfall triggered by a warming of cold permafrost**, both by heat conduction as simulated by the models, but also possibly reinforced by heat advection from water infiltration (likely leading to the thawing of areas that have never experienced conditions above freezing point, which could also lead to high hydrostatic pressure).

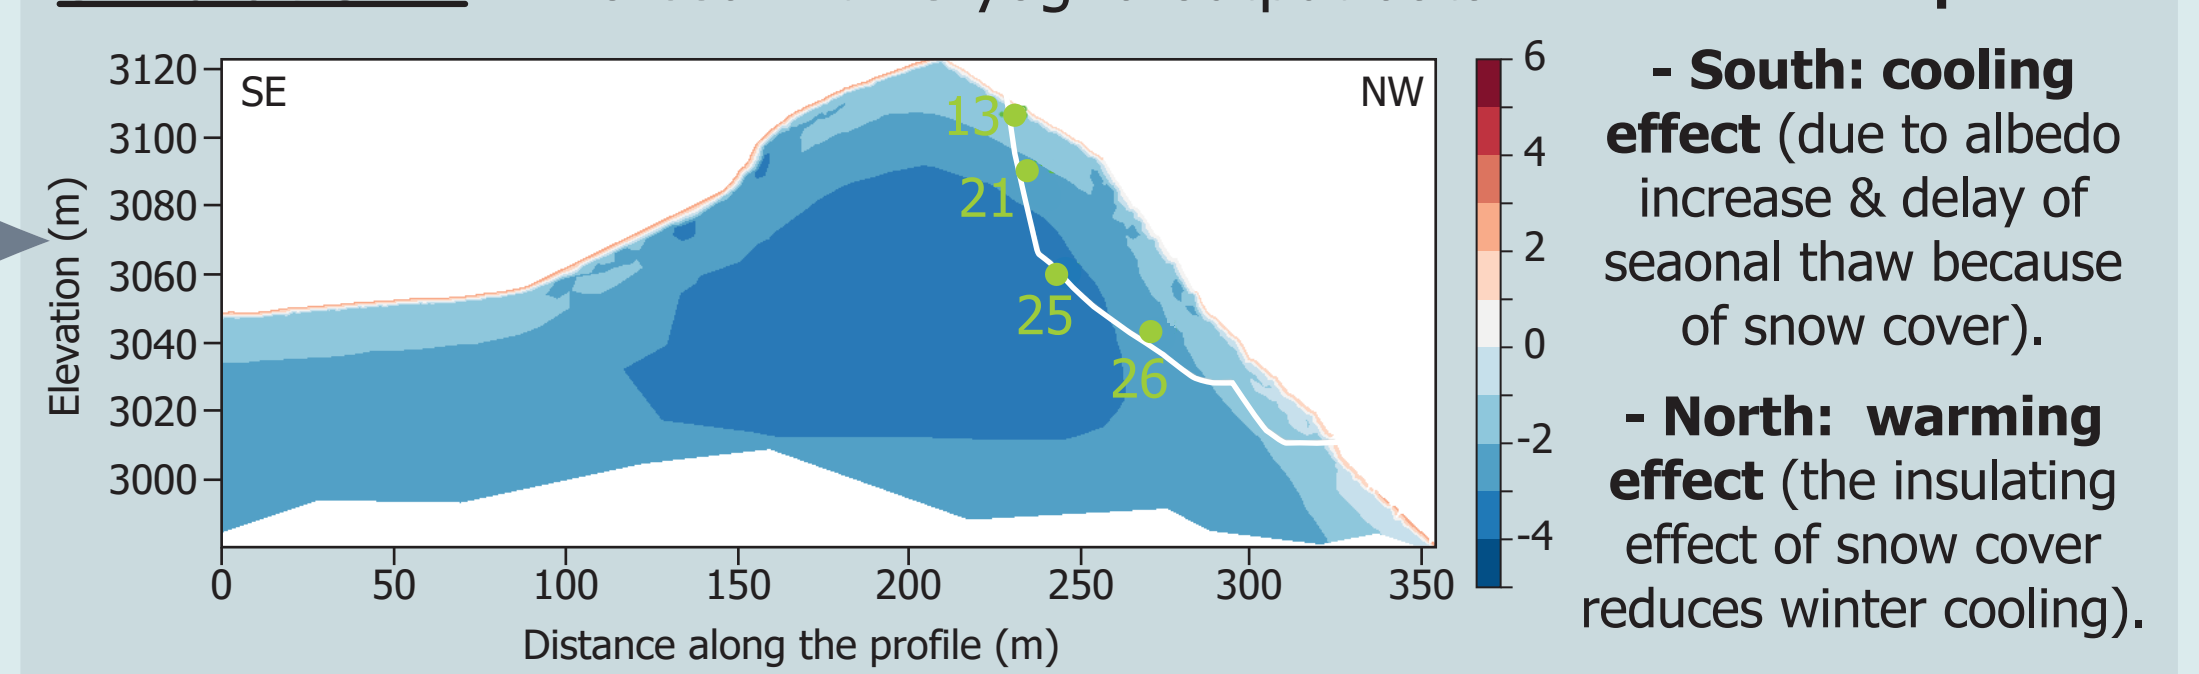
Simulation 2*2: Forced with Cryogrid output data.

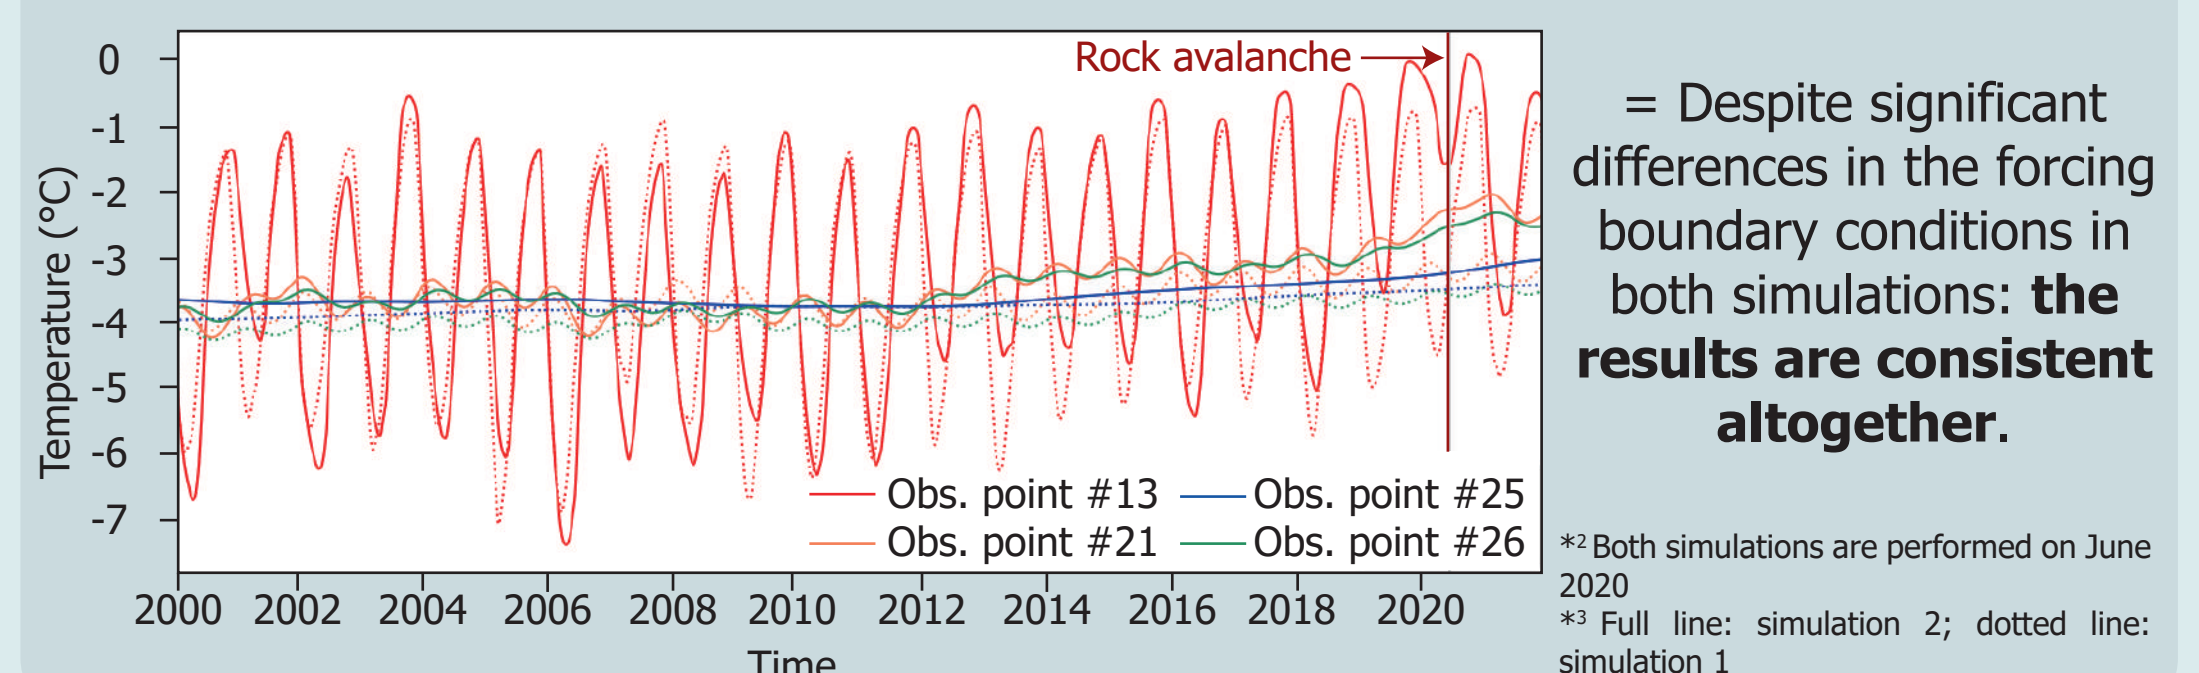
Timeseries of temperature at 4 observation points close to the rockfall scar, for both simulations*3.
