The Church of the Transfiguration (Khumarzhm) in Garni: Archeosismology and Transformations of this monumental Building from Antiquity to the 19th Century

The Church of the Transfiguration (Khumarzhm) in Garni: Archaeoseismology and Transformations of this monumental Building from Antiquity to the 19th Century.

Bruno Helly* and Alain Rideaud**

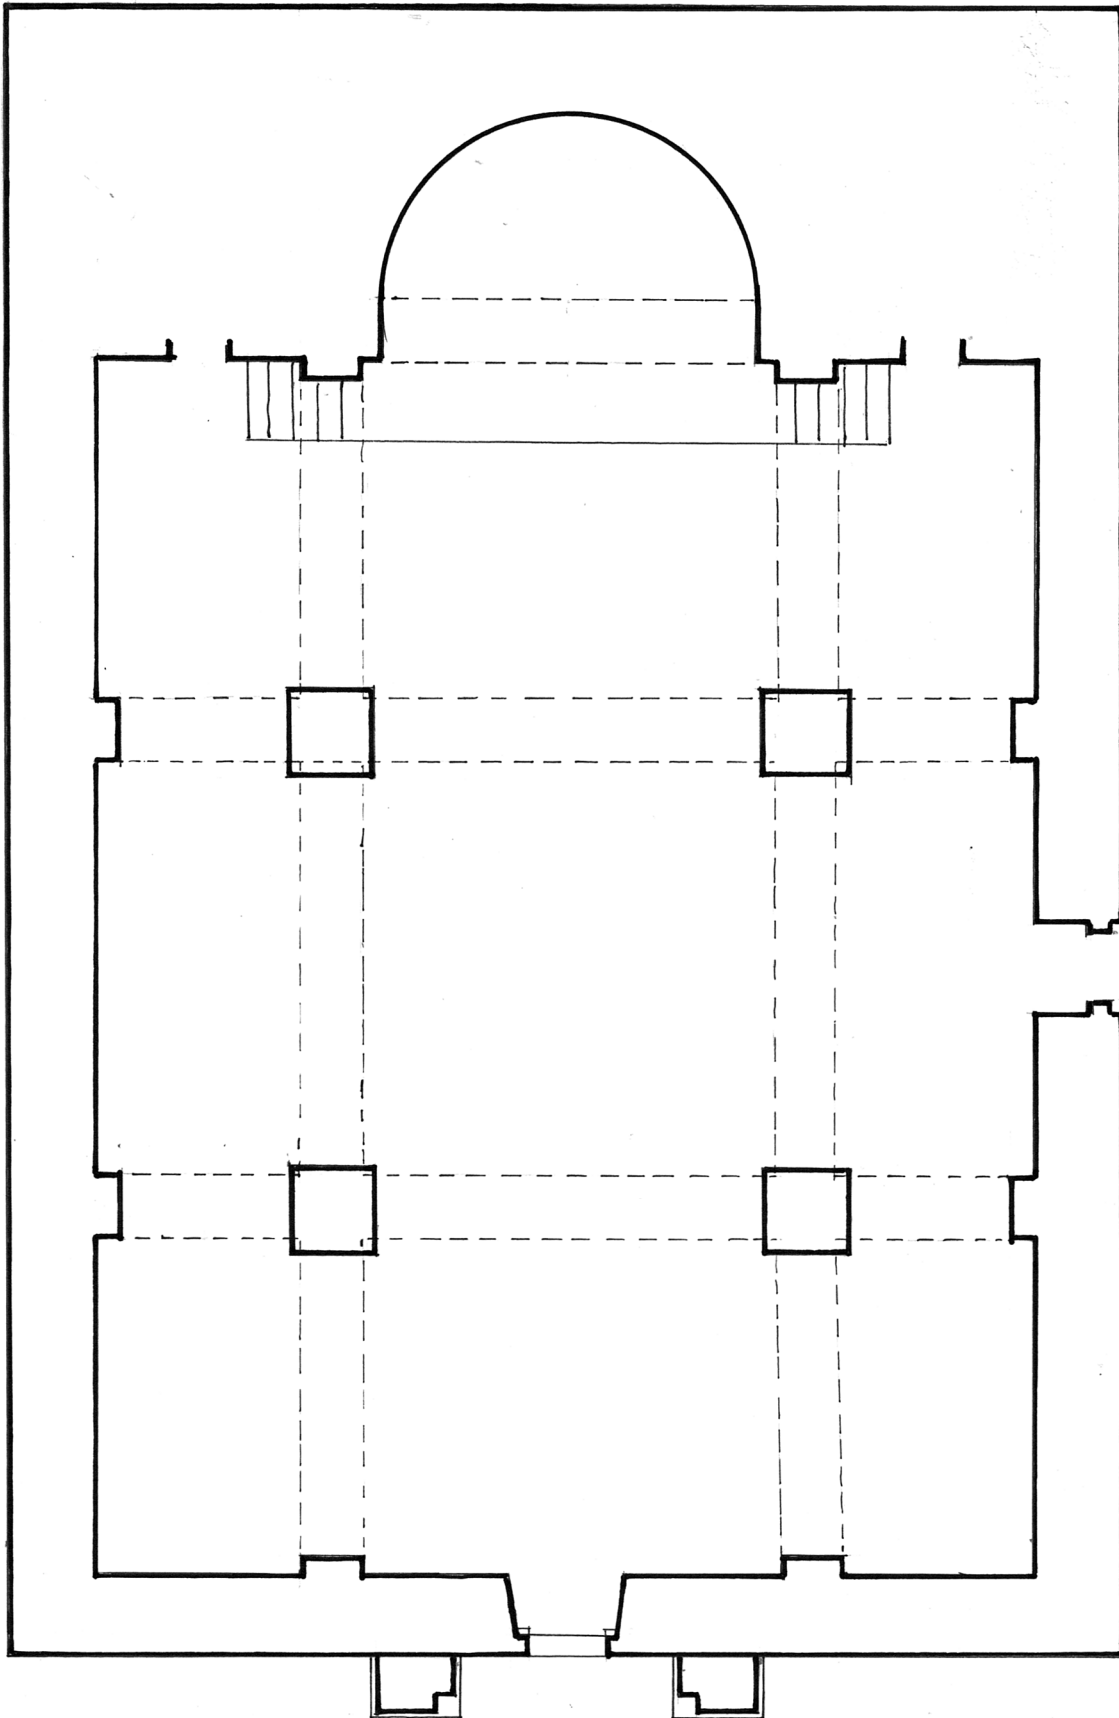
- Figure 2. Map of the Astvatatsin Church. Drawing Alain Rideaud.
- 450 Figure 3. a) and b) : Astvatatsin Church, North of the present church fragment of a door jamb with rotation, rest of an older building. c) and d): tilted pillar in the church and reconstructed vault. e) : the east wall with flat apse. Photos Alain Rideaud.

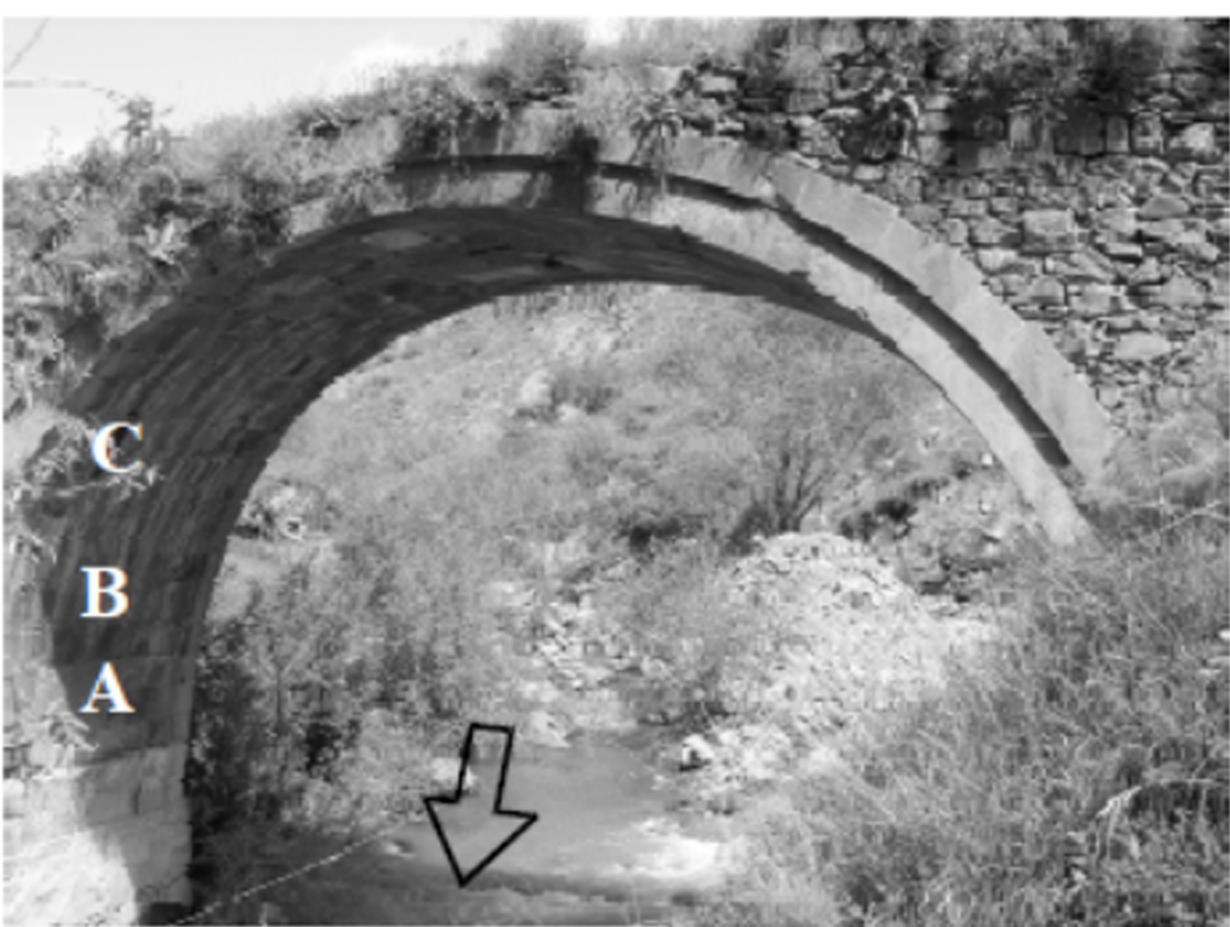
- Figure 4. The Bridge of Garni on the Azat River. Pictures before the total restauration; Three different phases from the oldest to the most recent : A. Oldest voussoirs at the foot. B. First reconstruction.C. Second reconstruction. Photo Alain Rideaud.

A detailed study of the different states of construction of the bridge over the Azat River is presented
in Helly and Rideaud (2016). It is commonly said that the bridge of Garni was built to allow the
construction of Havouts Tar Monastery and other, established from the 12th Century AD. Our
observations document that there were three successive stages A, B, C in the history of the bridge at
110 Garni (Figure 4). The collapse of the successive bridges of Garni were likely caused by earthquakes,
even if we agree with Karakanian to attribute possibly the destruction of the state B to the 1679
earthquake. It could be supposed that the destruction of the bridge, at first stages A or B, was not
necessarily related to a seismic event of high amplitude: the river caused big erosion, the local fault,
if it existed, played a role, freezing caused the destruction of sections of rock, the left pier collapsed.

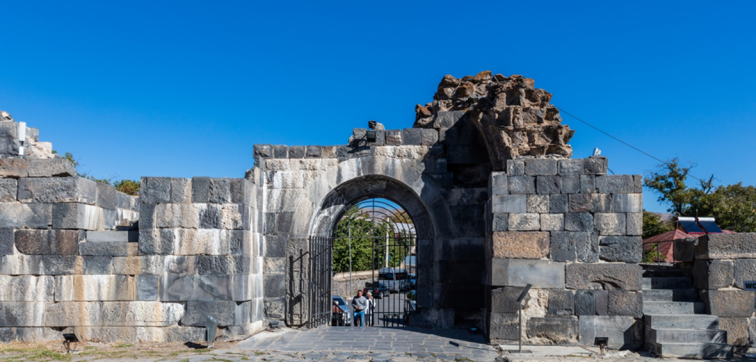
- 455 Figure 5. The reconstructed gate of the fortress of Garni. Photo Alain Rideaud.
- Figure 6. The Khumarzham Church, general view from the south-west. Photo Alain Rideaud.

For our point of view, the most important observation of Vinogradov is that the basalt block with the inscription was the lintel of the major gate of the fortress, hypothesis presented first by Moretti, which calculated the total length of the block, starting of the calculation of probable number of the letters in the probable restitution of the missing part of the inscription. In our opinion this position is clear, because it is the most visible place for dedicatory inscriptions of buildings or monuments. It is not surprising that in such position the block falled by shock and ground motion caused by an earthquake and was brocken when falling down (Figure 5).

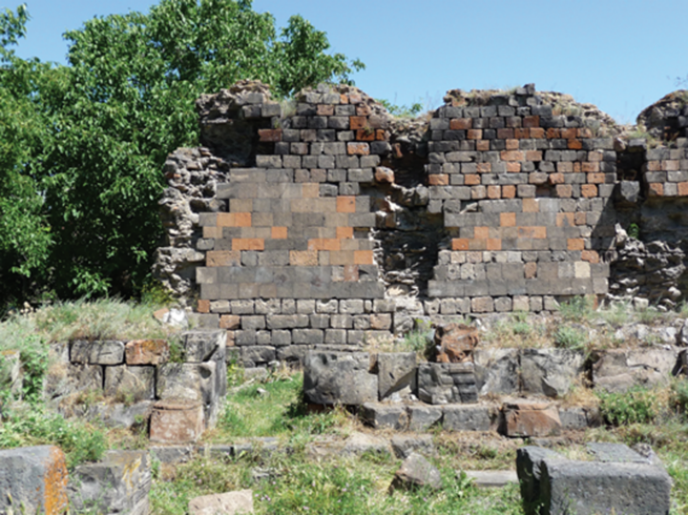
- Figure 7. Map of the Khumarzham Church at Garni (from Mourad Hasrat‘yan, Early Christian Architecture of Armenia, Moscou, 2000, p. 99).
- Figure 8. The North Wall of the main nave, inner face. Photo Alain Rideaud.

Another notice and another map of the building can be found in Mourad Hasratyans' 2000, 99. This plan is the most accurate, but it does not carry any exterior details to the monument.

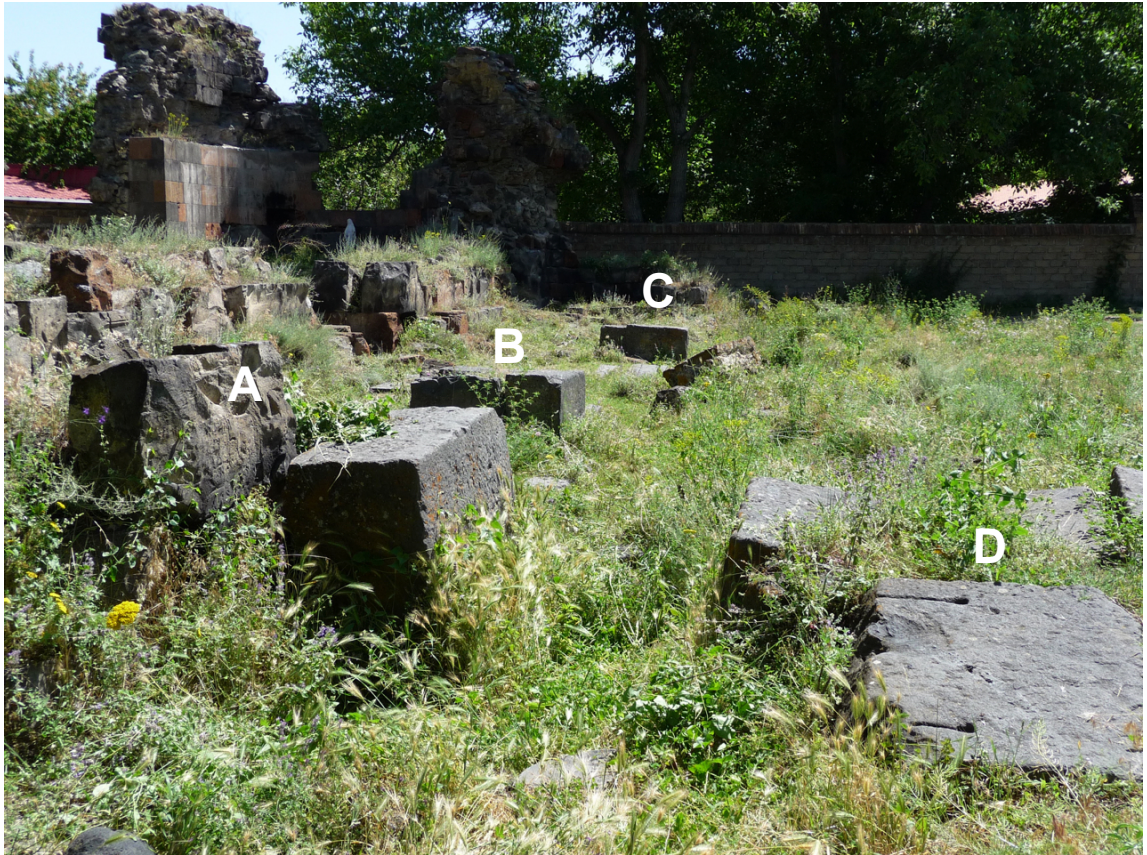
- 460 Figure 9. Sketch of the North Wall, inner face (from Mourad Hasrat‘yan, Early Christian Architecture of Armenia, Moscow, 2000, 99).
- Figure 10.The gallery on the south side and the pillars bordering it to the south (A, B, C); the third door at west with the remains of the massif (D) at the south-west corner of the building, with mortises for anchors. Photo Alain Rideaud.

The only remains of the building are the north wall of the main nave (Figures 8 and 9), preserved to
265 the cornice, and the deep semicircular apse inside, flat outside, pierced by a window. The south wall is only preserved over 1- 1,5m in height. just like the west wall where the front door is placed. South of the main nave is a secondary gallery or nave, with a chapel with a round apse to the east, and a door in the west, filled with small stones. Throughout the gallery, on the soil are tombstones in basalt and tufa, some with inscriptions. This gallery or nave is bordered on the south by a series
270 of large pillars built of basalt blocks (Figure 10 A, B, C), opening on to a third nave, also topped on the east by a round apse chapel built with blocks of tufa, to the west by a door. This third gallery or nave is bordered on the south by a wall leveled on the surface of the ground and a stony area by fine pebbles of white limestone, which seems to have been a street.

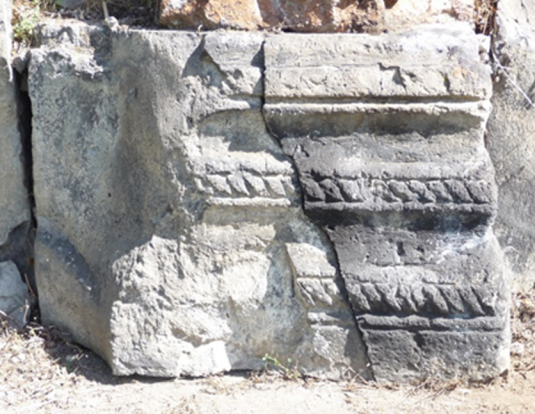
- 465 Figure 11. Decorated base of pillar in basalt rotated and fractured. Photo Alain Rideaud.
- Figure 12. Decorated base with palmette in the south wall from the outside: decorated base in basalt with twists on three degrees in basalt and a later inserted tufa base with shell decoration at the corners. Photo Alain Rideaud.

285 of the fortress. On the walls and pilasters, we have noted numerous traces of EAEs, rotations, block fractures and hammer shocks (Figure 11).

The bases of decorated pillars that seem the oldest were carved in basalt, material commonly used in monuments of Roman times. It is decorated with twisted bands (fig. 11), pattern used in late
290 Roman time and paleo-christian time, for example in the mosaic of the baths in the fortress of Garni.

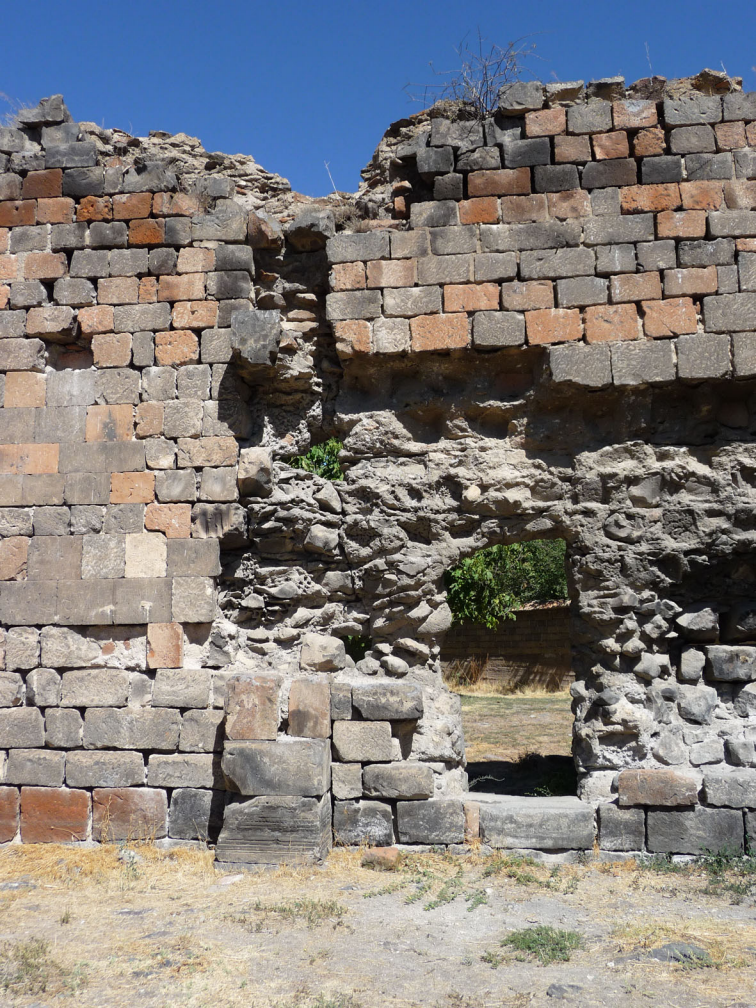
- Figure 13.The different wall construction techniques used in the north wall of the church. Photo
470 Alain Rideaud.
- Figure 14. The implantation of the Khumarzham Church in the urban plan of Garni, based on the Google Earth Image, with drawing Alain Rideaud.

The study of the wall construction techniques in the north wall of the church shows several phases of destruction-reconstruction marked by changes of stones on the wall and mortars of very different materials : use of volcanic ash, insertion of shells, filling with pebbles, or with trash. The typology of the mortars is characterized as follow : 1) from bottom to top apparatus comprising large rolled river embedded in light gray mortar, 2) gray mortar apparatus with inclusions of small white nodules, 3) equipment with very abundant mortar with inclusions of fragments of pink tuff, 4) a very dark gray mortar with blocks of modest size not including a sitting phase and a phase of recovery of level at the top of the walls (Figure 13).
