## Shipwreck LSG4: interdisciplinarity to increase and renew knowledge

Marc Guyon, Laure Meunier. Shipwreck LSG4: interdisciplinarity to increase and renew knowledge. 13th ICOM-CC Wet Organic Archaeological Materials Working Group, ICOM-CC WOAM, 2016, Florence, Italy. pp.292-296. hal-04769708

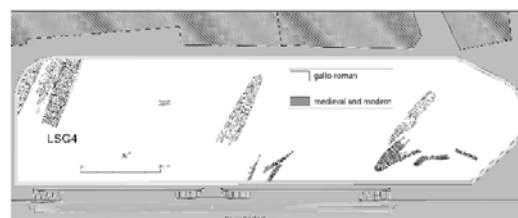
**Figure 1:** The Lyon Saint-Georges excavation. The six Roman boats are in light-grey

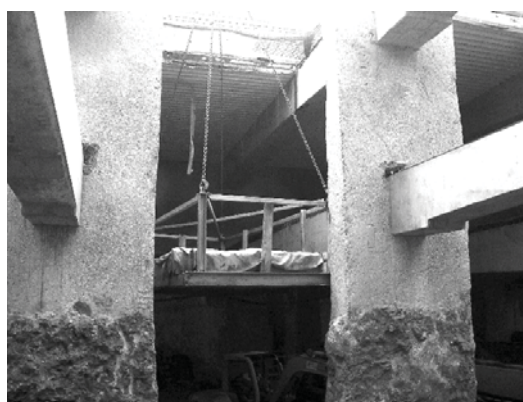
**Figure 2:** A section extraction from the rescue excavation. The dimensions of the construction provided the dimensions to cut the shipwrecks to allow removal.

were Roman boats. This constituted a significant discovery as it doubled the number of Roman shipwrecks found in France and allowed archaeologists to better understand river navigation in the province. Three of these boats, including one designated Lyon Saint Georges 4 (LSG4), were lifted and stored in a lake nearby for later study and display. It was not possible to remove the ships in one-piece because of the construction around them. Therefore, the boats were cut prior to lifting (Figure 2). Every effort was taken to minimize the number of cuts. LSG4 was cut into six parts each of which were nearly 2.5m long.

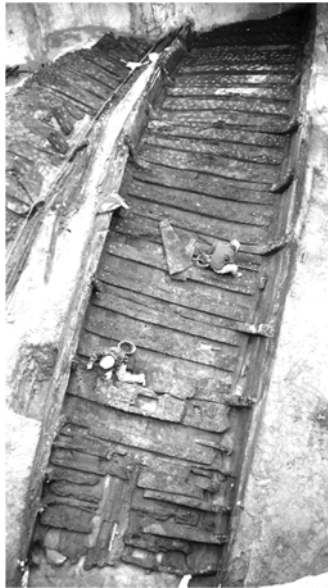
**Figure 3:** LSG4 as exposed at the rescue excavation.

meters wide although not all of it had been preserved (Figure 3). At the time it was excavated, due to the severe time constraints imposed for the excavation and the number of ships found, it was not possible to fully record any of the wrecks.

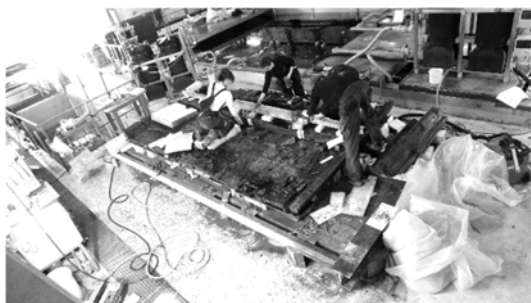
**Figure 6:** The removal of a frame during dismantling. After nail removal, wedges were placed to slightly push up the frame. Straps were used to fasten the frame to a new piece of wood. Then both were lifted with a crane.

Dismantling work (Figure 6) was planned around the archaeologist's availability to prevent data loss and to prevent the conservation work getting too far ahead of the recording work. A dismantling map was created based on photos, which allowed every piece of the boat to be drawn and numbered (Figure 7) and it allowed the location of nails and repairs to be indicated (Figure 8). These drawings were then digitized with CAD. Dismantled elements were organized for review by the archaeologist and the dendrochronologist (Figure 9). Dismantling drawings were used to create general plans to track freeze-drying, dendrochronology work and archaeological work, but also allowed us to record measurements such as the thicknesses of timber on the flat bottom part and at the bilge angles. However, it was found that some details could only be seen after freeze-drying so it was necessary to carry out a secondary review of the plans at this point.

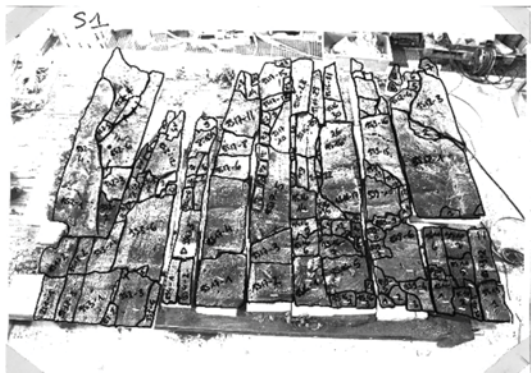
**Figure 7:** An example of dismantling documentation based on photos, to record flat bottom timbers fragmentation and its numbering.

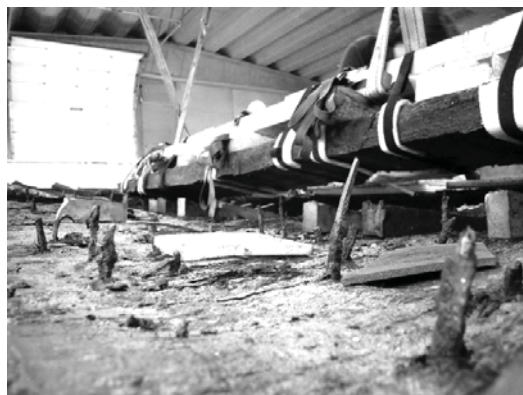
**Figure 8:** After frame removal, nails from the under part of the timber appeared clearly. No less than 2,100 nails were removed from the 15 meters conserved shipwreck. Their locations could be precisely recorded.

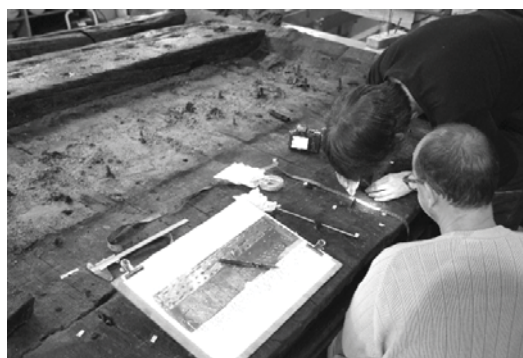
**Figure 9:** Intervention of the dendrochronologist to survey repair pegs in the flat-bottom timber during dismantling. The archaeologist had identified a possible change of the frame.

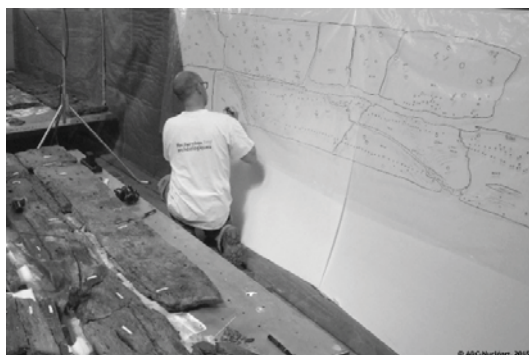
**Figure 10:** Each element was recorded after freeze-drying plastic film. It was then digitized to produce a plan used for conservation recording, follow-up plans and the archaeological survey.

However, the dismantling documentation still was not as accurate as we would have liked due to the low definition of the photos, which made it hard to see some of the archaeological data. Furthermore, the working conditions didn't allow zenithal shooting and there were light problems. We decided to make a 1:1 scale drawing of each face of every element from the shipwreck. These were done on a transparent plastic film with different ink pens (Figure 10). Once done, this freeze-drying plan was digitized with CAD. This was done prior to coring because of the potential for archaeological data to be lost during this process. It was a relief for conservators to know that all the data was recorded before they had to core nails holes.
