Caulking textiles from the Lyon Saint-Georges 4 shipwreck: recording and conservation questions

Laure Meunier, Marc Guyon

Laure Meunier, Marc Guyon. Caulking textiles from the Lyon Saint-Georges 4 shipwreck: recording and conservation questions. 14th ICOM-CC Wet Organic Archaeological Materials Working Group Interim Meeting, Portsmouth 2019, ICOM-CC WOAM, May 2024, Portsmouth (UK), United Kingdom. pp.128-133. hal-04770682

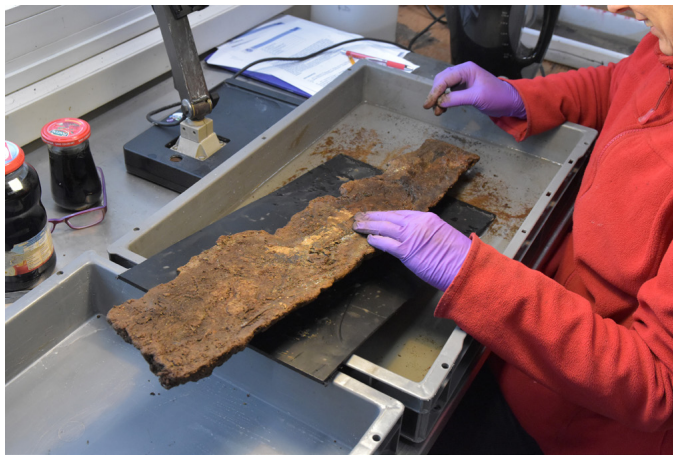
Figure 2 Before unfolding, the material used to provide water proofing looks like a piece of wood. © ARC Nucléart

During the dismantling of the barge, 26 m of caulking materials were removed for further study. They mainly came from the space between the bilge and the side. Initially, they looked like a piece of wood (Figure 2), but after more detailed examination, textiles were evident. The boat was made watertight with textiles impregnated with pitch, a well-known technique on the Rhône-Saône route between the first and the third century AD. Several wreck sites are known to contain pitch-coated textiles, including the Roman wrecks of the Chalon-sur-Saône bridge from the first century AD (Lonchambon *et al.*, 2009), the Arles Rhône 3 wreck from the first century AD (Marlier, 2014), the Arles-Rhône 5 wreck dated to between the first century BC and the second century AD (Marlier *et al.*, 2019), and the Tolozan shipwreck from the first century AD (Rieth 2011). The Lyon Saint-Georges site provided six additional

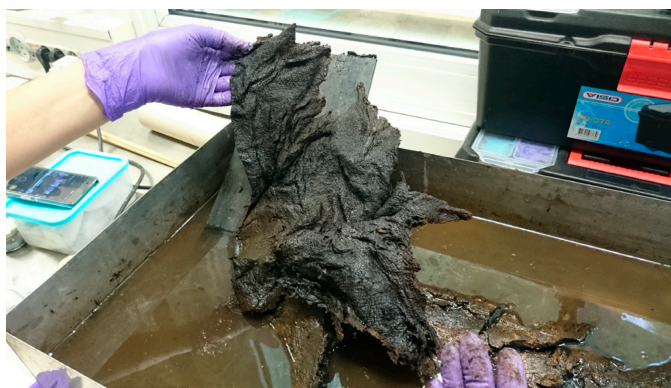
Figure 3 Heating the material to approximately 100°C allows pitch to be plastic enough to unfold the textiles. © Marc Guyon, Inrap.

Organic solvents have a tendency to attack fibers, which become more fragile leading to tearing along the folds. The new protocol uses hot water to plasticize the pitch enough to permit the unfolding of the textile (Figure 3). First, demineralized water was used, but after advice from Véronique de Bühren (textile conservator in the Musée des Tissus de Lyon), fresh water was used, to avoid losing ions and further damaging the textile. The piece of caulking material was completely immersed in water, and then heated to approximately 100 °C. After careful examination the textile was unfolded from one edge while a plan of the shape was built (Figure 4). After this the textile was placed on a mosquito net of fibers covered by plastic (8 threads/cm in warp and weft) to air-dry naturally. Often, after the first unfolding attempt, some parts remained folded. After another examination a second intervention with localized hot water from an electric kettle could be attempted. After drying, the textiles were removed from their net and wrapped in a Tyvek® textile, put in a polyethylene board with polyethylene foam around a central excavation. Then another polyethylene board is used as lid, and a double Velcro strap is used to maintain the two boards. This permits the textile to be turned without touching it. The technique allowed the recovery of larger pieces of textile than solvent cleaning permitted.

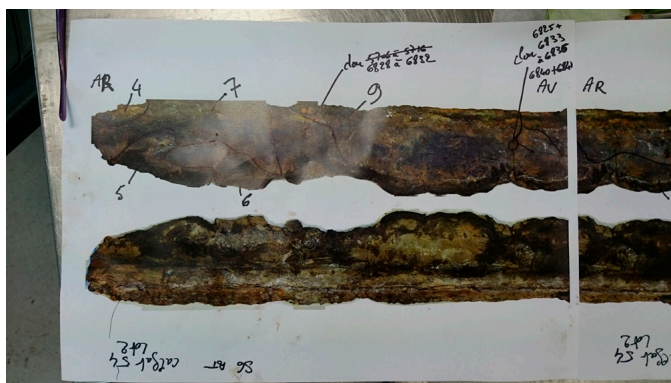
Figure 4 A map of the location of the various textiles is drawn while unfolding. © Marc Guyon, Inrap).

the caulking material was made providing a 3D memory of the shape of the caulking material before any intervention. (Figure 9). Once unfolding began, a Go Pro® film was made to document the process, and at the same time the location of the different pieces of textile were drawn on a picture to map their location. This first unfolding left the textile in a transitional state, between unfolded and flat. Some

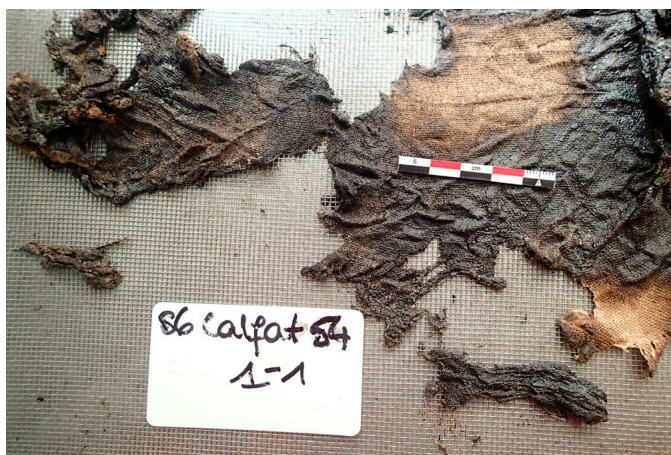
Figure 5 Additional cleaning by application of a mix of organic solvents with a brush, then dried. © ARC Nucléart

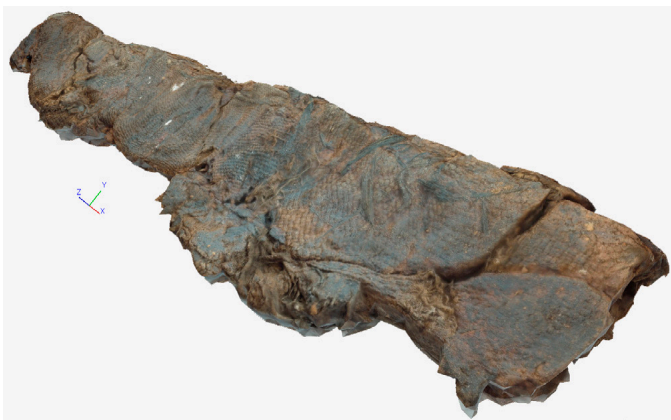
Figure 9 A 3D model is made from photogrammetry before beginning the unfolding operations. © Marc Guyon - Inrap.

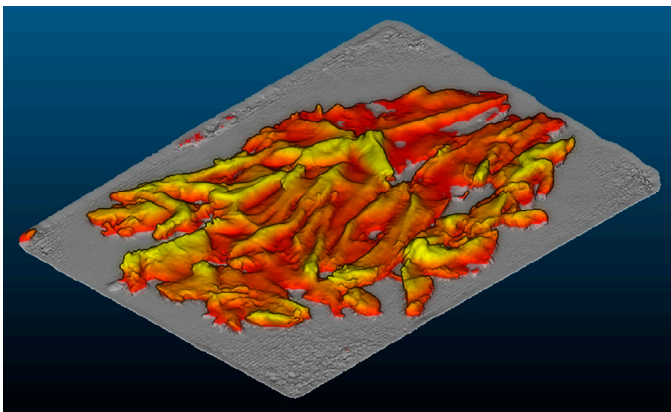
Figure 10 Based on an ortho-projection, an image can be transferred into a software allowing an adapted view with the ability to change the orientation of the light to highlight the folds. © Marc Guyon - Inrap.

observations about weaving and sewing could be made, but more results could be documented once the textile was fully flattened. This transitional state was also recorded, and a relief map was made to understand how the textile was folded to fit between the planks. The folds are still visible, and can be read by transferring the relief map into an adapted picture (Figure 10). Through this technique, we could compare the different ways of folding the textiles.

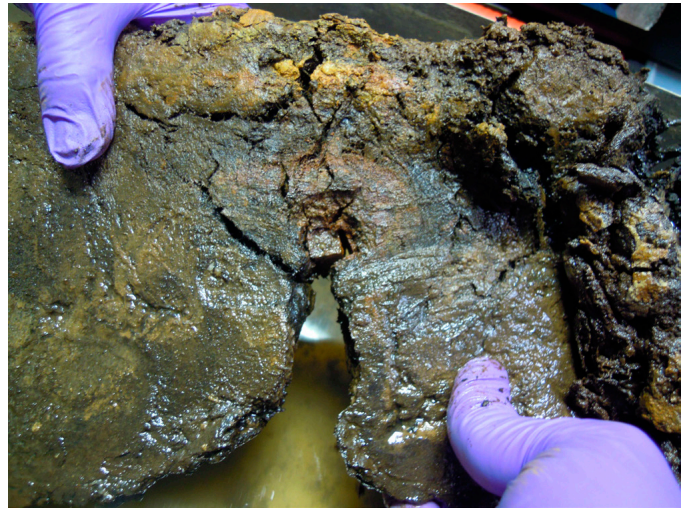
Figure 6 The nail is nailed into the caulking material, but did not penetrate. © Marc Guyon, Inrap.

During the unfolding of the textiles, a clue appeared about the caulking technique used on the LSG4 shipwreck. Usually, on the Rhône-Saône route between the first to the third century AD, luting was used. This technique consisted of applying the waterproofing material during the boat's construction before adding the next timber. On the LSG4 shipwreck we found a nail with textile wrapped around it (Figure 6). Careful examination showed that the nail was

not driven through the textile, suggesting that the waterproofing was added after the nail had been driven through the wood. Similar conditions were found in proximity to other nails, suggesting that all the waterproofing materials had been added after the initial construction of the boat. The revelation that rather than utilizing the luting technique the waterproofing consisted of caulking adds to our understanding of Roman shipbuilding techniques and questions some long-held beliefs.

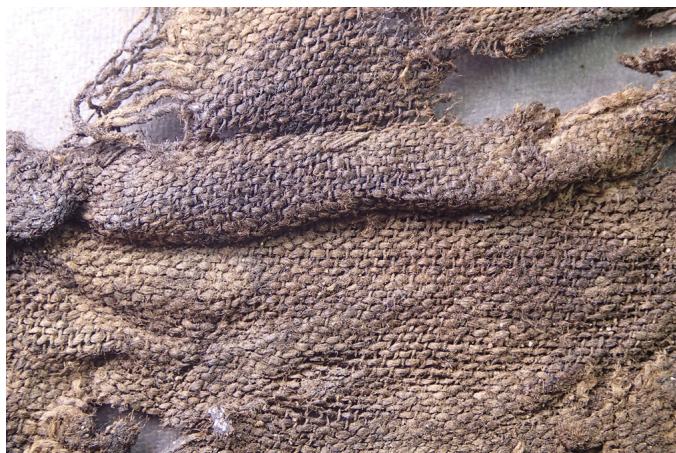
Figure 7 A textile used to provide waterproofing from the wreck Lyon Saint-Georges 8, from 55 AD. The sewing points form a strip nearly 5 cm wide, with large point on a side and invisible ones on the other. © ARC Nucléart

shipyard and whether they appeared to be everyday textiles that were reused or textiles that had been brought in from a distance. Interestingly, one of the fragments from the LSG8 shipwreck (1st century) is a reinforcement strip that is approximately 5 cm wide and has two types of sewing points, one with wide stitches and with a three twisted thread, and an invisible sewing on the other side. (Figure 7). It is similar to a piece of sail from the *Jeanne-Elisabeth* ship (Figure 8), which was wrecked in 1755 (Bartoš and Sanders, 2012), suggesting that perhaps parts of sails were reused for waterproofing, which would be a logical way to recycle old nautical textiles available in the shipyard. It also implies that there has been a technological continuity in the fabrication of sails over the last 1700 years, although the Roman fragment is made of wool, while the fragment

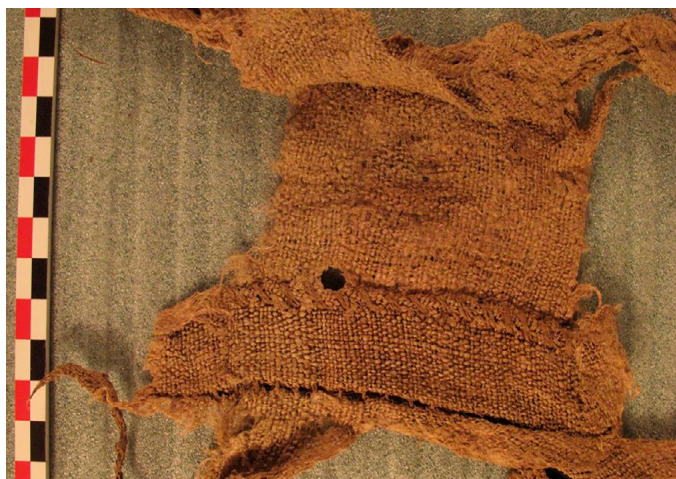
Figure 8 A piece of sail from the *Jeanne-Elisabeth*, wrecked in 1755, made of plant fibers. © DRASSM (Direction de la Recherche Archéologique Subaquatique et Sous-Marine).

from the *Jeanne-Elisabeth* is made of plant fibers. Woolen sails have been identified from Viking ships (Cooke *et al.*, 2002), but this represents a first for Roman shipbuilding.
