## **Analysis of capacitive discharges in motor bearings under different operation conditions**

Sara Jammoul, Remus Pusca, Raphael Romary, Guillaume Lefevre, Nicolas  
Voyer, Guilherme Bueno Mariani

Sara Jammoul, Remus Pusca, Raphael Romary, Guillaume Lefevre, Nicolas Voyer, et al.. Analysis of capacitive discharges in motor bearings under different operation conditions. *IET Electric Power Applications*, 2024, 18, pp.952 - 961. 10.1049/elp2.12444 . hal-04813007

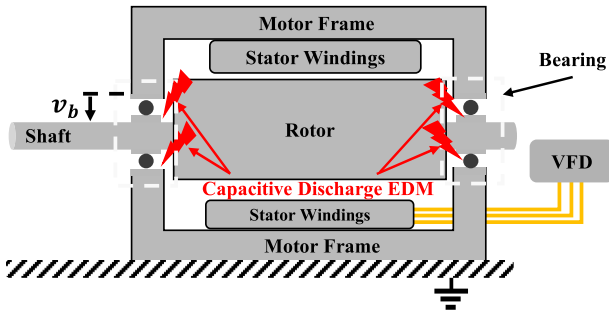
**FIGURE 1** Bearing voltage and capacitive discharges (electrical discharge machining currents) at the bearings.

However, due to the increasing use of Variable Frequency Drives (VFD) in the last decades, the electrical wear of bearings has become a major issue that is most recognisable in the case of low to medium-power motors. Indeed, the use of VFD causes high  $dV/dt$  and leads to an unbalanced three-phase system, where the sum of instantaneous voltages is no longer zero, inducing a common mode voltage  $v_{cm}$  [5]. Consequently, the bearing voltage  $v_b$ , illustrated in Figure 1, representing the potential difference between the inner and outer race of the

bearing, mirrors  $v_{cm}$ . This voltage prompts an accumulation of electrical energy within the lubrication film of the bearing. Consequently, when the bearing voltage  $v_b$  exceeds a critical threshold known as the lubricant breakdown voltage, capacitive discharge occurs, leading to significant damage to both the lubricant and the bearing components. This phenomenon, marked in red in Figure 1, is commonly referred to as Electrical Discharge Machining (EDM) currents.

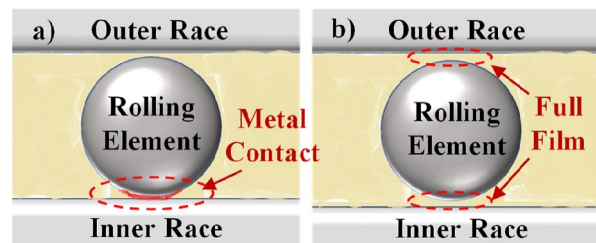
FIGURE 2 Lubrication regimes: Boundary lubrication during continuous and short conduction (a), full film lubrication during insulation (b).

between the bearing's components. Thus, contact points between the metallic elements exist as shown in Figure 2 (left), allowing the flow of current through the bearing. This state is defined in this study as 'continuous conduction' and it is observed at low speed. In this case, the boundary film thickness is in the order of a few nm permitting the passage of electrons. In these conditions, the bearing acts as an ohmic resistor  $R_b$  and there is no risk of EDM occurrence. This scenario may also be observed at high speed as a form of 'short conduction' that will be later presented in this section.

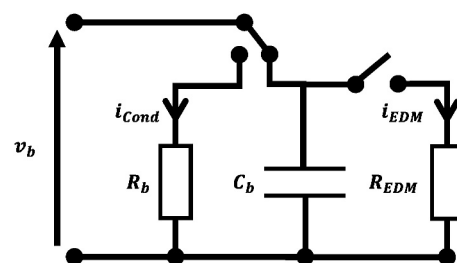
FIGURE 3 Equivalent circuit of a rolling element bearing.

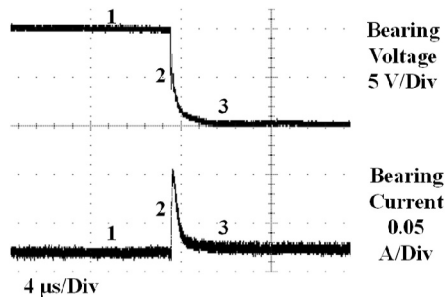
FIGURE 4 Bearing voltage and current variation during electrical discharge machining phases: (1) pre-breakdown, (2) breakdown, and (3) end of discharge.

Based on the description of EDM currents presented in Refs [28, 29], the capacitive discharge consists of the following phases:

- (1) Pre-breakdown: The electrical field is high and increasing.
- (2) Breakdown: Sudden discharge of the stored electrical energy during a very short time (nanoseconds). A severe

voltage drop can be observed as the current increases almost instantaneously. A plasma is created leading to high temperature and therefore the melting of metal and lubricant.

- (3) End of discharge: Bearing voltage and current drop to nearly zero. The surface is damaged, and melted particles contaminated the lubricant.
- (4) Post-breakdown: The lubricant returns to its insulating behaviour after a certain recovery time.

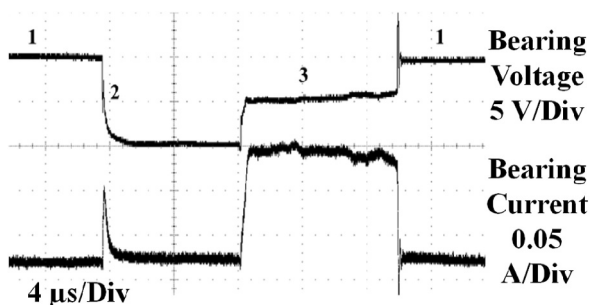
FIGURE 5 Different lubricant behaviours: (1) insulating behaviour (full film), (2) electrical discharge machining, and (3) conducting behaviour during 'short conduction'.

As for the 'short-conduction' state occasionally observed at high speed, this event can be easily confused with an EDM current, while not having any significant effect on the bearing surface nor the lubricant. The difference between the two phenomena is illustrated in Figure 5. As it is noticeable, the main dissimilarity appears in the duration of each event, where an EDM's duration is nearly  $1 \mu\text{s}$  (phase 2) while the short conduction lasts for more than  $10 \mu\text{s}$  (phase 3).

On the other hand, the voltage collapses to zero due to the discharge occurrence, while it is proportional to the resistance  $R_b$  during a conduction phase. It is worth mentioning that the conducting behaviour dominates as the bearing's temperature

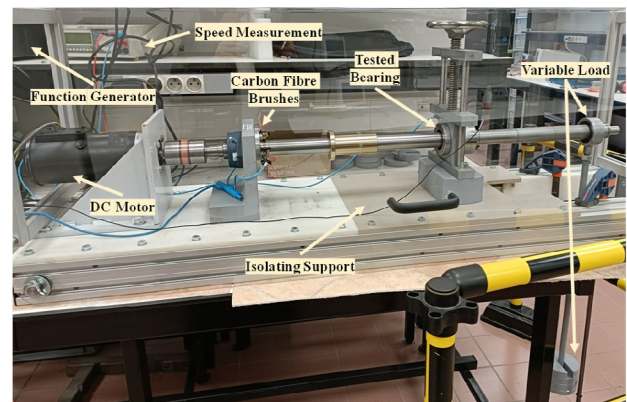
FIGURE 6 Test bench dedicated to bearing electrical ageing.

The experimental method used in this study to highlight the effect of EDM on rolling element bearings is based on the test bench shown in Figure 6. This assembly consists of a 6206 SKF bearing mounted on a variable length shaft, coupled to a dc motor to ensure a reliable rotation. The bearing is mounted using an isolated support. In addition, the setup was designed in a way to enable changing the radial load level at the bearing by modifying the applied vertical force.

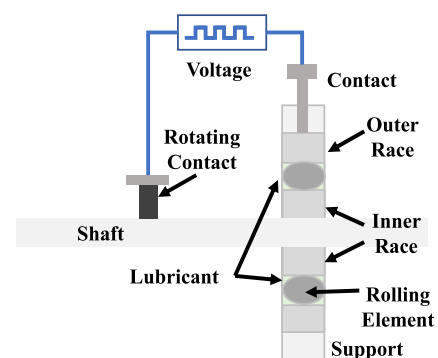
FIGURE 7 Sketch of the test bench's mechanical setup.

As for the electrical circuit, a square unipolar voltage is injected between the inner and outer races of the bearing. This voltage simulates the bearing voltage level inside an electrical machine  $v_b \cong (5 \dots 30) \text{V}$  at a bearing temperature of  $22^\circ\text{C}$  according to Ref. [30] and decreases with the increased temperature due to loaded run, which justifies the use of values from 5 to 30 V in our tests. The contact with the inner race (rotating part) is ensured using carbon fibre brushes. This assembly is sketched in Figure 7.

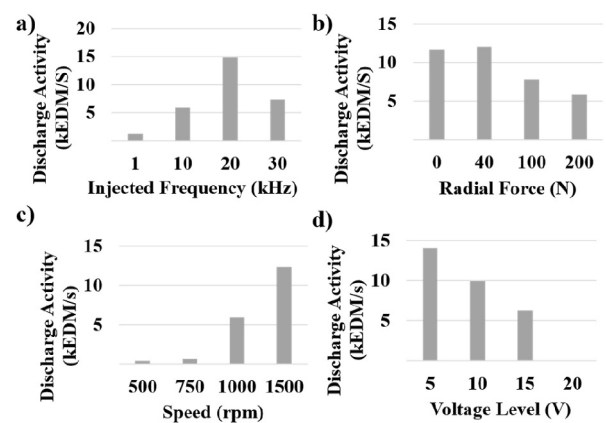
**FIGURE 8** Discharge activity in different operation conditions. (a) Frequency, (b) radial force, (c) speed, and (d) voltage level.

First, the DA evolution for each series of measurements was evaluated. Obtained results are detailed in Figure 8, where the variation of DA (expressed in number of EDM detected per second) with different operation conditions is highlighted.

It is worth mentioning that the variation of DA throughout the test duration was not considered in this test; therefore, the discharge occurrence frequency expressed in Figure 8 is the average frequency. The chosen test intervals and limit values for each parameter were set based on the literature [19, 20, 28–30], as well as the test bench limitations. For example, the voltage test values were initially set to (5...30) V. Then, the results showed rare occurrence of discharge for voltage levels above 20 V; this justifies not taking these values into consideration in the following results. Another encountered limitation was the high vibration level at speed points >1500 rpm. This is due to the ageing test bench design.

It is important to highlight that the DA observed in the 1 kHz test (Figure 8a), in the 500 and 750 rpm tests (Figure 8c), and in the 20 V test (Figure 8d) is notably lower compared to the corresponding values observed in other tests. Consequently, it would be unfitting to include the results of these measurements in the subsequent analysis.

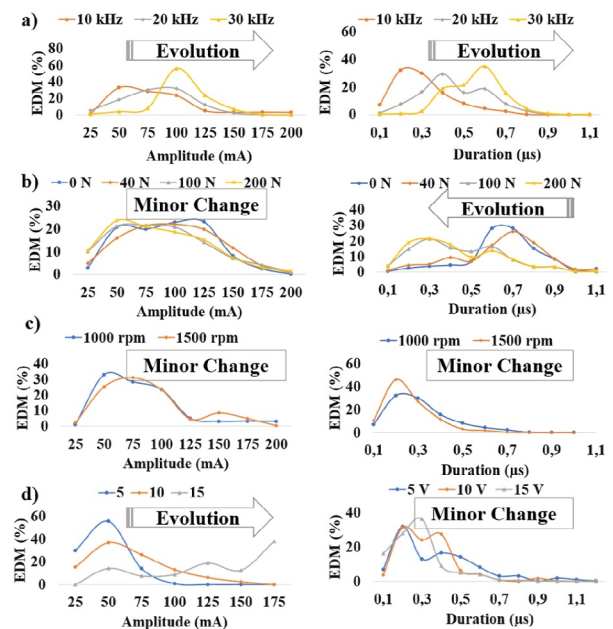
**FIGURE 9** Influence of operation conditions on the electrical discharge machining currents amplitude (left) and duration (right). (a) Frequency, (b) radial force, (c) speed, and (d) voltage level.

Though, analysing the DA alone cannot guarantee full knowledge of the discharges form and characteristics, namely the energy dissipated due to these sparks. For this reason, the influence of operation conditions on the amplitude and the duration of the detected capacitive discharges were further examined. This is presented in Figure 9 where the influence of each parameter on the form of EDM currents is highlighted. The applied voltage in Figures 9a–c is fixed to 10 V, while the switching frequency in Figures 9b–d is set to 10 kHz.

Hence, the variations of the amplitude distribution (left column) and duration distribution (right column) with different operating conditions are approximated. For instance, Figure 9a (left) presents the influence of different frequency levels on the amplitude of detected EDM currents. Each plot is attributed to a frequency value and obtained by the interpolation of the marked points. Let  $A_k$  be a marked point on a plot attributed to a frequency  $f$ , where  $k$  is an integer in  $\{1, \dots, 8\}$ . In that case,  $\gamma_{A_k}$  presents the percentage of EDM currents with an amplitude value in  $]x_{A_{k-1}}; x_{A_k}]$ .

The results show a noticeable impact on the characteristics of EDM currents, especially in the case of frequency variation Figure 9a. As the frequency level increases, the discharges tend to present both higher amplitude and duration. This results in higher energy dissipated through the bearing according to the expression in Equation (1). Indeed, this result is in accordance with Ref. [31], where it was stated that the breakdown strength increases dramatically with high-frequency impulse shaft voltage.

On the other hand, Figure 9b shows shorter EDM currents when the bearing is heavily loaded. This is possibly related to the thinner lubrication layer in the loaded bearing leading to smaller capacitance  $C_b$ . However, no apparent influence of the

vertical force variation on the amplitude distribution is recorded. Similarly, despite having a remarkable effect on the DA, the rotational speed variation has a minor effect on the EDM characteristics according to Figure 9c.

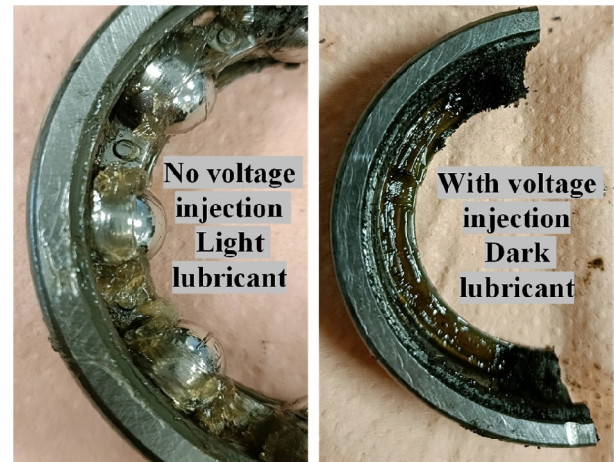
FIGURE 10 Lubricant chemical change due to electrical wear.

The test bearings were further evaluated by visual inspection. For instance, Figure 10 shows the difference between the lubricant of an electrically damaged bearing (right), which was subject to the ‘worst-case scenario’ defined in the previous section, for 60 h, and a test bearing that was subject to the same mechanical constraints without any electrical excitation (left).

Indeed, the chemical change in the lubricant of the electrically aged bearing was remarkable. The grease is turning black, and the texture is drier, and it also contains clumps and dark particles. It was noticed as well, during the runtime, that the lubricant becomes more and more conductive as the bearing ages. This is due to the grease being contaminated with metallic particles snatched from the bearing's surface on one hand and to this surface's roughness presenting pits and peaks, enhancing the metal–metal contact, on the other hand. In fact, beyond a certain stage of electrical damage, the lubricant was unable to regain its dielectric characteristics even after three consecutive days of rest time.

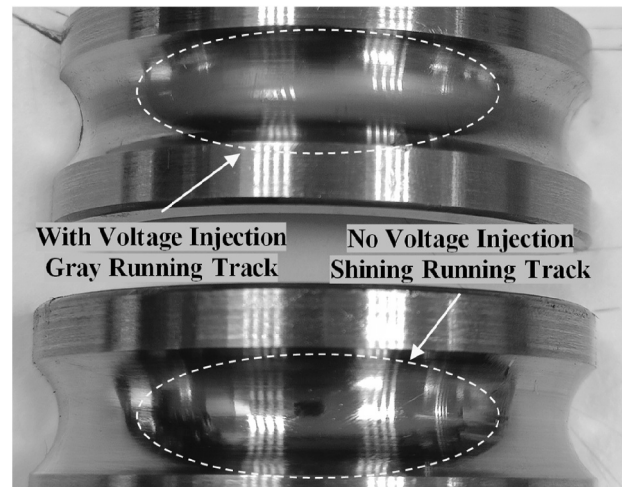
FIGURE 11 Inner race running track of the electrically aged test bearing (top) and the indicator test bearing (bottom).

Additionally, the inner and outer race of the electrically aged bearing presented a grey running track. This can be concluded from Figure 11 which shows the inner races of the above-mentioned bearings. We can notice the shining surface of the indicator bearing while a grey line is observed on the

surface of the aged bearing. This grey line can be linked to the degraded state of the lubricant. The author of Ref. [19] supports this possibility by linking this kind of fault (grey line on the race) to insufficient lubrication leading to a higher friction force.

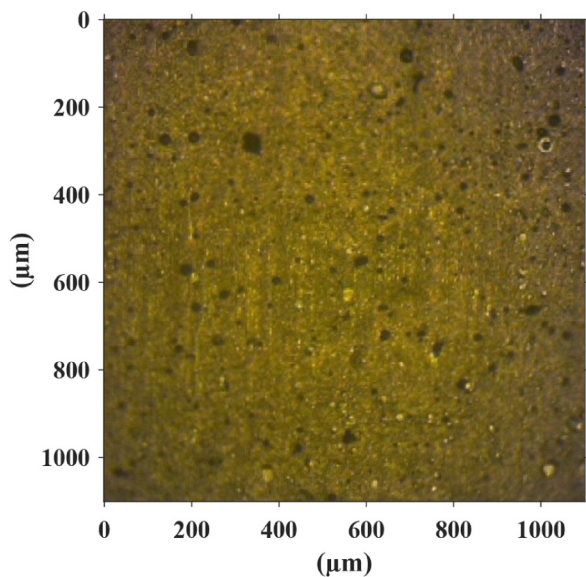
**FIGURE 12** Microscopic damage on a bearing surface due to electrical discharge machining currents: Total calculated damage 2.48%.

microscope highlights the direct outcome of EDM currents. A group of four bearings was damaged using the proposed ageing method and the operation conditions of the 'worst-case scenario'. The ageing lasted for 1, 6, 18, and 60 h, respectively. Consequently, different fault levels were obtained and photographed. To illustrate, Figure 12 presents the original image showing surface roughness of different diameters on the outer race of a bearing aged for 18 h. It should be noted that all the images used in the visual inspection test were taken at the same location of the outer race for each test bearing with  $\times 10$  magnification zoom. The photos were then analysed using a MATLAB image processing algorithm that can detect the presence of micro-pits and micro-peaks using colour identification and then calculate their percentages in each image. In fact, the micro-pits are the result of discharges that melt the metal particles of the bearing.

Parts of this melted metal contaminate the lubricant as previously highlighted. Other melted particles solidify and adhere to the surface once again, creating the above-mentioned micro-peaks. Thus, by calculating the percentage of micro-pits and micro-peaks, we can evaluate the surface damage generated in each bearing. The detection of micro-pits and micro-peaks is illustrated in Figure 13. The total damaged surface detected in Figure 12 is then 2.48% of the total analysed surface.

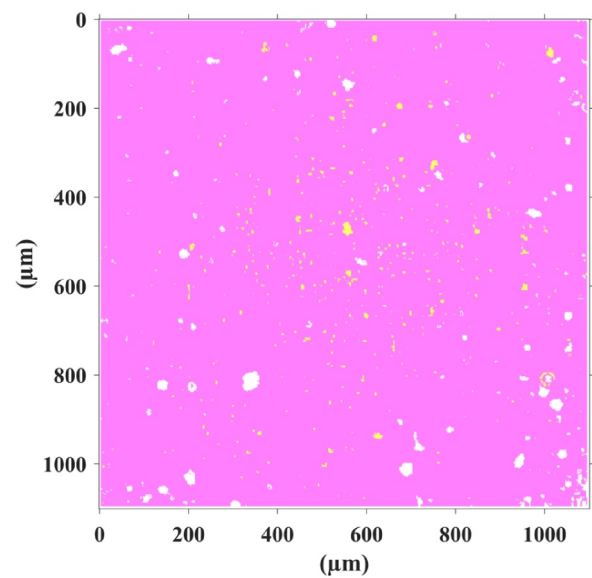
**FIGURE 13** Roughness inspection using image processing: Micro-pits in white (1.6%) and micro-peaks in yellow (0.88%).

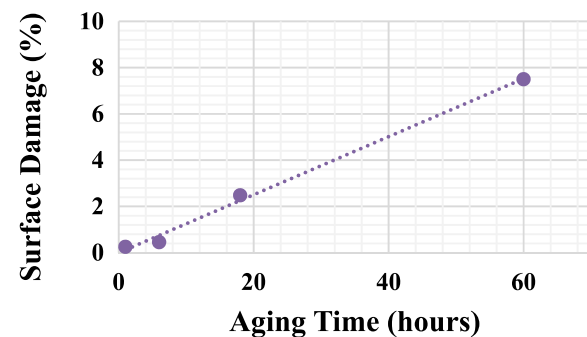
**FIGURE 14** Evolution of surface damage percentage with time.

The evolution of surface damage with ageing duration is plotted below (Figure 14). Indeed, after 18 h of electrical excitation, the surface damage rapidly rises representing an exponential increase tendency. Thus, the fourth test bearing that was aged for 60 h presented 16 times the damage of the bearing aged for 6 h.
