Impacts of heavy rainfall of July 2017 in mountainous watersheds in northern Kyûshû (Japan) on structural and process-based sediment connectivity

O4.306: Impacts of heavy rainfall of July 2017 in mountainous watersheds in northern Kyûshû (Japan) on structural and process-based sediment connectivity

How did the extreme event of 5-6 July 2017 influence the connectivity of these mountain watersheds?

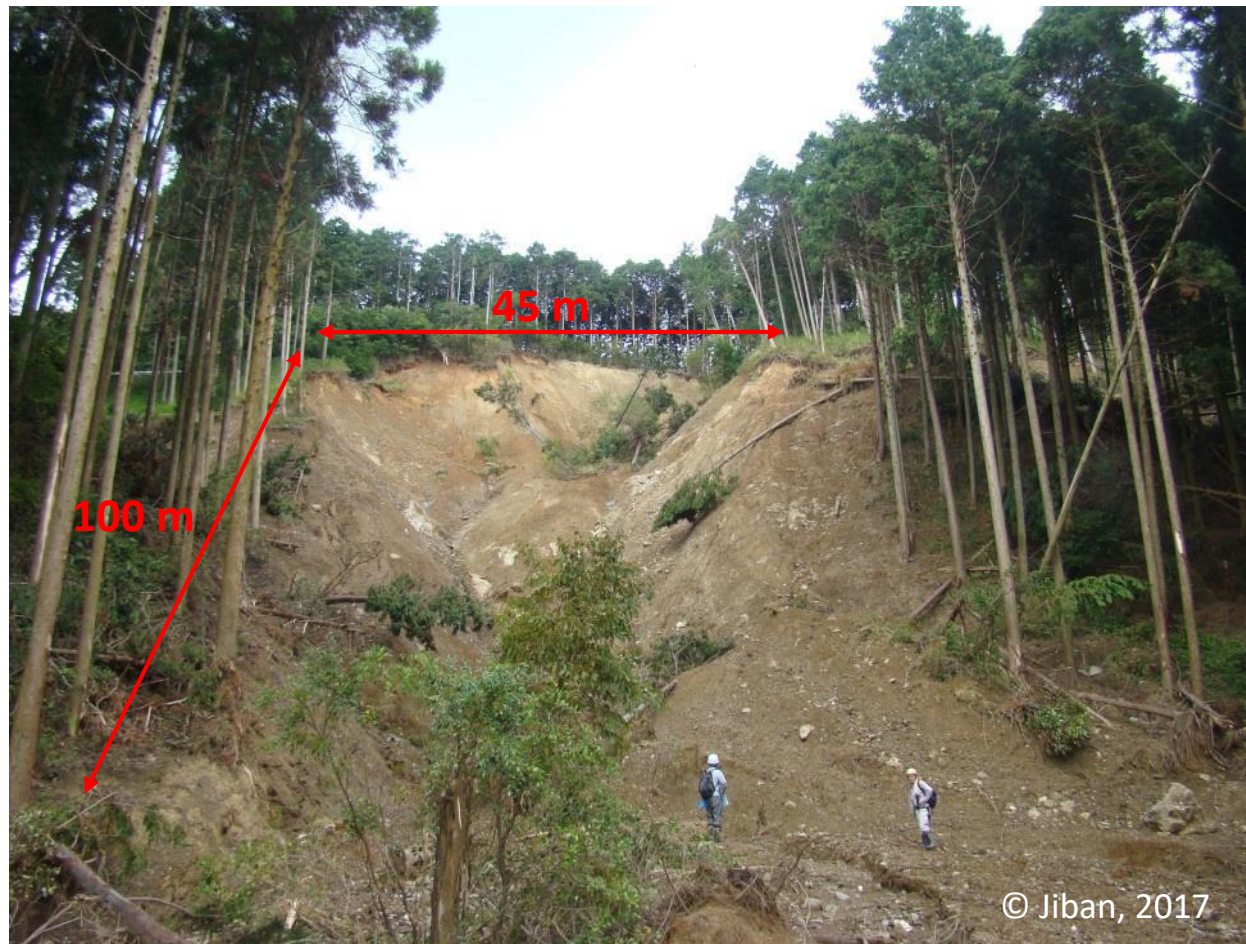
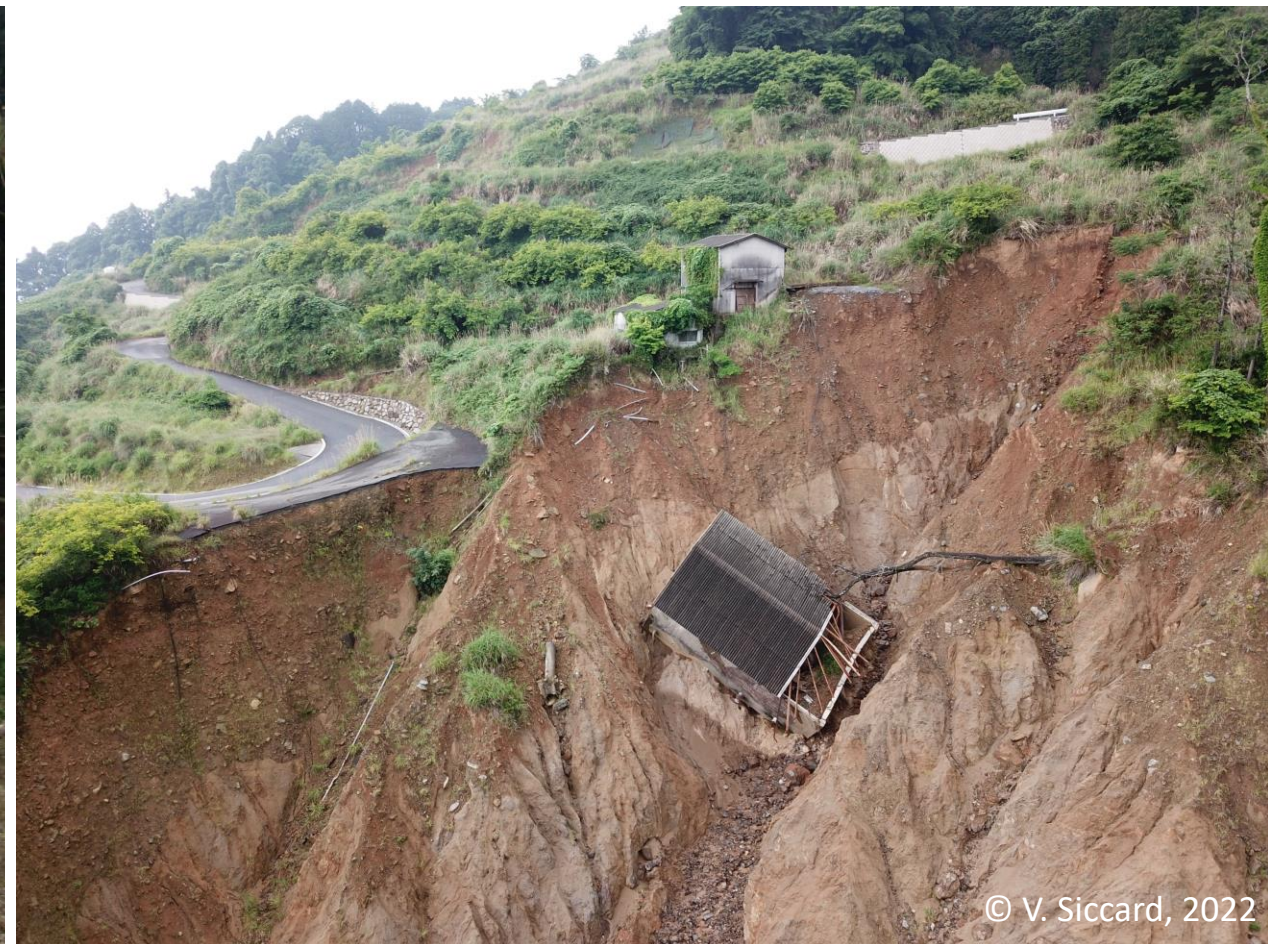
Deep landslide (>10m) in headwater with deeply weathered granodiorite and schist. (Jiban, 2017)

Large amount of Landslide deposit remain on site. (Jiban, 2017)

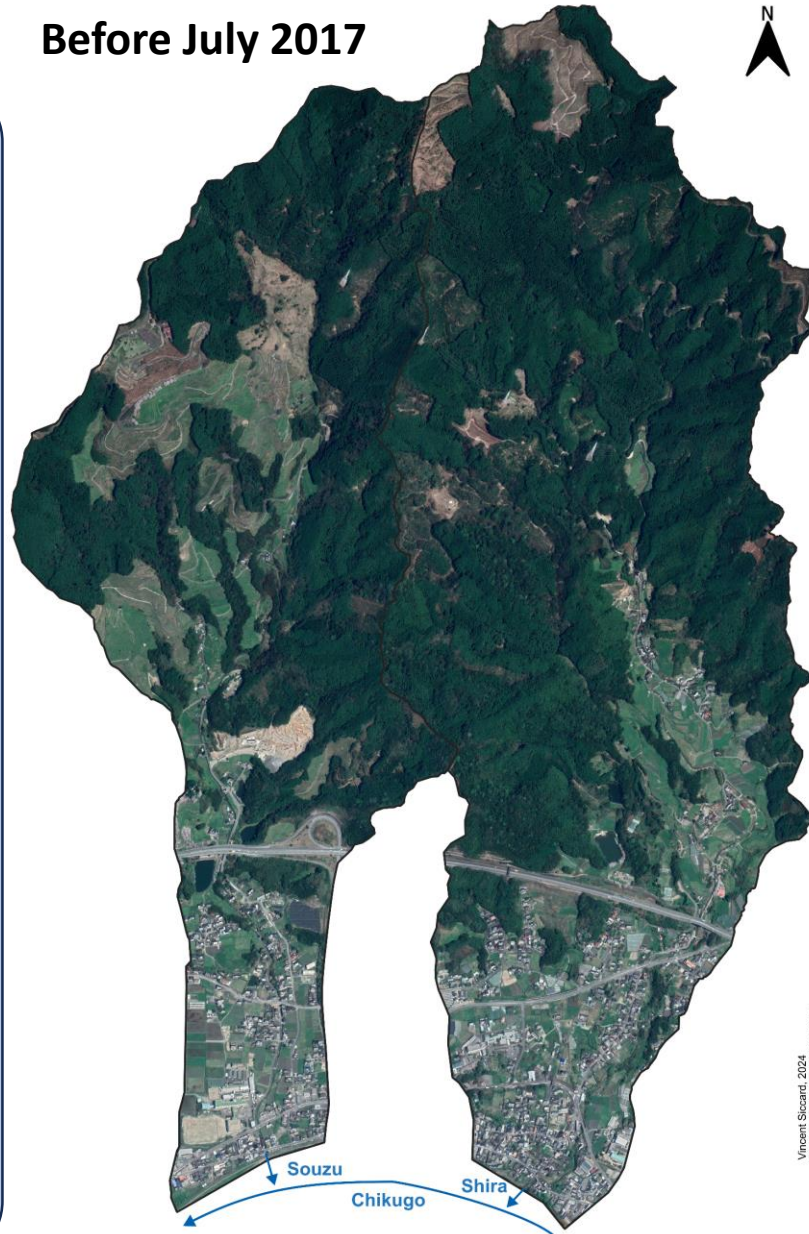
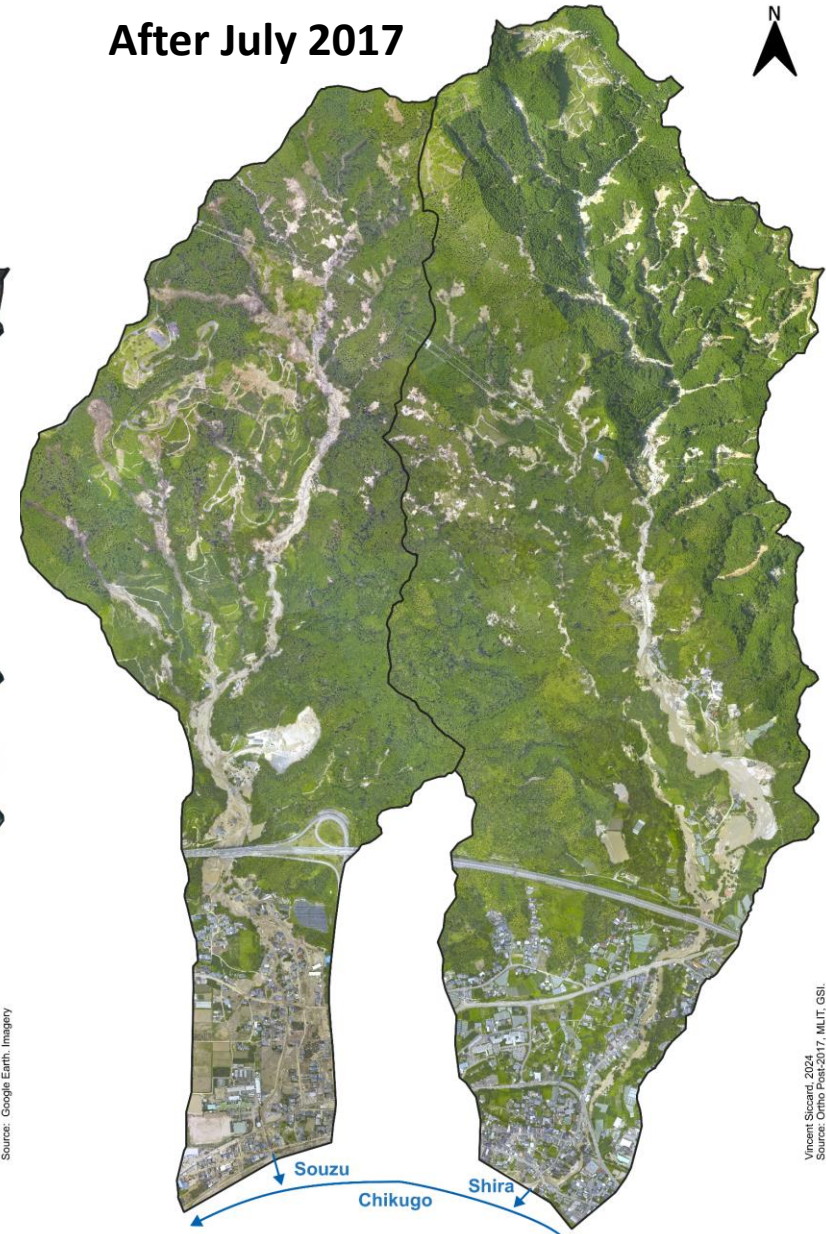
Before July 2017

After July 2017

Landscape metamorphosis caused by a wide range of hydro-gravitational processes

- Mostly Shallow landslides (0.5m to 2m); Few deeper landslide ; 2 Mega landslide (> 300k cubic meters)

Significant landscape changes

- **Landslide area = 10,5 %** (294 725 m²)
- Flooded area = 17%

- **Landslide area = 7,3 %** (284 576 m²)
- Flooded area = 4,7% contained by topography

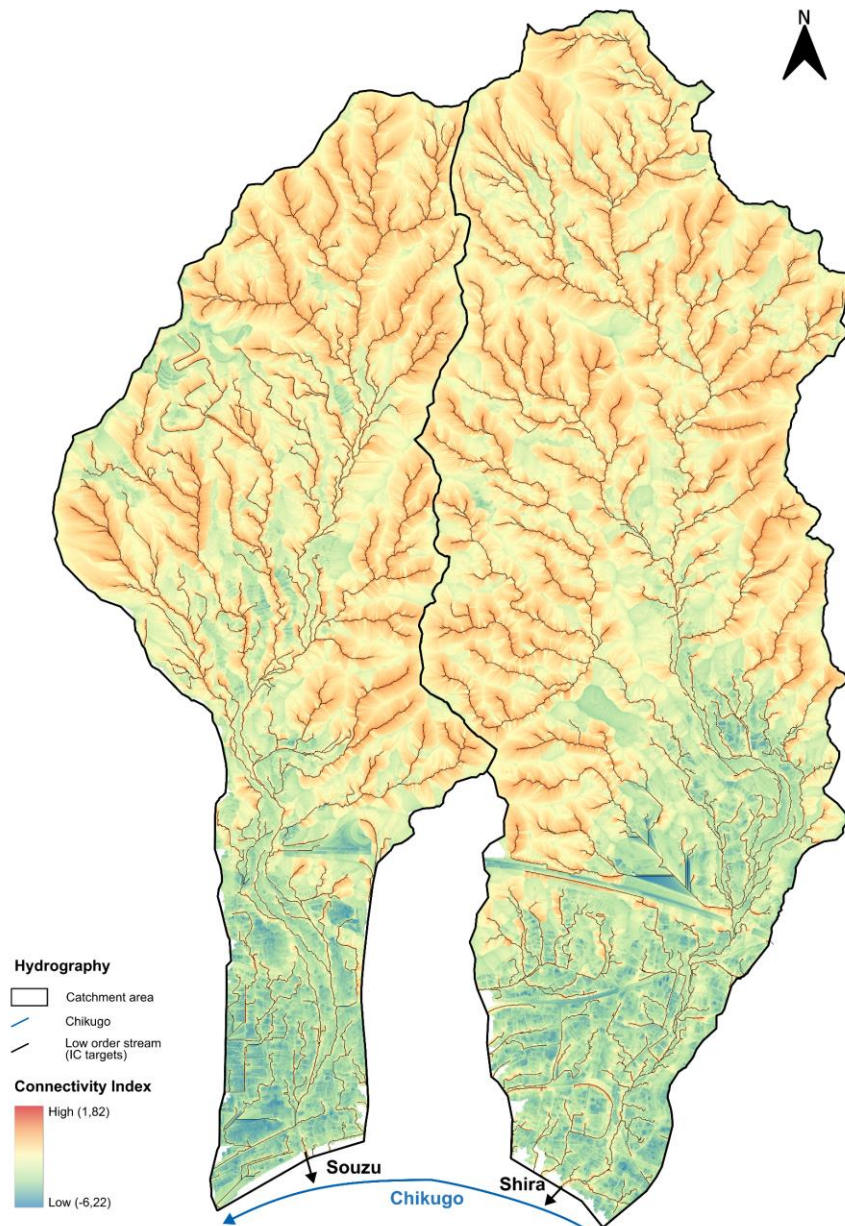
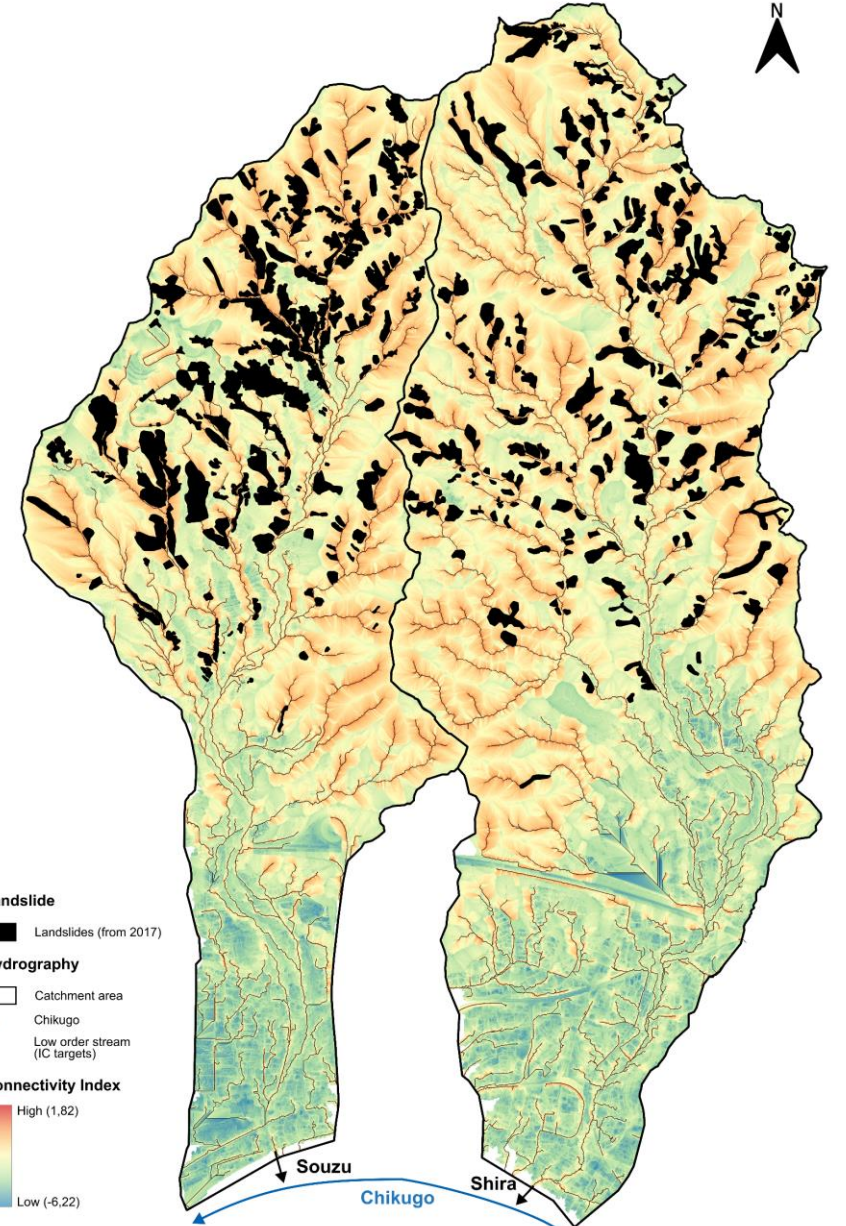
Structural connectivity:

- **Connectivity Index** with low order streams as targets (Cavalli et al., 2013)
- => **High lateral hillslope-channel connectivity** especially in low order catchment

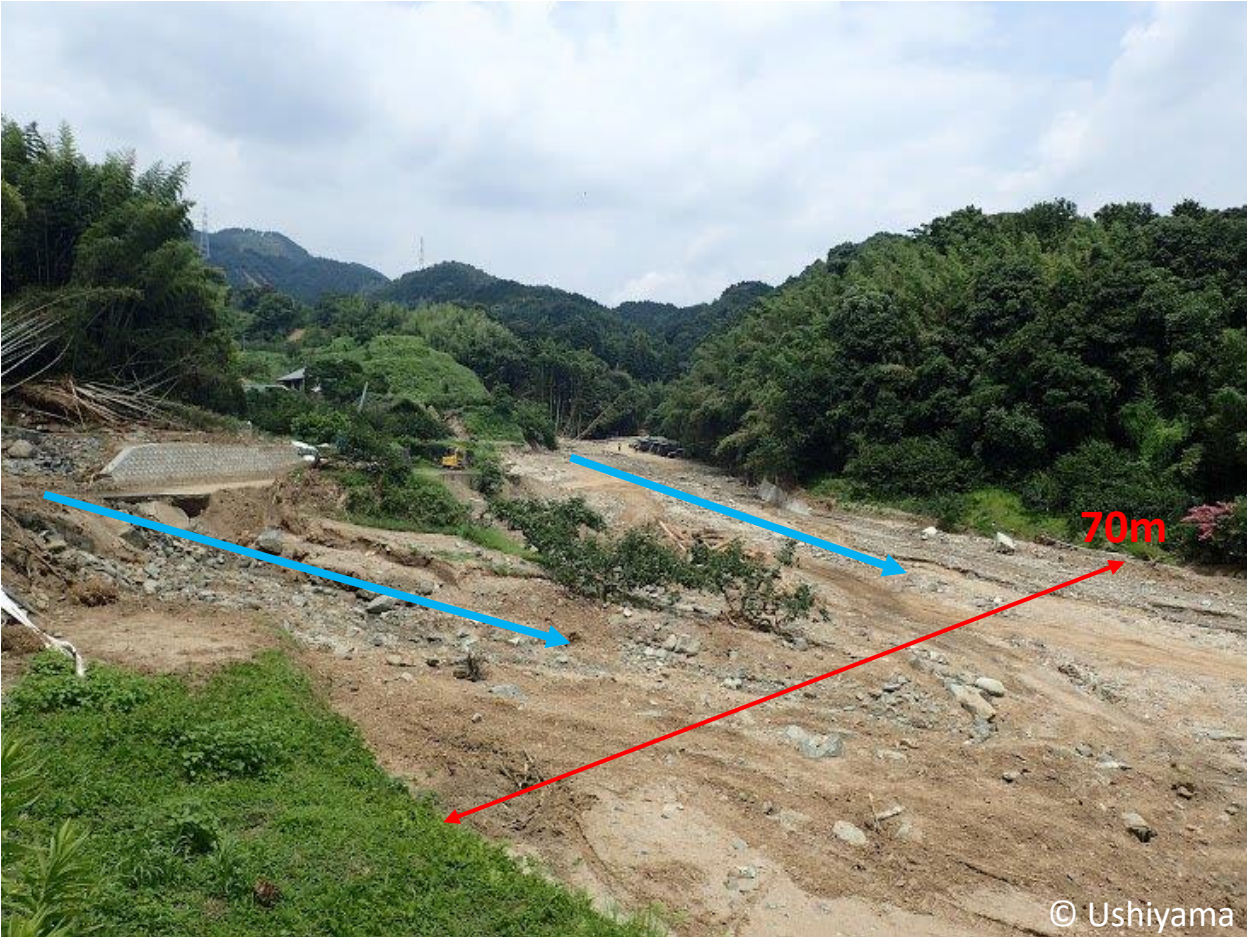
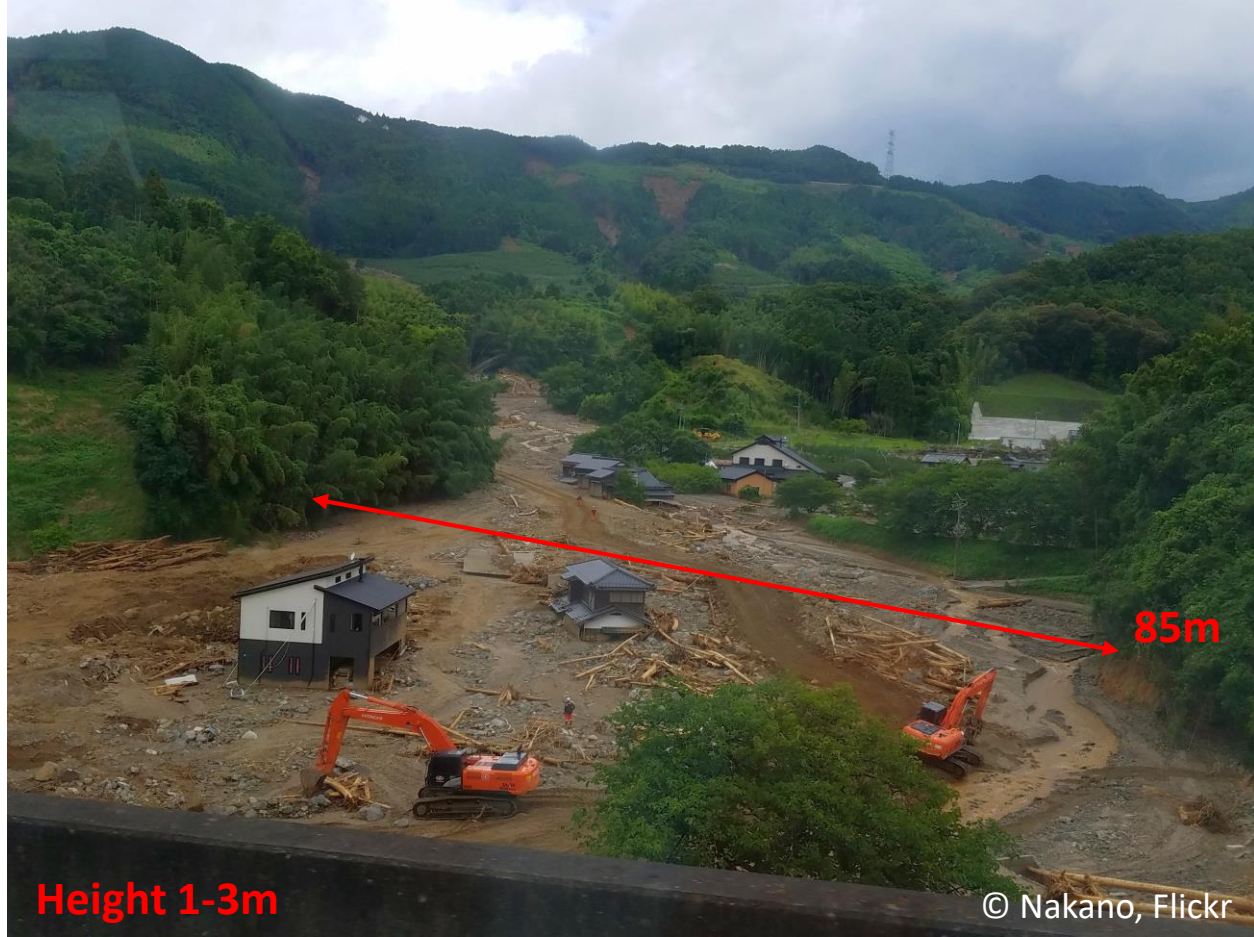
Concomitant sediment production from the slopes and high transport capacity

=> Flood and valley filling over 1-3 meters in Souzu watershed

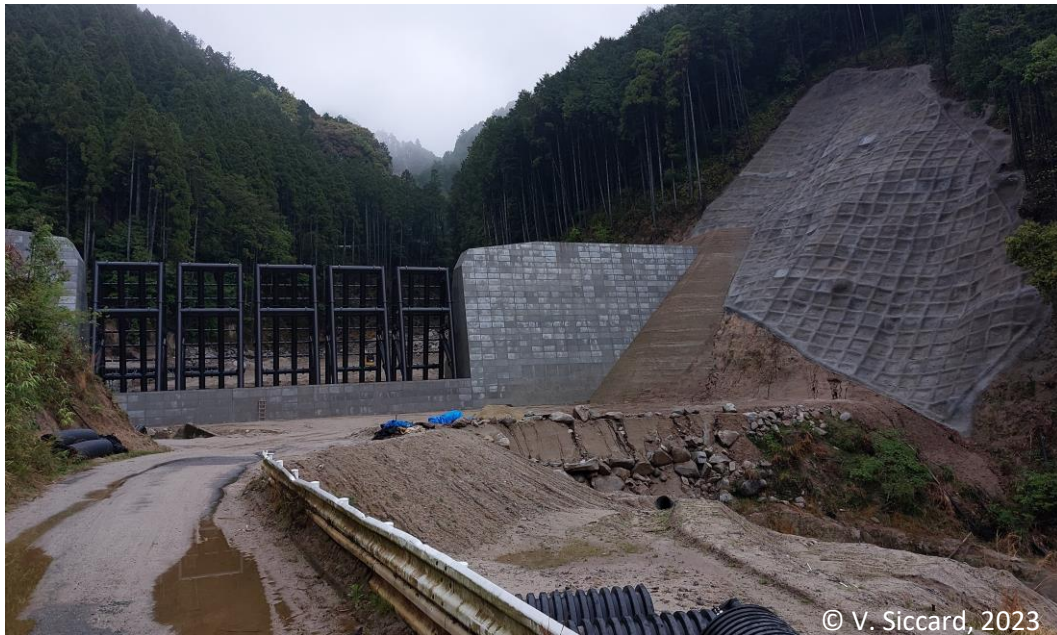
Open Sabo dam: steel frame structure dam

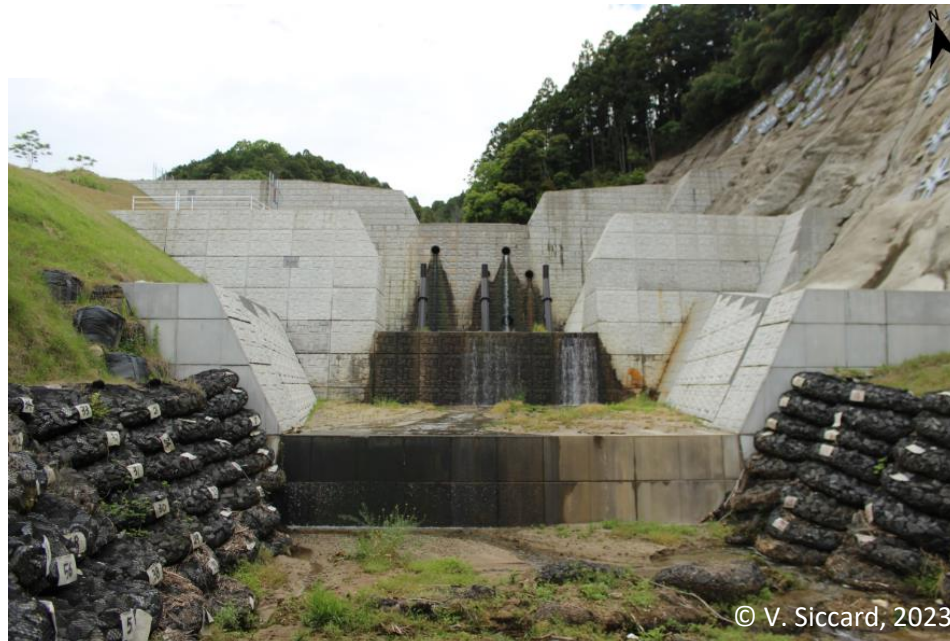
Close Sabo dam: 3 dimensional dam

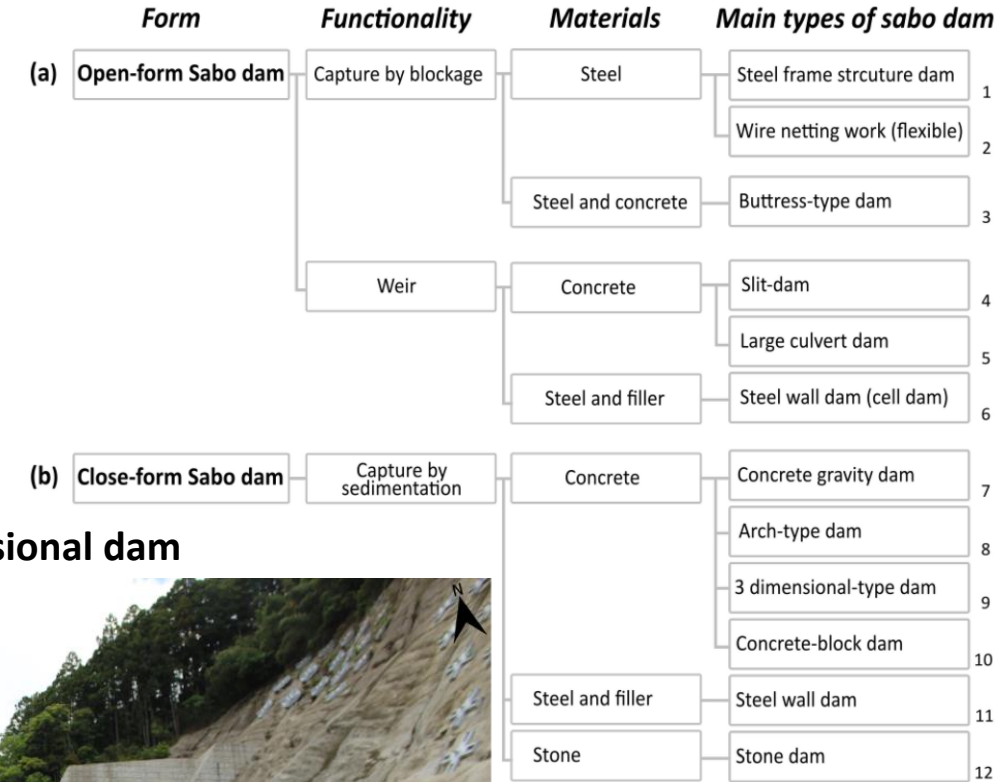
Classification of Sabo dams according to the MLIT (Dumont et al., 2023)

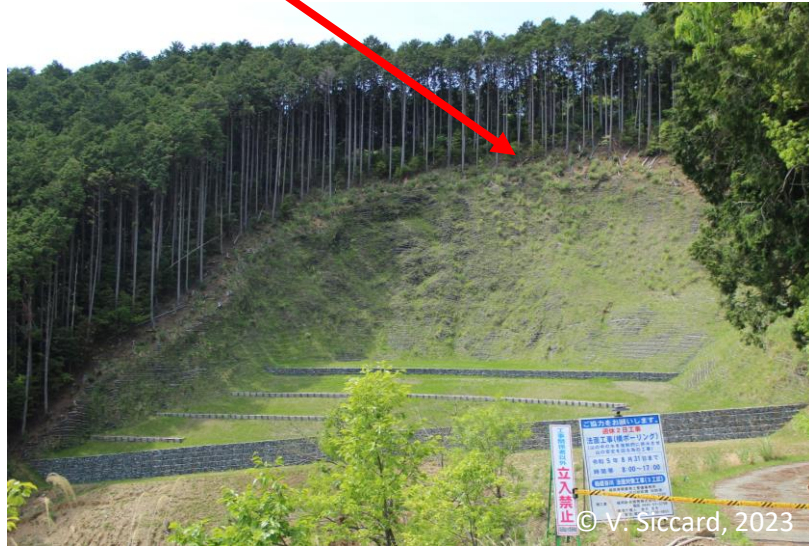
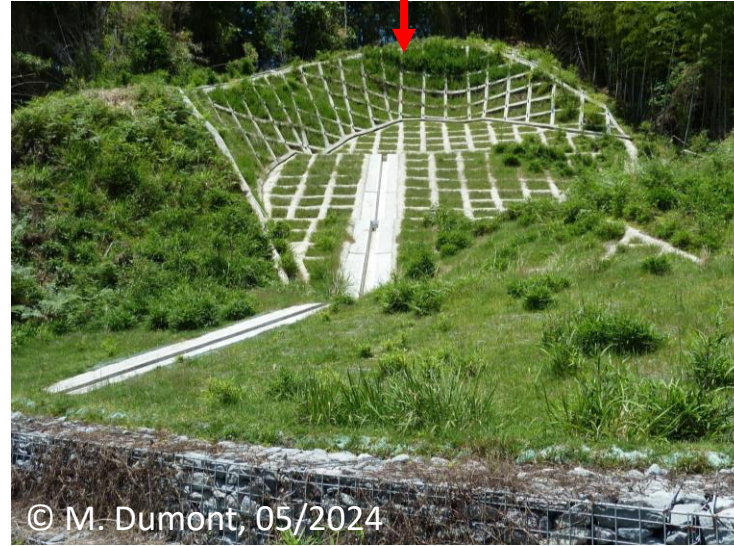
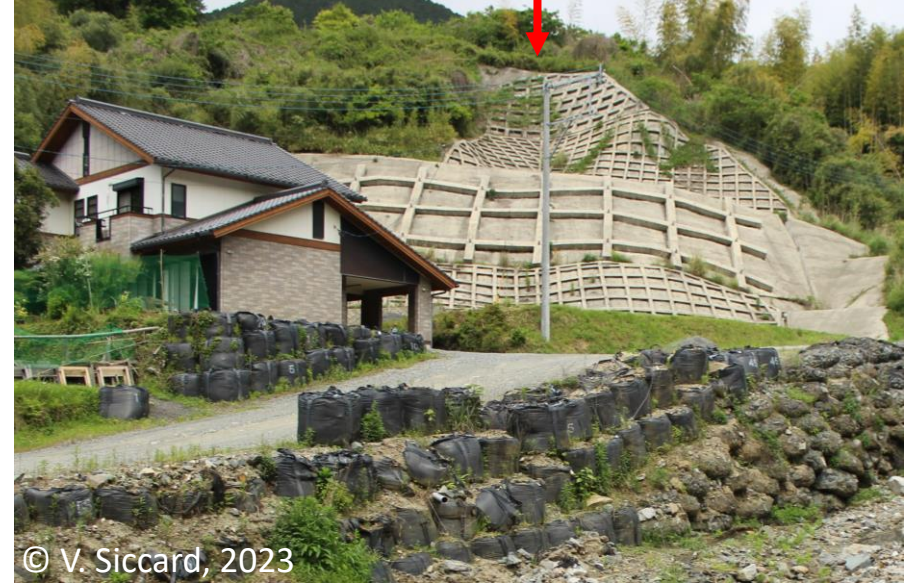
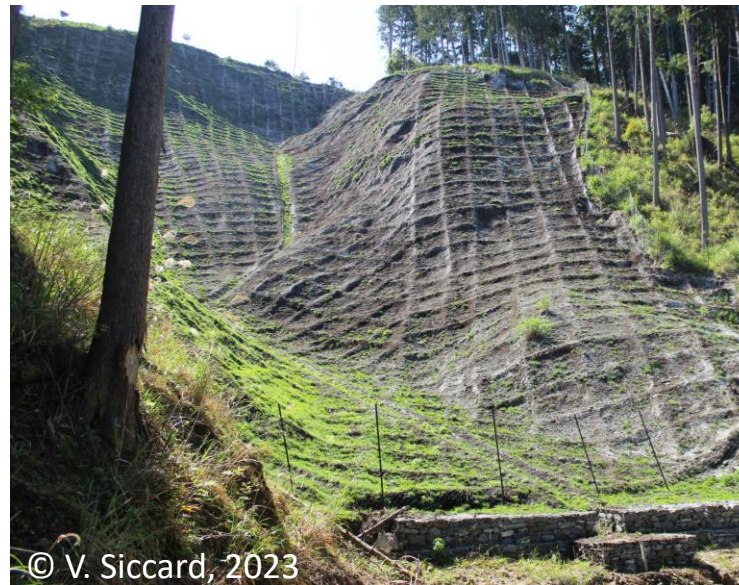
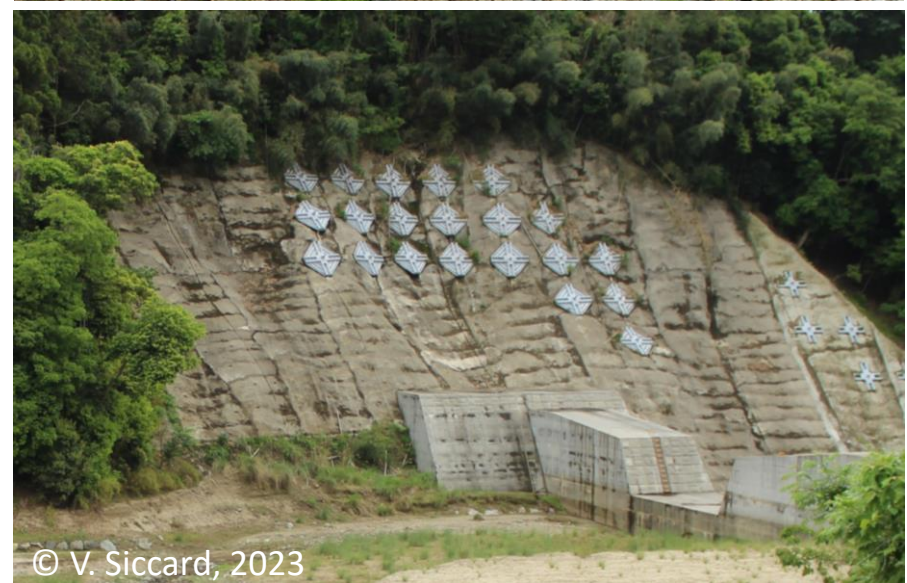
Soft engineering

Medium engineering

Hard engineering

A wide range of slope works from soft to hard engineering:

- Vegetation and Biological Soil Crust (BSC)
- Geotextile and Tarpaulin
- Terrace and gabion work
- Wire mesh
- Shortcrete grid beam
- Concrete cover
- Concrete cover with anchor and soil nailing

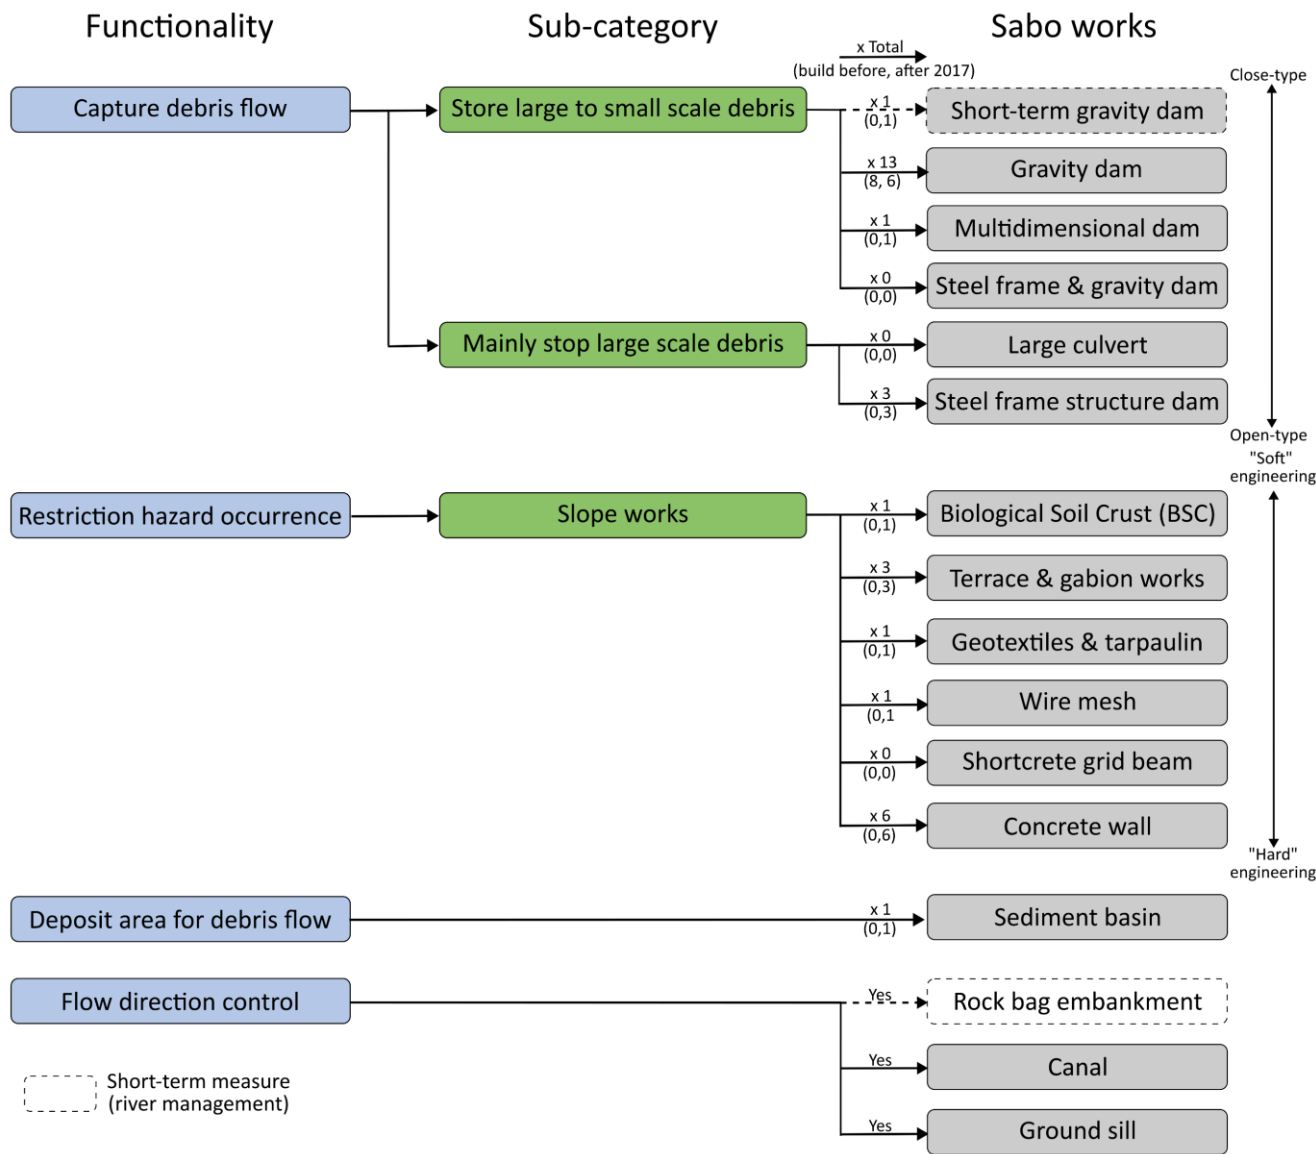
Sabo system in Souzu watershed: 11 dams built after 2017 (8 before) = massive response with engineering

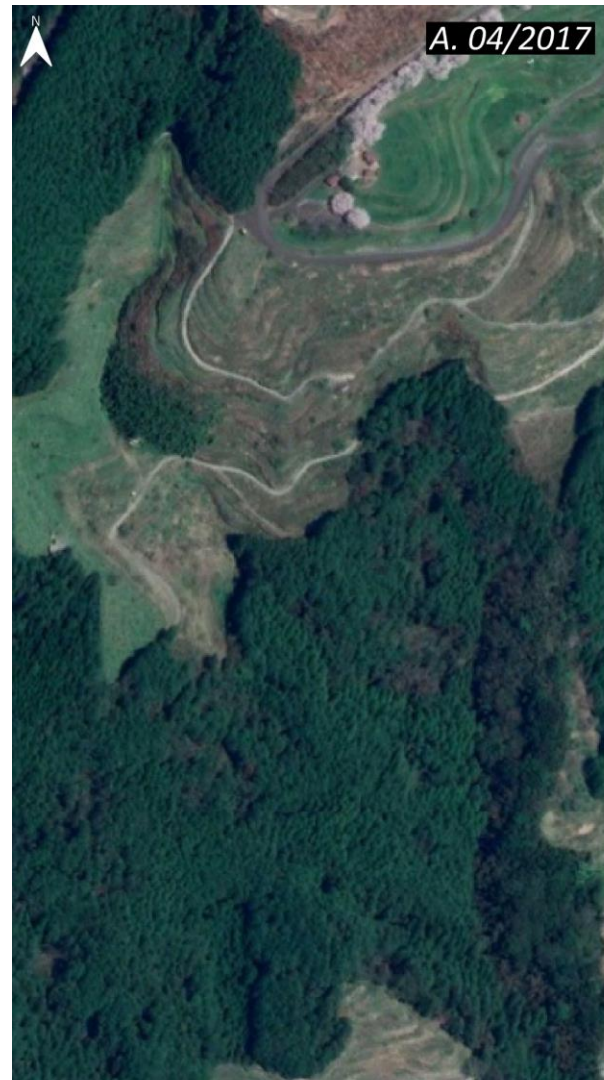
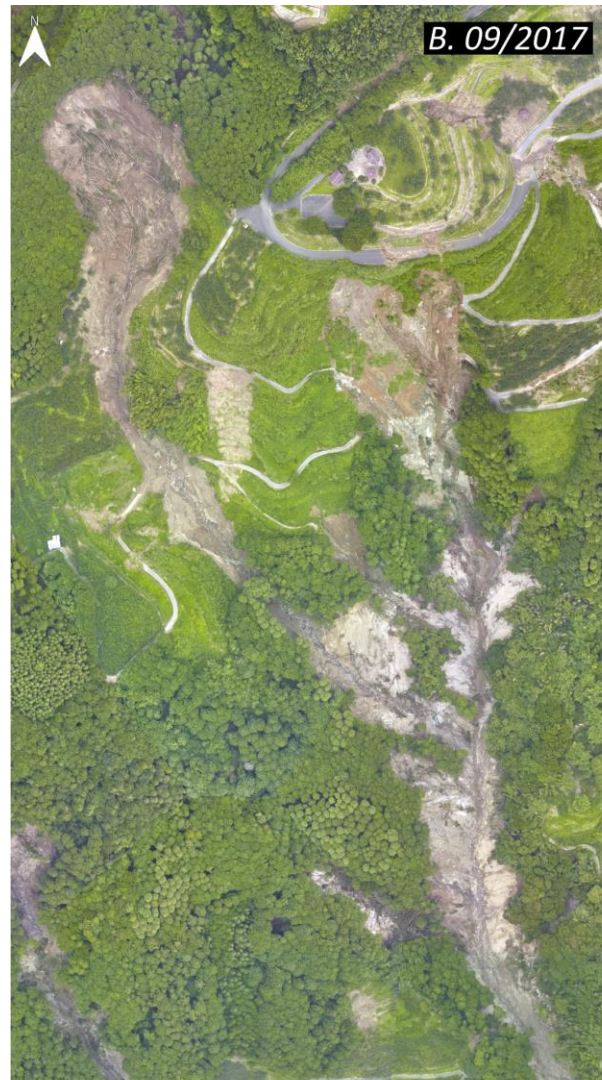
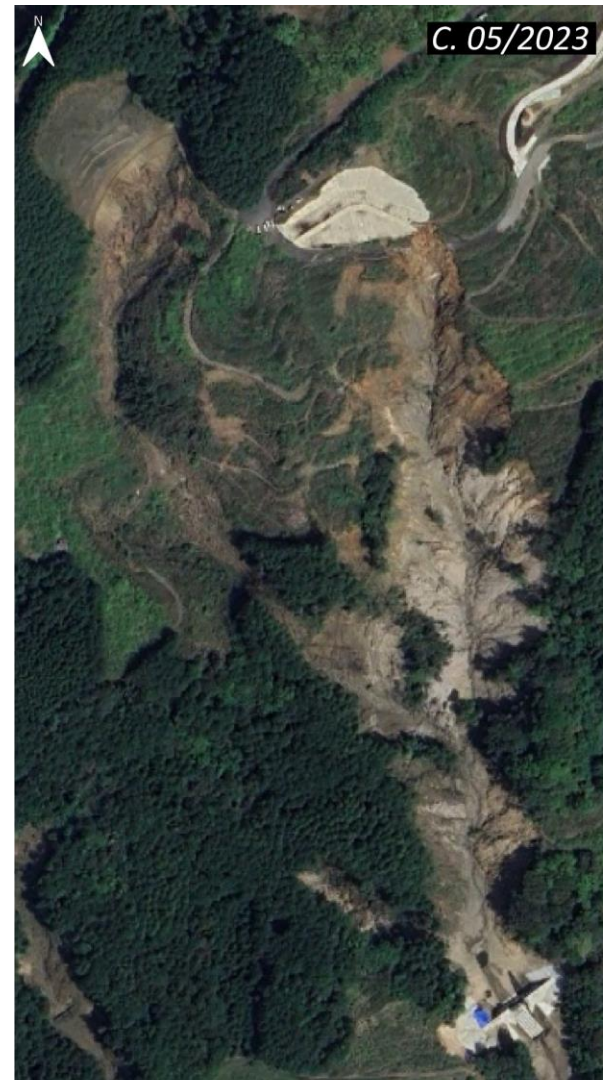
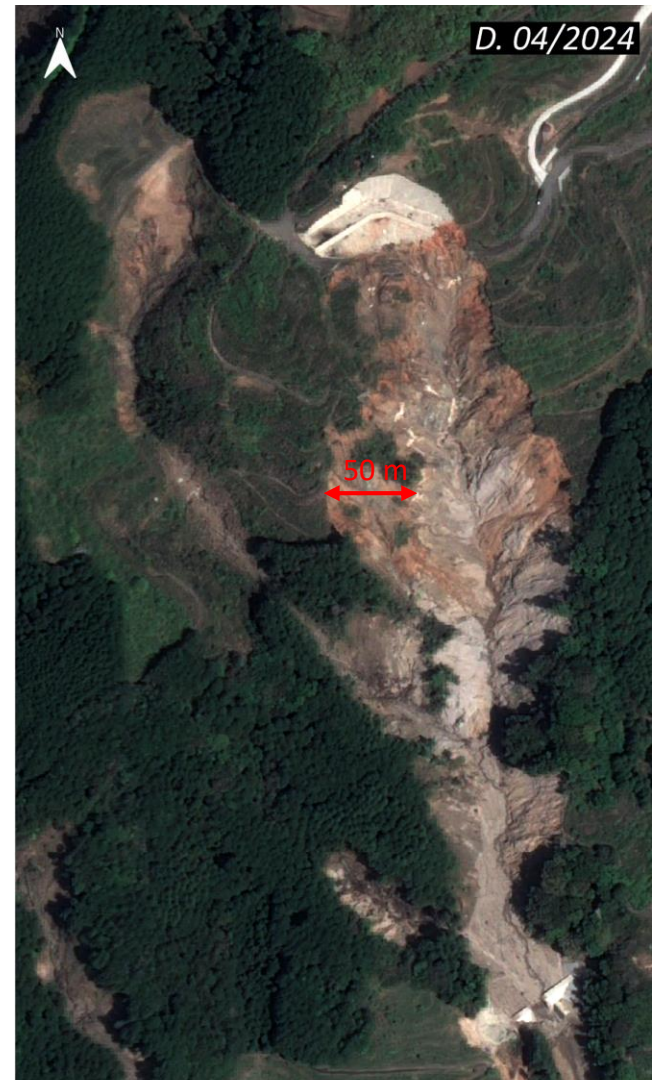
Post-event landscape dynamics: radical change and rapid evolution once the breach has been open

=> Increased sensibility to lower magnitude event and runoff

A. 04/2017

B. 09/2017

C. 05/2023

D. 04/2024

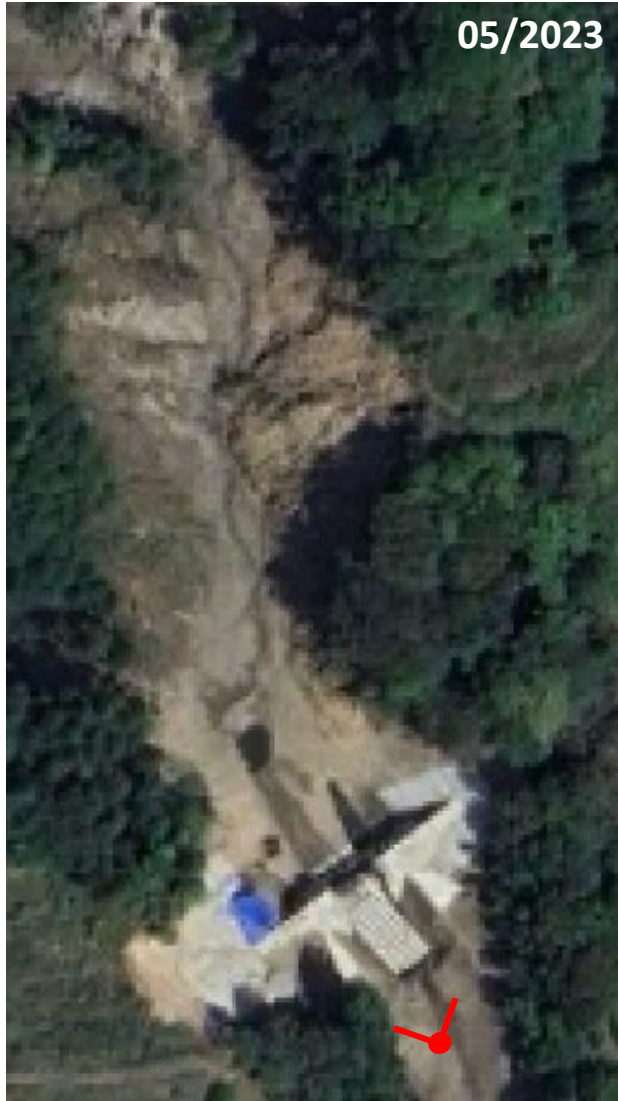
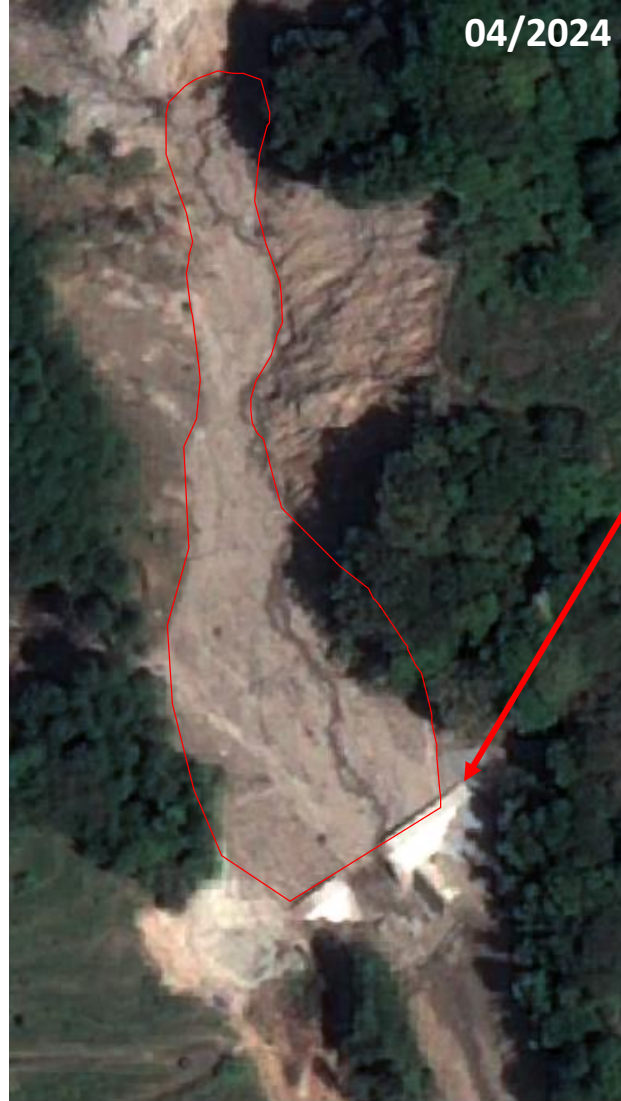
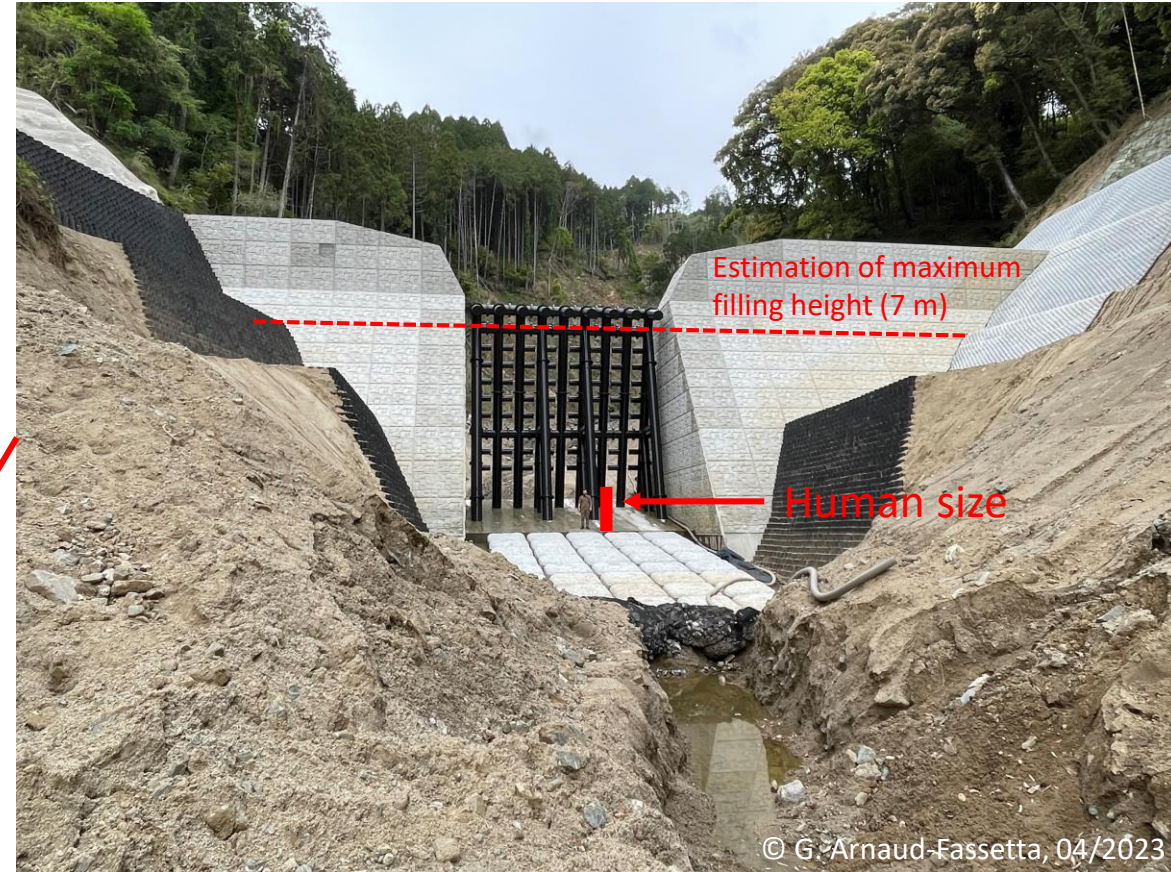
Steel frame structure dam filled after the heavy rainfall of 2023:

2023 heavy rainfall during rainy season:

- Section of approx. 150 m ; 3500 m² filled; 5 m height
- Thousands of cubic meters of sediment
- Probably more than 10 000-15 000 cubic meters

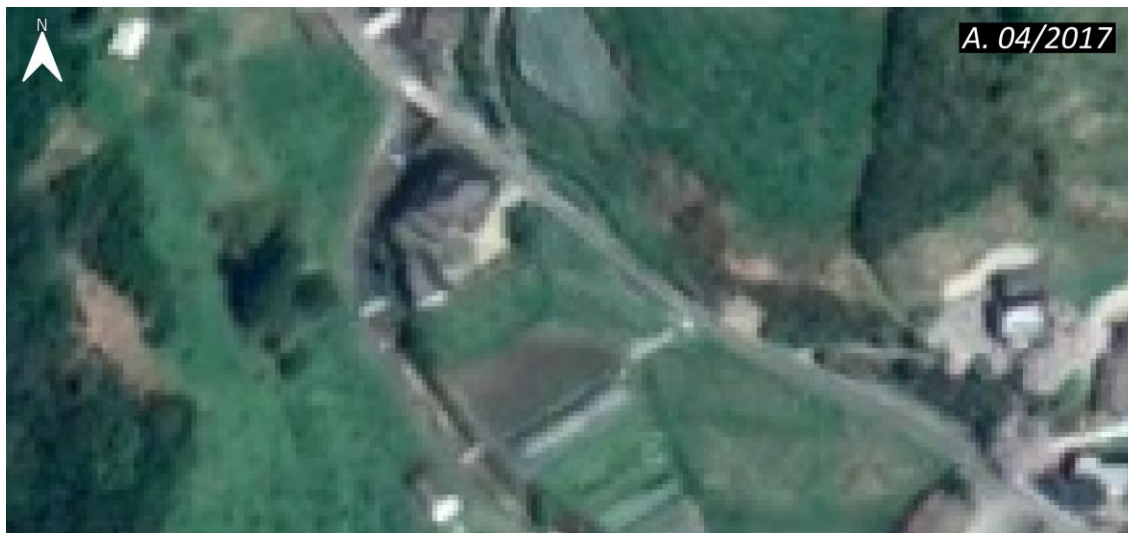
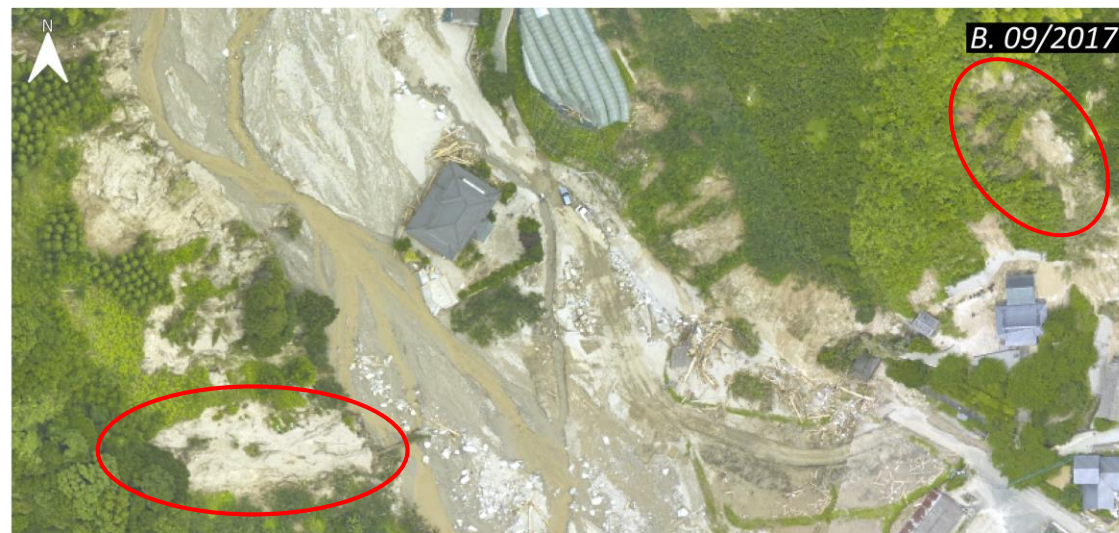
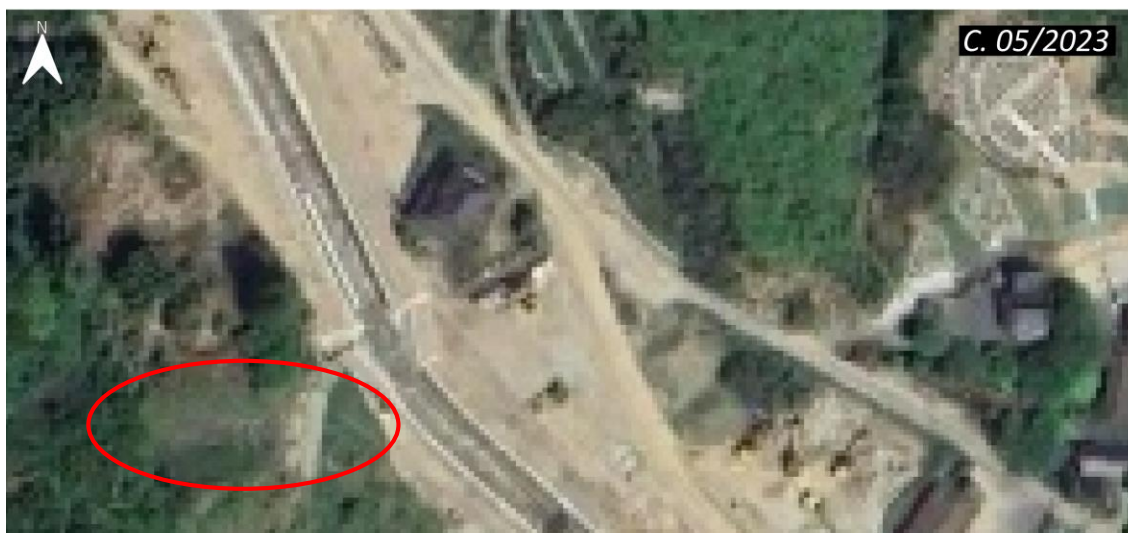
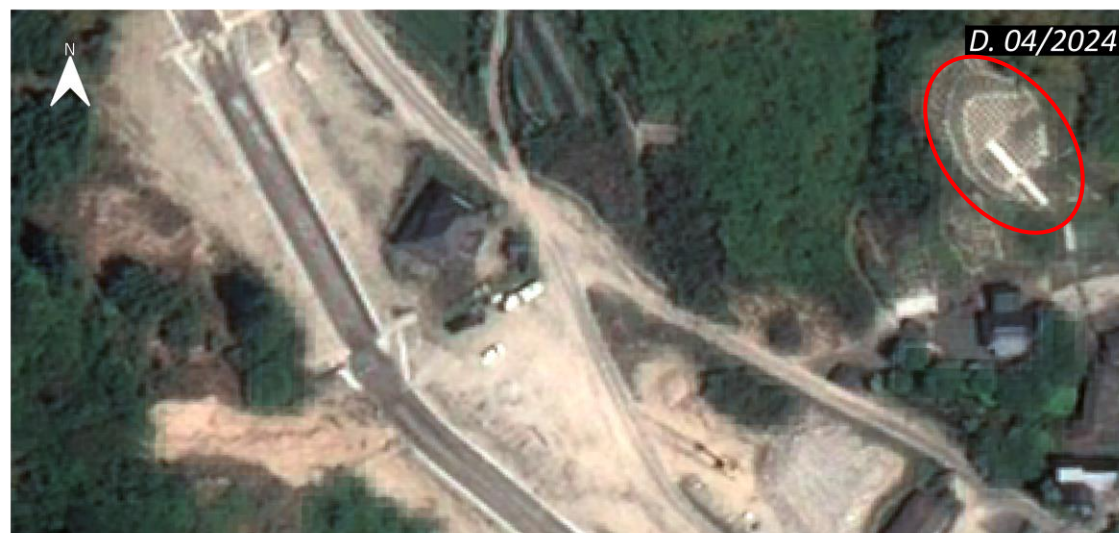
Slope works changes in reaction to the 2023 heavy rainfall:

A. 04/2017

B. 09/2017

C. 05/2023

D. 04/2024
