Impacts of heavy rainfall of July 2017 in mountainous watersheds in northern Kyûshû (Japan) on structural and process-based sediment connectivity

O4.306: Impacts of heavy rainfall of July 2017 in mountainous watersheds in northern Kyûshû (Japan) on structural and process-based sediment connectivity

How did the extreme event of 5-6 July 2017 influence the connectivity of these mountain watersheds?

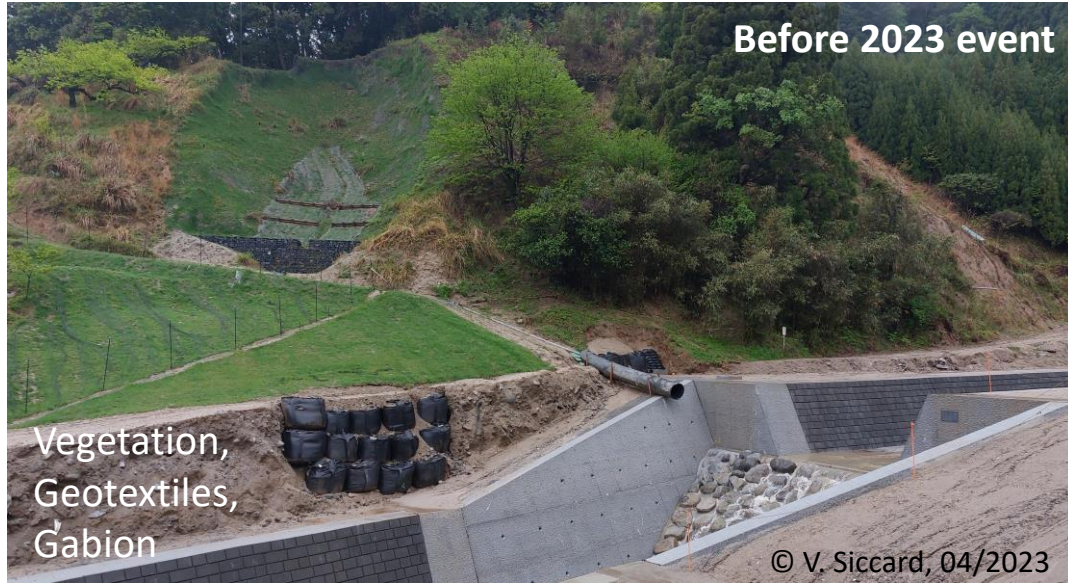
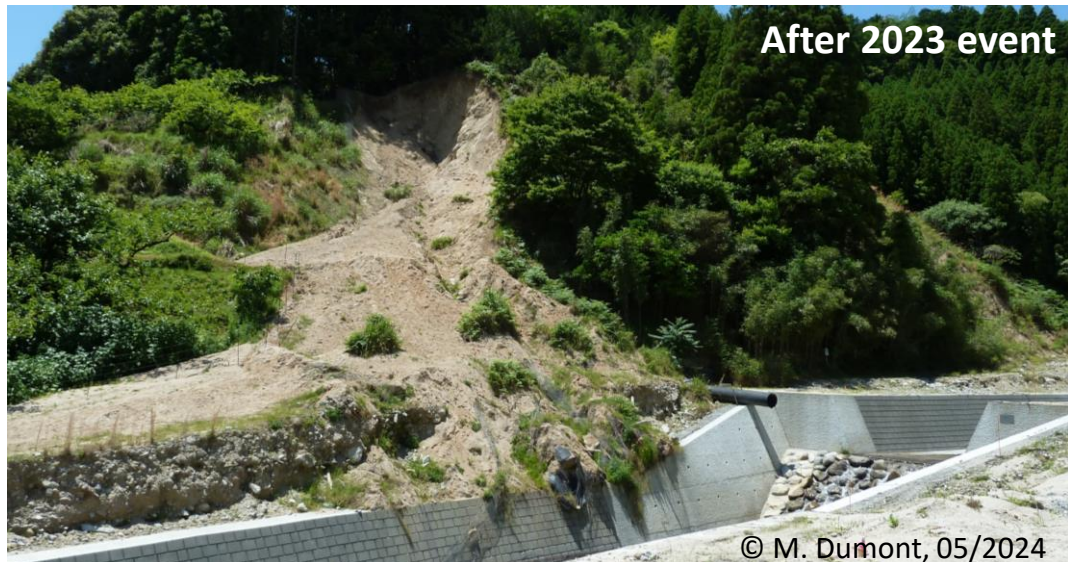
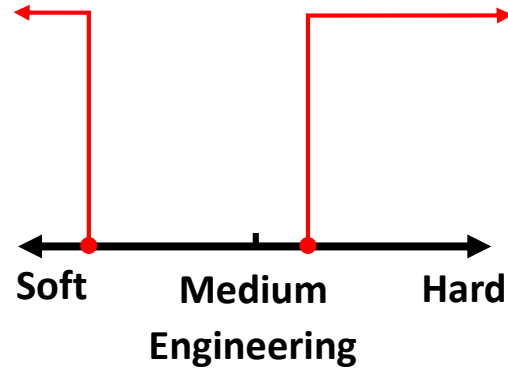
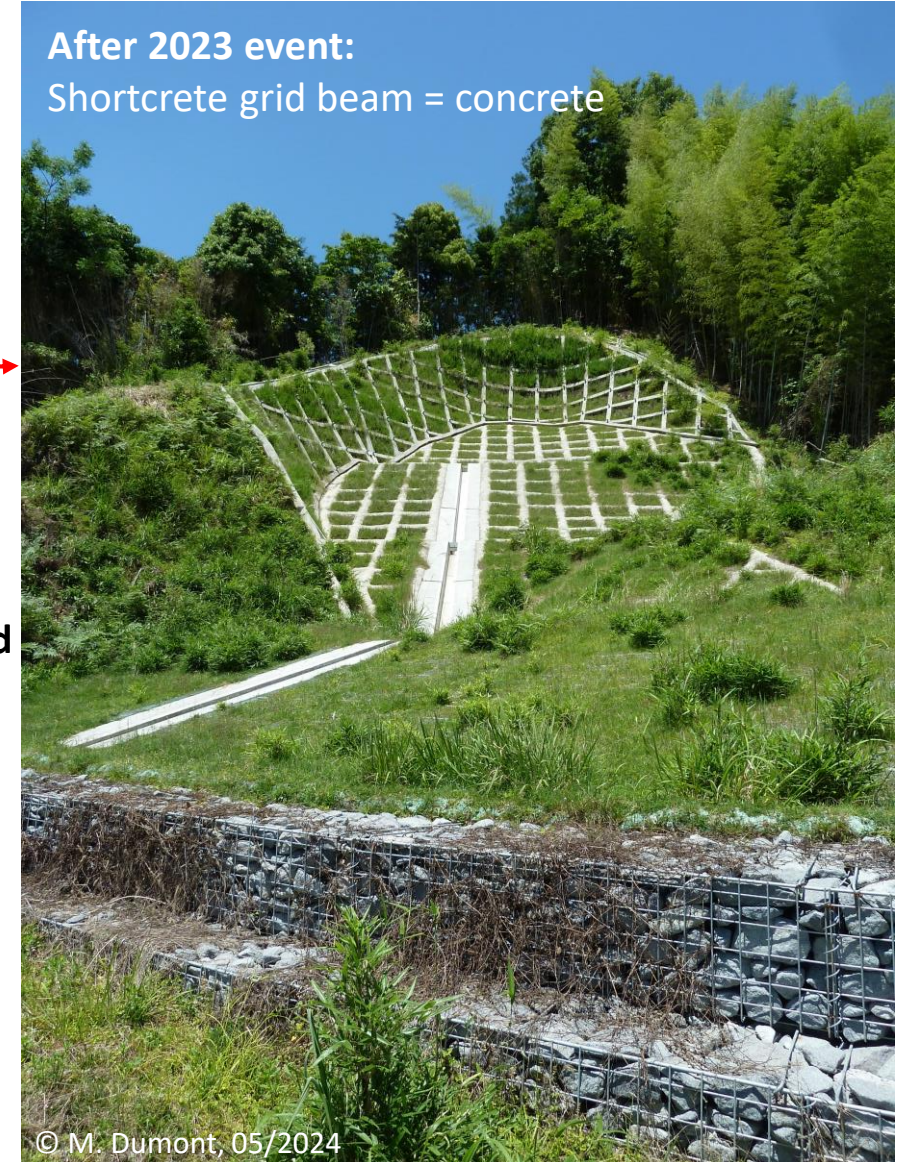
Different reactions from the slope works to the 2023 event
