Pushover Tests on Unreinforced Masonry Wallettes Retrofitted with an Innovative Coating: Experimental Study and Finite Element Modelling

Article

Keywords: masonry walleTte; pushover test; strengthening; finite element modelling; damage mechanics; vertical loading mode

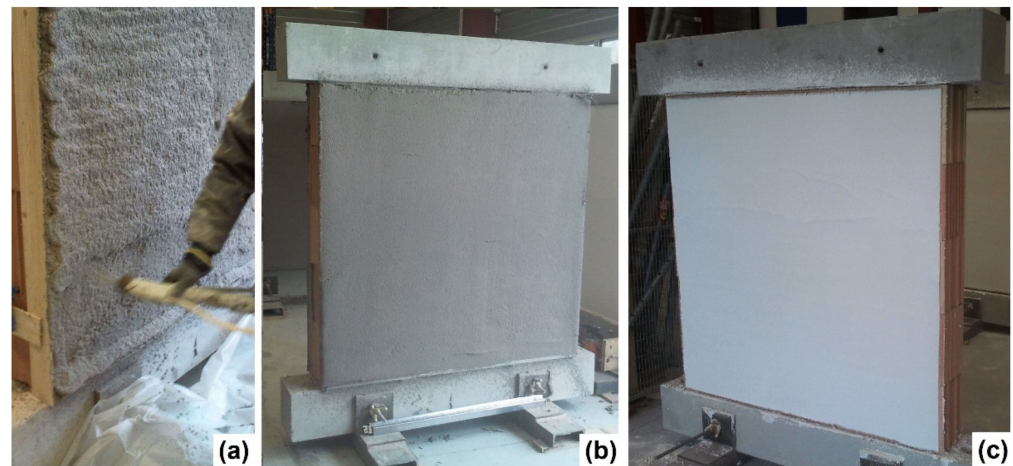
Figure 1. (a) Applying the second ISO layer on the masonry specimen; (b) masonry with ISO coating; (c) masonry with MGF coating.

Then, the coatings were sprayed on walls B3 to B7. The MGF coating consisted of one layer of 10 mm thickness, while the ISO coating was applied in two successive layers of 20 mm each to obtain a total thickness of 40 mm (Table 2). As the coatings covered only one side of the experimental walls, such a building method could have led to an out-of-plane response from the walls during the test. Hence, both sides of the walls were sprayed with the coating so that the symmetry condition was met during the test. The coated walls are presented in Figure 1.

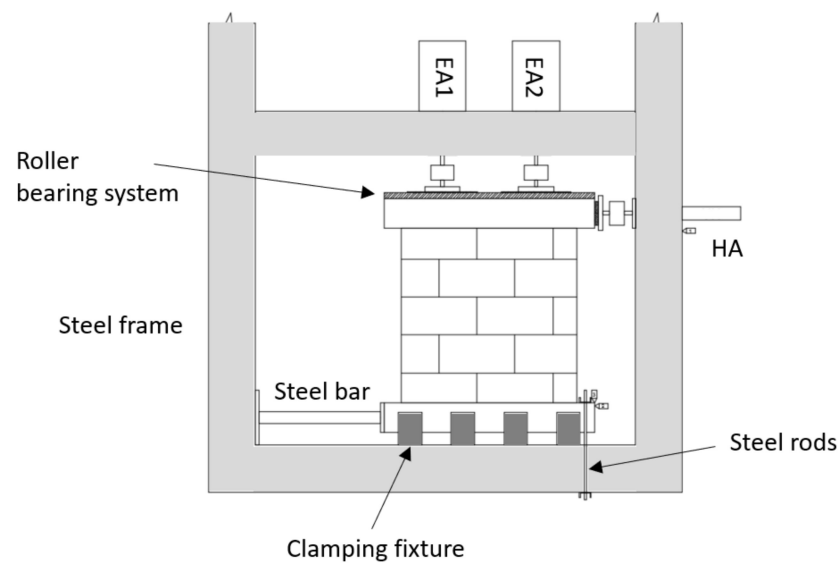
Figure 2. Experimental setup of a URM wall.

The tests were performed with a steel frame on which boundary conditions were applied. The beam inertia was equivalent to HEB400. Figure 2 depicts the URM wall with the boundary conditions acting on it during the test. The lower concrete beam of the wall was maintained against the frame by four vices blocking and centring the specimen inside the frame. This beam was also blocked laterally by a steel bar to prevent any sliding motion. Two tie rods, on the right, blocked the uplift of the beam during the horizontal loading. Two displacement transducers were used to assess the efficiency of the boundary conditions. For the upper concrete beam of the specimens, the horizontal (in-plane) displacement was allowed by a roller-bearing system. An UPN300 steel upper beam was used (with the roller-bearing system) to distribute the vertical load on the specimen. During the loading, the displacement fields of the front surface were computed in order to evaluate the appearance and propagation of cracks in relation to the loading. For this reason, a speckle with various grey levels was generated on this side of the walls. Digital images were obtained using a black and white numerical camera with a resolution of 16 million pixels. The image correlation software 7D [16] was used to assess the strain and displacement values of the specimen throughout the test. The crack patterns of both sides were systematically compared during the tests to verify that the behaviour was invariant in the out-of-plane direction. Tests showed a precision of 0.02 mm with the designated configuration. Thus, the level of precision was similar to that of typical displacement transducers; however, here, the displacement field was defined for the whole face of the wall and in both horizontal and vertical directions.

The pushover test is described in the following. The vertical load was applied by two actuators, while only one was required for the horizontal loading. Two electrical actuators (EA1 and EA2, with 120 kN capacity each) were used to apply the vertical pre-load, at a rate of 1 kN/s in 10 kN steps, until a 202 kN global load was reached. This pre-loading level was representative of the vertical load encountered in a three-story building, which corresponds to the building type for which this coating may be used. Furthermore, this loading value was close to the one used in [22], in which the authors observed shear failures of walls. As the two actuators were force-controlled, the 202 kN pre-loading setting was kept constant during the continuation of the test. Then, a horizontal in-plane displacement was applied by the hydraulic actuator (HA) to the lateral face of the upper beam. The horizontal displacement was imposed at a rate of 1 mm/min in steps of 1 mm until failure. All the actuators were used with ball joints so that no bending moment could be transferred to the wall.

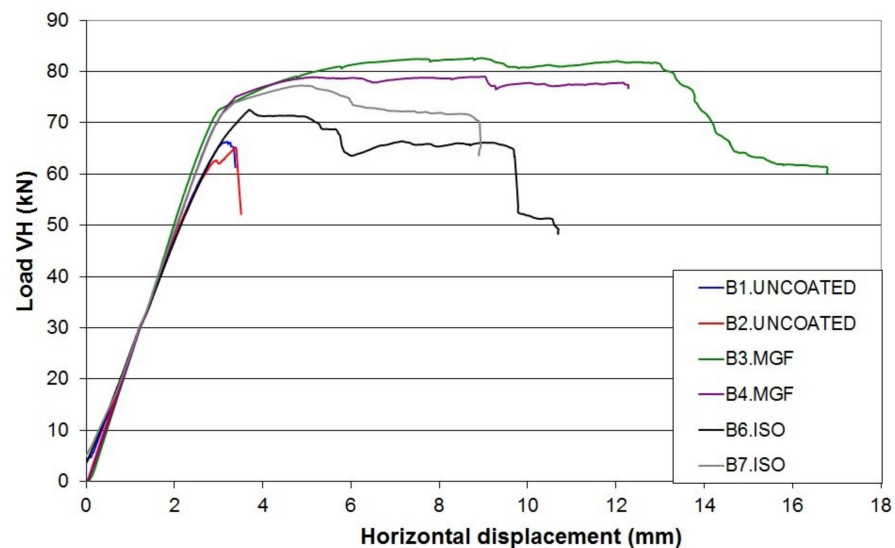
Figure 3. Force–displacement relationship of the tested specimens.

Figure 3 shows the force–displacement relationship for each tested specimen. The displacement corresponds to the lateral displacement of the beam near the contact with the hydraulic actuator. This displacement was derived from the DIC measurement, as the deformations of the metallic frame did not allow consideration of the displacement values from the actuator. The consistency of this measurement was verified by comparing the displacement values of one given point, as well as one value from a displacement transducer.

First of all, the experimental results in the tests of the masonry response to the applied solicitations showed good reproducibility (Figure 3). The initial stiffnesses were measured in the linear part of the curves. The lateral stiffnesses were similar for the URM and the ISO walls, with values of about 22 kN/mm. The MGF wall appeared to be 3 kN/mm stiffer, with a value of about 25 kN/mm. Considering that the MGF coating was isotropic with a Poisson's ratio of 0.2, a shear modulus G of 125 MPa \pm 62.5 MPa was deduced from the Young's modulus provided in Table 1. The supplementary stiffness Δk_s provided by the coating was derived from the expression $G \times A/h$, where A denotes the horizontal surface of the coating and h corresponds to the wall height. Considering the coatings of both sides, Δk_s was equal to 2.5 kN/mm \pm 1.25 kN/mm, which was quite consistent with the experimental value indicated above. The URM walls (B1 and B2) underwent brittle failures with an average maximum force of around 65 kN and an average maximum displacement at failure of around 3.5 mm. In comparison, the ISO-coated wall specimens (B6 and B7) showed more ductile behaviour, with an average maximum force of 75 kN

and an average maximum displacement at failure of around 9 mm. This was even more noticeable for the MGF walls (B3 and B4), which exhibited a maximal strength of about 90 kN. It is safe to assume that the change of slope, observed between 3 mm and 4 mm for the coated specimens, corresponded to the propagation of the failure inside the masonry. Thus, this coating, applied here on the two sides of the specimens, allowed a 14% increase in the maximum horizontal force. Moreover, horizontal displacements at failure were almost three times greater, which could be useful in terms of energy dissipation during a seismic event.

The experimental increase in strength ΔF_{exp} for the ISO walls compared to the URM walls was about 10 kN (Figure 3). As the crack patterns were very similar for both types of wall, this increase can be attributed to the ISO coating. DIC analysis of the URM walls showed the presence of tensile strains along the vertical joints and the development of cracks in the bricks, while shear strains occurred in the horizontal joints. This means that the ISO coating was subject to tensile stress along those vertical joints and also along the brick cracks. The strength gain ΔF was also estimated analytically when the crack had completely developed through the wall. In order to compute this gain, three assumptions were required:

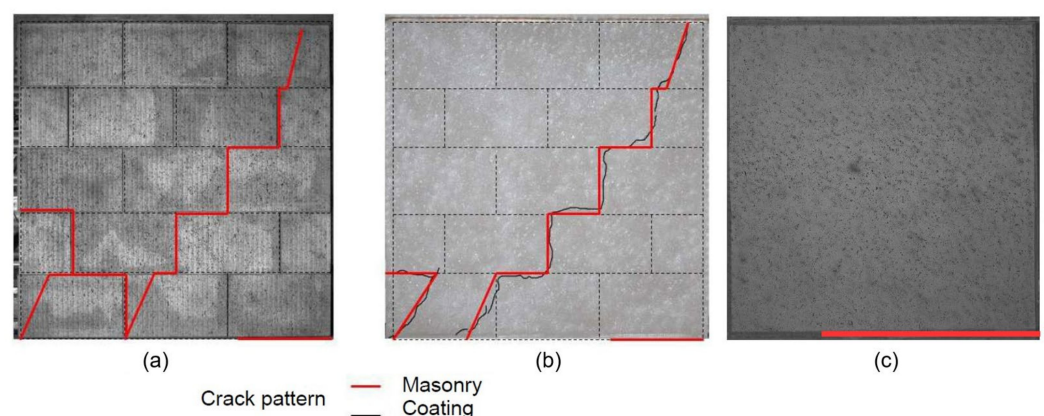
Figure 4. Crack patterns on the wall surfaces at masonry failure for specimens: (a) URM B1, (b) ISO-coated B7, and (c) MGF-coated B3.

In terms of the failure mode, similar failure patterns were also observed. Figure 4 shows examples of the crack patterns for a URM wall (B1) and an ISO-coated specimen (B7). These two types of specimen experienced stair-shaped shear failures with crack propagation along the horizontal and vertical joints of the masonry. This feature was noticed after manually removing the ISO coating from the masonry panel at the end of the test. It is also important to note that, along this crack pattern, bricks in contact with a concrete beam showed a diagonal crack, while this type of failure did not occur for inner rows of bricks. The flexural failure was the predominant failure mechanism for both specimens involving the MGF coating. The relevant crack was characterised by a tension failure in the lower bed joint (Figure 4c). No debonding of the coating was observed, even after the masonry failure, for either type of coating.

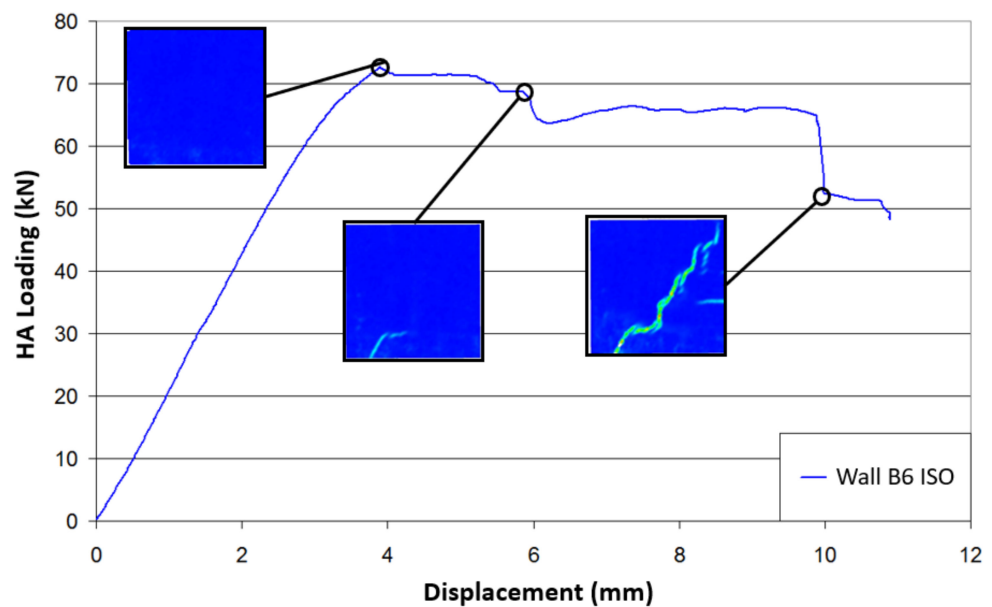
Figure 6. Evolution of cracking during the test of ISO-coated wall B6.

where ε_{max} and ε_{min} denote the major and minor principal strains, respectively. To investigate the behaviour of the specimen, a qualitative study was carried out first. Indeed, once a crack opens, the measured strain may no longer be pertinent, but the appearance and opening of cracks are easy to identify with this variable. Figures 5 and 6 show the evolution of the crack pattern along the effort–displacement curve for the specimens B1 and B6, respectively. For the wall B1, the stair-shaped shear failure did not develop first. Indeed, small cracks due to masonry faults could already be noticed in the left bottom edge during the pre-loading phase. At a load of 57 kN, these cracks were still relevant, but the initiation of a flexural crack at the opposite side was also noticed. At the maximal load, the stair-shaped shear failure occurred, but the flexural failure mode was still present. At this point, the principal strains computed by the DIC analysis indicated that the horizontal joints involved in the cracks underwent shear strains, while tensile strains were noticed along the vertical joints. The post-peak behaviour was rather brittle. Finally, the relevant failure mode was the stair-shaped one, but it seems that the test configuration almost corresponded to the configuration of the transition between a flexural failure and a shear failure. Figure 6 shows the crack pattern on the external surface of the coating for the wall B6. Here, the measured strains could not be related to those of the masonry. It can be seen that the outside of the ISO coating did not crack before the loading peak was reached. From a thermal point of view, this means that the coating would be able to provide continuous insulation until the failure of the masonry occurs. It means that the critical aspect is the mechanical behaviour. Here, the ductility was far more important than for the URM wall. It can be observed that the shear strength decreased by 10% only when the displacement was twice that at the peak. Furthermore, the corresponding strength was more or less the same as the URM specimens at the peak. The crack patterns in Figures 5 and 6 were similar at failure. The coating did not modify the shapes of the cracks or the failure mode, but its deformation ability seemed to postpone the failure propagation.

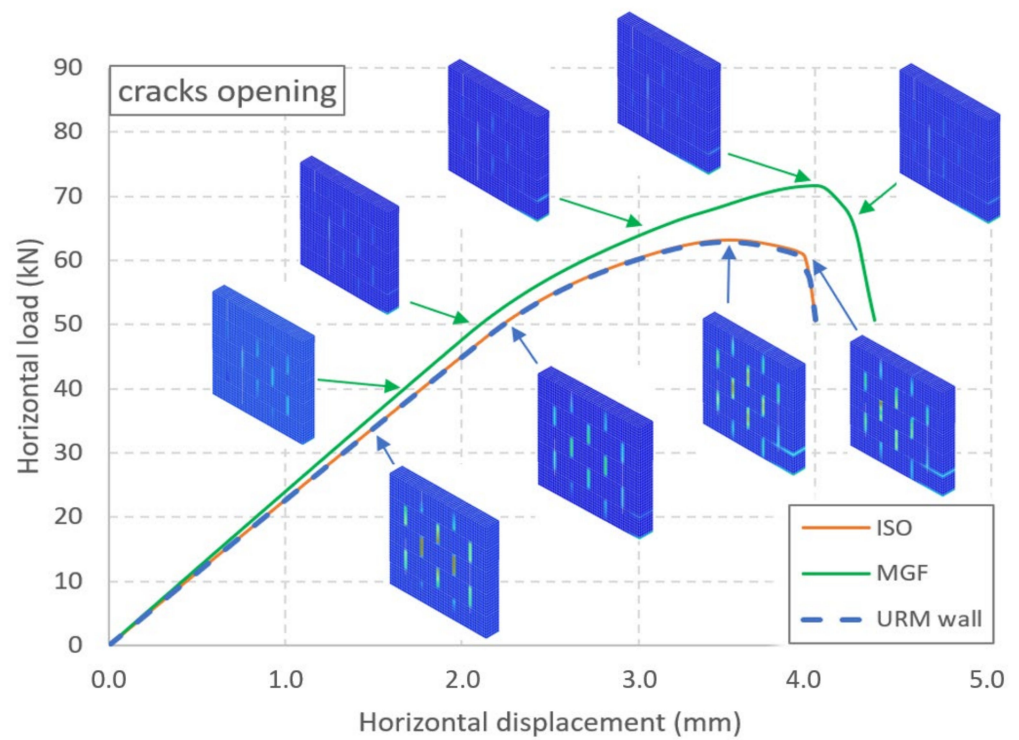
Figure 9. Numerical force vs. displacement curves for the three types of wall and the evolution of the opening of the cracks for the URM and MGF walls.

The force–displacement curves for the three types of wall are presented in Figure 9. For the URM wall, a linear trend up to 50 kN is noticeable (Figure 5). Then, a curve emerges until the maximal strength is reached at a horizontal displacement of 3.52 mm and a horizontal load of 62.8 kN. The strength decreases rapidly after the peak is reached. Thus, the results for the URM wall were similar to the experimental ones. On the other hand, the models of the coated walls failed to reproduce the experiments adequately. The model of the ISO wall exhibited almost the same evolution as the URM wall. A maximal strength of 63.2 kN was reached for a displacement equal to 3.5 mm. This represented a gain of less than 1%, as if the coating had no influence. Moreover, the ductile behaviour was also not reproduced. Similar findings were obtained for the MGF wall. The maximal strength was 71.73 kN, reached at a displacement of 4 mm. Here, the coating had an influence, but this was still less than the maximal value of around 90 kN from the experiments. The strength dropped quickly after the peak, as for the two other wall models. As an intermediate conclusion, we found that two major aspects were not reproduced adequately by the simulations: the maximal strength and the ductility.

The crack patterns and the compression damage in the masonry are presented for several loading levels of the URM and MGF walls in Figures 9 and 10, respectively. Here, we focused on the pattern of these two quantities and not on their value. Up to around 50 kN, cracks were concentrated in the dry vertical joints (Figure 9). Then, a crack developed along the base joint below the right brick of the first row, which could have been linked to the start of the nonlinearity of the curve. For higher values, a second crack even appeared in the joint located between the first and second rows. The crack pattern did not evolve after that, even once the maximal strength was reached. The evolution of the compression damage (Figure 10) indicated that the damage was located in the vertical joints for most of the rising portion of the curve. Then, for both types of walls, a staircase pattern developed just before the maximal strength was reached. Finally, the strength decreased with the crushing of the corner brick. Cracking of joints propagated across the major part of the masonry, but this can be linked to the instability caused by the crushing of the brick. As a conclusion, we found that the pattern evolution of the damage under compression seemed to be a valuable index for the estimation of the state of masonry walls subject to staircase failure.

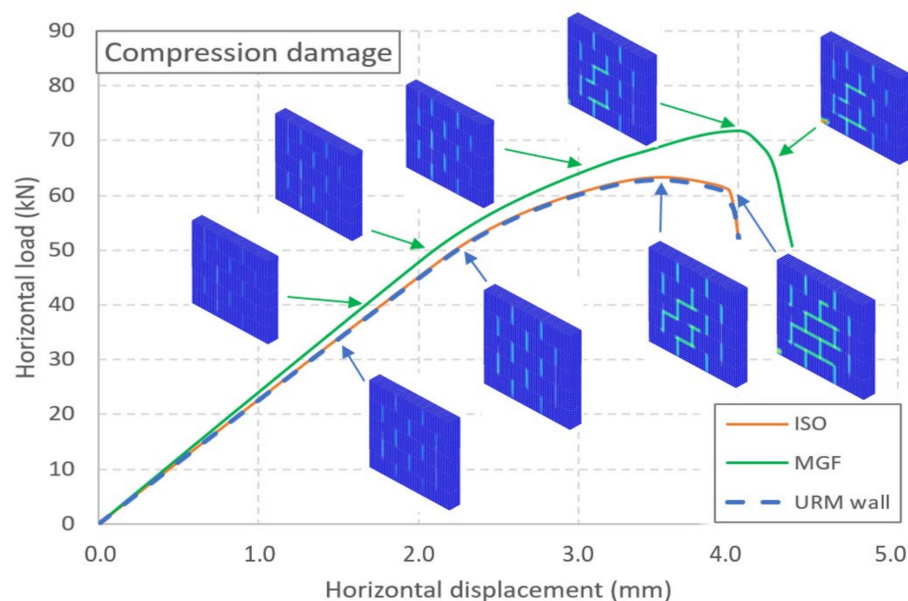
Figure 10. Numerical force vs. displacement curves for the three types of wall and the evolution of the damage under compression for the URM and MGF walls.

Let us consider the pattern of damage under compression (Figure 14). As already shown in Figure 10, this can be an interesting index of staircase failure in masonry walls. A cross-comparison was undertaken for the type of vertical loading (UVL vs. ISL) and the type of reinforcement (MFG vs. TRM) and for both the maximal strength and the maximal displacement states. Damage under compression at the peak was quite independent of the loading mode for both the MGF and the TRM reinforcement. The difference between the two loading modes at the maximal displacement was also not significant for either of the

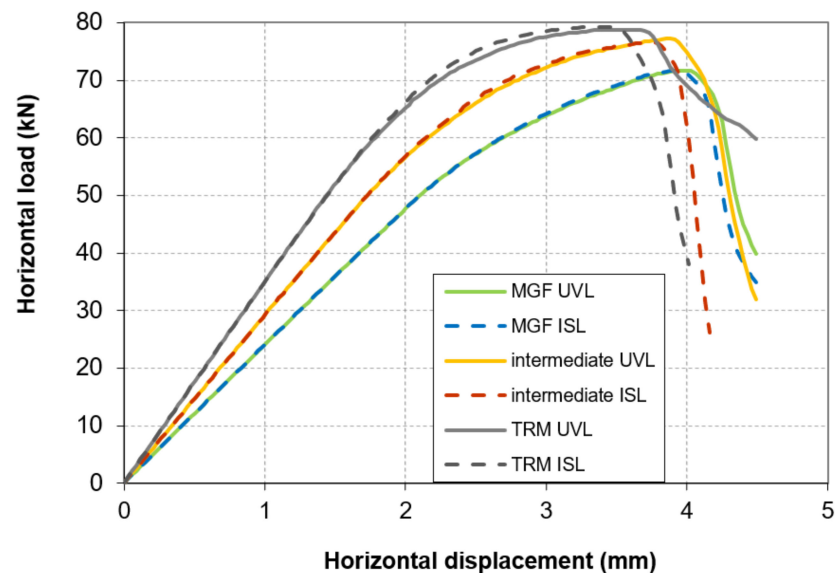
Figure 13. Influence of the in-situ stress: force vs. displacement curves for the tested loading configurations.

Table 6 indicates the vertical stress σ_{V_m} transmitted to the masonry after the application of the vertical loading. The variation for the three ISL configurations was marginal and can be explained by the low but not null value of the hydration coefficient used for the coating during the vertical loading phase. On the other hand, this vertical stress σ_{V_m} dropped by 36% in the MGF UVL configuration compared to the TRM UVL one. As a consequence, a significant part of the vertical loading was transferred by the reinforcement in this last case, and thus the failure mode could be modified [40]. From Table 6, it can be deduced that the effect of the vertical loading mode on the maximal strength was less than 1% (Figure 13). The post-peak behaviour was rather more dependent on the vertical loading configuration. It was even more significant for the TRM case. In the three cases tested, the strength dropped faster after the peak for the ISL mode than for the UVL loading mode.
