Pushover Tests on Unreinforced Masonry Wallettes Retrofitted with an Innovative Coating: Experimental Study and Finite Element Modelling

Pushover Tests on Unreinforced Masonry WalleTTes Retrofitted with an Innovative Coating: Experimental Study and Finite Element Modelling

Keywords: masonry walleTte; pushover test; strengthening; finite element modelling; damage mechanics; vertical loading mode

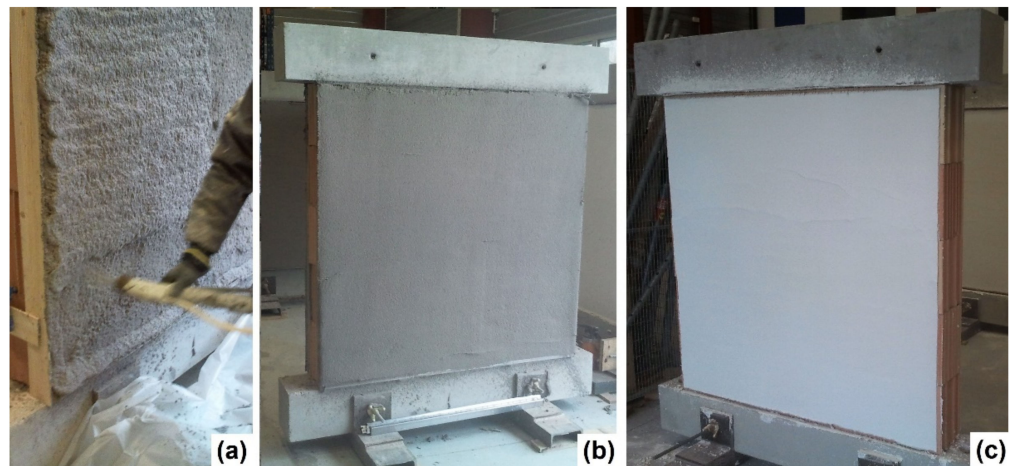
Figure 1. (a) Applying the second ISO layer on the masonry specimen; (b) masonry with ISO coating; (c) masonry with MGF coating.

Then, the coatings were sprayed on walls B3 to B7. The MGF coating consisted of one layer of 10 mm thickness, while the ISO coating was applied in two successive layers of 20 mm each to obtain a total thickness of 40 mm (Table 2). As the coatings covered only one side of the experimental walls, such a building method could have led to an out-of-plane response from the walls during the test. Hence, both sides of the walls were sprayed with the coating so that the symmetry condition was met during the test. The coated walls are presented in Figure 1.

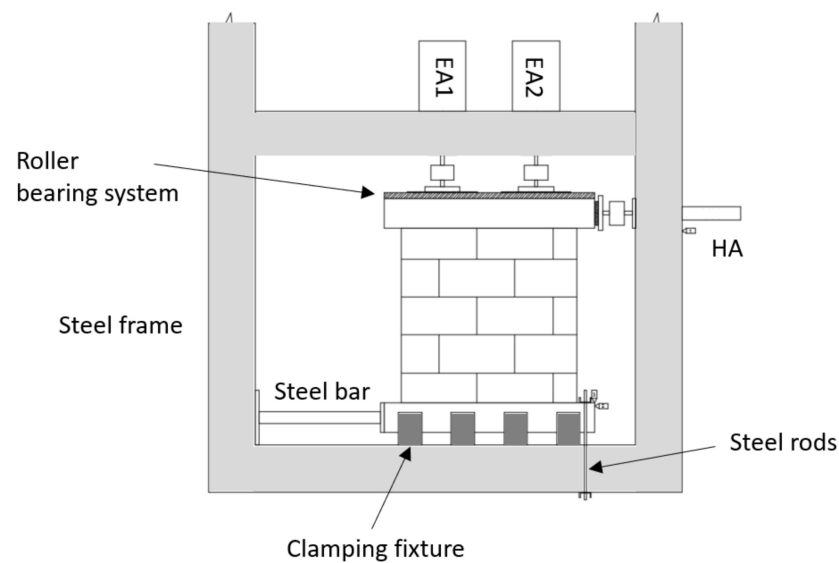
Figure 2. Experimental setup of a URM wall.

The tests were performed with a steel frame on which boundary conditions were applied. The beam inertia was equivalent to HEB400. Figure 2 depicts the URM wall with the boundary conditions acting on it during the test. The lower concrete beam of the wall was maintained against the frame by four vices blocking and centring the specimen inside the frame. This beam was also blocked laterally by a steel bar to prevent any sliding motion. Two tie rods, on the right, blocked the uplift of the beam during the horizontal loading. Two displacement transducers were used to assess the efficiency of the boundary conditions. For the upper concrete beam of the specimens, the horizontal (in-plane) displacement was allowed by a roller-bearing system. An UPN300 steel upper beam was used (with the roller-bearing system) to distribute the vertical load on the specimen. During the loading, the displacement fields of the front surface were computed in order to evaluate the appearance and propagation of cracks in relation to the loading. For this reason, a speckle with various grey levels was generated on this side of the walls. Digital images were obtained using a black and white numerical camera with a resolution of 16 million pixels. The image correlation software 7D [16] was used to assess the strain and displacement values of the specimen throughout the test. The crack patterns of both sides were systematically compared during the tests to verify that the behaviour was invariant in the out-of-plane direction. Tests showed a precision of 0.02 mm with the designated configuration. Thus, the level of precision was similar to that of typical displacement transducers; however, here, the displacement field was defined for the whole face of the wall and in both horizontal and vertical directions.

The pushover test is described in the following. The vertical load was applied by two actuators, while only one was required for the horizontal loading. Two electrical actuators (EA1 and EA2, with 120 kN capacity each) were used to apply the vertical pre-load, at a rate of 1 kN/s in 10 kN steps, until a 202 kN global load was reached. This pre-loading level was representative of the vertical load encountered in a three-story building, which corresponds to the building type for which this coating may be used. Furthermore, this loading value was close to the one used in [22], in which the authors observed shear failures of walls. As the two actuators were force-controlled, the 202 kN pre-loading setting was kept constant during the continuation of the test. Then, a horizontal in-plane displacement was applied by the hydraulic actuator (HA) to the lateral face of the upper beam. The horizontal displacement was imposed at a rate of 1 mm/min in steps of 1 mm until failure. All the actuators were used with ball joints so that no bending moment could be transferred to the wall.

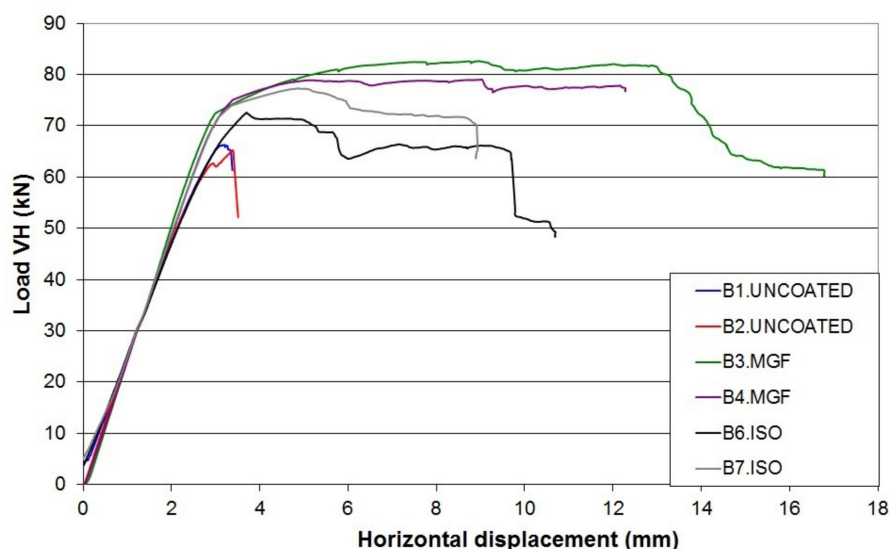
Figure 3. Force–displacement relationship of the tested specimens.

Figure 3 shows the force–displacement relationship for each tested specimen. The displacement corresponds to the lateral displacement of the beam near the contact with the hydraulic actuator. This displacement was derived from the DIC measurement, as the deformations of the metallic frame did not allow consideration of the displacement values from the actuator. The consistency of this measurement was verified by comparing the displacement values of one given point, as well as one value from a displacement transducer.

First of all, the experimental results in the tests of the masonry response to the applied solicitations showed good reproducibility (Figure 3). The initial stiffnesses were measured in the linear part of the curves. The lateral stiffnesses were similar for the URM and the ISO walls, with values of about 22 kN/mm. The MGF wall appeared to be 3 kN/mm stiffer, with a value of about 25 kN/mm. Considering that the MGF coating was isotropic with a Poisson's ratio of 0.2, a shear modulus G of $125 \text{ MPa} \pm 62.5 \text{ MPa}$ was deduced from the Young's modulus provided in Table 1. The supplementary stiffness Δk_s provided by the coating was derived from the expression $G \times A/h$, where A denotes the horizontal surface of the coating and h corresponds to the wall height. Considering the coatings of both sides, Δk_s was equal to $2.5 \text{ kN/mm} \pm 1.25 \text{ kN/mm}$, which was quite consistent with the experimental value indicated above. The URM walls (B1 and B2) underwent brittle failures with an average maximum force of around 65 kN and an average maximum displacement at failure of around 3.5 mm. In comparison, the ISO-coated wall specimens (B6 and B7) showed more ductile behaviour, with an average maximum force of 75 kN

and an average maximum displacement at failure of around 9 mm. This was even more noticeable for the MGF walls (B3 and B4), which exhibited a maximal strength of about 90 kN. It is safe to assume that the change of slope, observed between 3 mm and 4 mm for the coated specimens, corresponded to the propagation of the failure inside the masonry. Thus, this coating, applied here on the two sides of the specimens, allowed a 14% increase in the maximum horizontal force. Moreover, horizontal displacements at failure were almost three times greater, which could be useful in terms of energy dissipation during a seismic event.

The experimental increase in strength ΔF_{exp} for the ISO walls compared to the URM walls was about 10 kN (Figure 3). As the crack patterns were very similar for both types of wall, this increase can be attributed to the ISO coating. DIC analysis of the URM walls showed the presence of tensile strains along the vertical joints and the development of cracks in the bricks, while shear strains occurred in the horizontal joints. This means that the ISO coating was subject to tensile stress along those vertical joints and also along the brick cracks. The strength gain ΔF was also estimated analytically when the crack had completely developed through the wall. In order to compute this gain, three assumptions were required:

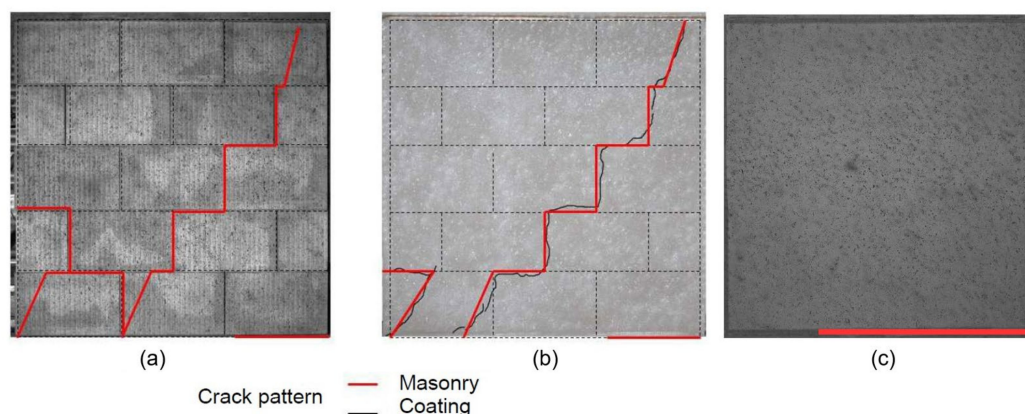
Figure 4. Crack patterns on the wall surfaces at masonry failure for specimens: (a) URM B1, (b) ISO-coated B7, and (c) MGF-coated B3.

In terms of the failure mode, similar failure patterns were also observed. Figure 4 shows examples of the crack patterns for a URM wall (B1) and an ISO-coated specimen (B7). These two types of specimen experienced stair-shaped shear failures with crack propagation along the horizontal and vertical joints of the masonry. This feature was noticed after manually removing the ISO coating from the masonry panel at the end of the test. It is also important to note that, along this crack pattern, bricks in contact with a concrete beam showed a diagonal crack, while this type of failure did not occur for inner rows of bricks. The flexural failure was the predominant failure mechanism for both specimens involving the MGF coating. The relevant crack was characterised by a tension failure in the lower bed joint (Figure 4c). No debonding of the coating was observed, even after the masonry failure, for either type of coating.

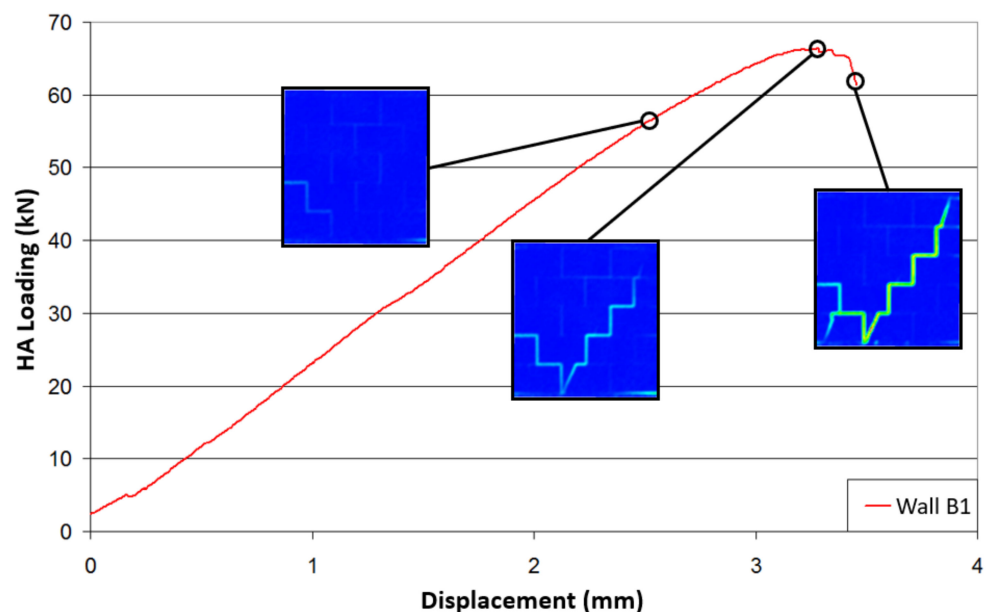
Figure 5. Evolution of cracking during the test of URM wall B1.

where ε_{max} and ε_{min} denote the major and minor principal strains, respectively. To investigate the behaviour of the specimen, a qualitative study was carried out first. Indeed, once a crack opens, the measured strain may no longer be pertinent, but the appearance and opening of cracks are easy to identify with this variable. Figures 5 and 6 show the evolution of the crack pattern along the effort–displacement curve for the specimens B1 and B6, respectively. For the wall B1, the stair-shaped shear failure did not develop first. Indeed, small cracks due to masonry faults could already be noticed in the left bottom edge during the pre-loading phase. At a load of 57 kN, these cracks were still relevant, but the initiation of a flexural crack at the opposite side was also noticed. At the maximal load, the stair-shaped shear failure occurred, but the flexural failure mode was still present. At this point, the principal strains computed by the DIC analysis indicated that the horizontal joints involved in the cracks underwent shear strains, while tensile strains were noticed along the vertical joints. The post-peak behaviour was rather brittle. Finally, the relevant failure mode was the stair-shaped one, but it seems that the test configuration almost corresponded to the configuration of the transition between a flexural failure and a shear failure. Figure 6 shows the crack pattern on the external surface of the coating for the wall B6. Here, the measured strains could not be related to those of the masonry. It can be seen that the outside of the ISO coating did not crack before the loading peak was reached. From a thermal point of view, this means that the coating would be able to provide continuous insulation until the failure of the masonry occurs. It means that the critical aspect is the mechanical behaviour. Here, the ductility was far more important than for the URM wall. It can be observed that the shear strength decreased by 10% only when the displacement was twice that at the peak. Furthermore, the corresponding strength was more or less the same as the URM specimens at the peak. The crack patterns in Figures 5 and 6 were similar at failure. The coating did not modify the shapes of the cracks or the failure mode, but its deformation ability seemed to postpone the failure propagation.

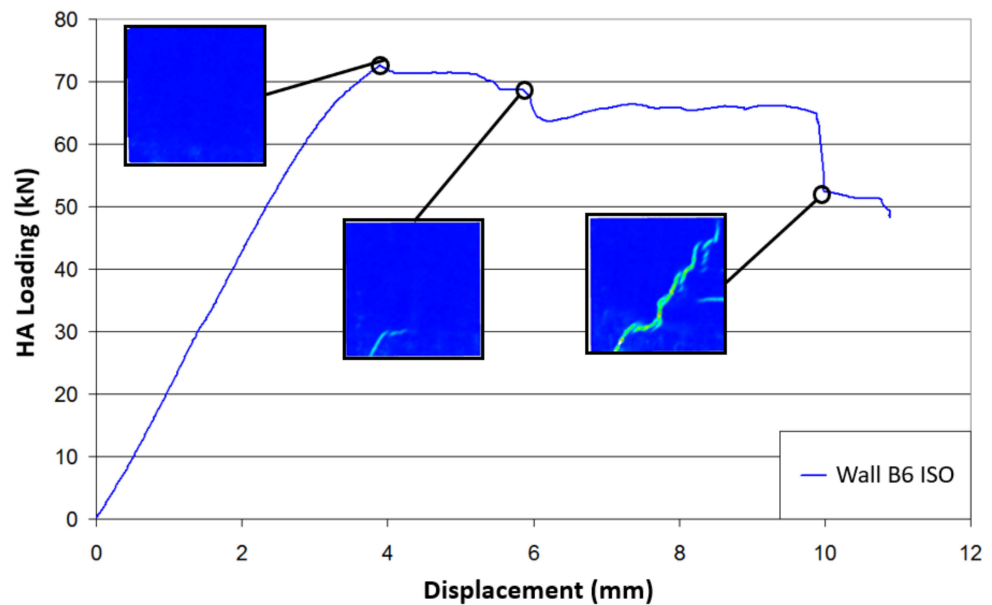
Figure 6. Evolution of cracking during the test of ISO-coated wall B6.

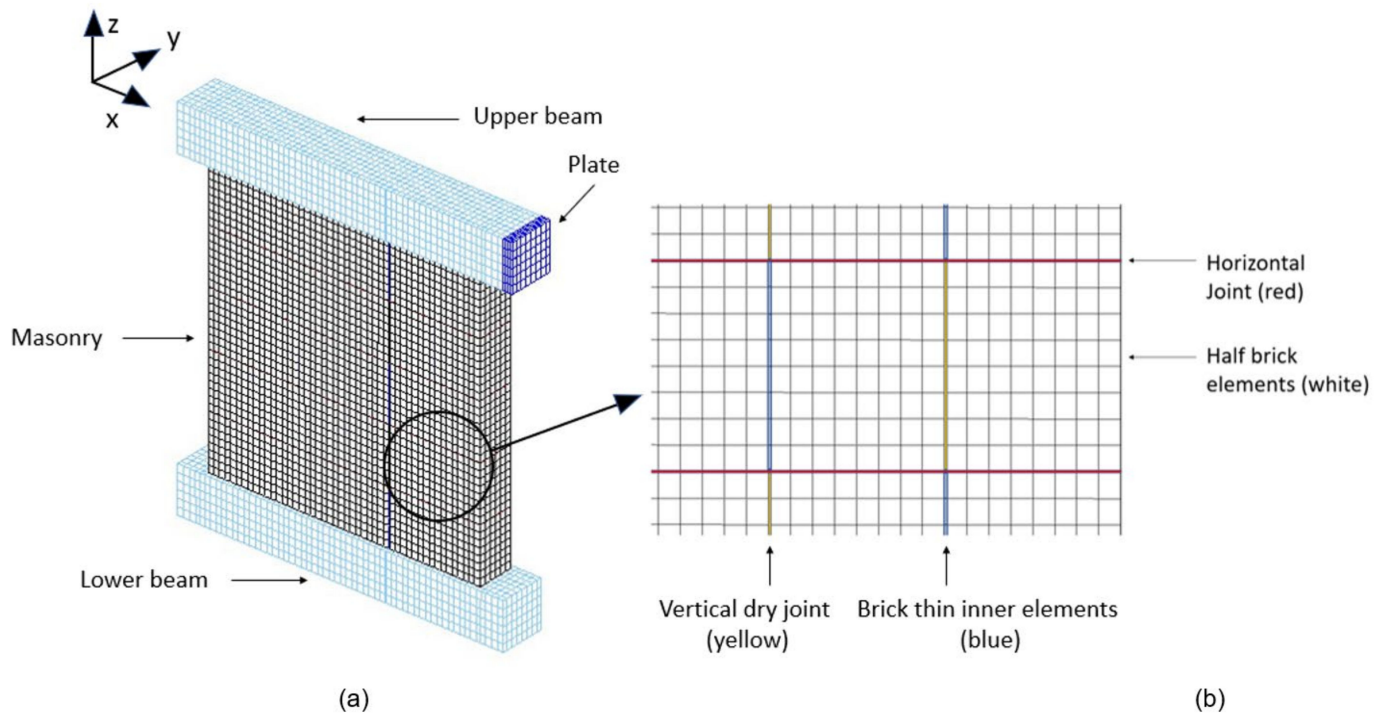
Figure 7. Numerical configuration for the URM wall (a) and front view of the masonry mesh (b). This figure was published in *Computers and Structures*, Vol 254, Jean-Patrick Plassiard, Ibrahim Alachek, Olivier Plé, Damage-based finite-element modelling of in-plane loaded masonry walls repaired with FRCM, Page, Copyright Elsevier (2021) [30].

All materials of the masonry units and of the coatings were modelled with the previously described constitutive law, except to the thin inner elements of the masonry. Furthermore, Hooke's law was considered in order to avoid the premature cracks of those elements and the resulting unrepresentative failure of the masonry [30]. The Young's modulus and the Poisson's ratio of the other brick elements were also assigned for the thin elements. The concrete beam and the steel plates were modelled as linearly elastic, with Young's moduli equal to 30 GPa and 210 GPa, respectively, and the same Poisson's ratio of 0.2. The global presentation of the mesh for the URM wall is depicted in Figure 7, along with a detailed view of the masonry units. The model of the ISO-coated wall is presented in Figure 8. For both ISO and MGF walls, each coating was represented with four elements of thickness. For the thicknesses of the ISO and the MGF coatings, each element layer had a thickness of 1 cm and 0.25 cm, respectively. These elements were contiguous with those of the masonry on each side of the wall. In accordance with the experiments, a spacing of one element was left without a coating element at the bottom and the top of the masonry to avoid any contact between the coating and the concrete beams. Even though the interface characteristics between the coating and the masonry could be defined, as in [23], it was assumed that each coating type could be represented as a single material. Indeed, no debonding areas between the masonry and the coatings were noticed following the experiments. Therefore, perfect adhesion was assumed, as for previous models of FRP and TRM strips on masonry and of beams units [31–34]. Finally, the model shown in Figure 7 [30] was represented with 20,868 finite elements, while the model of the coated wall involved 41,932 elements (Figure 8).

The pushover tests were simulated in accordance with the experiments. The bottom surface of the lower beam was fixed in the three directions. In order to generate a similar load to that in the experiment, both load and displacement controls were required. During the first phase of loading, a vertical stress was applied progressively on the top surface of the upper beam until the target load of 202 kN was reached. Then, in the second phase, a progressive displacement along the x-axis was imposed on the middle point of the right surface of the plate, while the vertical loading was maintained (Figure 8). Here, corresponding displacement increments of 3×10^{-2} mm were applied at each step, as in a previous study [30].

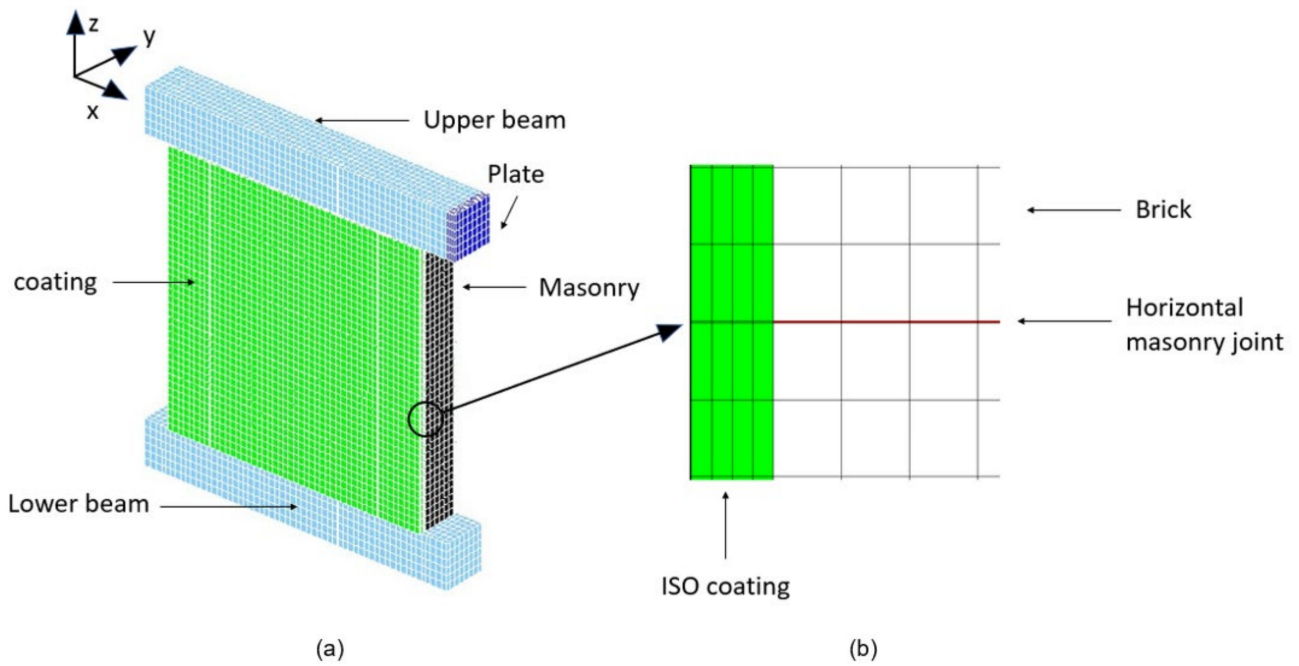
Figure 8. Numerical configuration of the MGF wall (a) and side view of the coating model (b).

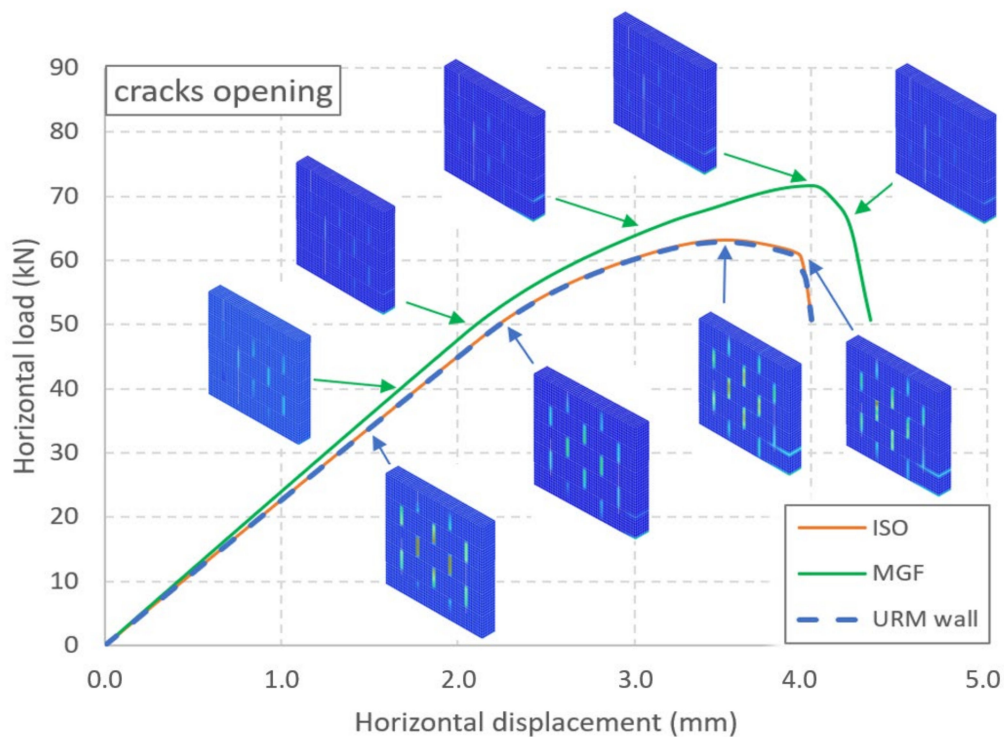
Figure 9. Numerical force vs. displacement curves for the three types of wall and the evolution of the opening of the cracks for the URM and MGF walls.

The force–displacement curves for the three types of wall are presented in Figure 9. For the URM wall, a linear trend up to 50 kN is noticeable (Figure 5). Then, a curve emerges until the maximal strength is reached at a horizontal displacement of 3.52 mm and a horizontal load of 62.8 kN. The strength decreases rapidly after the peak is reached. Thus, the results for the URM wall were similar to the experimental ones. On the other hand, the models of the coated walls failed to reproduce the experiments adequately. The model of the ISO wall exhibited almost the same evolution as the URM wall. A maximal strength of 63.2 kN was reached for a displacement equal to 3.5 mm. This represented a gain of less than 1%, as if the coating had no influence. Moreover, the ductile behaviour was also not reproduced. Similar findings were obtained for the MGF wall. The maximal strength was 71.73 kN, reached at a displacement of 4 mm. Here, the coating had an influence, but this was still less than the maximal value of around 90 kN from the experiments. The strength dropped quickly after the peak, as for the two other wall models. As an intermediate conclusion, we found that two major aspects were not reproduced adequately by the simulations: the maximal strength and the ductility.

The crack patterns and the compression damage in the masonry are presented for several loading levels of the URM and MGF walls in Figures 9 and 10, respectively. Here, we focused on the pattern of these two quantities and not on their value. Up to around 50 kN, cracks were concentrated in the dry vertical joints (Figure 9). Then, a crack developed along the base joint below the right brick of the first row, which could have been linked to the start of the nonlinearity of the curve. For higher values, a second crack even appeared in the joint located between the first and second rows. The crack pattern did not evolve after that, even once the maximal strength was reached. The evolution of the compression damage (Figure 10) indicated that the damage was located in the vertical joints for most of the rising portion of the curve. Then, for both types of walls, a staircase pattern developed just before the maximal strength was reached. Finally, the strength decreased with the crushing of the corner brick. Cracking of joints propagated across the major part of the masonry, but this can be linked to the instability caused by the crushing of the brick. As a conclusion, we found that the pattern evolution of the damage under compression seemed to be a valuable index for the estimation of the state of masonry walls subject to staircase failure.

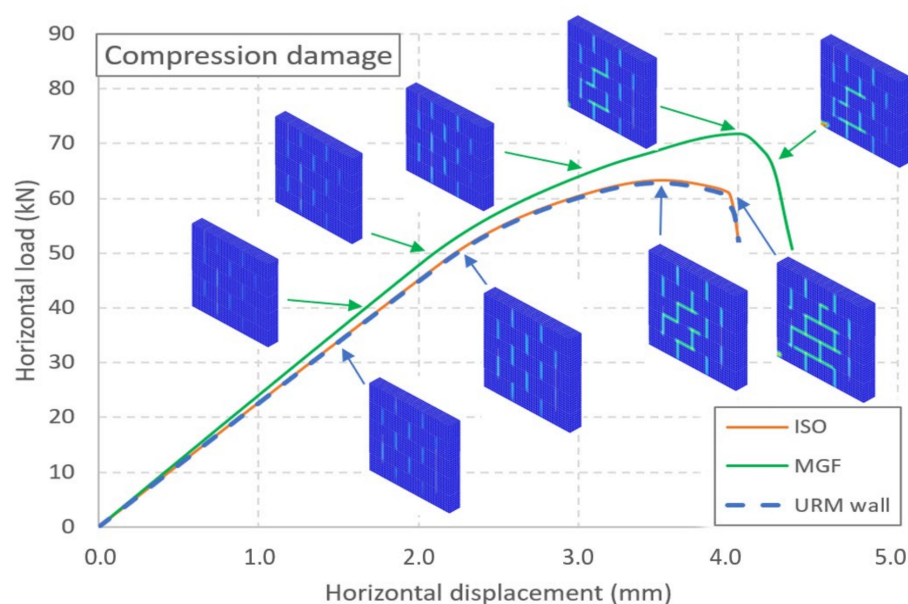
Figure 10. Numerical force vs. displacement curves for the three types of wall and the evolution of the damage under compression for the URM and MGF walls.

Let us consider the pattern of damage under compression (Figure 14). As already shown in Figure 10, this can be an interesting index of staircase failure in masonry walls. A cross-comparison was undertaken for the type of vertical loading (UVL vs. ISL) and the type of reinforcement (MFG vs. TRM) and for both the maximal strength and the maximal displacement states. Damage under compression at the peak was quite independent of the loading mode for both the MGF and the TRM reinforcement. The difference between the two loading modes at the maximal displacement was also not significant for either of the

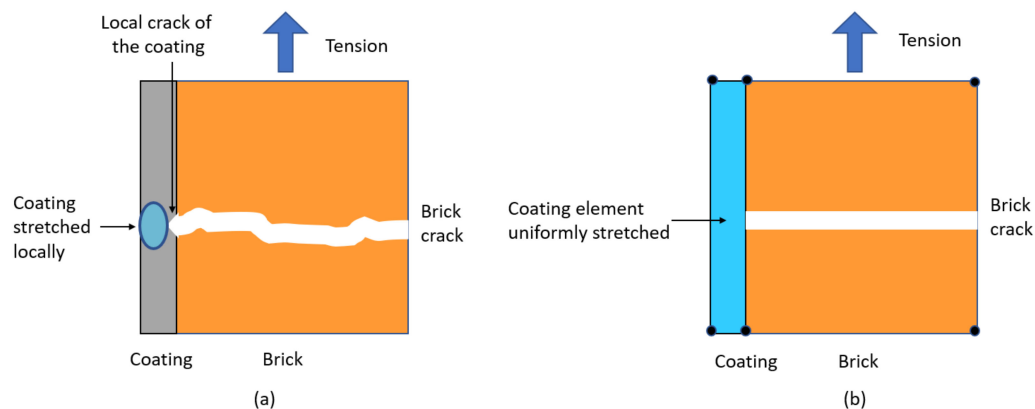
Figure 11. Comparison of the coating behaviour close to a crack in the experiment (a) and in the simulation (b).

The abovementioned findings highlighted that the reinforcement effects of both types of coating were difficult to model numerically. One reason could lie in the difference between the local stretching of the coating close to the crack that occurred during the experiment and the smoother elongation of the whole coating element in the simulation (Figure 11). The perfect adhesion [31–34] or the mesh densification of the retrofitting material [35,36] may not be totally sufficient to model its experimental contribution.

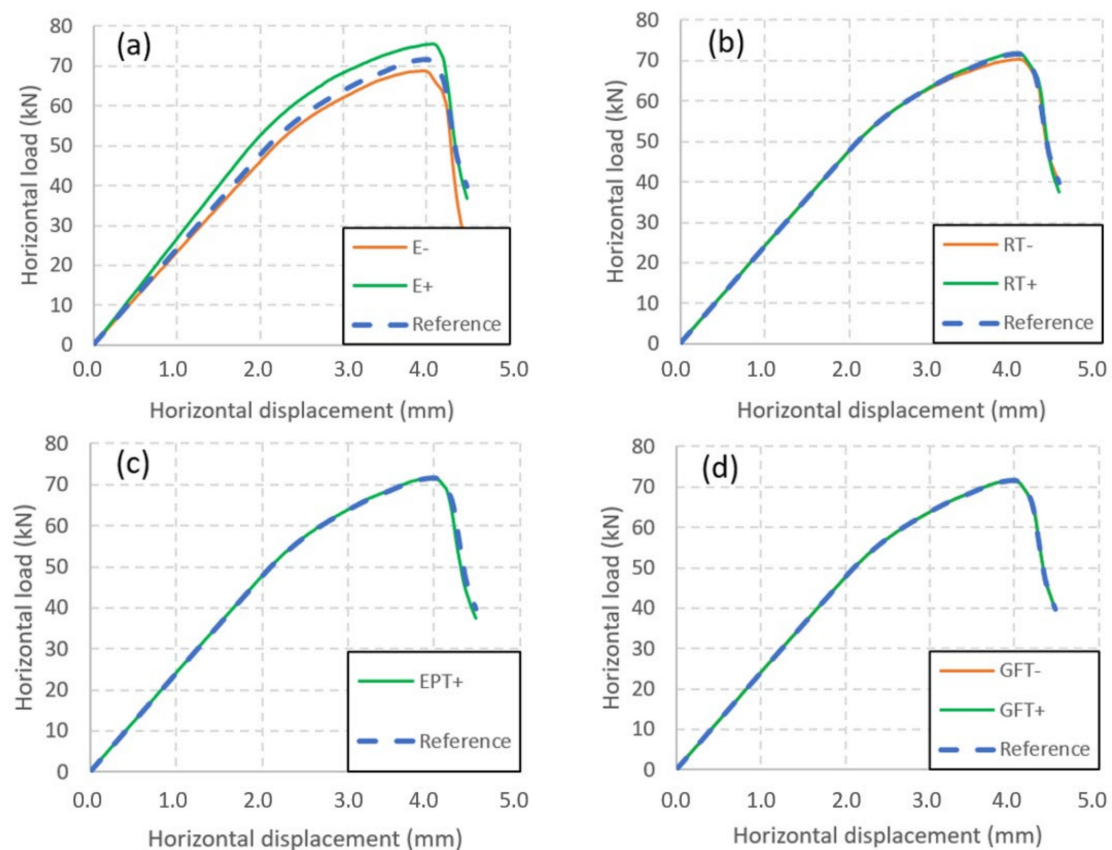
Figure 12. Influence of the coating parameters on the force–displacement curve of the masonry shear wall: (a) Young’s modulus; (b) tensile strength; (c) peak tensile strain; (d) fracture energy under tension.

Figure 12 and Table 5 summarize the results of the sensitivity study. The results show that the most sensitive parameter was the Young's modulus, as has already been noticed [30]. Thus, the correct estimation of this parameter is of the utmost importance for the estimation of the bearing capacity of a coated wall. The influence of the tensile strength was also significant, but the gain offered by the amplified value was marginal. This aspect could be associated with the influence of the fracture energy under tension, which was almost null. This was also confirmed by another simulation in which a very high tensile strength was used, without generating any improvement in the bearing capacity. As a consequence, an improvement of the modelling approach is required to capture the effect of the coating correctly. This aspect should be considered when reinforcing materials that exhibit great deformability compared to the support they reinforce.

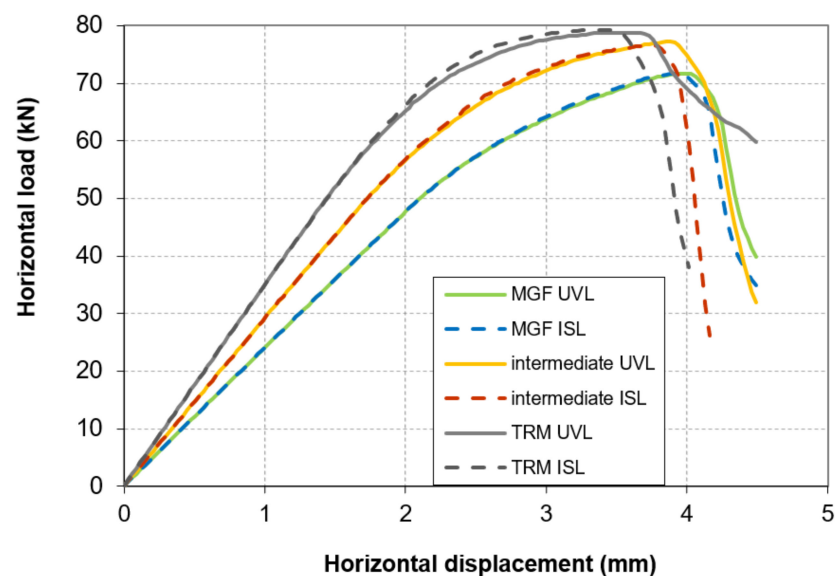
Figure 13. Influence of the in-situ stress: force vs. displacement curves for the tested loading configurations.

Table 6 indicates the vertical stress σ_{V_m} transmitted to the masonry after the application of the vertical loading. The variation for the three ISL configurations was marginal and can be explained by the low but not null value of the hydration coefficient used for the coating during the vertical loading phase. On the other hand, this vertical stress σ_{V_m} dropped by 36% in the MGF UVL configuration compared to the TRM UVL one. As a consequence, a significant part of the vertical loading was transferred by the reinforcement in this last case, and thus the failure mode could be modified [40]. From Table 6, it can be deduced that the effect of the vertical loading mode on the maximal strength was less than 1% (Figure 13). The post-peak behaviour was rather more dependent on the vertical loading configuration. It was even more significant for the TRM case. In the three cases tested, the strength dropped faster after the peak for the ISL mode than for the UVL loading mode.

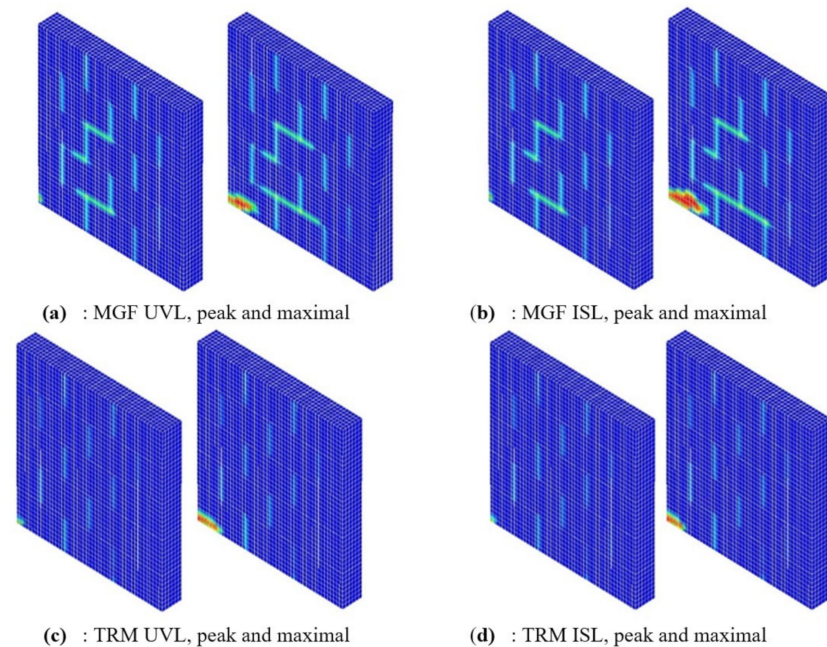
Figure 14. Compressive damage at peak and maximal displacement for the (a) MGF UVL, (b) MGF ISL, (c) TRM UVL, and (d) TRM ISL configurations.

materials presented. As a conclusion, we found that, even if the results were quite similar in term of strength and failure patterns, the limitations of the modelling approach seemed to annihilate the effect of the effective vertical stress applied to the masonry. Further investigations are required to establish the possible effect of the mode of vertical loading.
