Landscape coevolution of human-geomorphic system in northern Kyûshû (Japan) induced by the July 2017 heavy rainfall

Vincent Siccard, Mélody Dumont, Candide Lissak, Christopher Gomez, Gilles Arnaud-Fassetta. Landscape coevolution of human-geomorphic system in northern Kyûshû (Japan) induced by the July 2017 heavy rainfall. European Geosciences Union, Apr 2025, Vienna, Austria. <10.5194/egusphere-egu25-12564>. <hal-05056558>

EGU25-12564: Landscape coevolution of human-geomorphic system in northern Kyûshû (Japan) induced by the July 2017 heavy rainfall

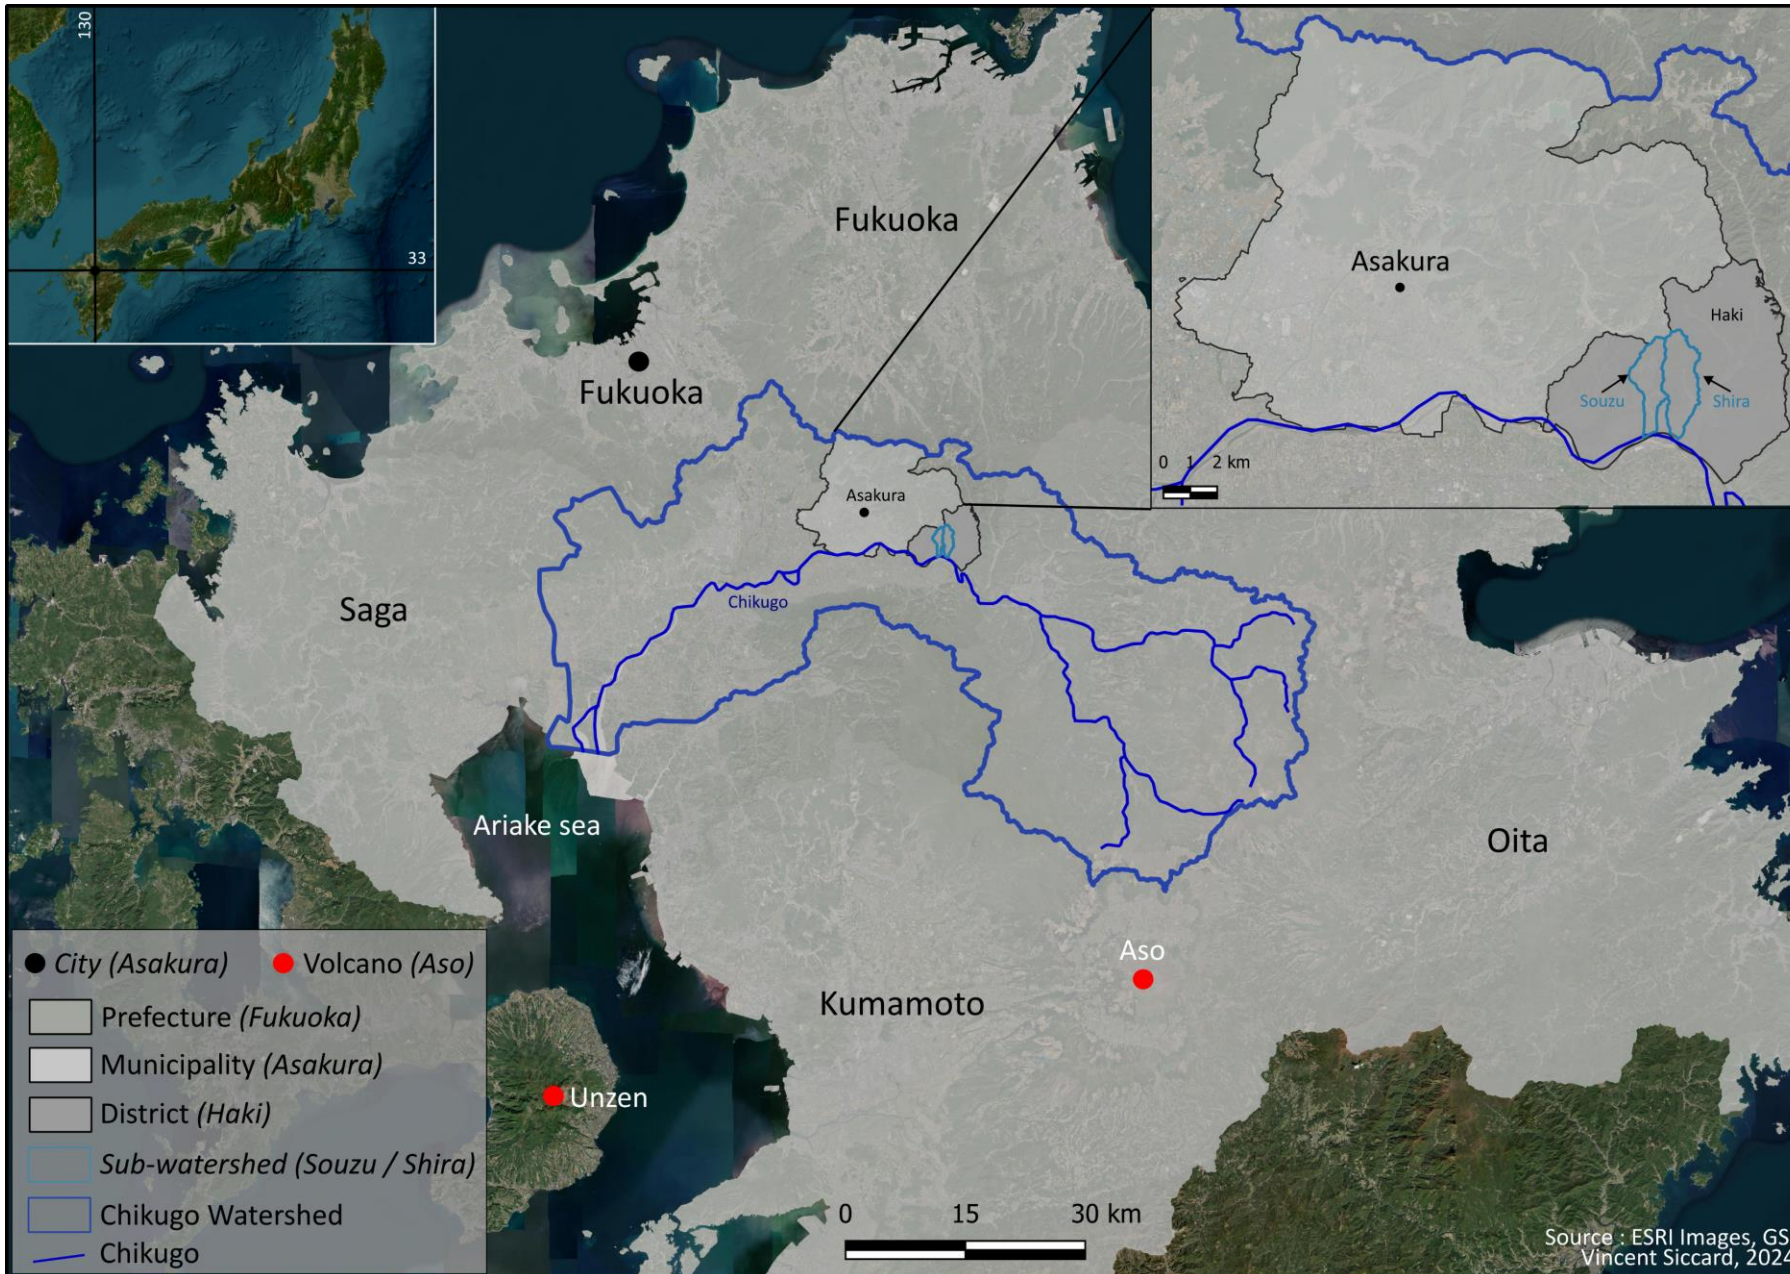
Location :

- Northern Kyûshû (South Japan)
- Municipality of Asakura
- Chikugo watershed
- Souzu and Shira subcatchments

- Low mountain area
- Small size watershed (< 4 km²)

- **Sangu-Suo Metamorphic rocks (schist)**
 - Souzu = 56%
 - Shira = 13%
- **Granodiorite**
 - Souzu = 27%
 - Shira = 65%

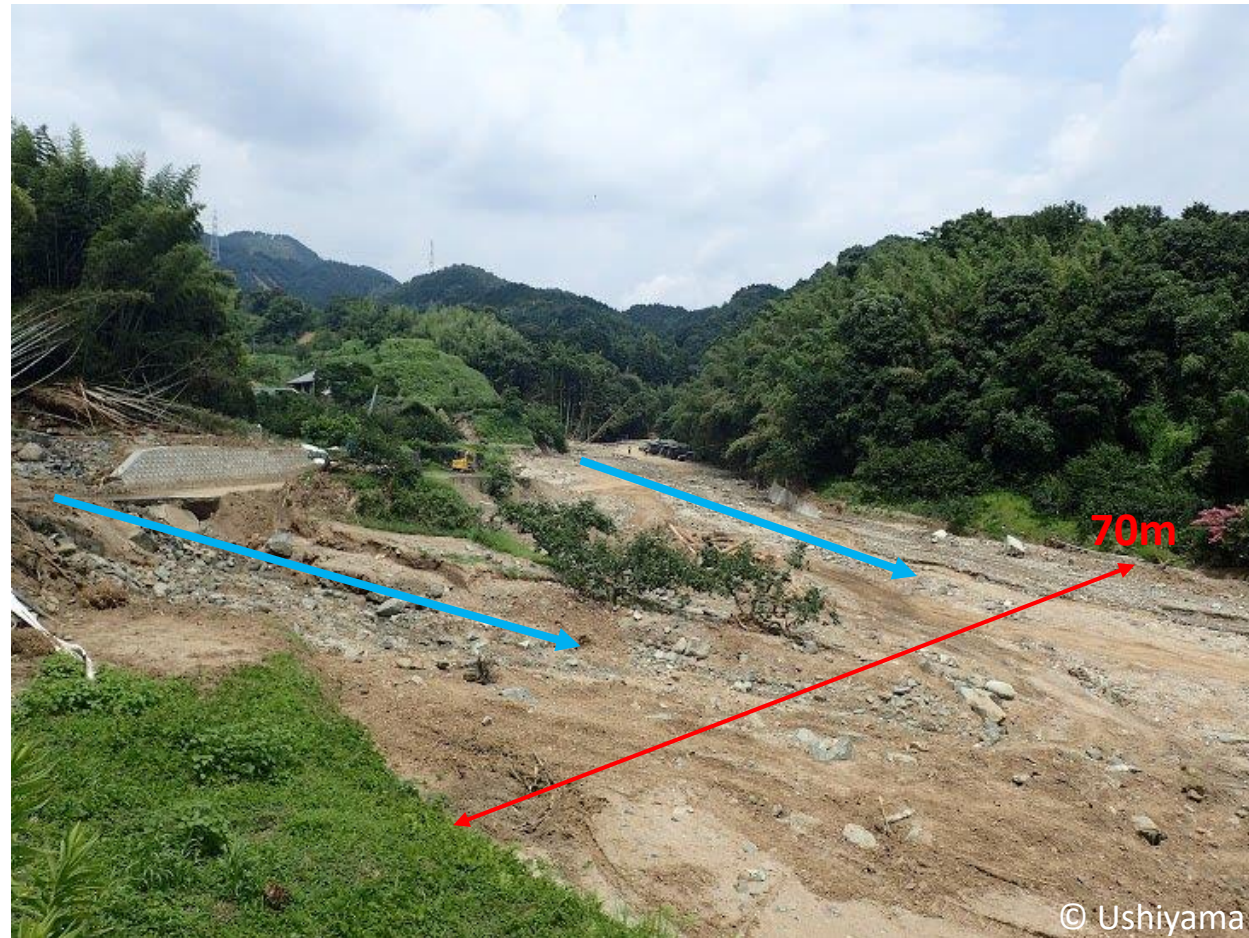
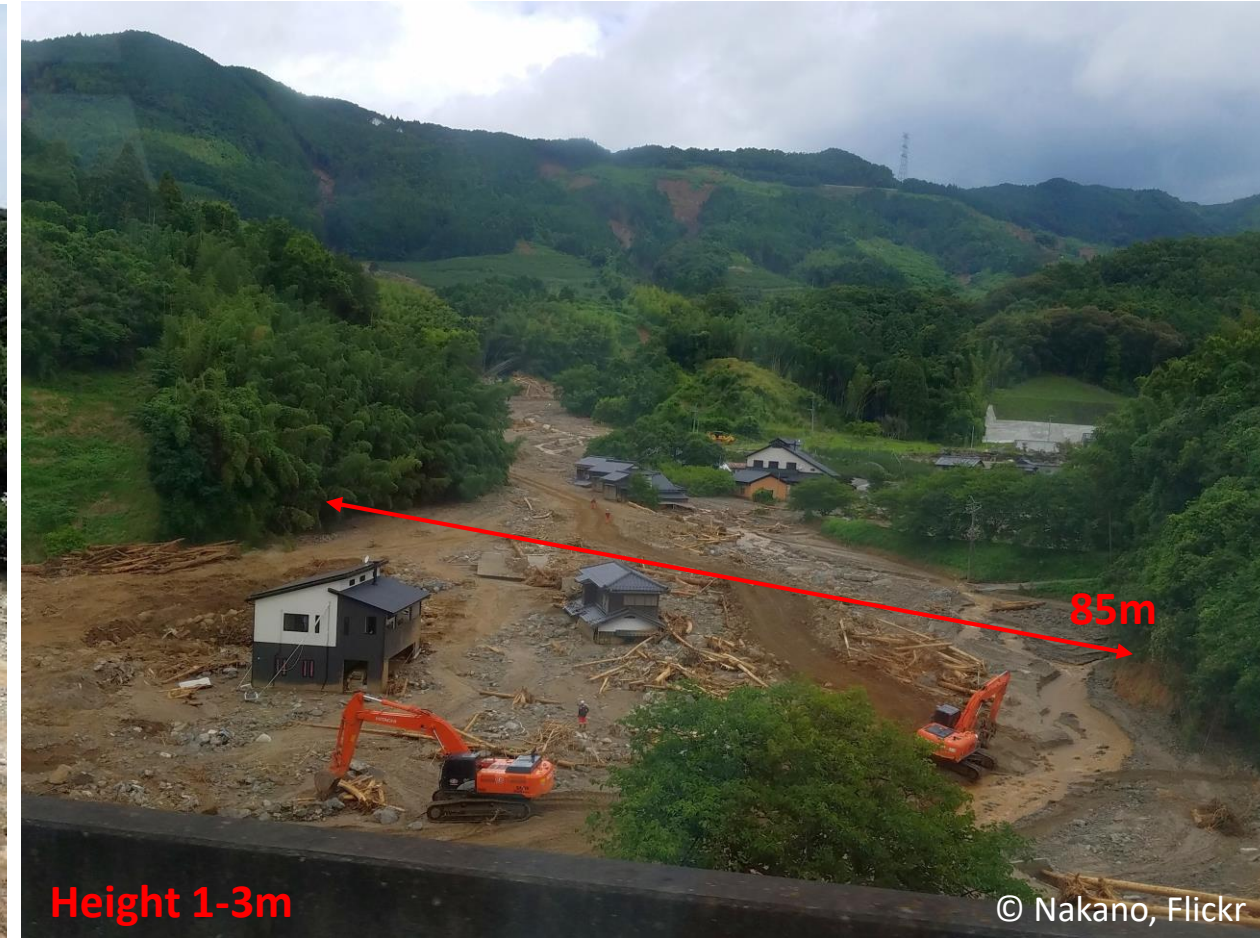
2.3) High sediment fluxes generated by concomitant heavy rainfall and sediment production

Souzu watershed: sediment fluxes have reinforced flooding by clogging the channelized river

- **Lower valley pre-2017:** inhabited places and agricultural production
- **Lower valley post-2017:** sediment filling over 1-3m; destroyed houses

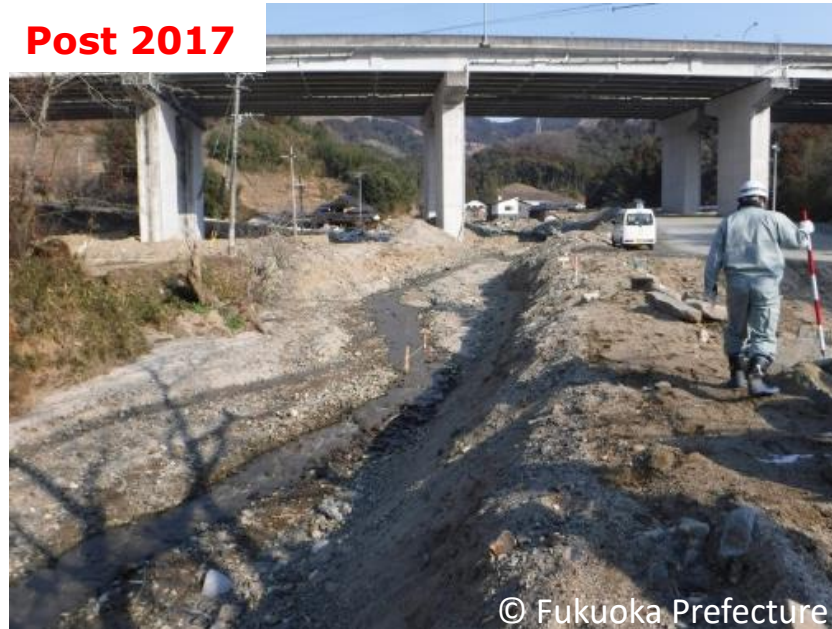
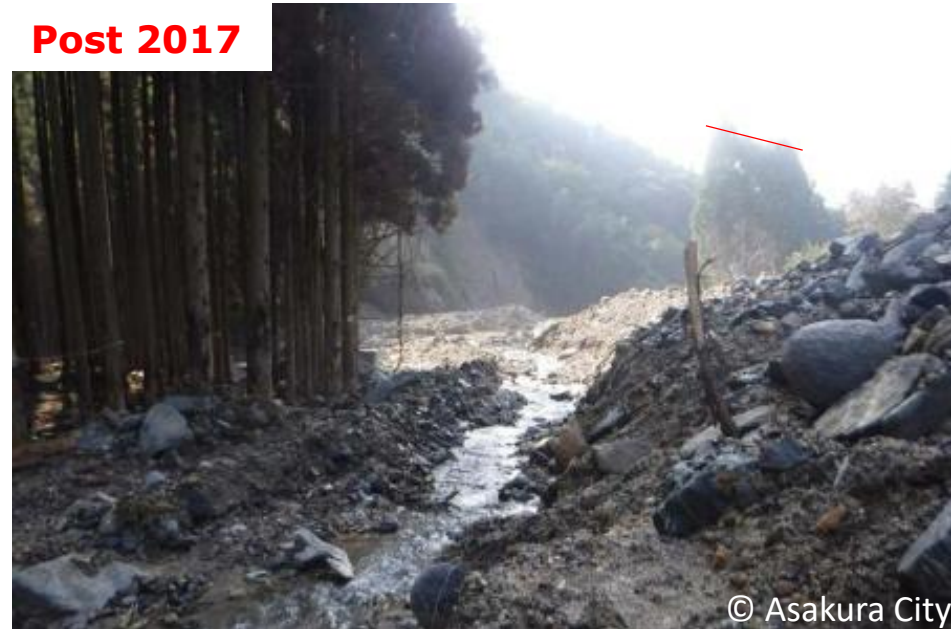
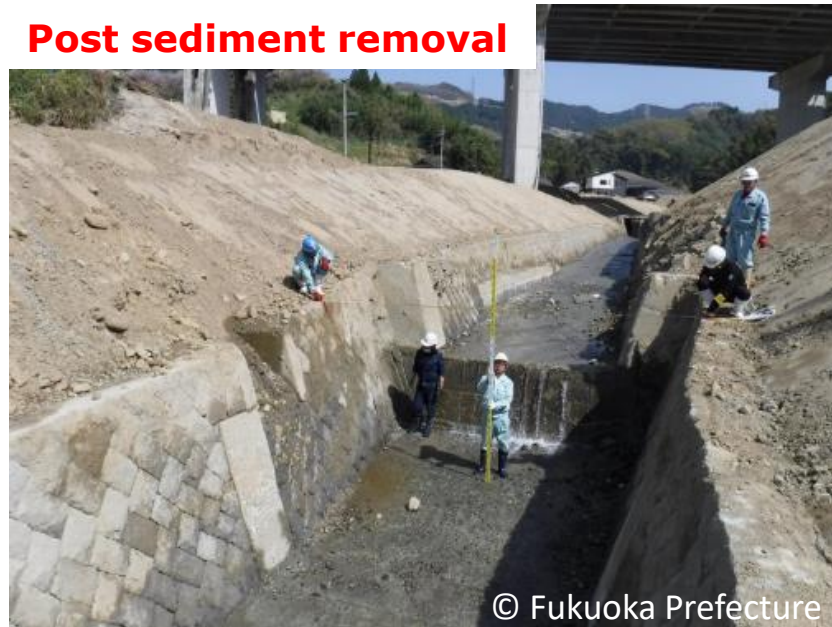
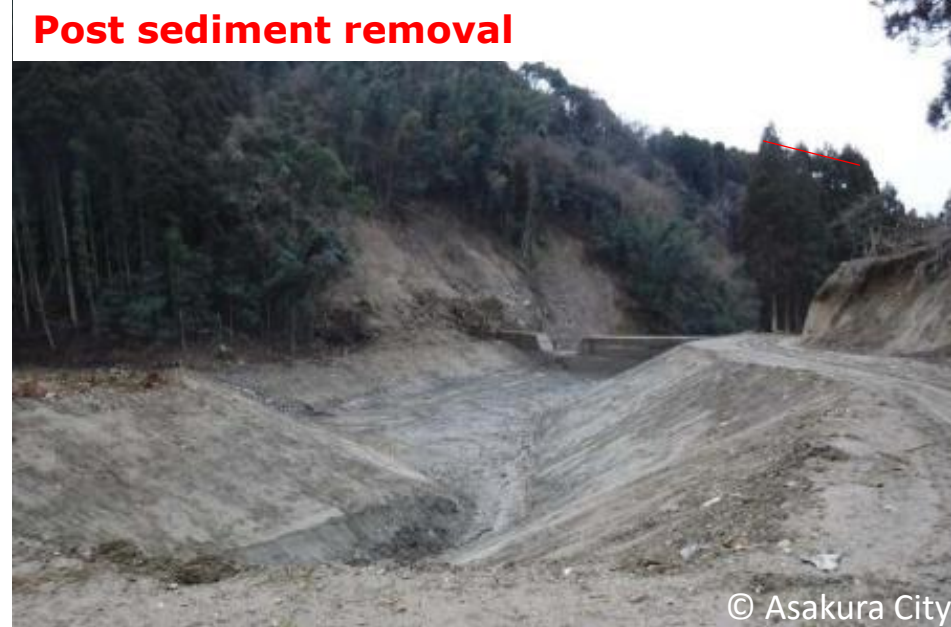
3.1) Removal of sediment deposits in valley floors: exemple of Souzu watershed

Post 2017

Post sediment removal

⇒ removal of hundreds of thousands of m³ of sediment deposits

⇒ Partially reused in reconstruction work

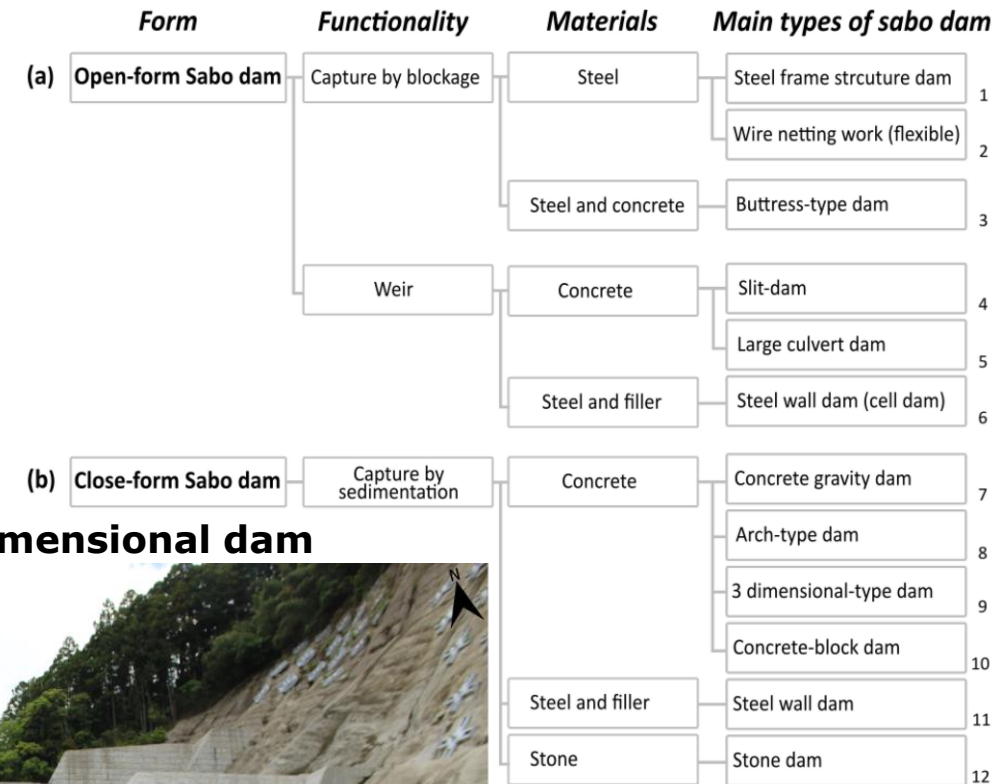
Classification of Sabo dams according to the MLIT (Dumont et al., 2023)

- **Sabo system:** when designed by the Japanese Ministry of Land Infrastructure and Transport (MLIT)
 - **Check dam system:** for similar objects not built by MLIT
- ⇒ **System of structural countermeasures** to mitigate sediment production from hillslopes to transport in rivers
- ⇒ **Modification of the sediment cascade**, the structural and process-based connectivity

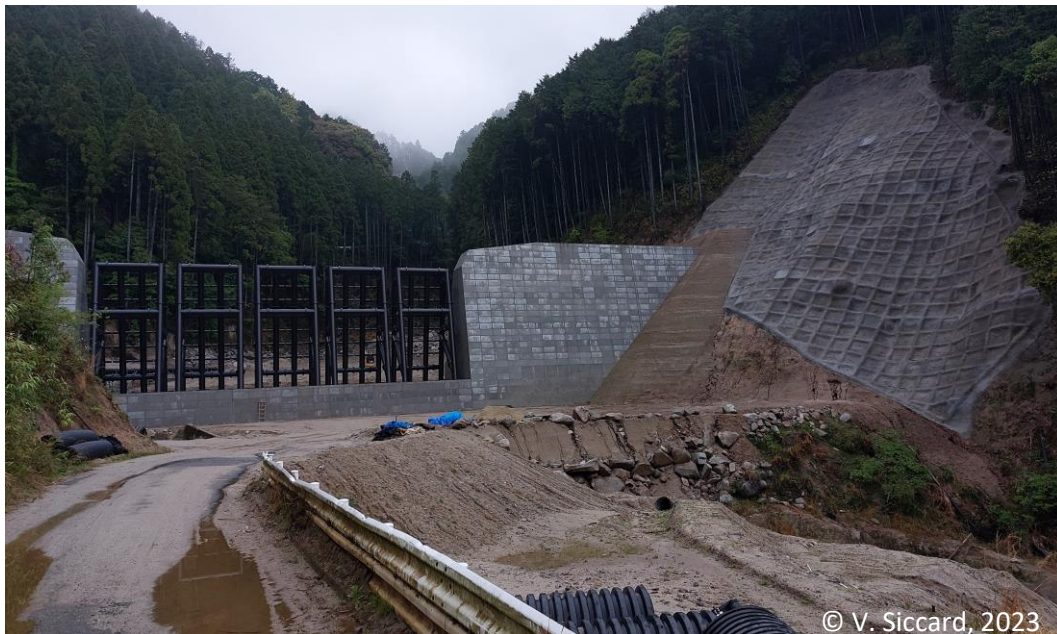
Open check dam: steel frame structure dam

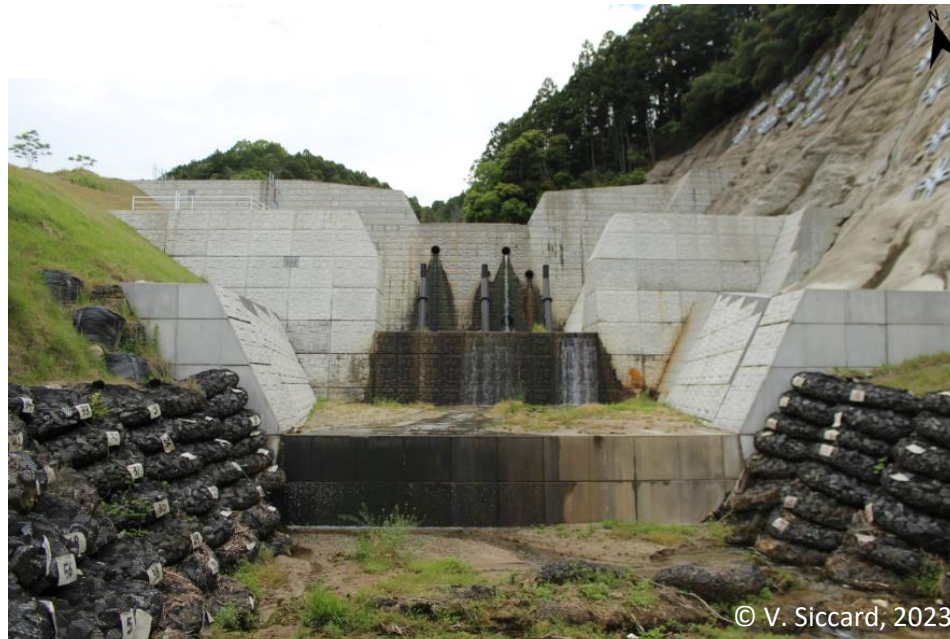
Close check dam: 3 dimensional dam

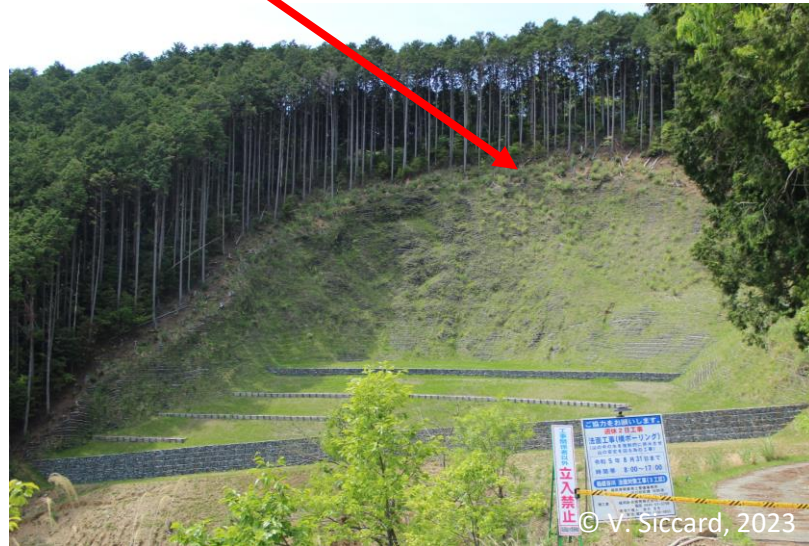
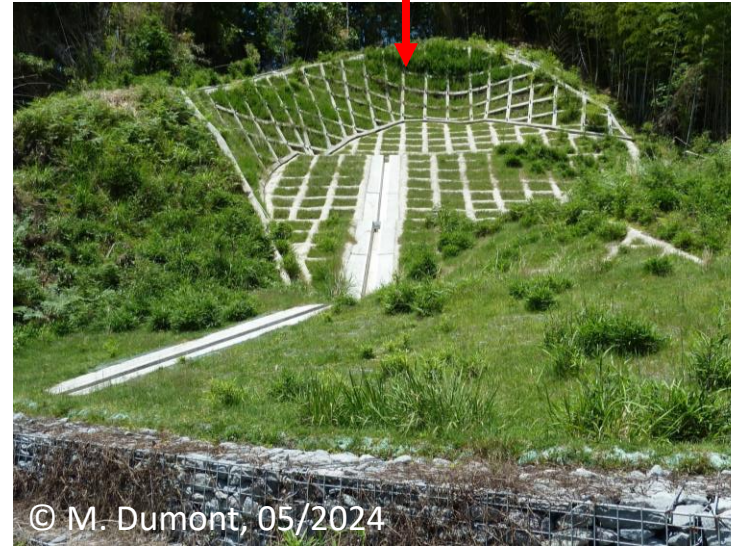
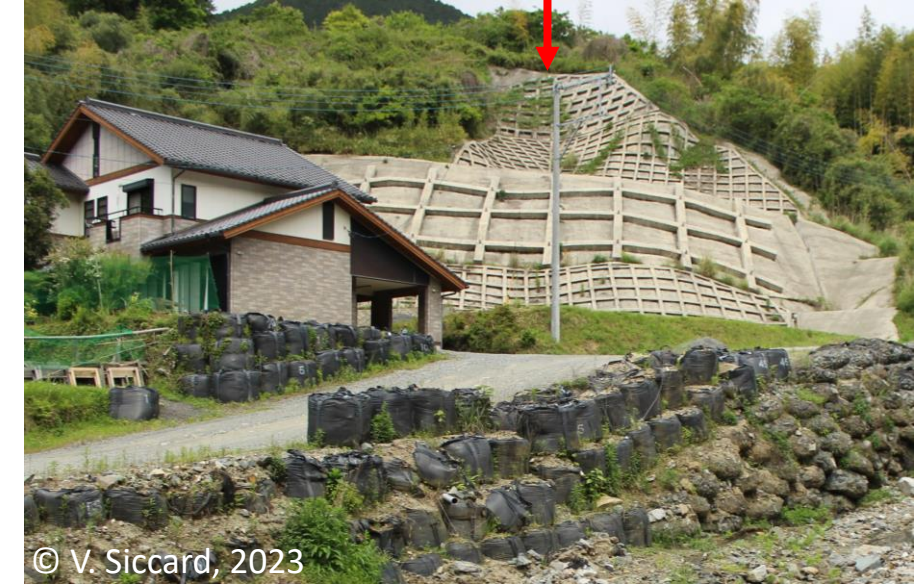
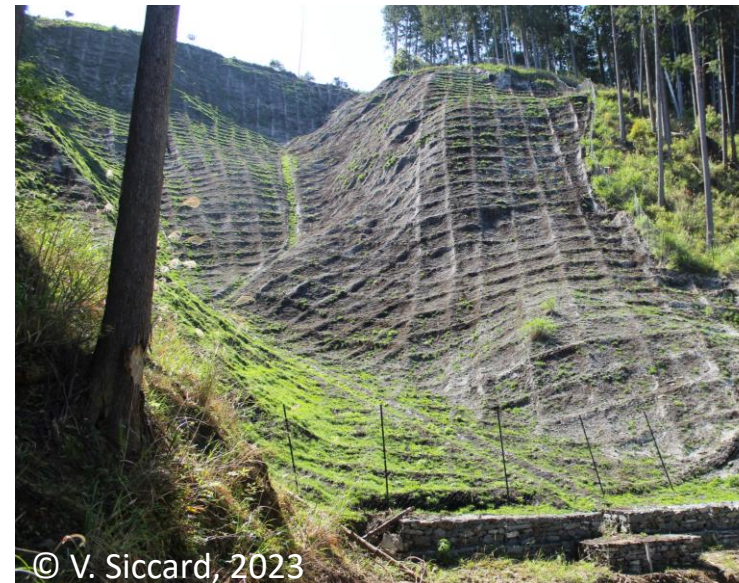
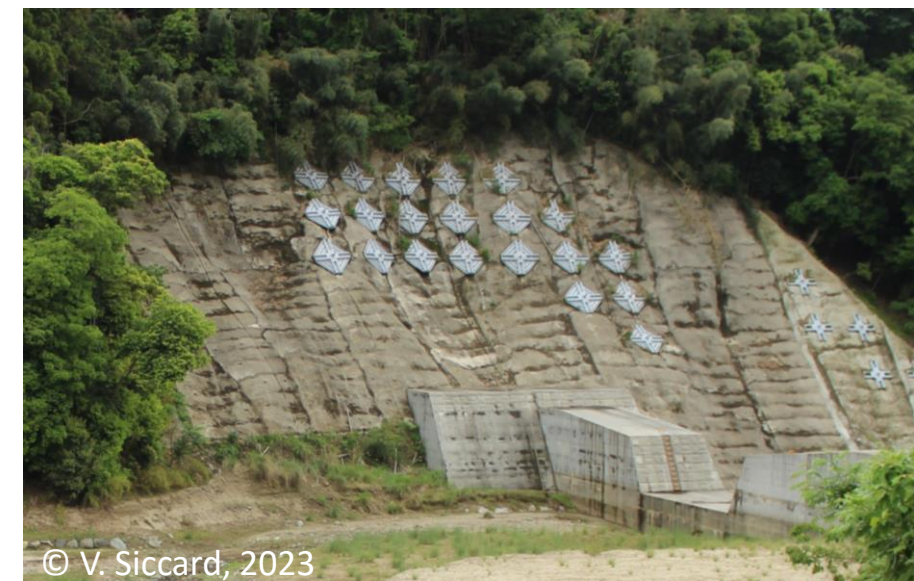
3.2.2) High responsiveness and intervention post-event through engineering: slope works

Soft engineering

Medium engineering

Hard engineering

A wide range of slope works from soft to hard engineering:

- Vegetation and Biological Soil Crust (BSC)
- Geotextile and Tarpaulin
- Terrace and gabion work
- Wire mesh
- Shortcrete grid beam
- Concrete cover
- Concrete cover with anchor and soil nailing

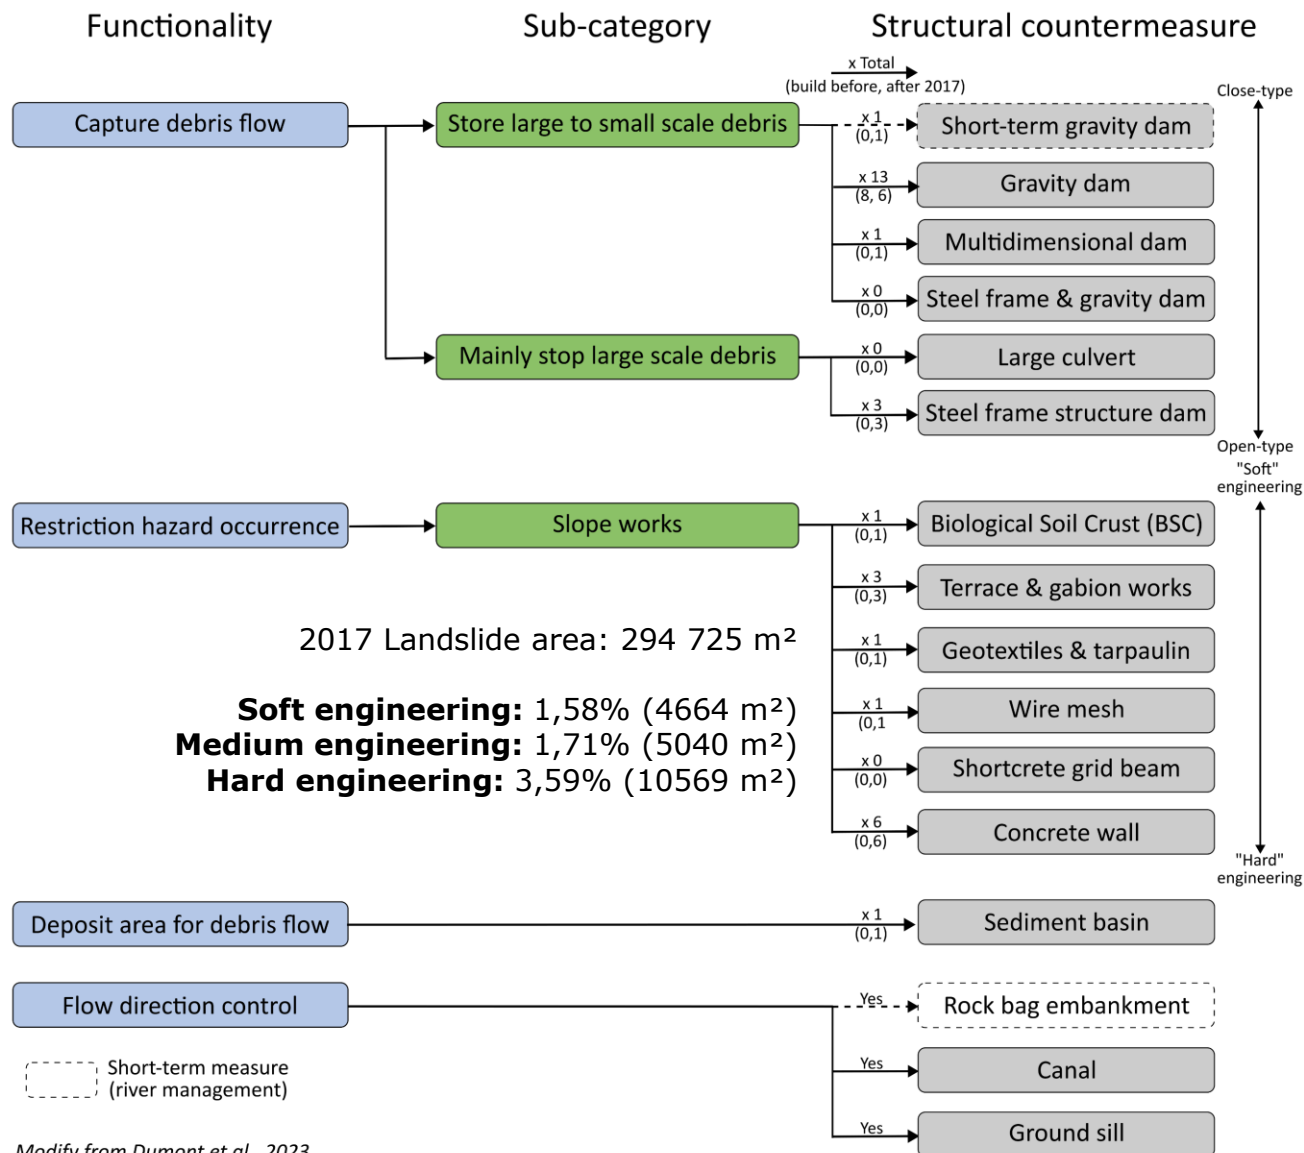
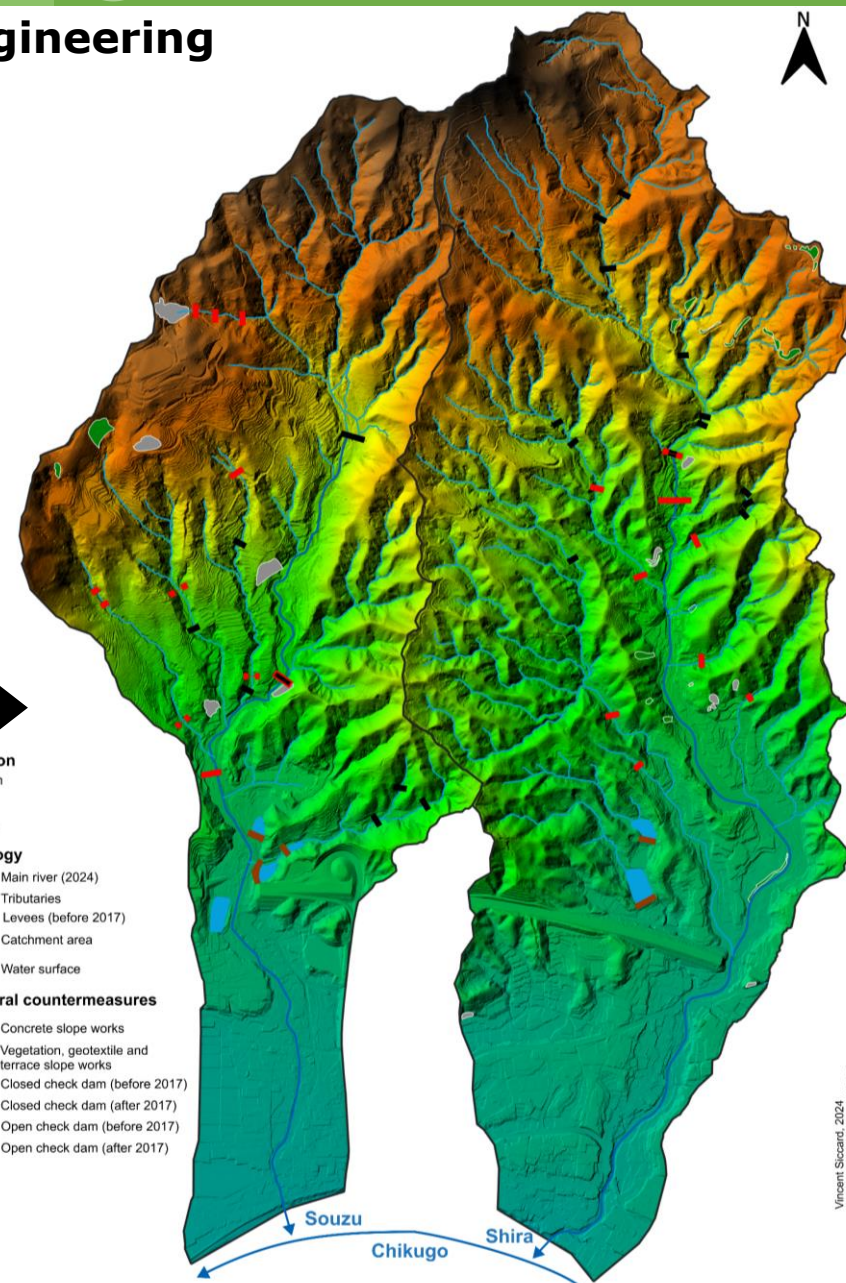
Check dam system in Souzu watershed: 11 dams built after 2017 (8 before 2017)

Slope works: mainly hard engineering

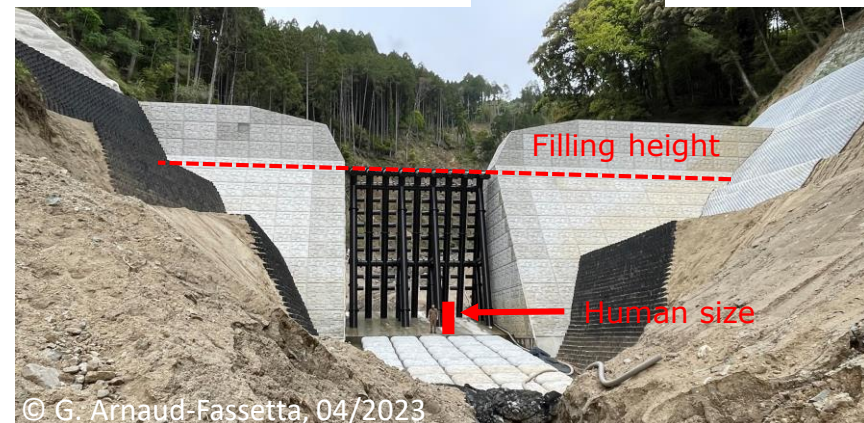
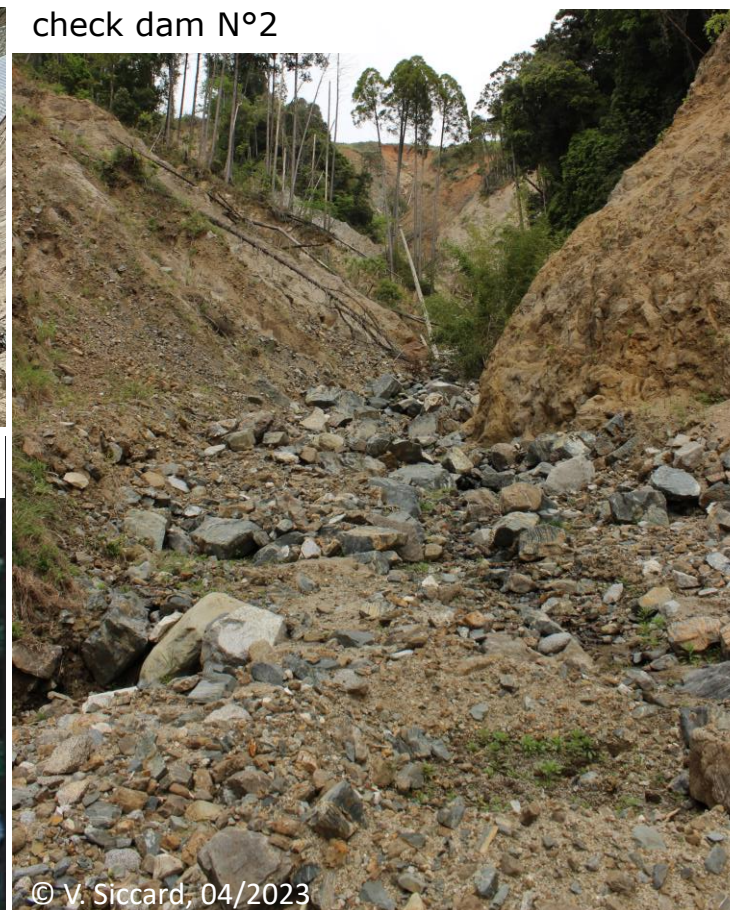
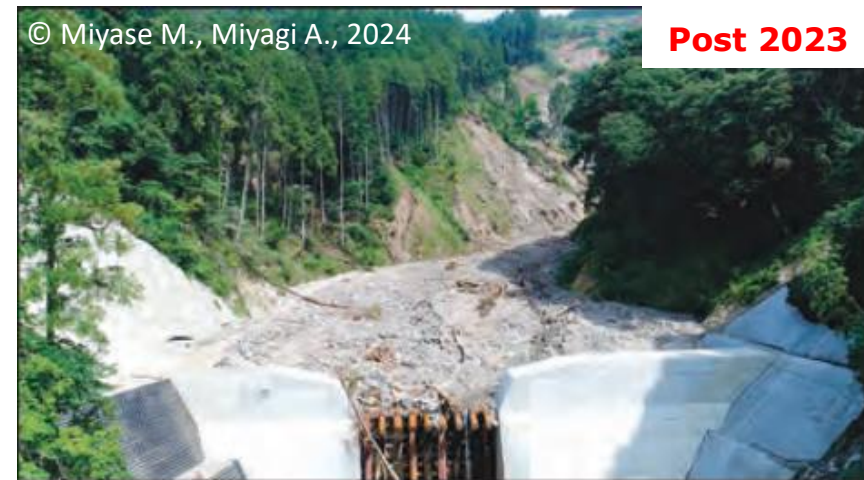
Funasoko check dam N°2 => $\approx 20\,000\text{ m}^3$ of $59\,000\text{ m}^3$ (upstream erosion)

Efficiency of the sediment capture countermeasures but higher sediment fluxes production => Dam maintenance is crucial for maximum efficiency

Funasoko subcatchment
 Erosion: $\approx 90\,400\text{ m}^3$
 (59 000 m³ from landslide area (A))
 Sediment storage: $\approx 25\,400\text{ m}^3$
 ($\approx 20\,000\text{ m}^3$ => N°2 check dam)
 Sediment discharge: $\approx 65\,000\text{ m}^3$
 (Honma et al., 2024)
 Funasoko check dam N°2
