# ATOM PROBE MICROANALYSIS OF WELD METAL IN A SUBMERGED ARC WELDED CHROMIUM-MOLYBDENUM STEEL

B. Josefsson, A. Kvist, H. André

## ATOM PROBE MICROANALYSIS OF WELD METAL IN A SUBMERGED ARC WELDED CHROMIUM-MOLYBDENUM STEEL

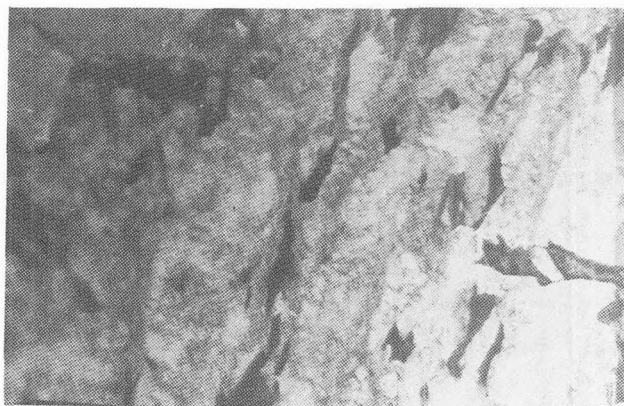
**Fig. 3.** Bright field TEM image of the as-welded material. The dark areas with sharp contours are martensite and the rest is ferrite.

**Microstructure.** Optical microscopy combined with TEM showed that the microstructure, in both cases, could be described as bainitic. A bright field TEM image of the as-welded material is shown in Fig. 3. The dark areas with sharp contours are martensite and the rest is ferrite. (The dark contrast is probably due to a greater thickness of the martensite areas because of a somewhat lower electropolishing rate.) The size of the ferrite grains was ~ 10 µm and the dislocation density was very high. An atom probe mass spectrum recorded in the ferrite is shown in Fig. 4, and the corresponding composition is given in Table II. A very low concentration of carbon, 0.005±0.003 wt%, was present in the ferrite.
