Fatigue mechanisms in Al-based metallizations in power MOSFETs

THÈSE

DOCTORAT DE L'UNIVERSITÉ DE TOULOUSE

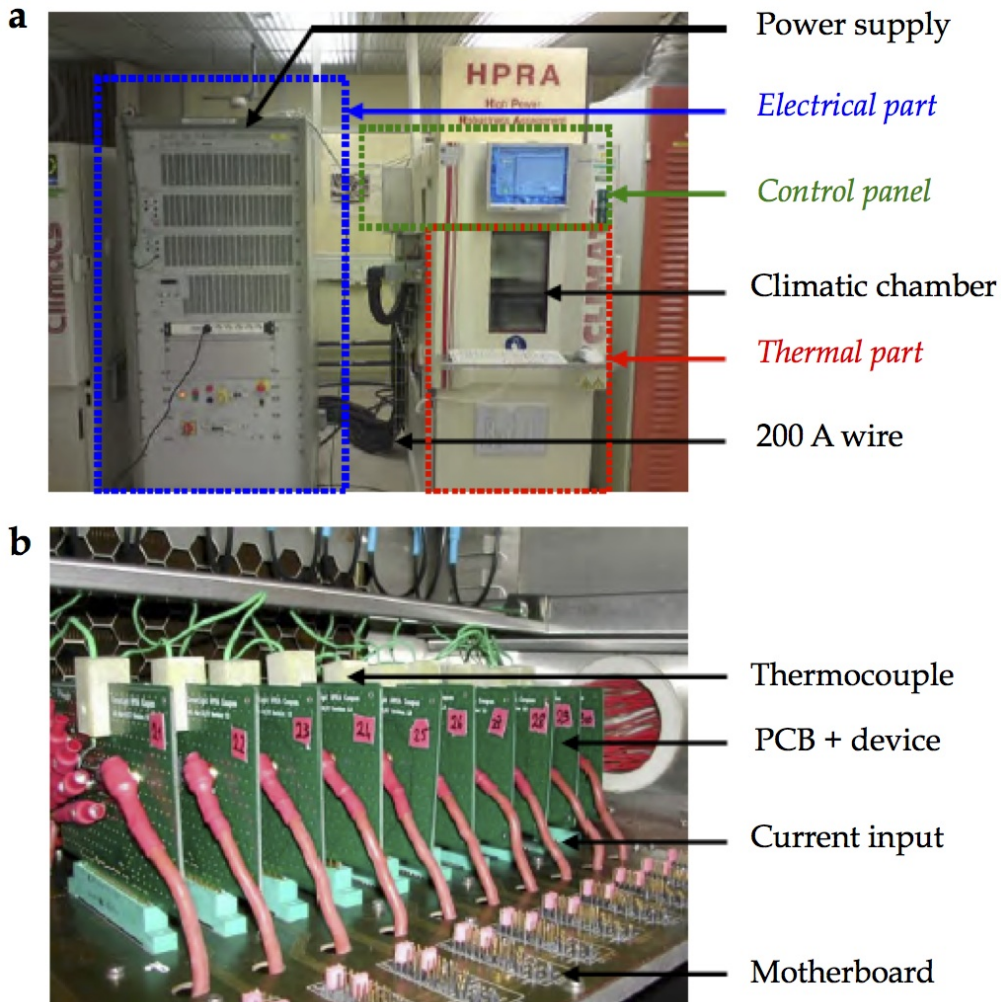
Figure 28: (a) Climats Sapratin Excal 2223-TE test bench at NXP Semiconductors. it consists in an electrical part (in blue), equipped with a 80 V, 200 A power supply and an active charge (5 - 200 A), a climatic chamber (-80°C - 180°C) containing the devices under test (in red), and a control panel (in green) with an electronic board that control the devices switching.

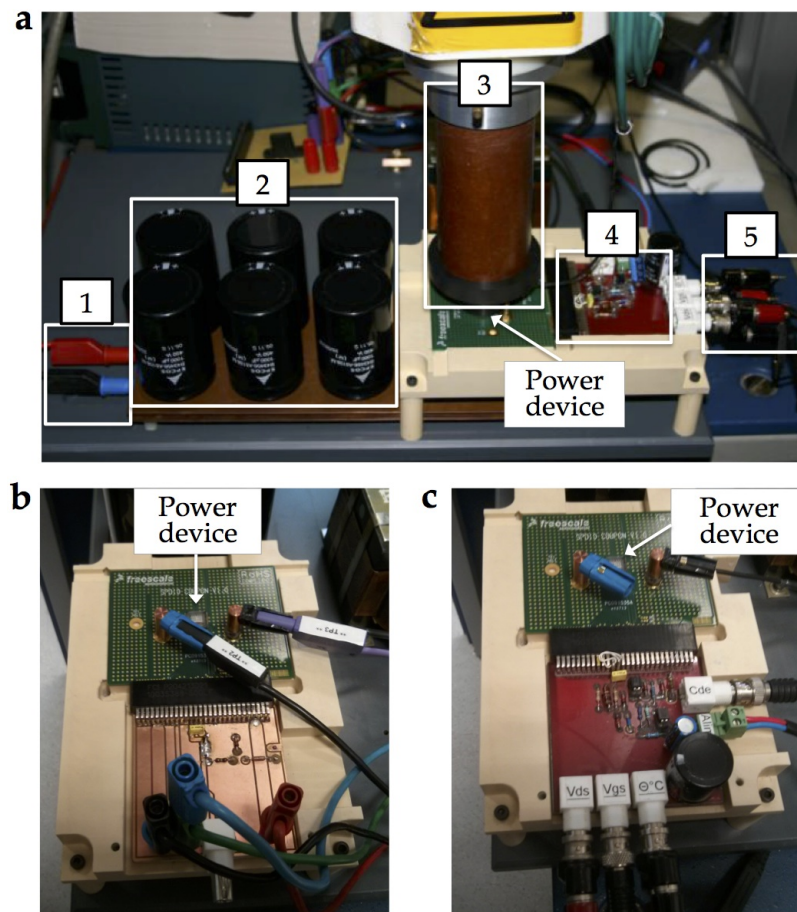
Figure 31: (a) Accelerated aging test bench set up at the Satie laboratory. The device under test can be connected to (b) a measuring board or to (c) the driving board.

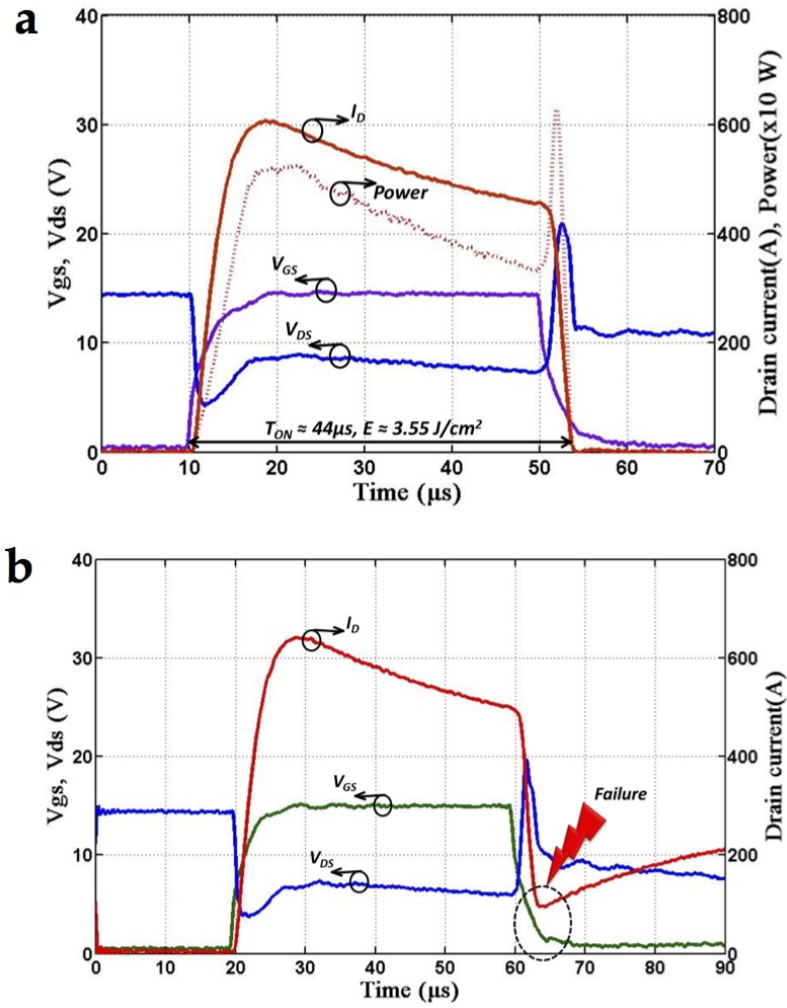
Figure 36: SC characteristics (a) just before failure (after 300 kcycles) and (b) at failure (330 kcycles). $V_{DS} = 15V$, $f = 5Hz$, $T_{ON} = 40\mu s$.

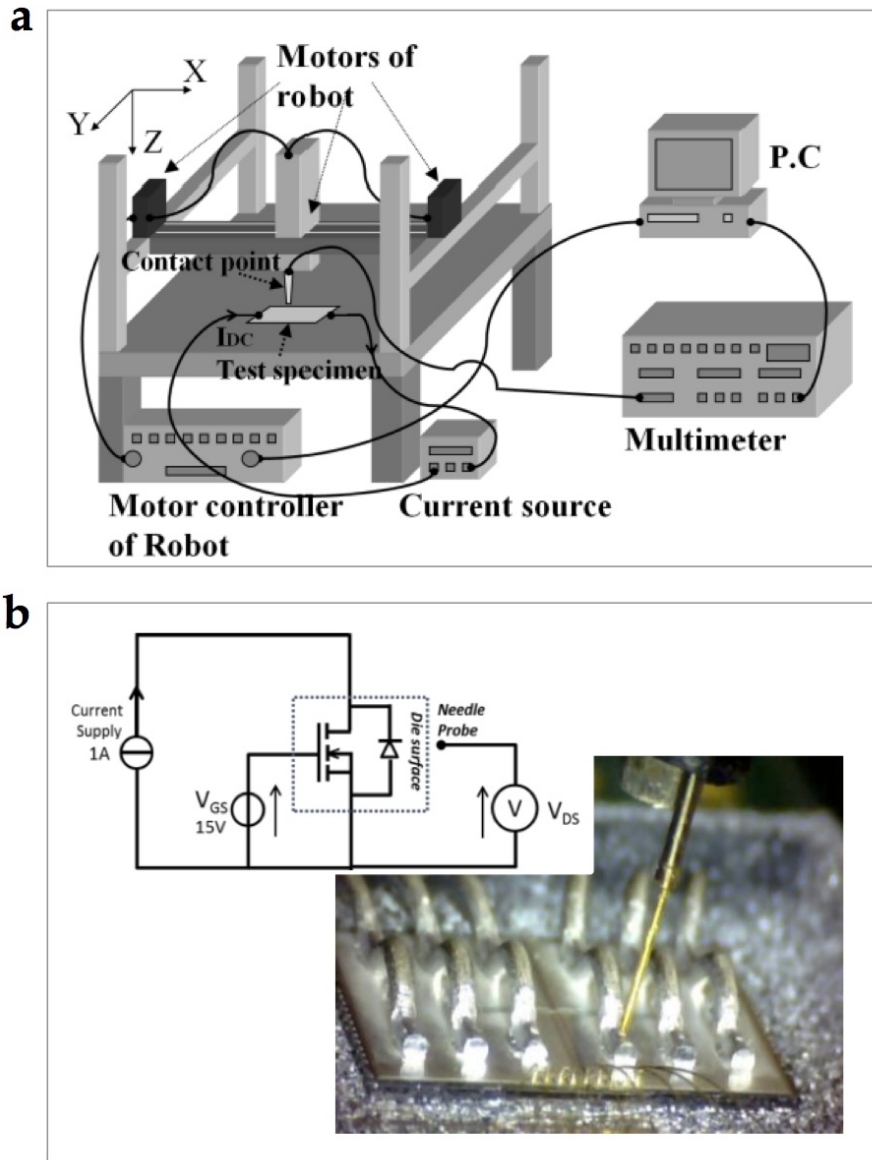
Figure 37: (a) Experimental set-up for source potential mapping of the power die. (b) Spring probe for source potential mapping, $V_{GS} = 15V$, $I_{DS} = 1A$.

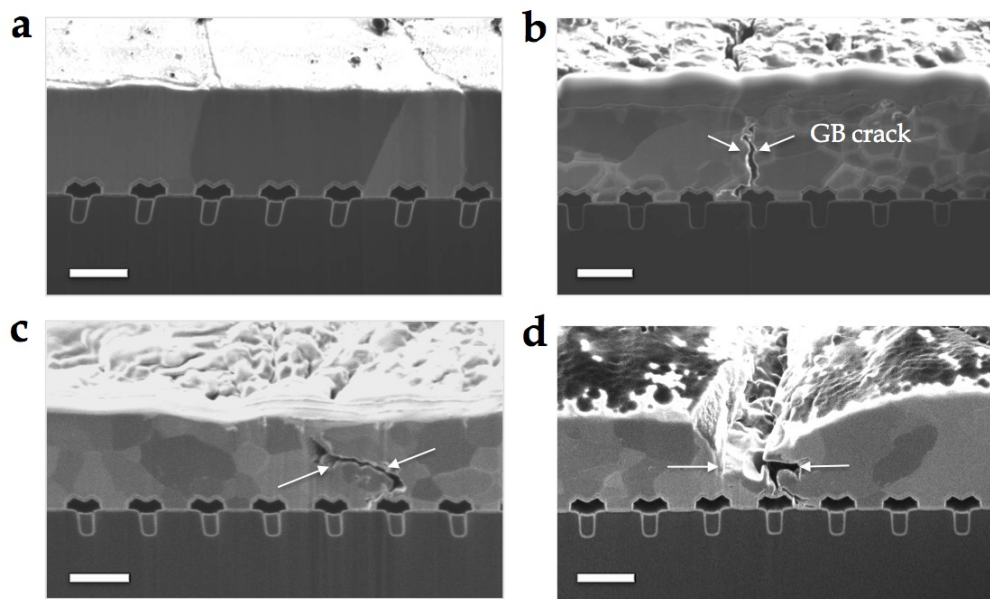
Figure 79: SIM imaging of the Al source metallization of an (a) as-is and (b) 100, (c) 200 and (d) 300 kcycles aged power modules. Scale bar 2 μm .

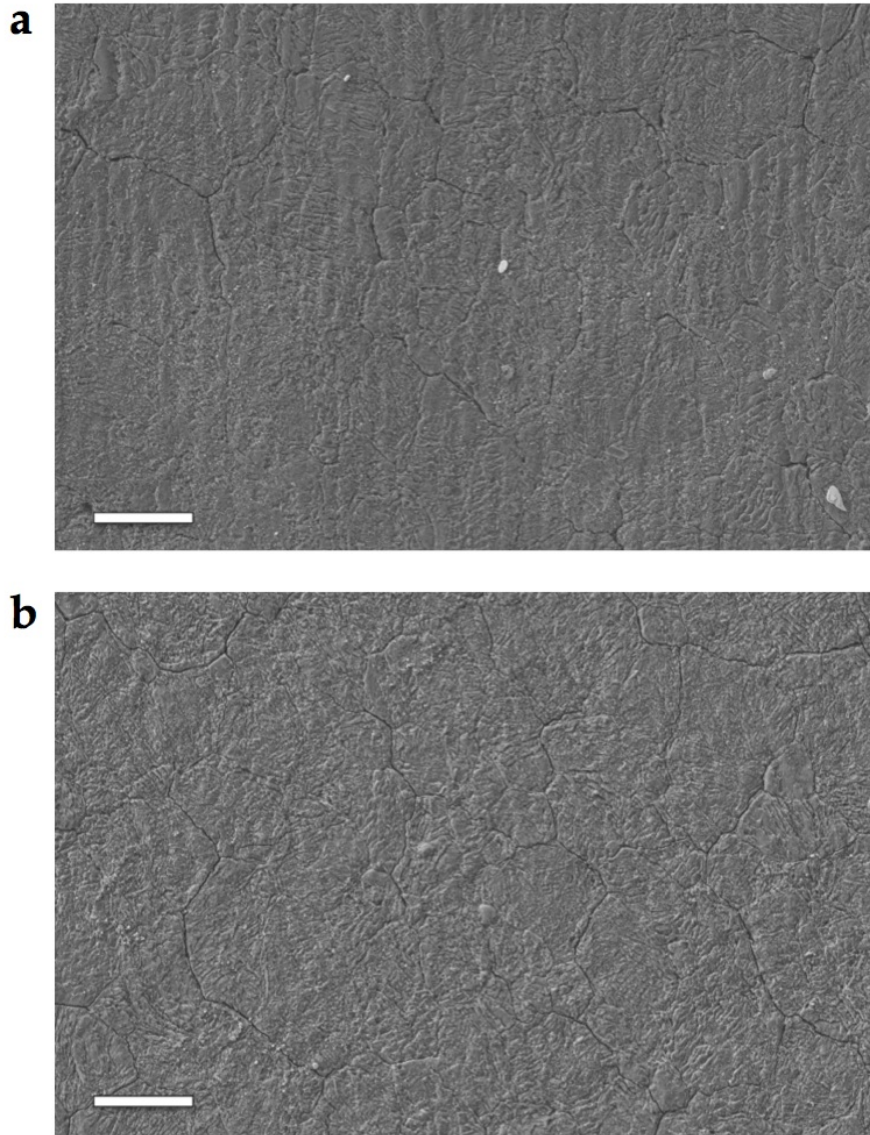
Figure 89: SEM images of the Al metallization close to the bonding wire in a (a) 25°C aged module (failed after 5.3 million cycles) and in a (b) 70°C aged one (failed after 300 kcycles). Scale bar 10 μm

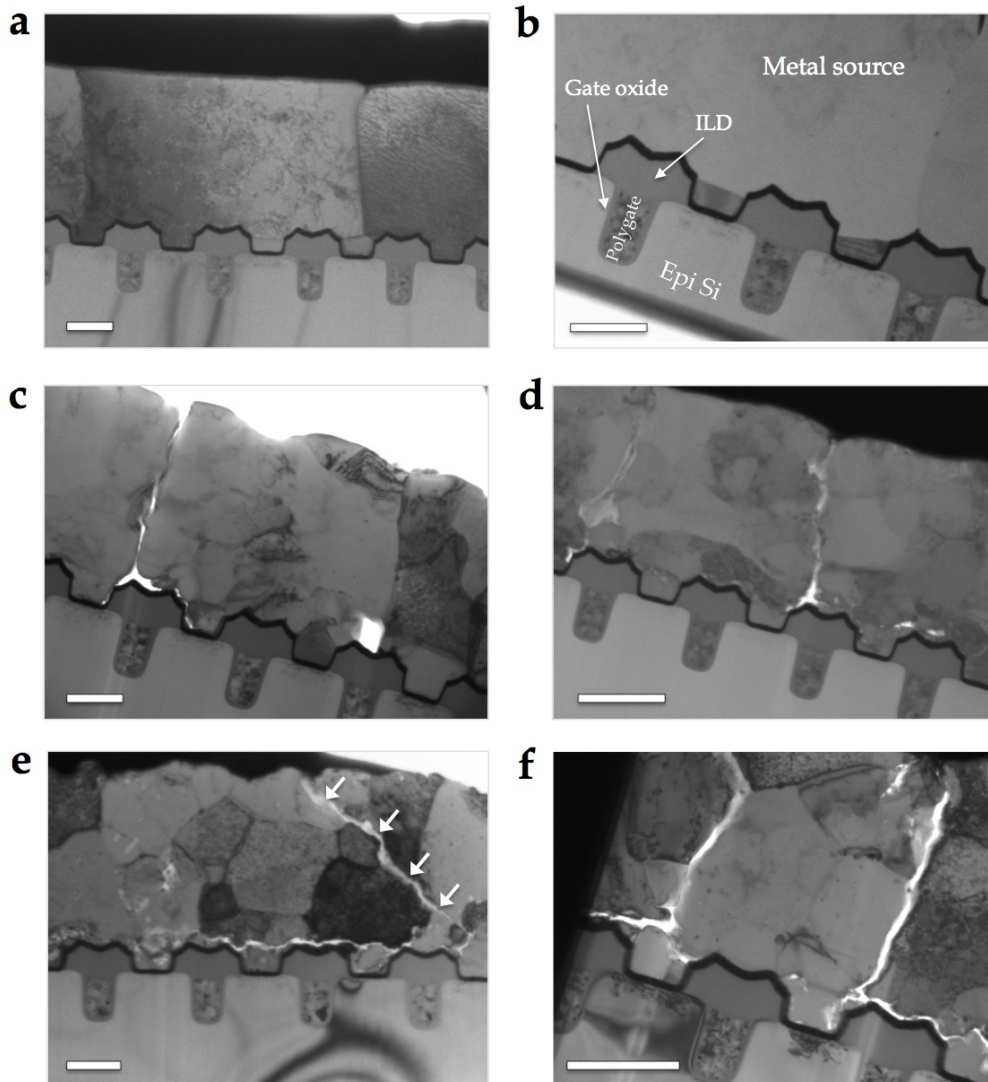
Figure 91: TEM images of some details of the transistor/metallization area from the naked metallization of an (a, b) as-is, (c, d) 25°C aged and (e, f) 70/degree C aged power modules. The trench MOSFET layered structure is described in (a) and consists in: metal source, interlayer dielectric (ILD), gate oxide and polySi (Poly Gate), epitaxial Si. Scale bar: 1 μm .

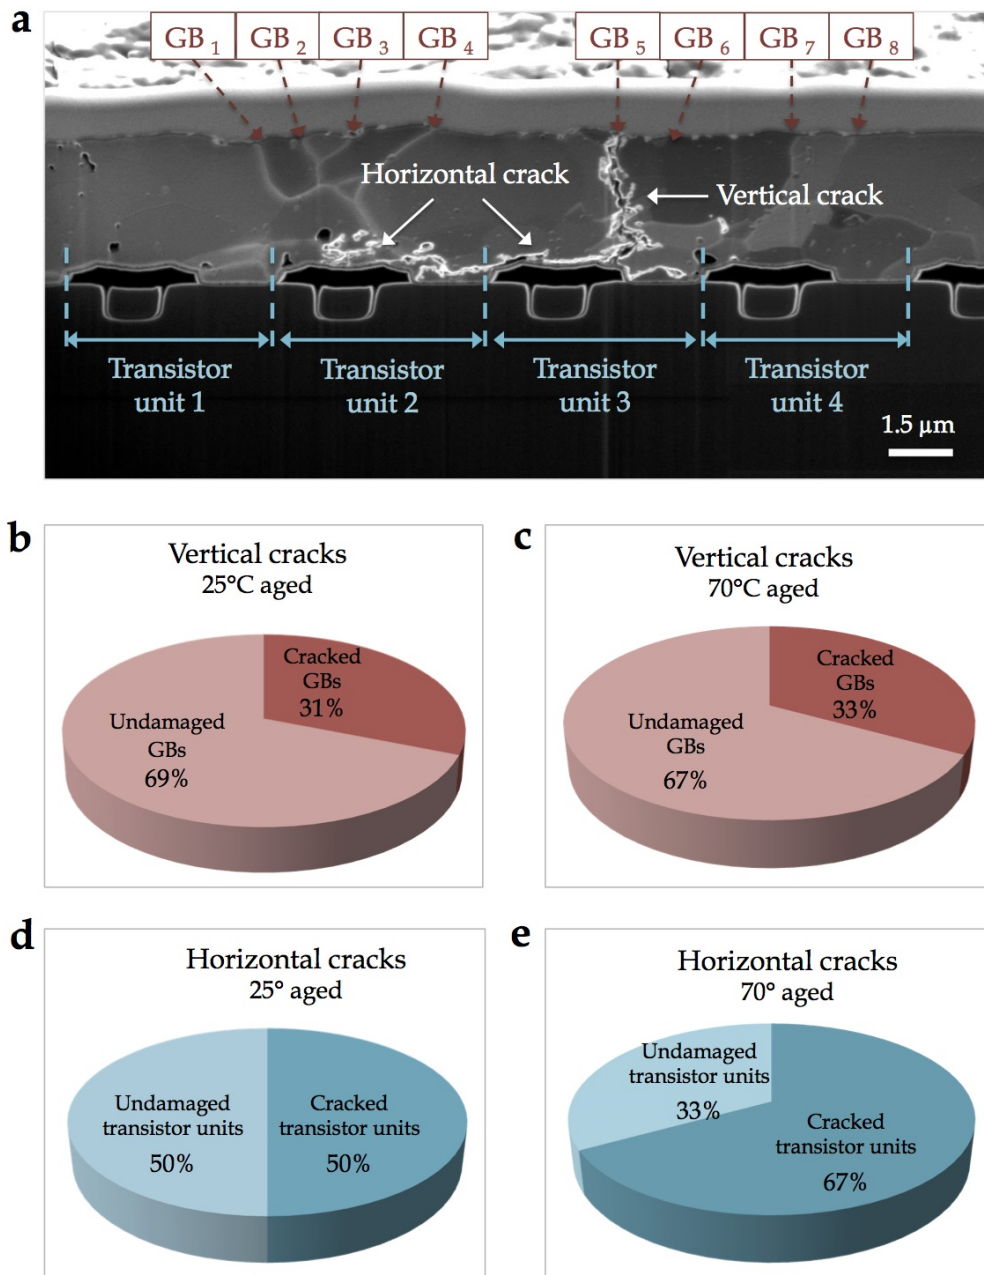
Figure 93: Horizontal and vertical cracks statistics in a 25°C and 70°C aged module.

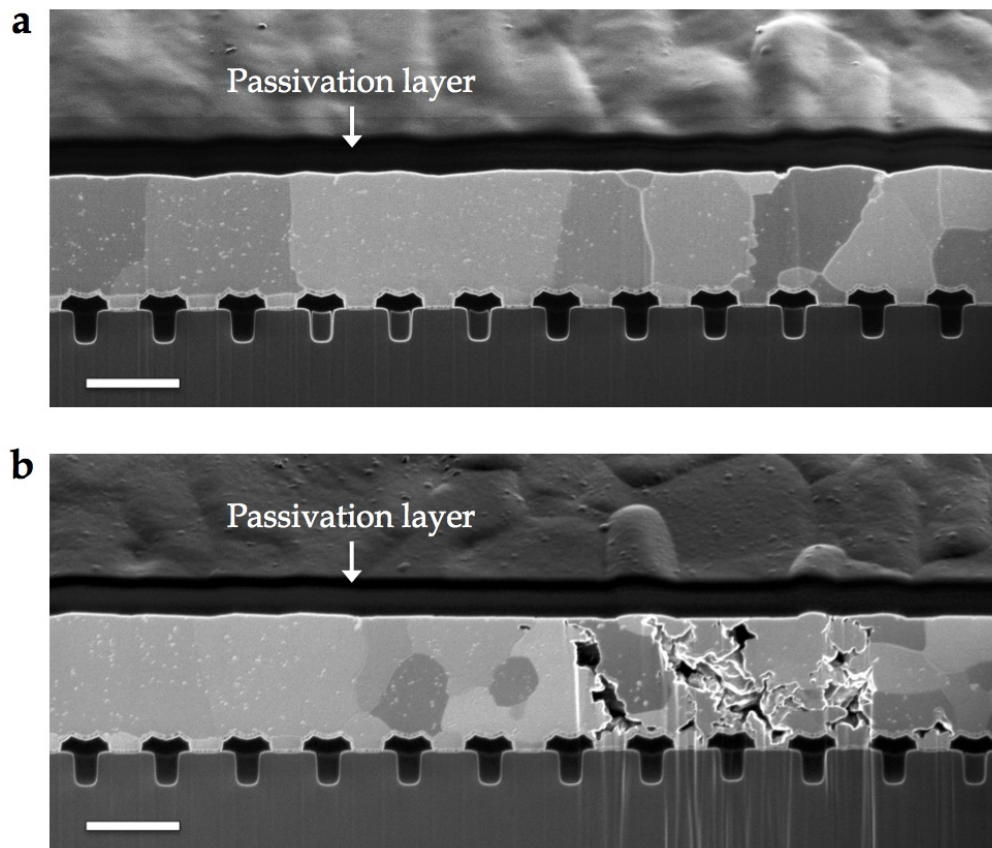
Figure 94: SIM image of the Al top metallization coated by SiO₂ passivation from two close cross-sections in a 70°C aged module.

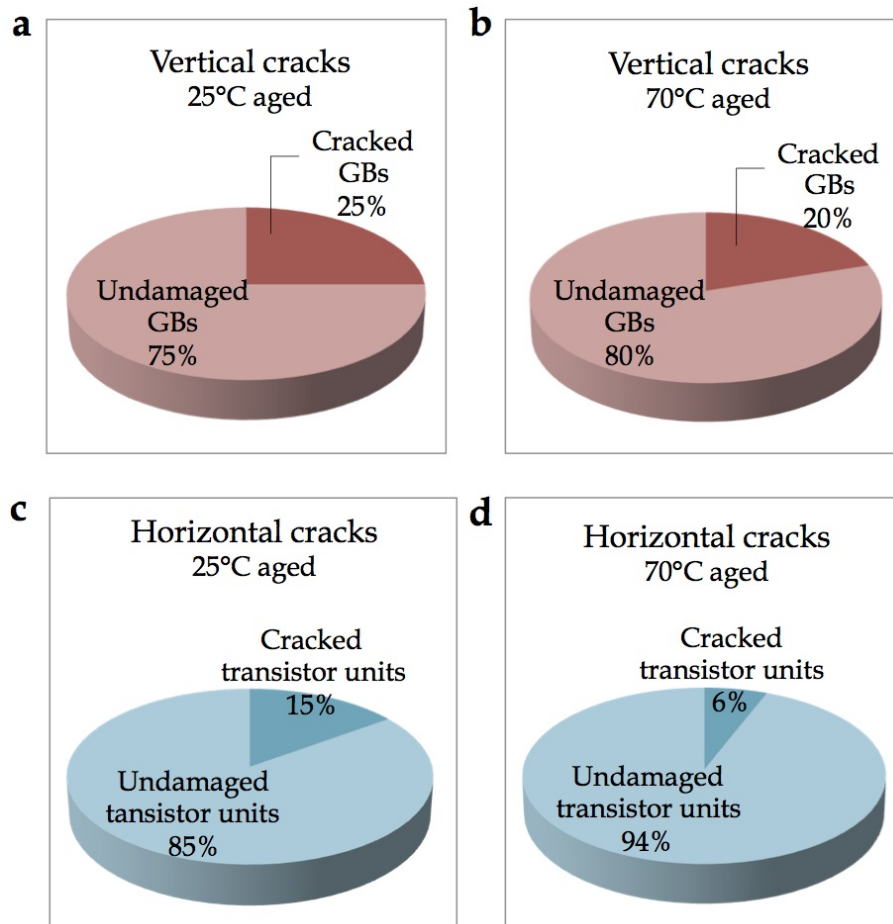
Figure 95: Ratio of cracked vs undamaged GBs in (a) a 25°C aged module and in a (b) 70 °C aged one.
 Ratio of cracked versus undamaged transistor units in (c) a 25°C aged module and in a (d) 70 °C aged one.

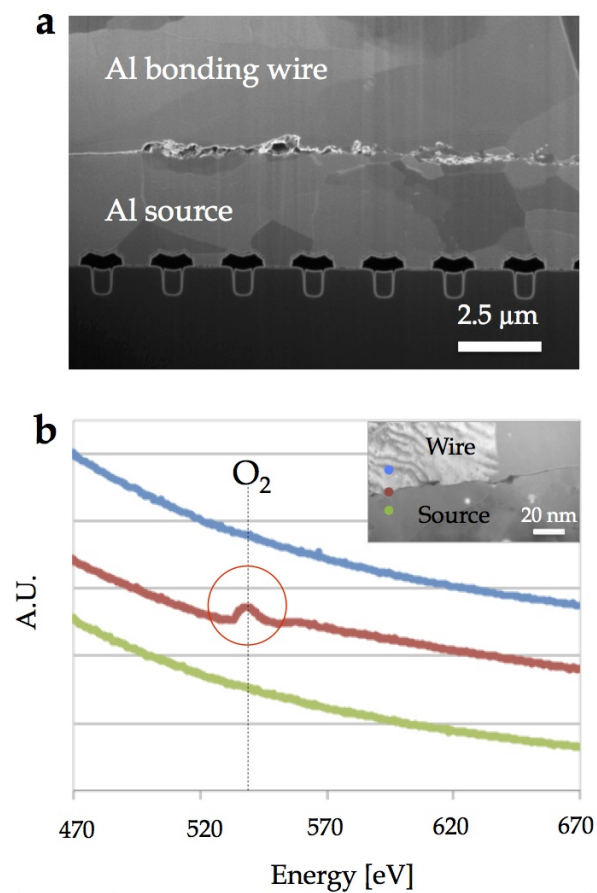
Figure 99: (a) SIM image of the initial artifacts which characterize the wire-metallization bonding of an as-is module. (b) EELS spectra from the wire (in blue), the metallization (in green) and the wire-metallization interface (in red). The red spectrum at the wire-metallization interface reveals the presence of oxygen.

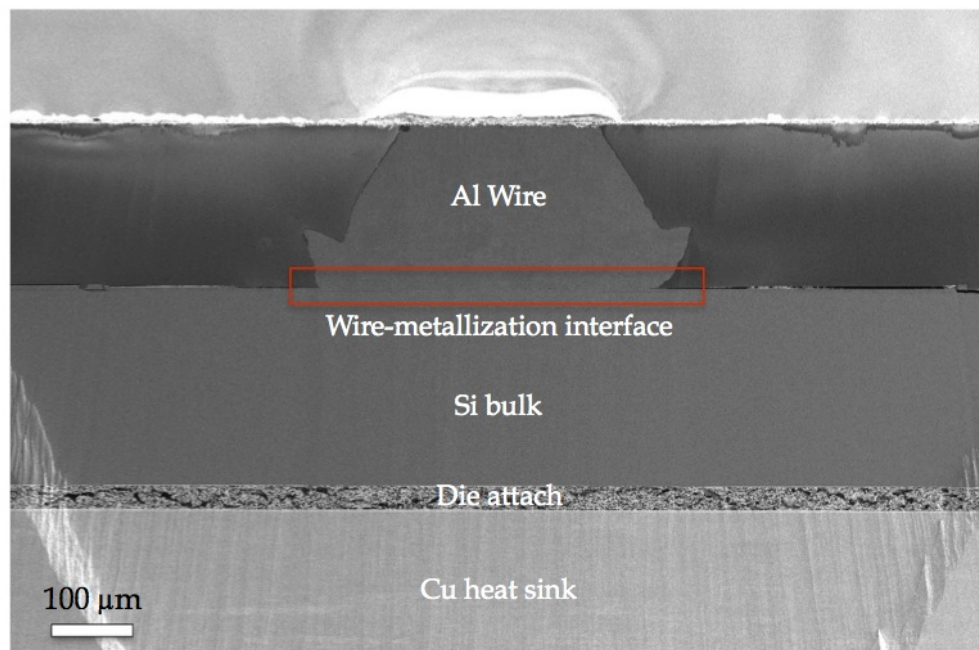
Figure 107: SEM image of a cross-section prepared by Cross Polisher system in an as-is module. The large cut area shows the power die layered structure: Al wire, Si bulk and Cu heat sink. The Al source metallization on the transistor area, at interface with the semiconductor, is not visible at this scale. The red area indicates the location of the Al wire-metallization interface that is shown in detail in Fig. 108a - n.

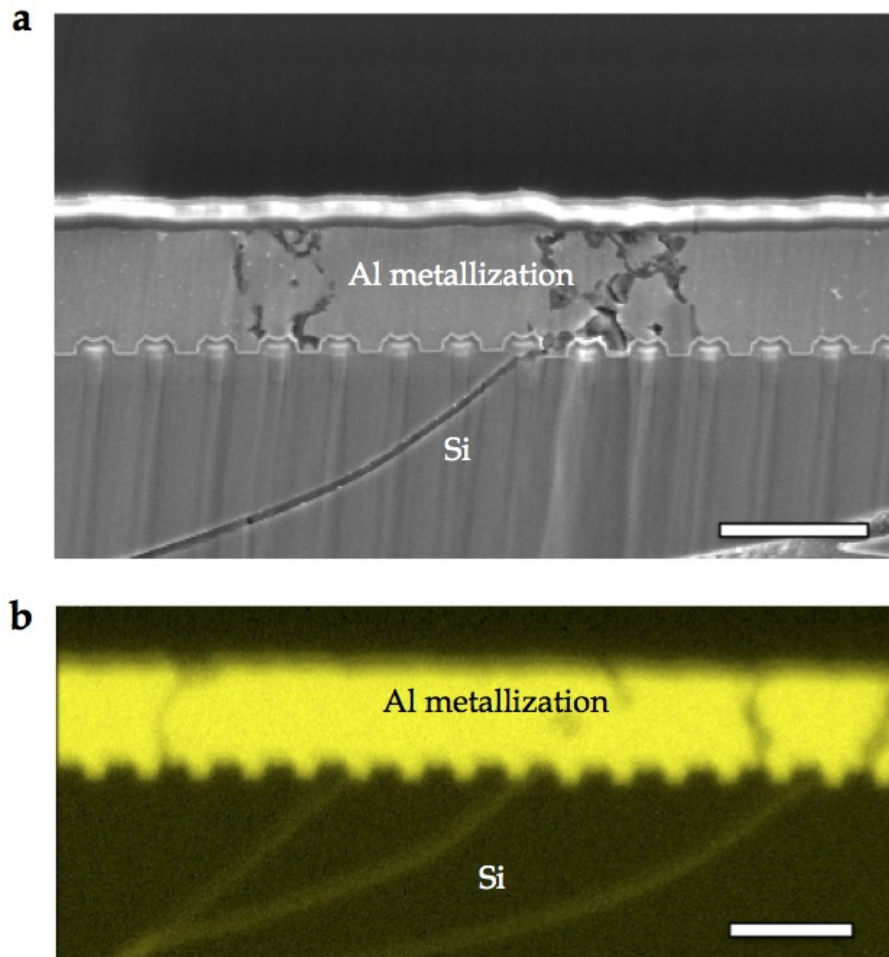
Figure 113: (a) SEM cross-sectional image of a fine crack in the Si layer contacted to the Al metallization in a 70°C aged module. (b) Al mapping by EDX showing some of these Si fine cracks filled with Al. Scale bar 5µm

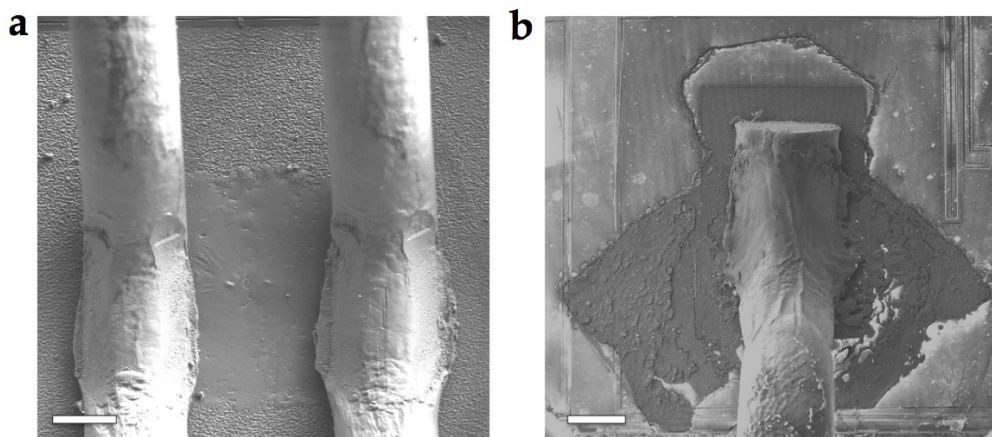
Figure 118: Burnout spots detected after failure (a) between two bond wires in a SPD06 module and (b) at the bonding connection in a T07D17 module. Scale bar: 250 μ m.

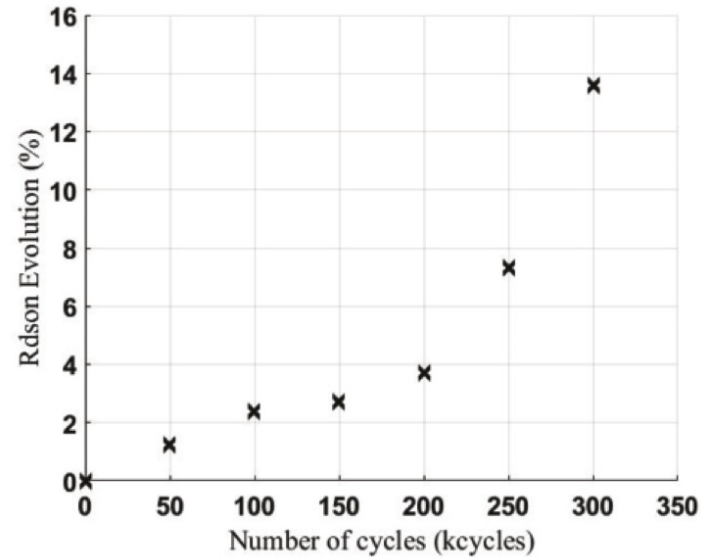
Figure 119: Increase of about 14% in the on-state resistance after repetitive SC events (3.55 J/cm^2) at ambient temperature. At 300kcycles the device failed.

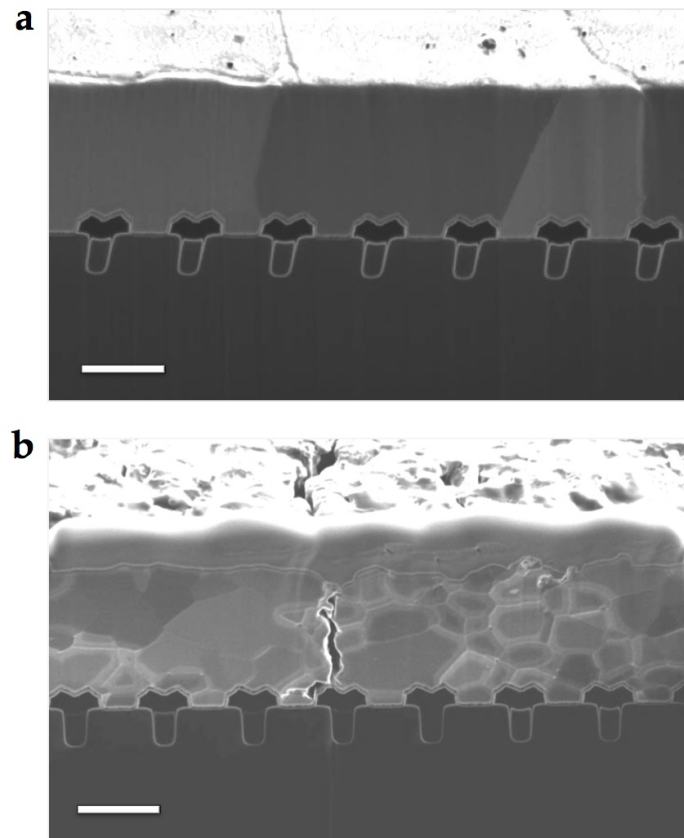
Figure 123: Cross-sectional cuts through the Al source metallization. (a) Before aging, bamboo Al grains fill all the metallization volume. After electro-thermal aging, an apparent grain shrinkage and crack propagation along the grain boundaries are observed. Scale bar: 2.5 μm.

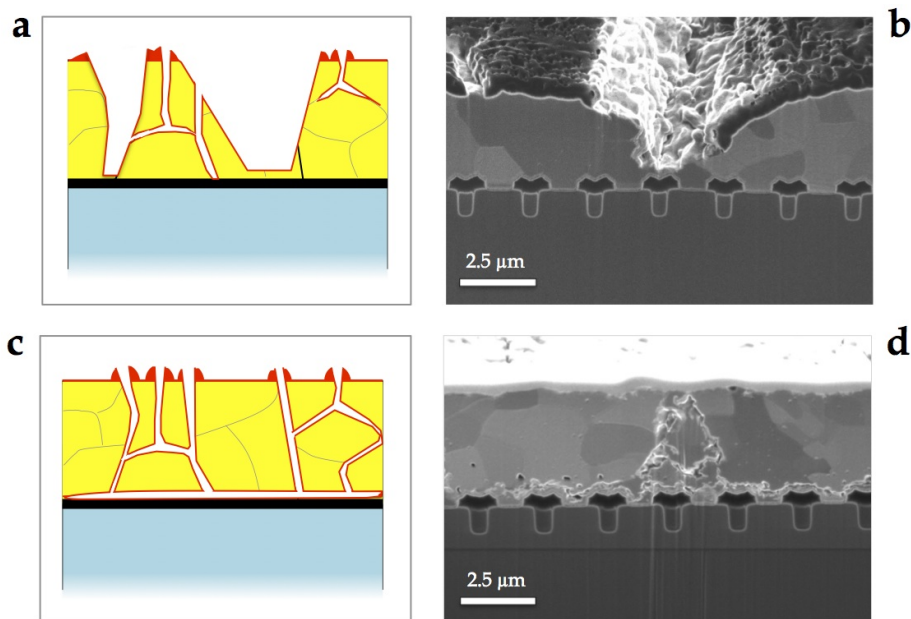
Figure 126: Crack propagation models through the Al layer at failure. (a) For SPD06 power modules at the final aging stage until failure, fatigues cracks running from the surface along the grain boundaries become broader and broader. (b) SIM cross-sectional image of the cracked metal in a failed SPD06, showing a crack width on the same order of the metallization thickness. (c) In To7D17 failed power modules, finer vertical cracks branch out and propagate horizontally all long the MOSFETs region. (d) Relative SIM cross-sectional imaging from a 70°C aged module.

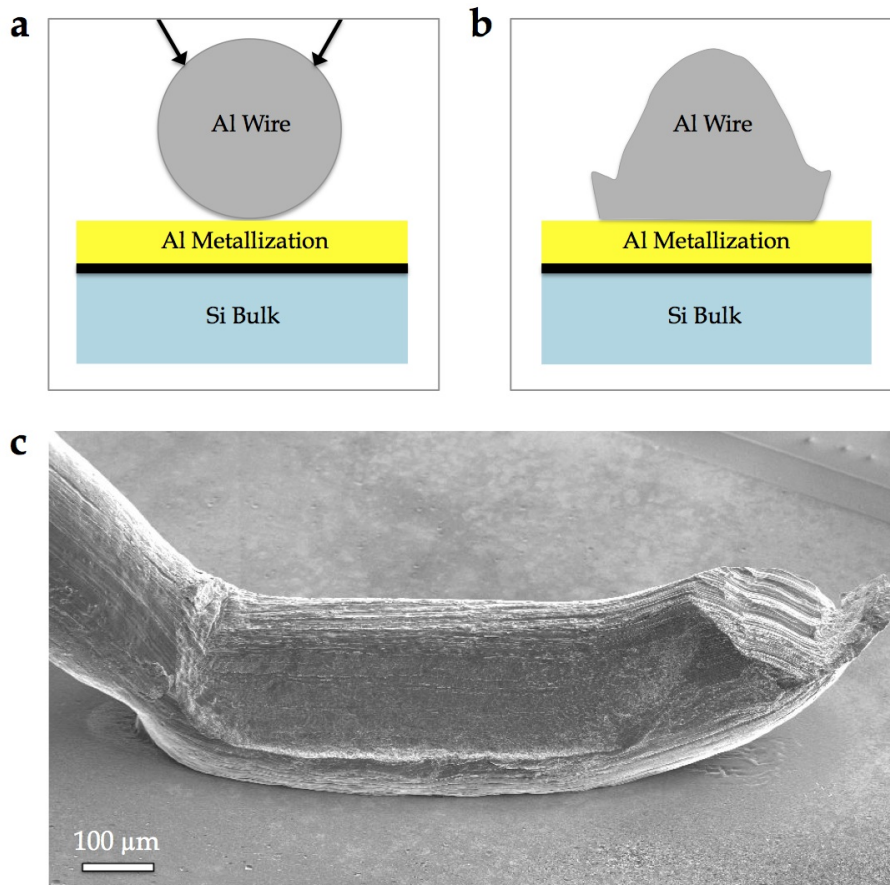
Figure 130: Cross-sectional schema of the cylindric wire on the top metallization (a) before and (b) after bonding process. The black flashes in (a) represent the force direction during the bonding process. (c) Lateral view SEM image of the elliptical bond area.
