Fatigue mechanisms in Al-based metallizations in power MOSFETs

THÈSE

DOCTORAT DE L'UNIVERSITÉ DE TOULOUSE

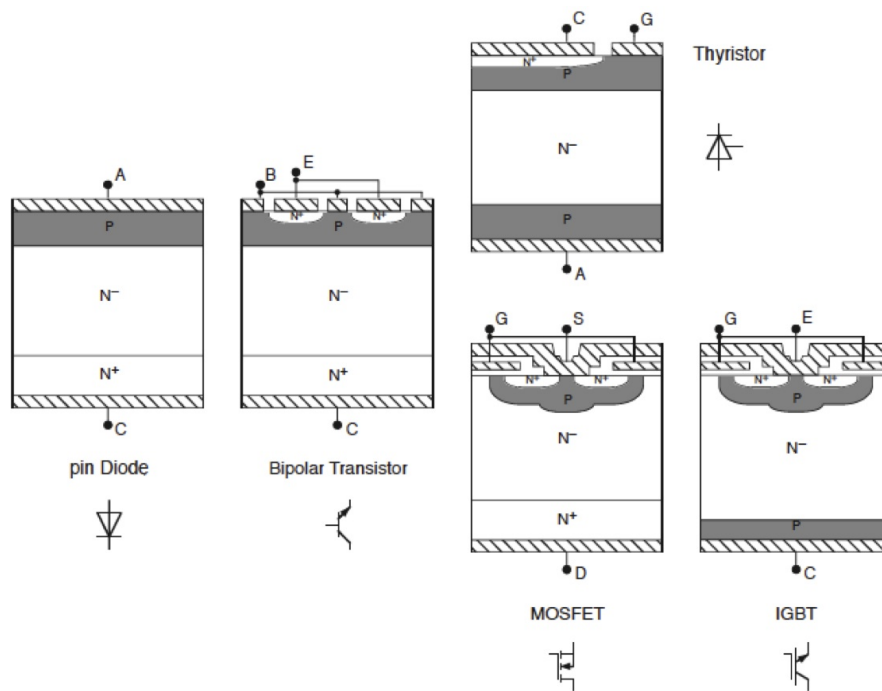
Figure 1: Basic structures of common power semiconductor devices [Lut11].

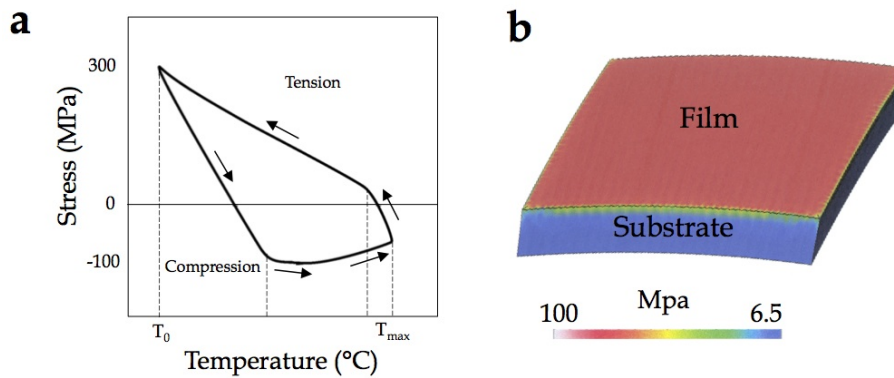
Figure 19: (a) Typical stress-temperature cycle for a 1- μm -thick poly-crystalline Al film on oxidized Si substrate ($T_{\text{max}} \sim 450^\circ\text{C}$). (b) Finite element simulation showing the Von Mises stresses generated by a temperature change of 50 °C in a 1 cm x 2 cm x 0.5 mm specimen (typical size used in wafer curvature) [Leg09].

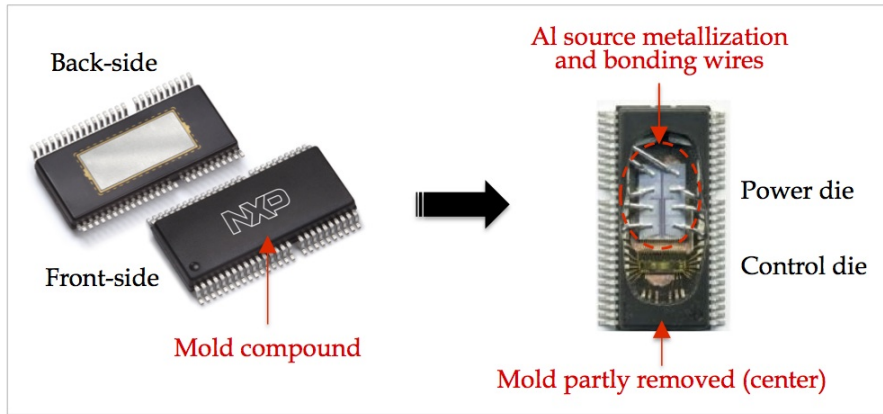
Figure 39: Decapsulation of epoxy-packaged semiconductor devices. Al source metallization and bonding wires are beneath the front epoxy side.

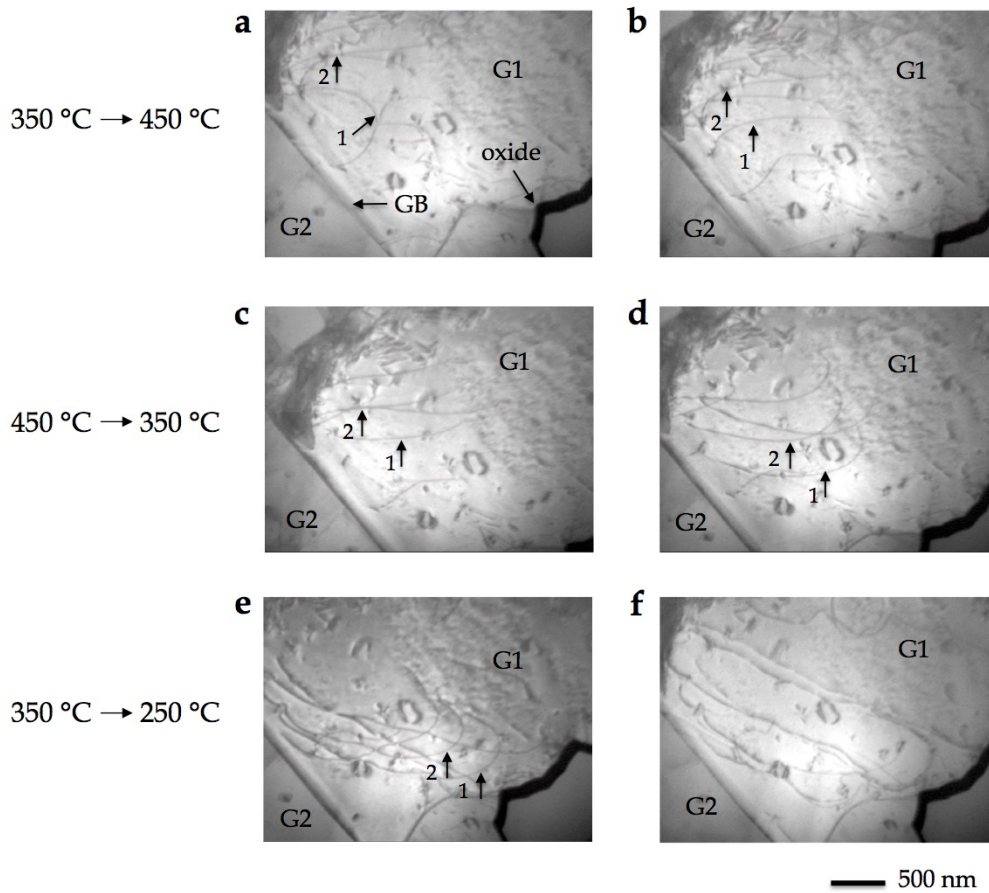
Figure 87: In situ TEM thermal cycling from 25°C to 450°C of a device cross-section prepared by tripod. The Si substrate is preserved, inducing a reversible motion, according to the stress inversion for a Al/Si substrate thin film in the stress-temperature curve [Fli87]. (a)-(b) are snapshots captured during the heating up phase from 350°C to 450 °C, showing the dislocation activation. During the cooling down phase, the reversible motion is characterized by an initial dislocation straightening (c) followed by a bowing in the opposite direction (d), towards the oxide (d)-(e).

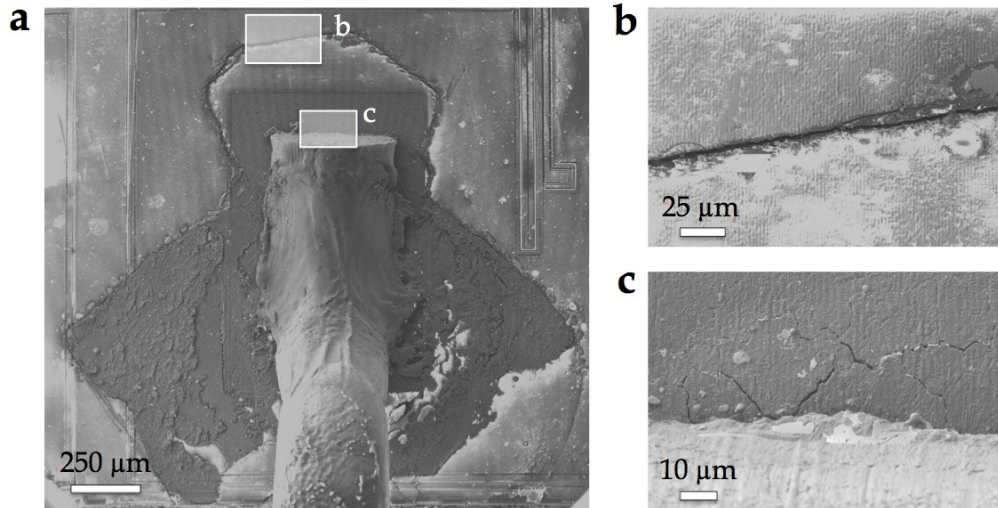
Figure 105: (a) Top view SEM image of an Al bond wire welded on the Al source metallization in a 25°C aged device, after a short-circuit event. At higher magnification, big cracks propagating in (b) the passivated metallization and (c) next to the bonding wire (located in the boxes (b) and (c) in (a)).

Figure 106: Cross-sectional SEM images of the heavily cracked metallization (a) in the passivated area and (b) close to the melted bonding wire of the module depicted in (Fig. 105a).
