# Fatigue mechanisms in Al-based metallizations in power MOSFETs

**Fatigue mechanisms in Al-based metallizations in power MOSFETs**

This thesis, a collaboration between CEMES-CNRS, Satie laboratory (ENS Cachan) and NXP Semiconductors is motivated by the comprehension of the failure mechanisms of low voltage power MOSFET devices produced for applications in the automotive industry.

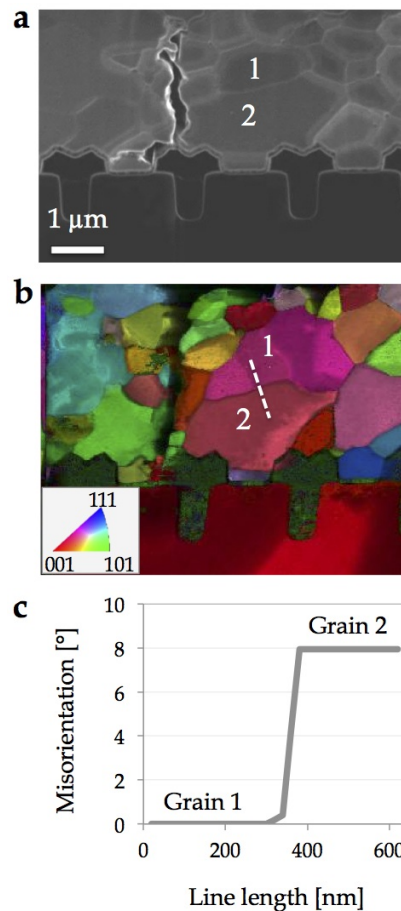
Figure 82: (a) FIB imaging and (b) ACOM orientation mapping of the source metal of an aged module (short circuit, 130k cycles) at the interface with the Si substrate. The standard stereographic triangle gives the color codes of the grain orientations, taken here along the horizontal direction. (c) The plot represents the misorientation between the grains 1 and 2 along the white line in b).

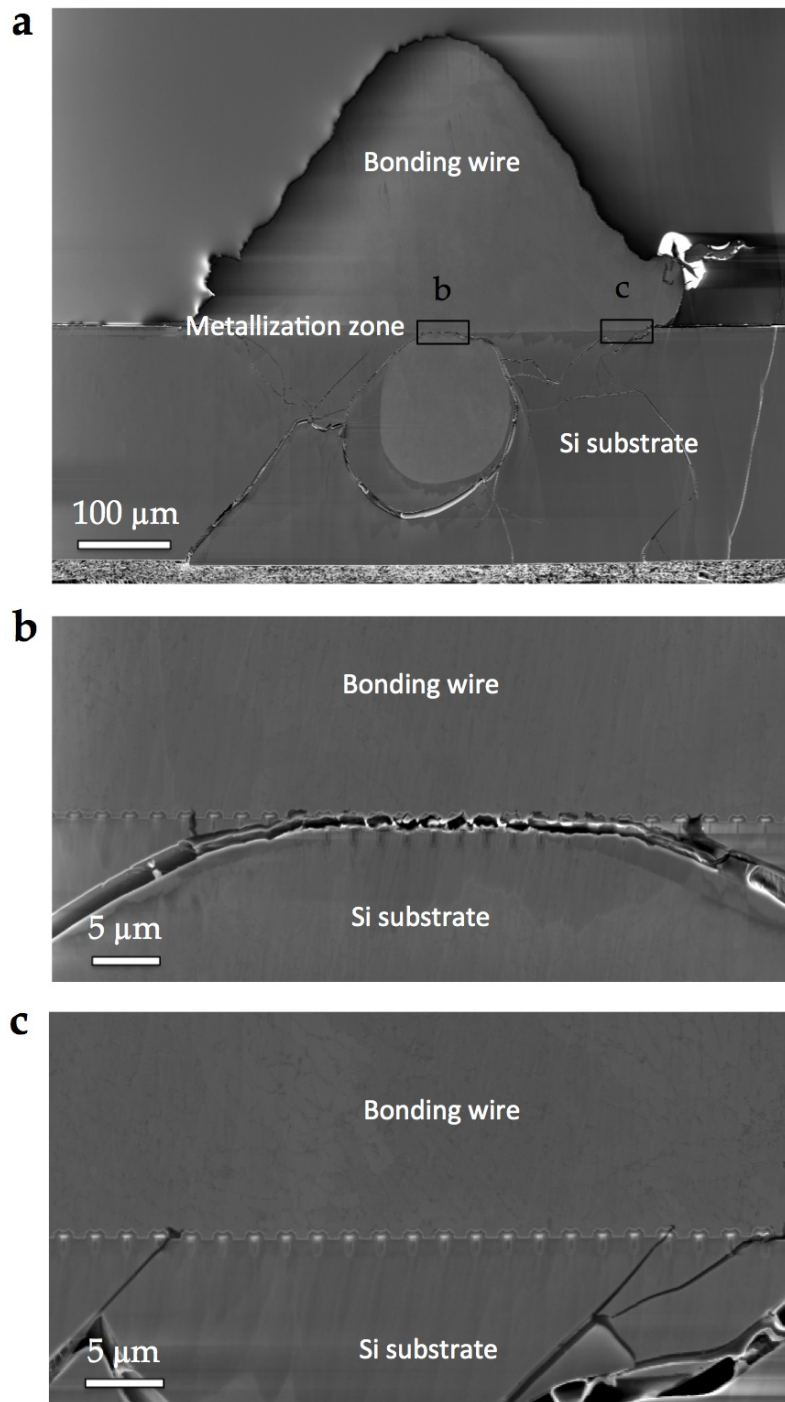
Figure 114: (a) SEM cross-sectional imaging of the bonding wire from an aged power module (25 °C aged) showing different types of cracks; (b), (c) higher magnification images of the wire- metallization interface located in the boxes (b) and (c) in (a). The die crack resulted from an electro-thermal event occurring at failure time.

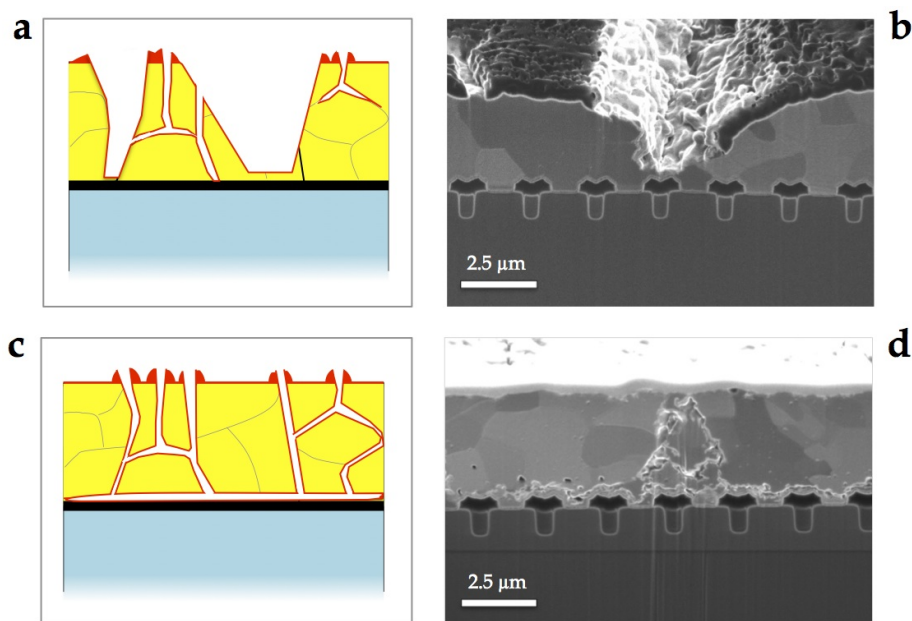
Figure 126: Crack propagation models through the Al layer at failure. (a) For SPD06 power modules at the final aging stage until failure, fatigue cracks running from the surface along the grain boundaries become broader and broader. (b) SIM cross-sectional image of the cracked metal in a failed SPD06, showing a crack width on the same order of the metallization thickness. (c) In To7D17 failed power modules, finer vertical cracks branch out and propagate horizontally all along the MOSFETs region. (d) Relative SIM cross-sectional imaging from a 70°C aged module.

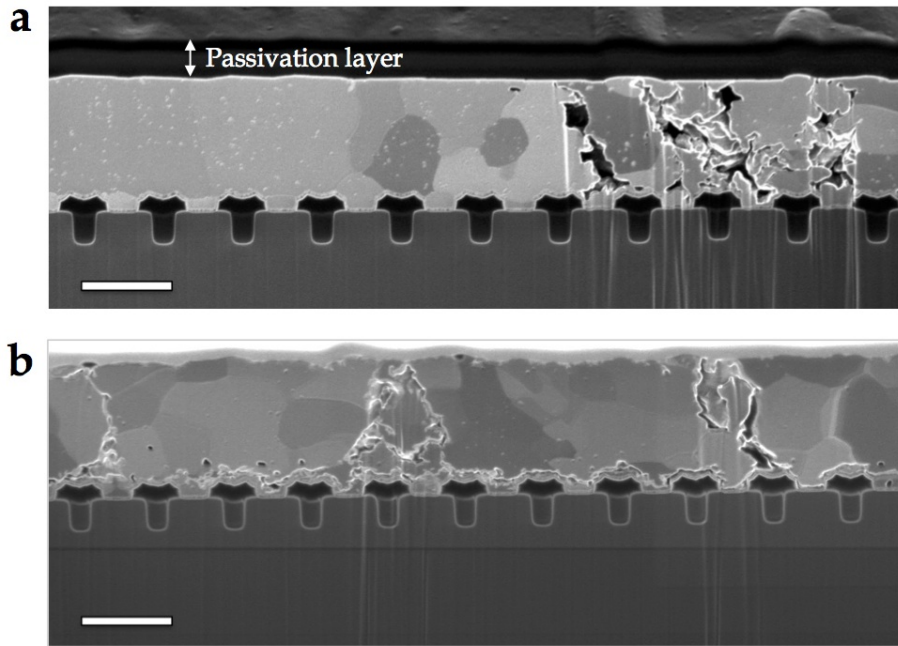
Figure 128: Cross-sectional SIM images of the (a) passivated and (b) bare Al source metallization, showing a localized propagation of vertical cracks in the first one and a generalized degradation in the second one, with horizontal cracks branching out all along the metal-transistor interface. Scale bar:  $2.5\mu\text{m}$

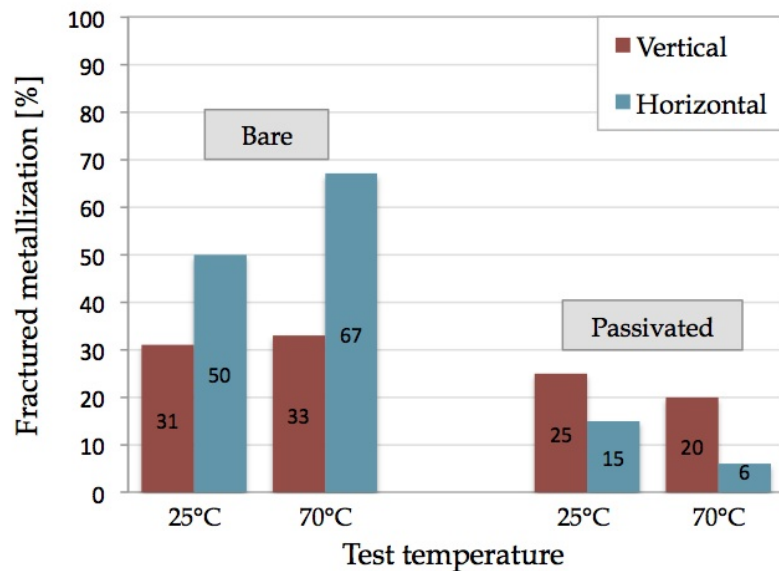
Figure 129: Metallization crack statistics for a To7D17 module aged at  $25\text{ }^{\circ}\text{C}$  and  $70\text{ }^{\circ}\text{C}$ , in non passivated –bare– (left) and passivated (right) zones.
