# Fatigue mechanisms in Al-based metallizations in power MOSFETs

**Fatigue mechanisms in Al-based metallizations in power MOSFETs**

This thesis, a collaboration between CEMES-CNRS, Satie laboratory (ENS Cachan) and NXP Semiconductors is motivated by the comprehension of the failure mechanisms of low voltage power MOSFET devices produced for applications in the automotive industry.

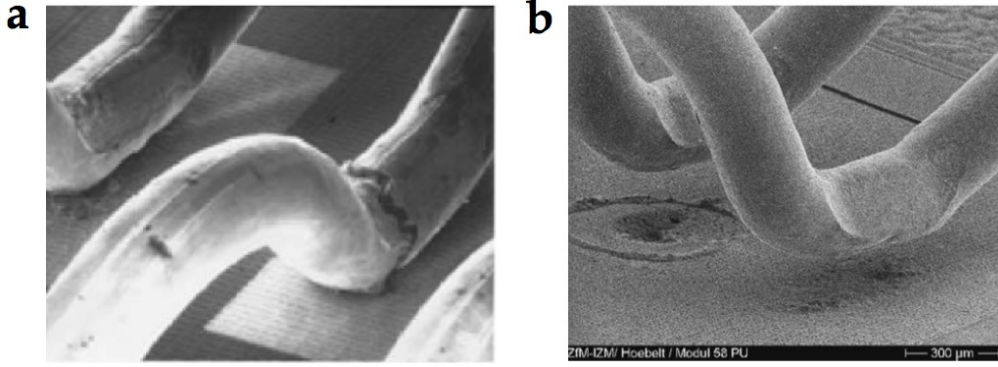
Figure 21: Examples of bond failures in power components: (a) heel crack failure [Ciao2] and (b) wire lift-off [Den17].

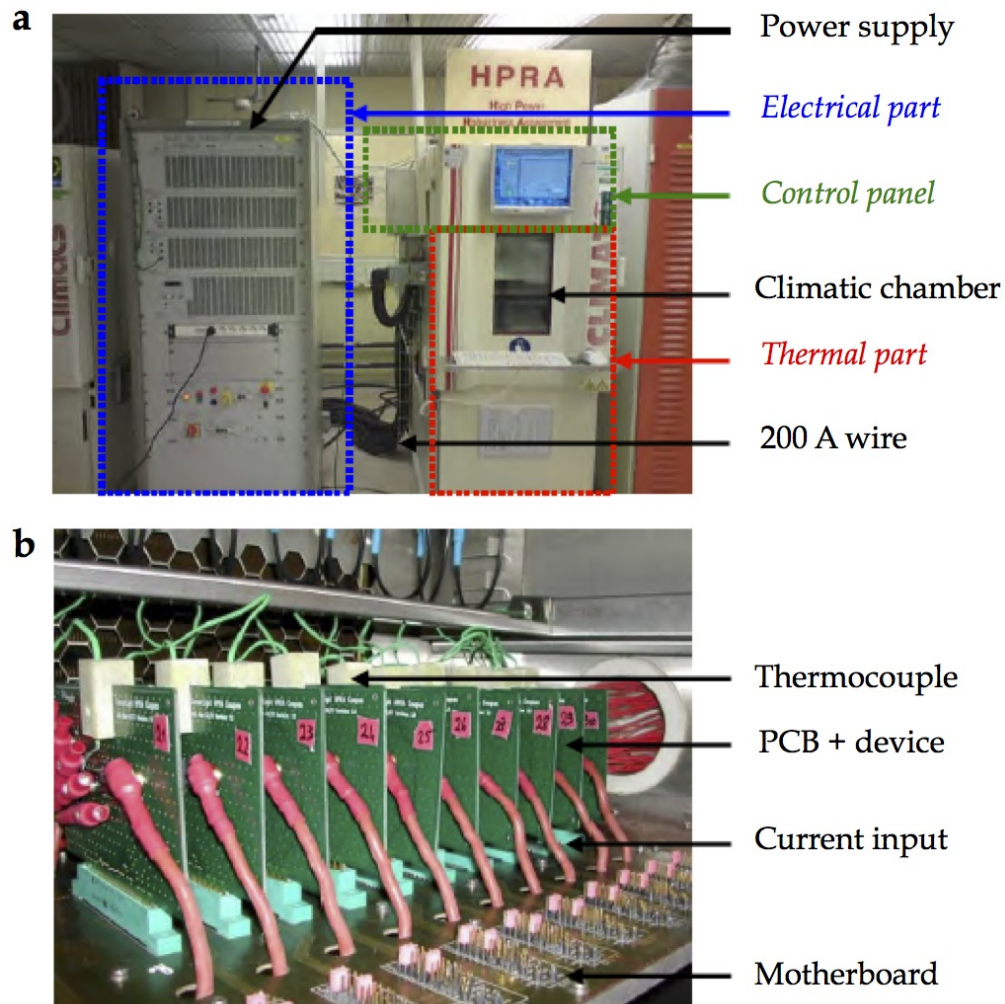
Figure 28: (a) Climats Sapratin Excal 2223-TE test bench at NXP Semiconductors. it consists in an electrical part (in blue), equipped with a 80 V, 200 A power supply and an active charge (5 - 200 A), a climatic chamber ( $-80^{\circ}\text{C}$  -  $180^{\circ}\text{C}$ ) containing the devices under test (in red), and a control panel (in green) with an electronic board that control the devices switching.  
 (b) Inner part of the climatic chamber, showing the motherboard and the PCBs containing the power devices to test. The motherboard is in charge of sending the current to the devices and communicates with the control electronic board during the switch stage.

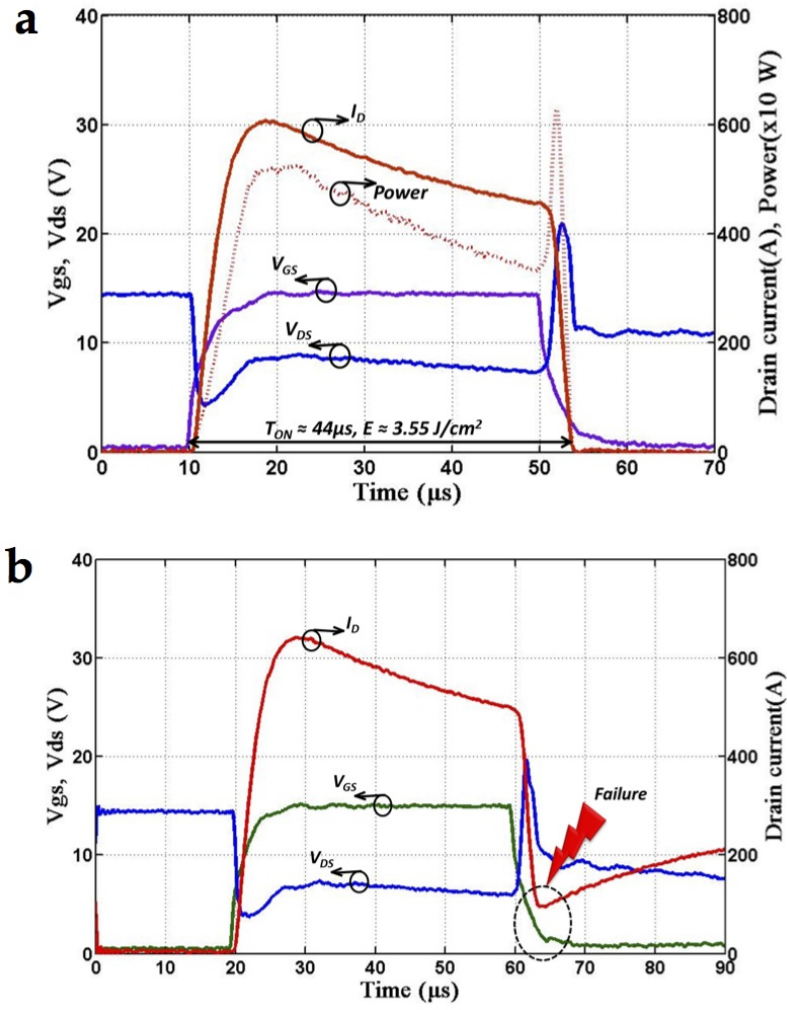
Figure 36: SC characteristics (a) just before failure (after 300 kcycles) and (b) at failure (330 kcycles).  $V_{DS} = 15\text{V}$ ,  $f = 5\text{Hz}$ ,  $T_{ON} = 40\mu\text{s}$ .

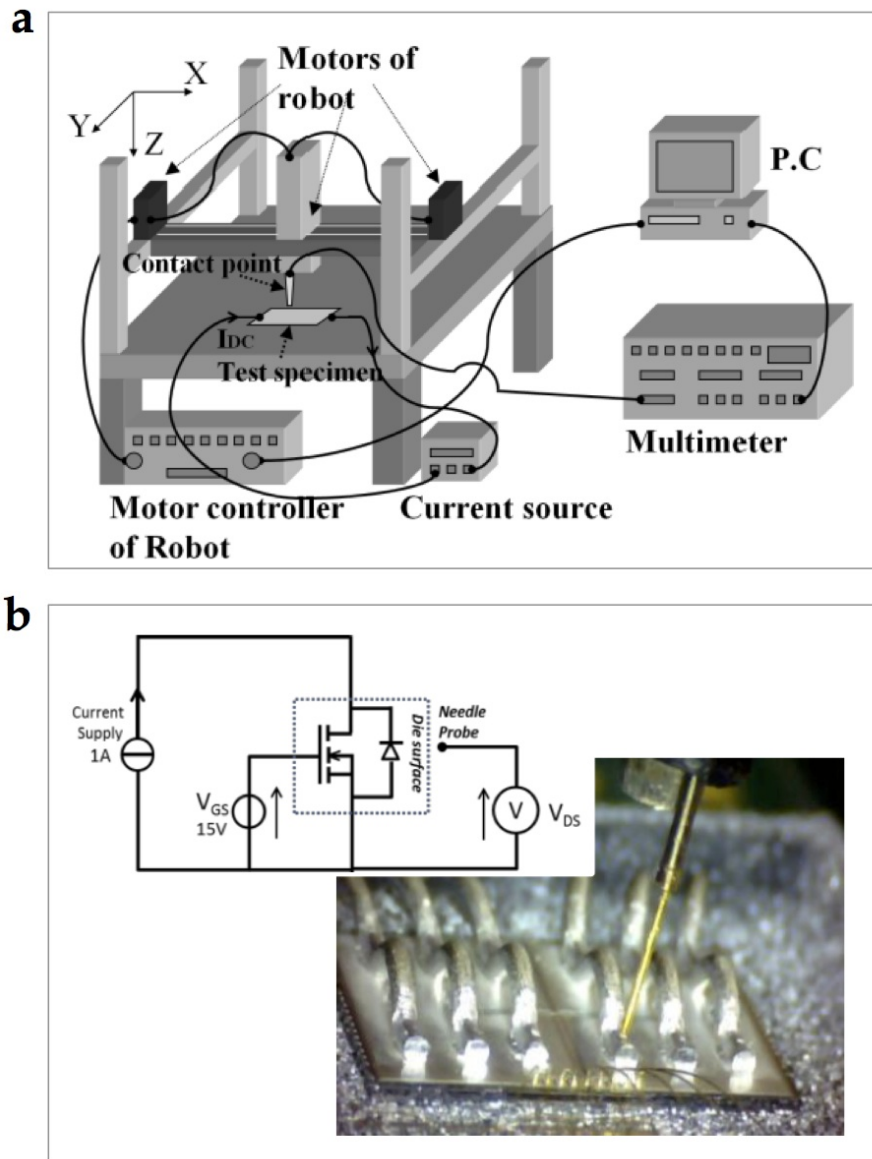
Figure 37: (a) Experimental set-up for source potential mapping of the power die. (b) Spring probe for source potential mapping,  $V_{GS} = 15V$ ,  $I_{DS} = 1A$ .

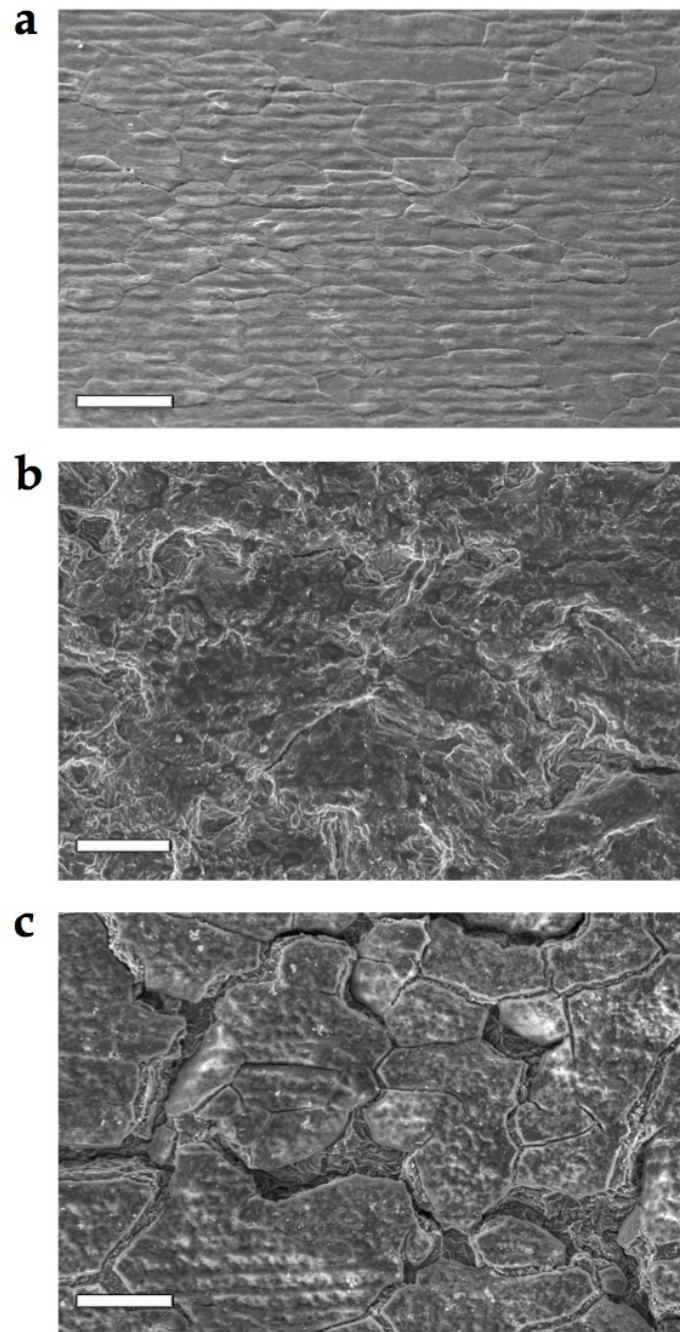
Figure 75: Top view SEM images showing the Al metallization of (a) an as-is module and (b), (c) a failed one at two different locations. The grain structure is visible in all of them as GBs are slightly grooved in (a) and more heavily cracked in (b) and (c). Scale bar 10  $\mu\text{m}$ .

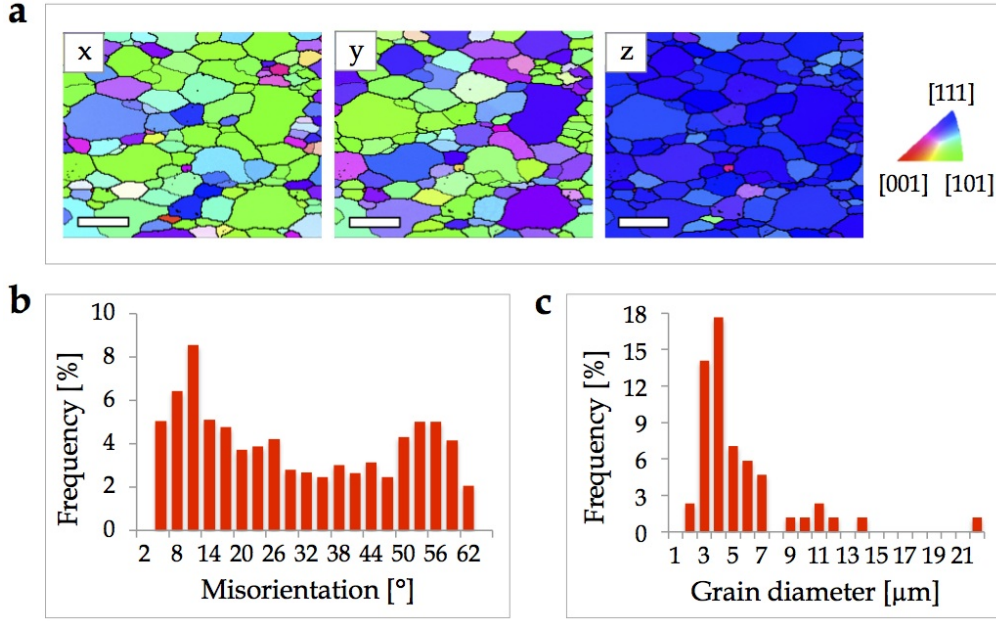
Figure 76: (a) EBSD orientation mapping along x, y and z axis of the Al metallization of a reference module and relative histograms of the (b) grain misorientation and (c) grain size (equivalent diameter).

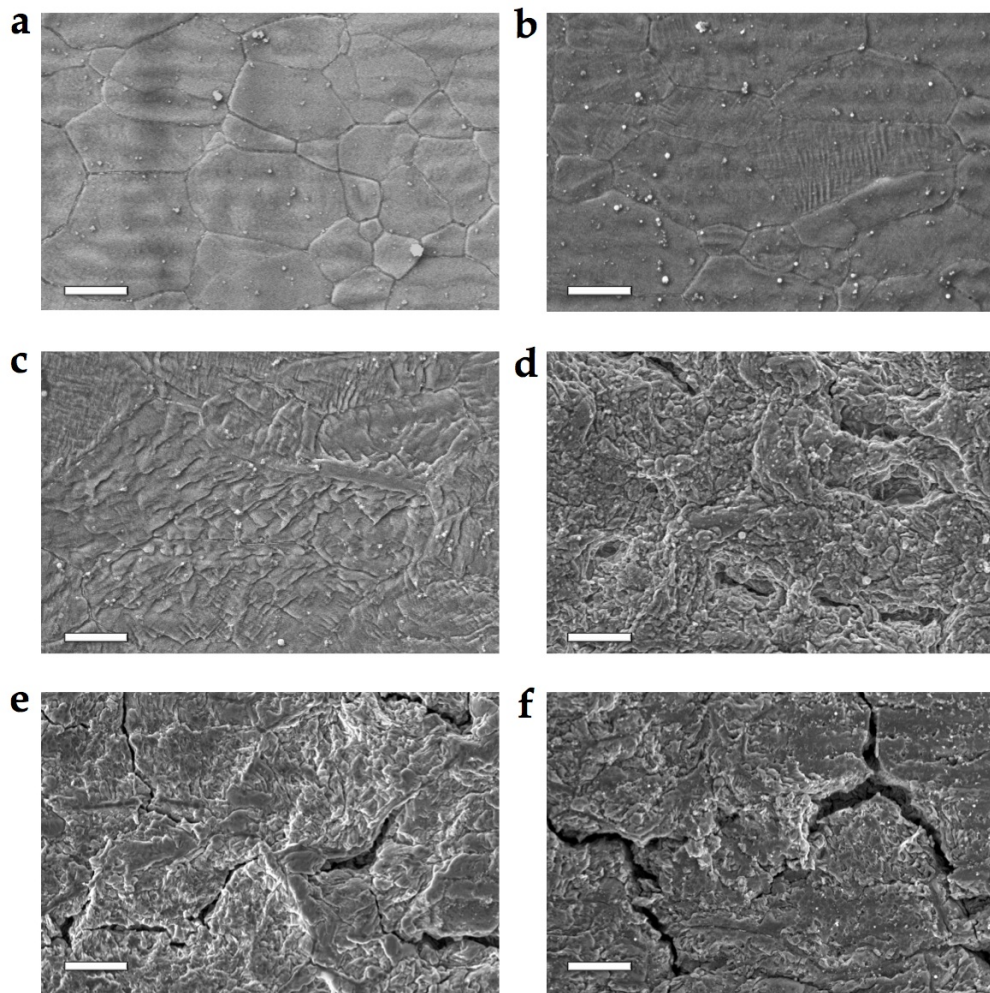
Figure 77: Top view SEM images showing the evolution of the Al source metallization surface. Grain structure (a) before starting the accelerated aging and after (b) 1 kcycles, (c) 10 kcycles, (d) 100 kcycles, (e) 200 kcycles and (f) 300 kcycles. Scale bar 5  $\mu\text{m}$ .

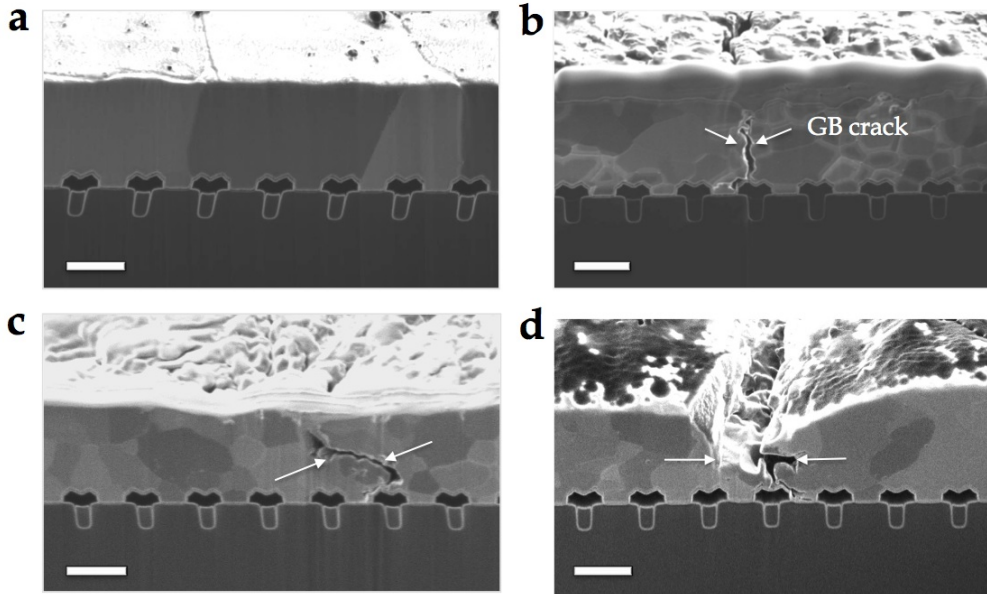
Figure 79: SIM imaging of the Al source metallization of an (a) as-is and (b) 100, (c) 200 and (d) 300 kcycles aged power modules. Scale bar 2  $\mu\text{m}$ .

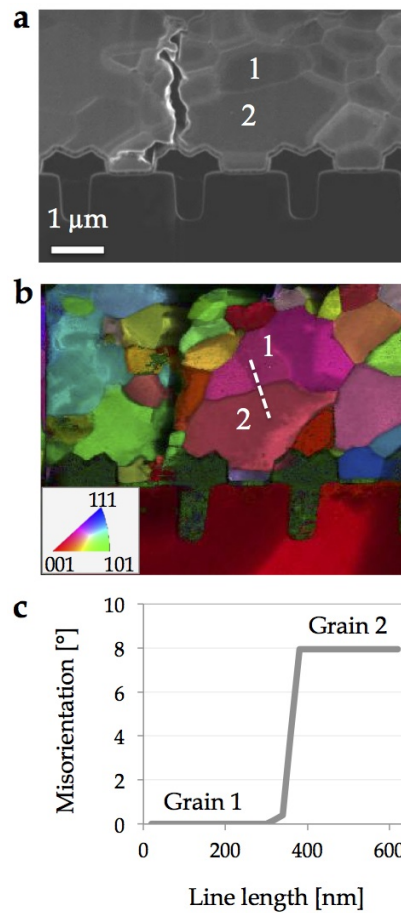
Figure 82: (a) FIB imaging and (b) ACOM orientation mapping of the source metal of an aged module (short circuit, 130k cycles) at the interface with the Si substrate. The standard stereographic triangle gives the color codes of the grain orientations, taken here along the horizontal direction. (c) The plot represents the misorientation between the grains 1 and 2 along the white line in b).

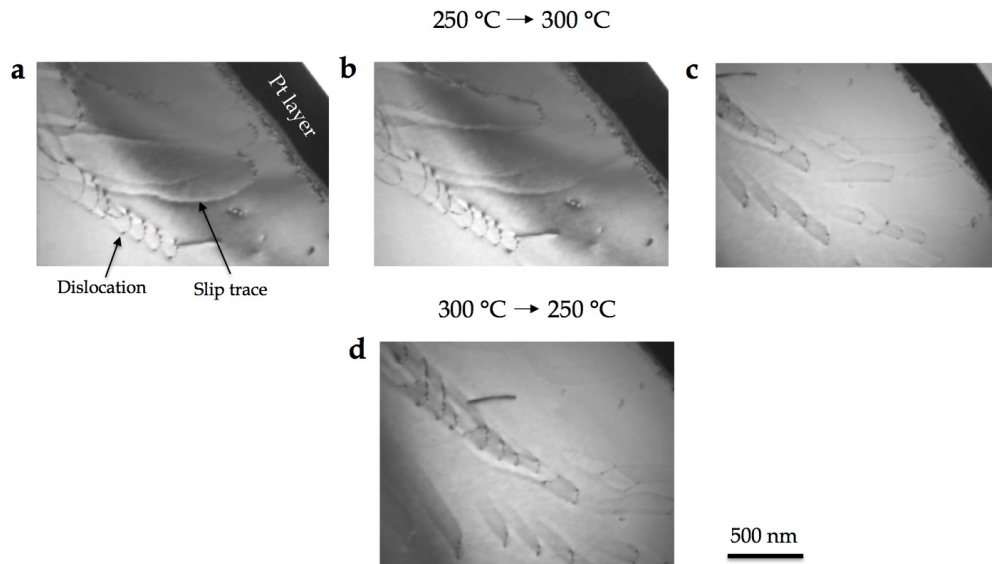
Figure 86: In situ TEM thermal cycling of a device FIB-prepared cross-section from 25 °C to 450 °C. (a)-(c) are snapshots captured during the heating up phase from 250 °C to 300 °C, showing curved slip traces associated to a combination of dislocation climbing and gliding. Once the dislocations are dispersed, during the correspondent cooling down phase (d), no reverse motion is observed because the Si substrate is too thin to induce significant stress in the Al film.

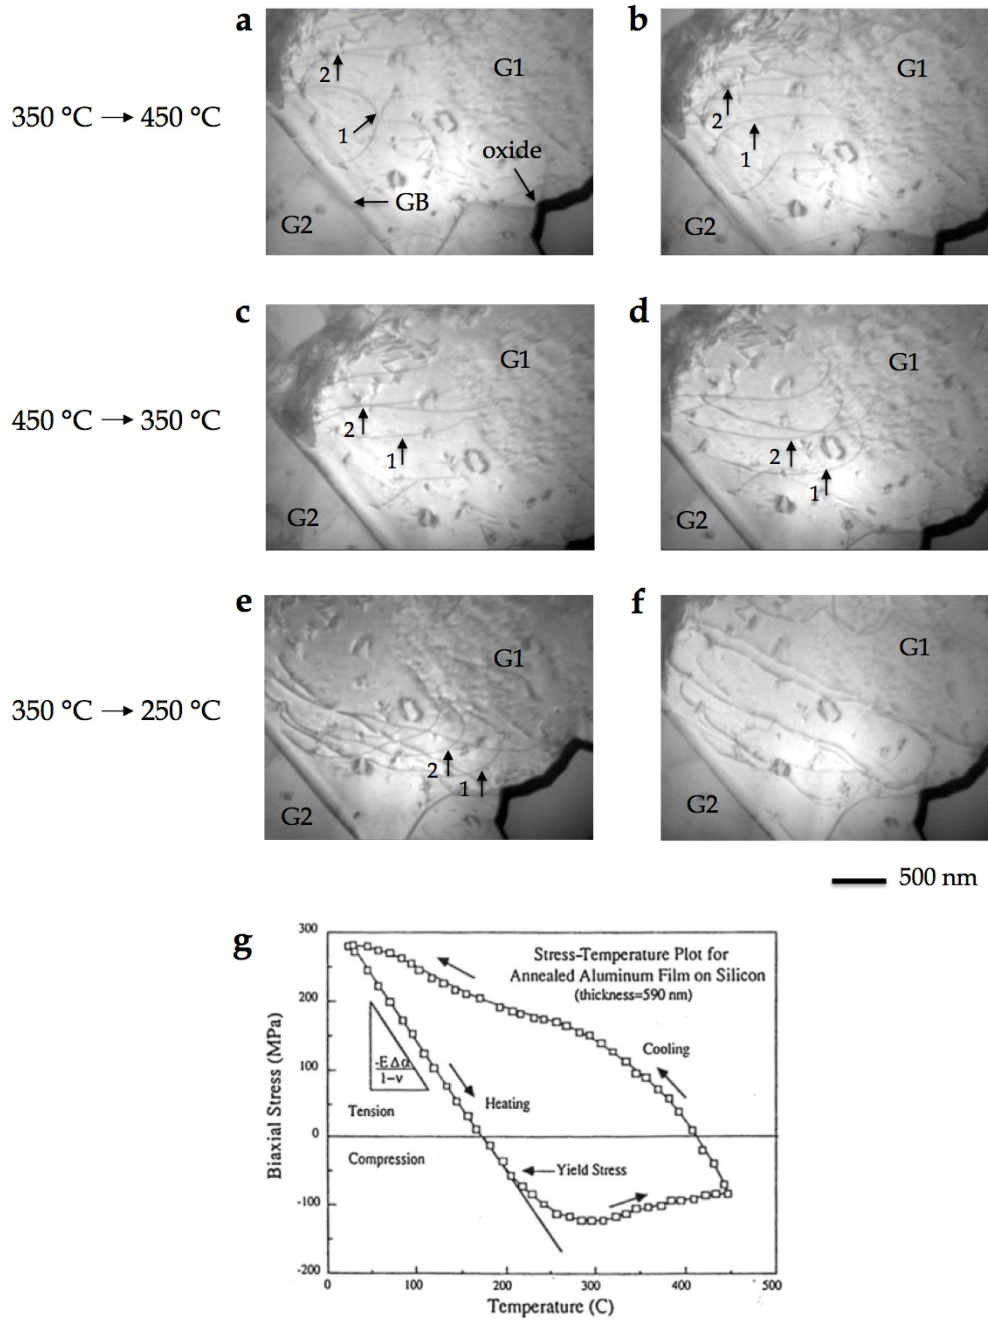
Figure 87: In situ TEM thermal cycling from 25°C to 450°C of a device cross-section prepared by tripod. The Si substrate is preserved, inducing a reversible motion, according to the stress inversion for a Al/Si substrate thin film in the stress-temperature curve [Fli87]. (a)-(b) are snapshots captured during the heating up phase from 350°C to 450 °C, showing the dislocation activation. During the cooling down phase, the reversible motion is characterized by an initial dislocation straightening (c) followed by a bowing in the opposite direction (d), towards the oxide (d)-(e).

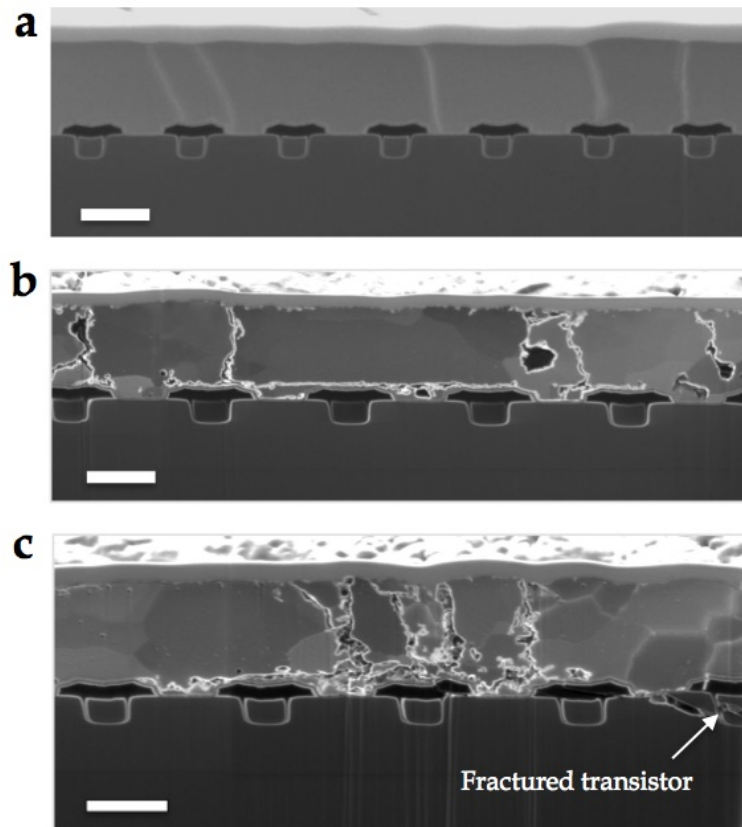
Figure 90: SIM images of the naked metallization cross-sections of (a) as-is, (b) 70°C aged and (c) 25°C aged power modules. The top layer ( $\sim 1\mu\text{m}$  thick) is the Pt protective coating to prevent curtaining artefacts on the imaging faces. Scale bar  $2.5\mu\text{m}$ .

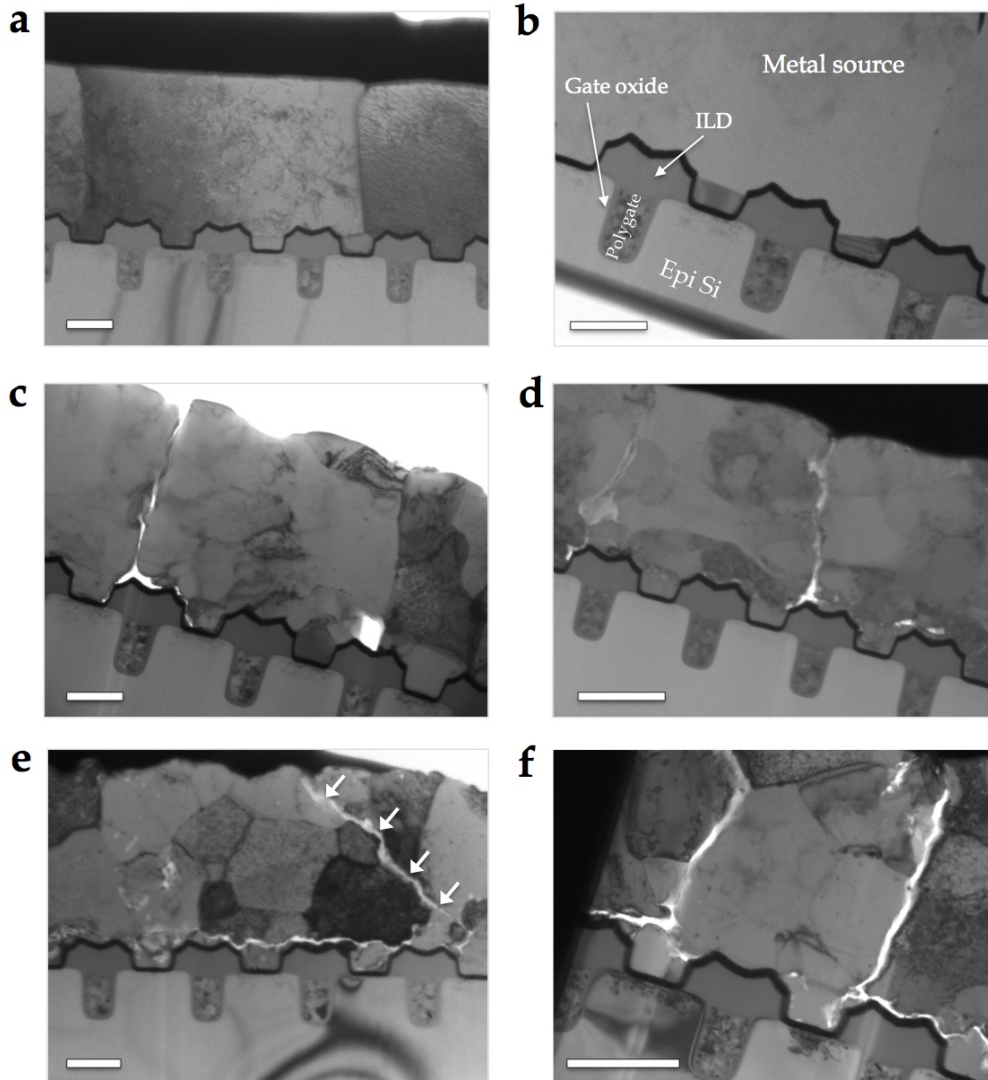
Figure 91: TEM images of some details of the transistor/metallization area from the naked metallization of an (a, b) as-is, (c, d) 25°C aged and (e, f) 70/degree C aged power modules. The trench MOSFET layered structure is described in (a) and consists in: metal source, interlayer dielectric (ILD), gate oxide and polySi (Poly Gate), epitaxial Si. Scale bar: 1  $\mu\text{m}$ .

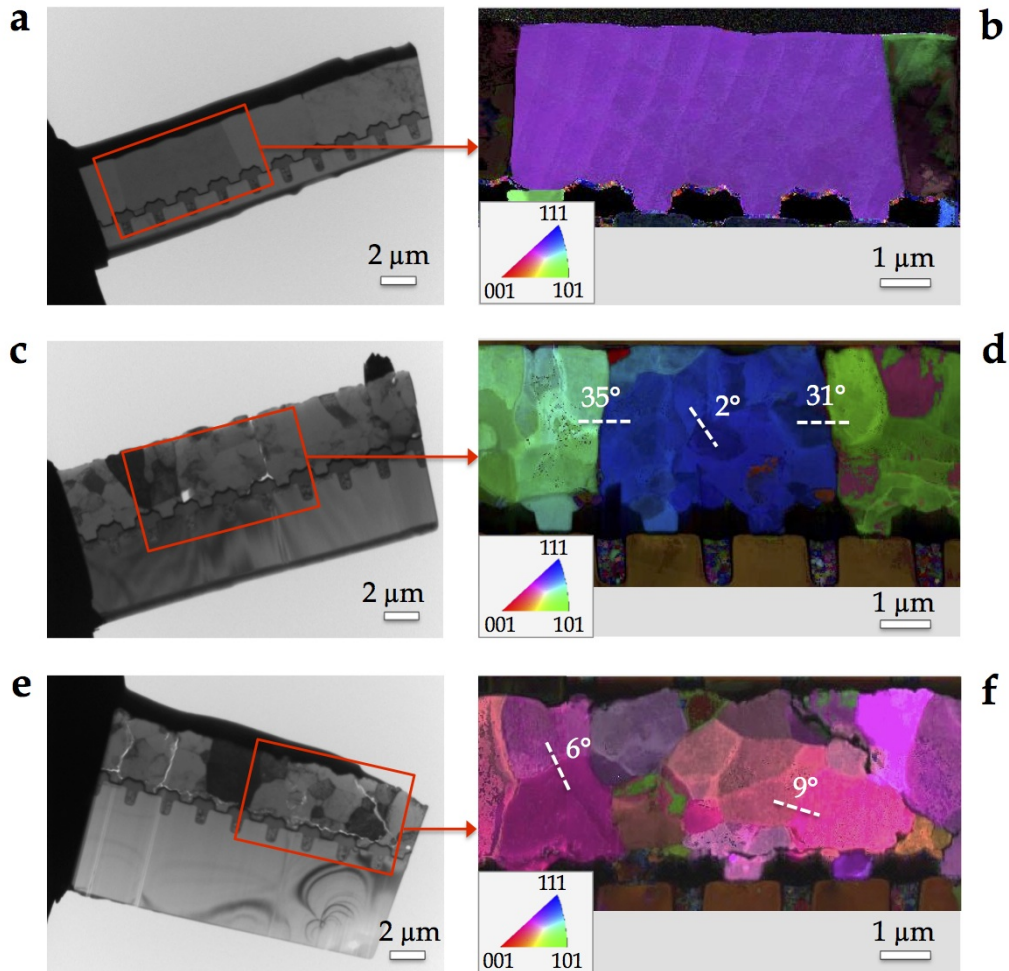
Figure 92: TEM images of FIB lamella extracted from the naked metallization of an (a) as-is, (c) 25°C aged and (d) 70°C aged power modules. ACOM mapping relative to the red area in the TEM images for the (b) as-is, (d) 25°C aged and (f) 70°C aged lamella. The standard stereographic triangle gives the color codes of the grain orientations, taken here along the horizontal direction, perpendicular to the growth direction, in order to have better visibility (the relative misorientation between subgrains does not change along the three axis).

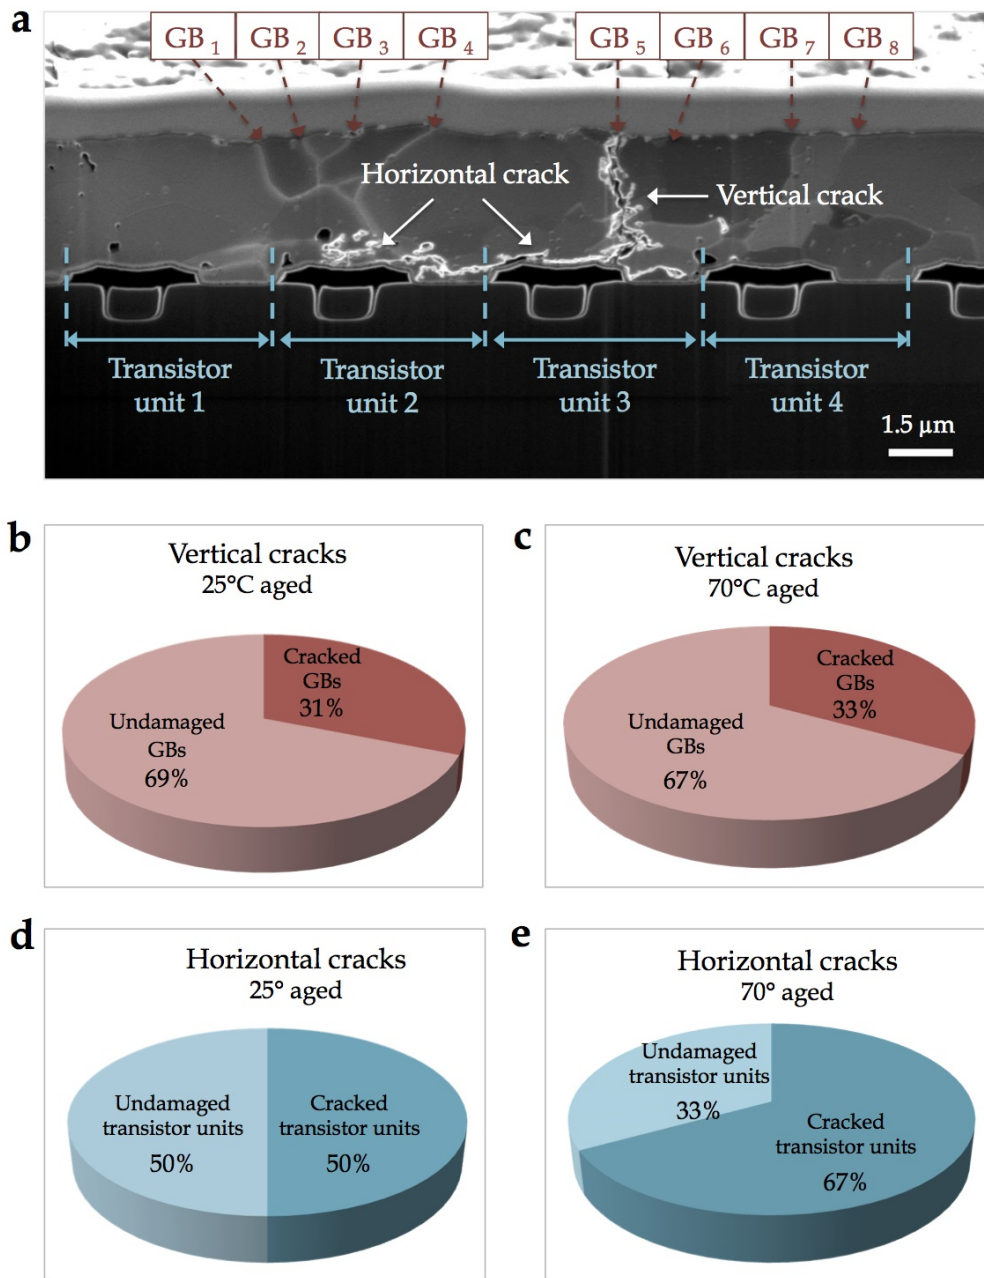
Figure 93: Horizontal and vertical cracks statistics in a 25°C and 70°C aged module. (a) Vertical cracks are evaluated by counting at the metal surface the number of cracked (GB<sub>5</sub>) and undamaged (GB<sub>1</sub> – GB<sub>4</sub> and GB<sub>6</sub> – GB<sub>8</sub>) grain boundaries. Horizontal cracks are evaluated by counting the number of transistor units with cracks on top (Transistor unit 2 and Transistor unit 3) with respect to the undamaged ones (Transistor unit 1 and Transistor unit 4). The ratio of cracked vs undamaged GBs is showed in (b) for a 25°C aged module and in (c) for a 70 °C aged one. The ratio of cracked vs undamaged transistor units is showed in (d) for a 25°C aged module and in (e) for a 70 °C aged one.

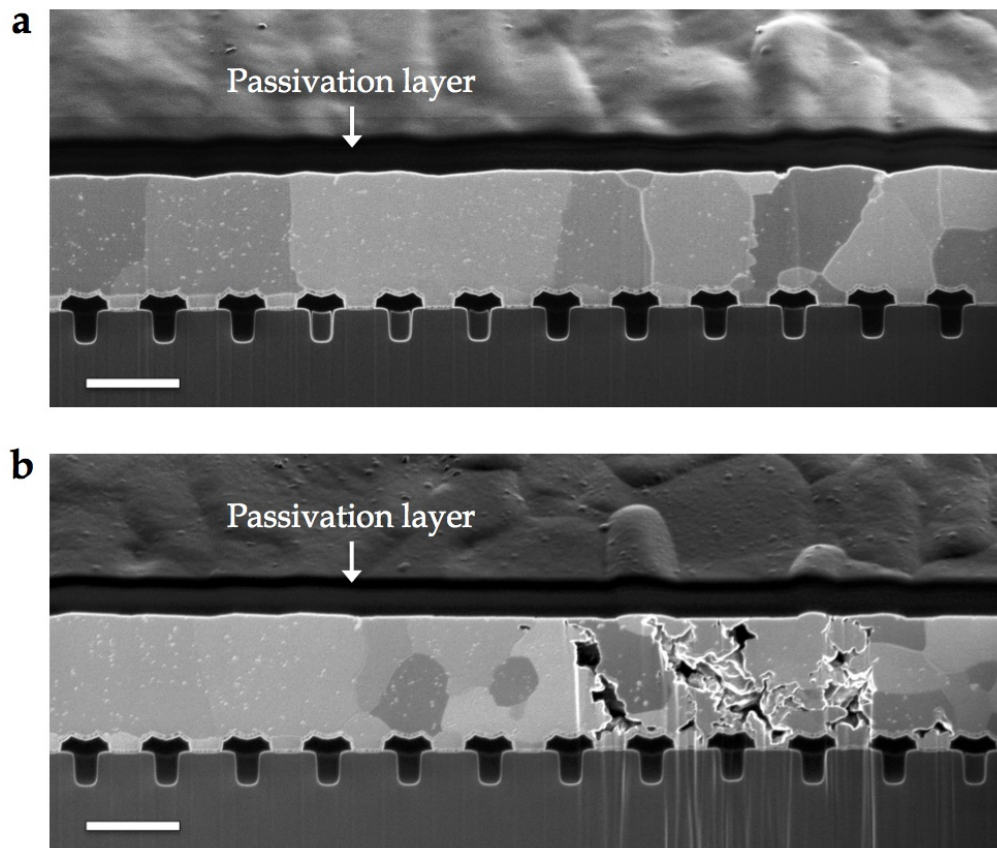
Figure 94: SIM image of the Al top metallization coated by  $\text{SiO}_2$  passivation from two close cross-sections in a  $70^\circ\text{C}$  aged module.

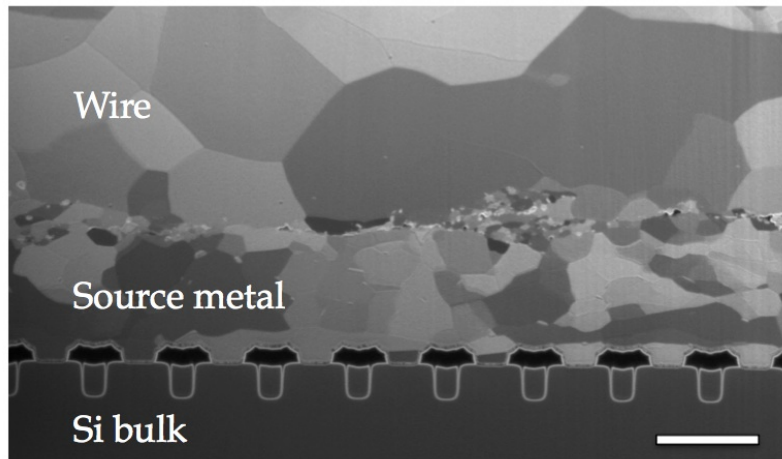
Figure 96: SIM images of the wire-source metallization interface, at the center of the bonding wire, in an as-processed module. Scale bar  $2.5\ \mu\text{m}$ .

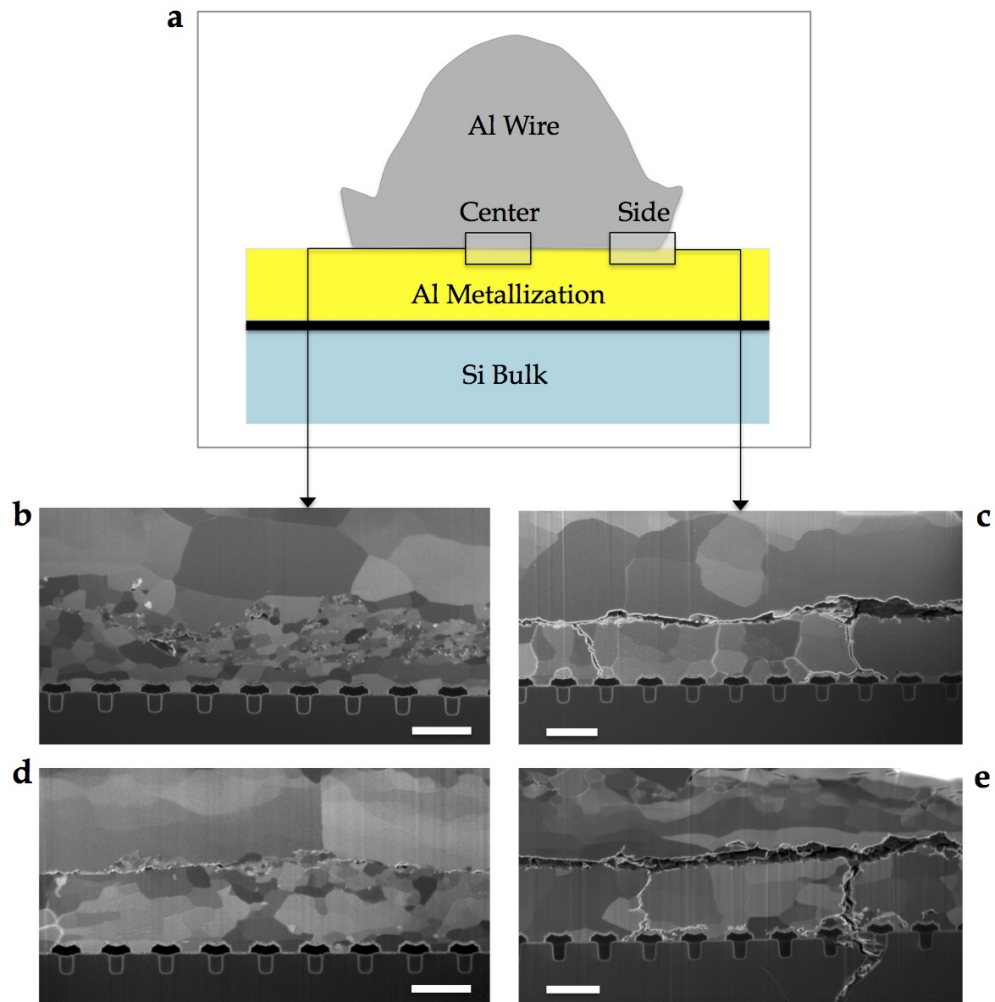
Figure 98: (b) Central and (c) side SIM images of the wire-metallization interface in a 25°C aged module. (d) Central and (e) side SIM images of the wire-metallization interface in a 70°C aged module. The images correspond to the FIB cross-section locations ("center" and "side") in the schema in (a). Scale bar 2.5  $\mu\text{m}$ .

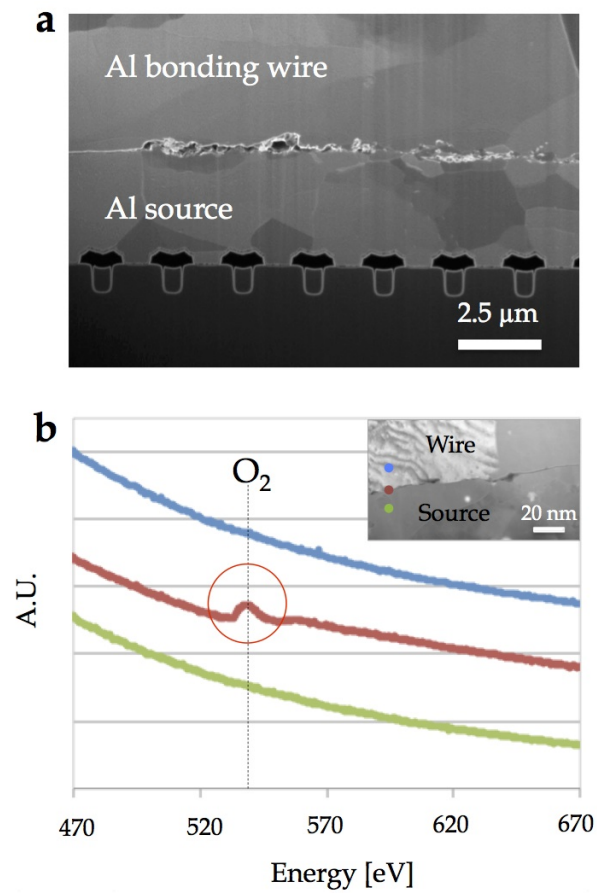
Figure 99: (a) SIM image of the initial artifacts which characterize the wire-metallization bonding of an as-is module. (b) EELS spectra from the wire (in blue), the metallization (in green) and the wire-metallization interface (in red). The red spectrum at the wire-metallization interface reveals the presence of oxygen.

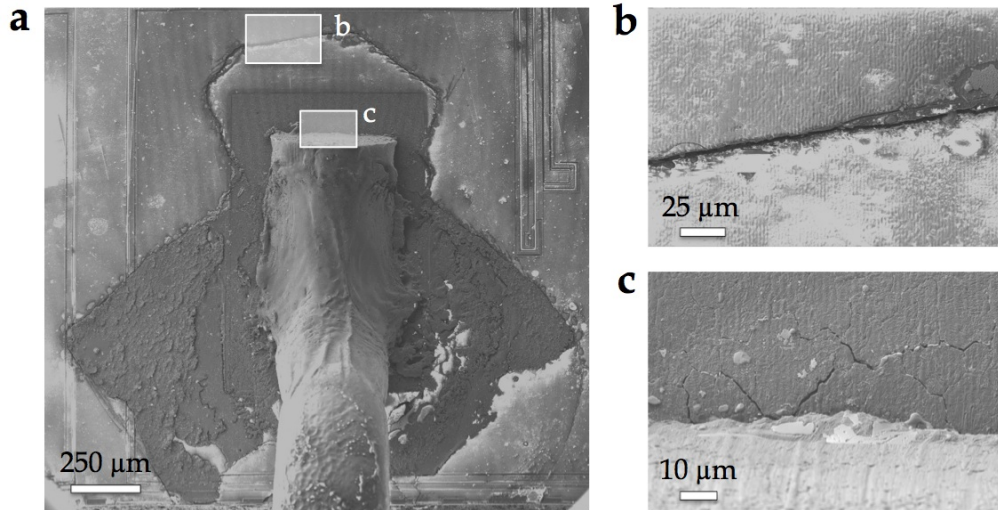
Figure 105: (a) Top view SEM image of an Al bond wire welded on the Al source metallization in a  $25^\circ\text{C}$  aged device, after a short-circuit event. At higher magnification, big cracks propagating in (b) the passivated metallization and (c) next to the bonding wire (located in the boxes (b) and (c) in (a)).

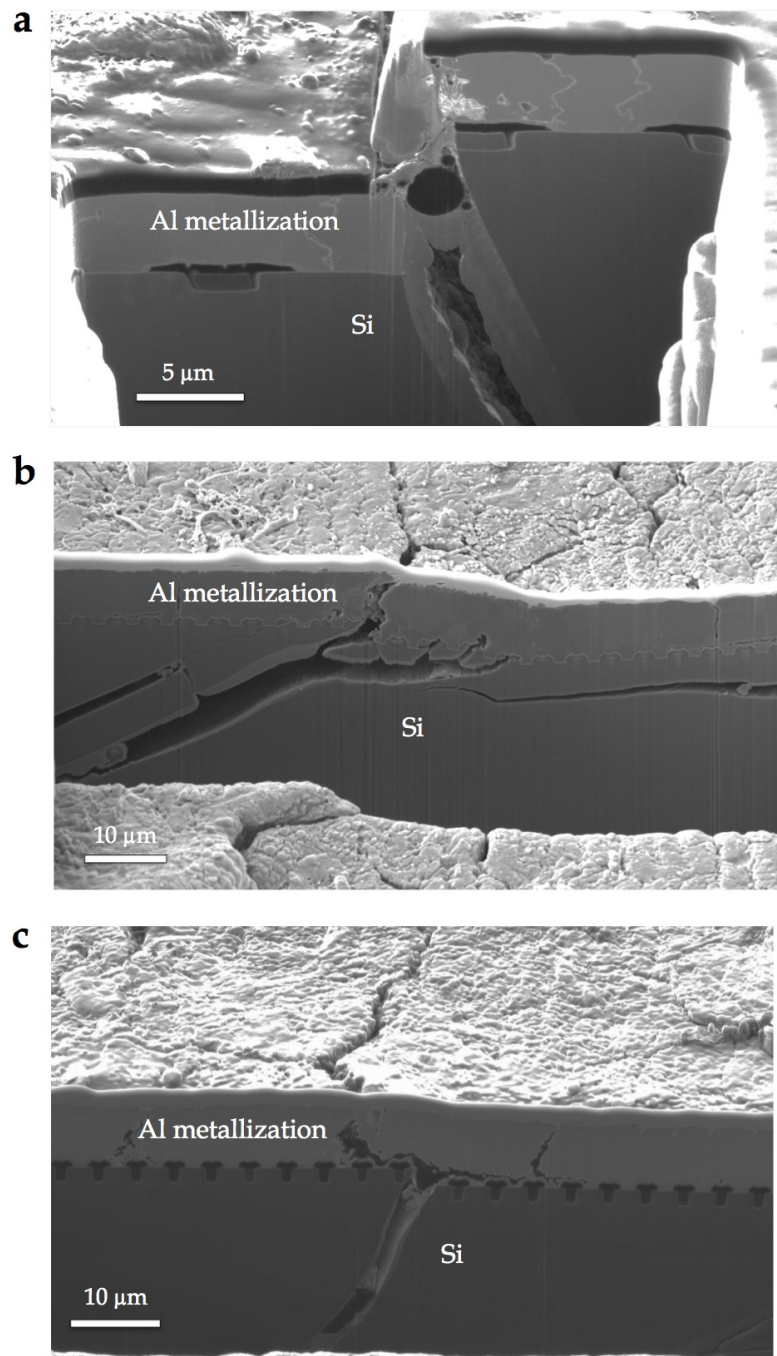
Figure 106: Cross-sectional SEM images of the heavily cracked metallization (a) in the passivated area and (b) close to the melted bonding wire of the module depicted in (Fig. 105a).

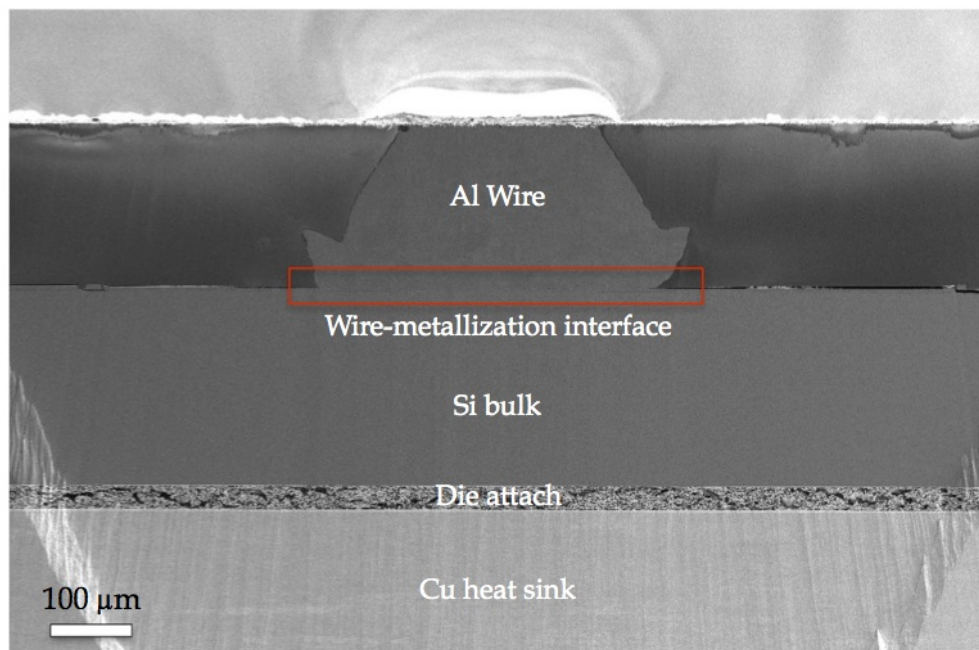
Figure 107: SEM image of a cross-section prepared by Cross Polisher system in an as-is module. The large cut area shows the power die layered structure: Al wire, Si bulk and Cu heat sink. The Al source metallization on the transistor area, at interface with the semiconductor, is not visible at this scale. The red area indicates the location of the Al wire-metallization interface that is shown in detail in Fig. [108a - n](#).

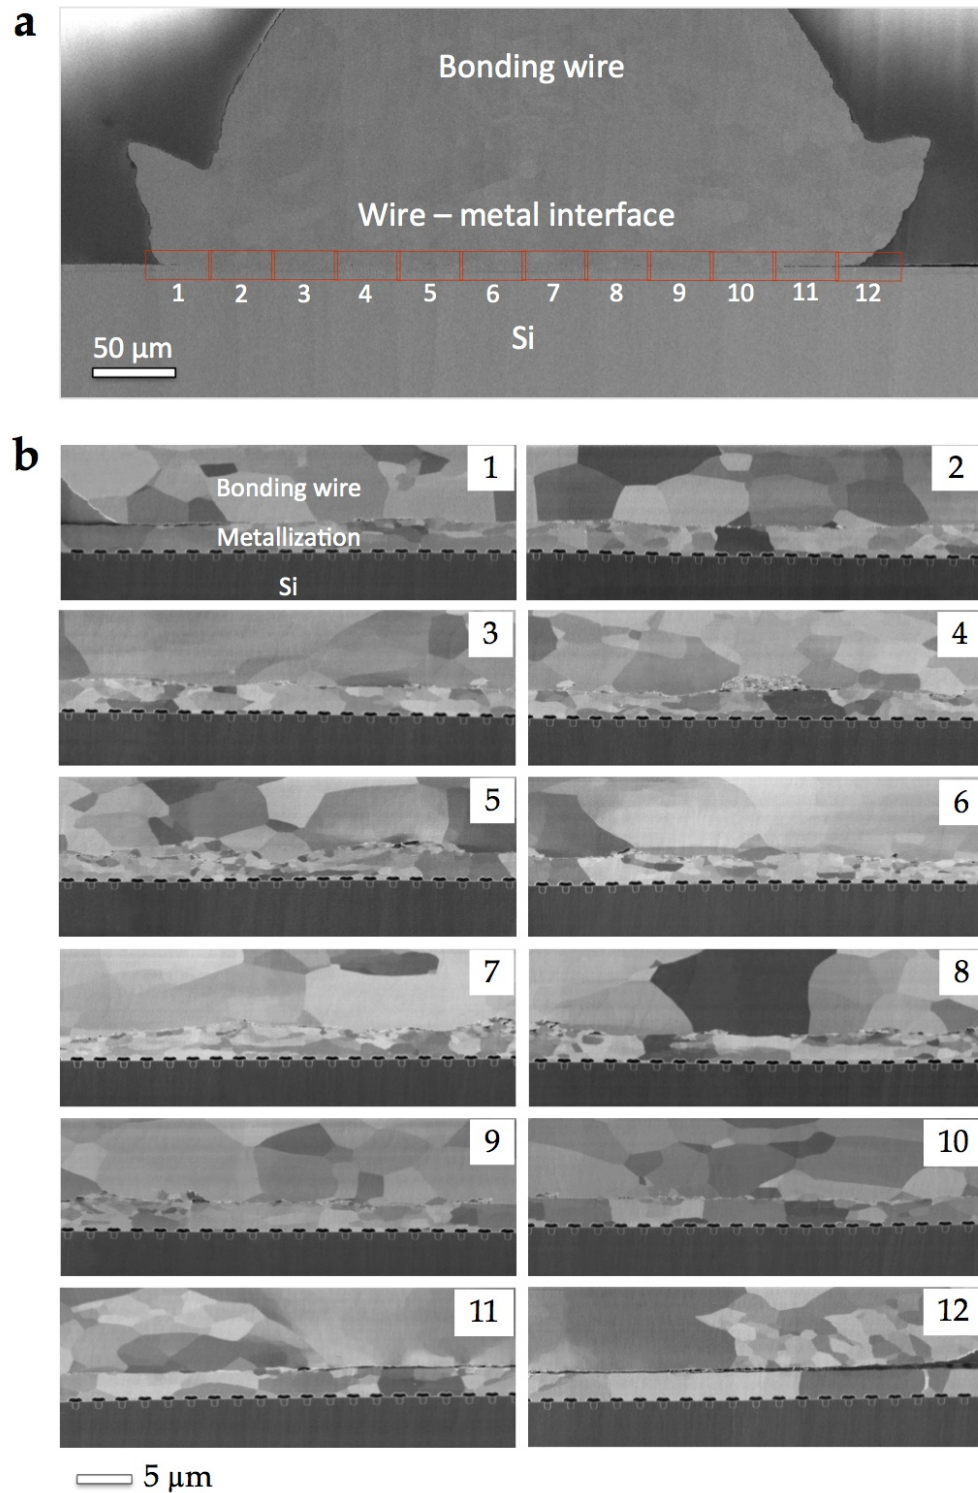
Figure 108: (b) SIM images mosaicing of the whole wire-metallization cross-section prepared by cross-polisher, according to the schema in (a). The images sequence offers a global vision of the metallization grain structure under the bonding wire and of the wire metallization interface. It can be used to calculate the total amount of deformed area due to the bonding process.

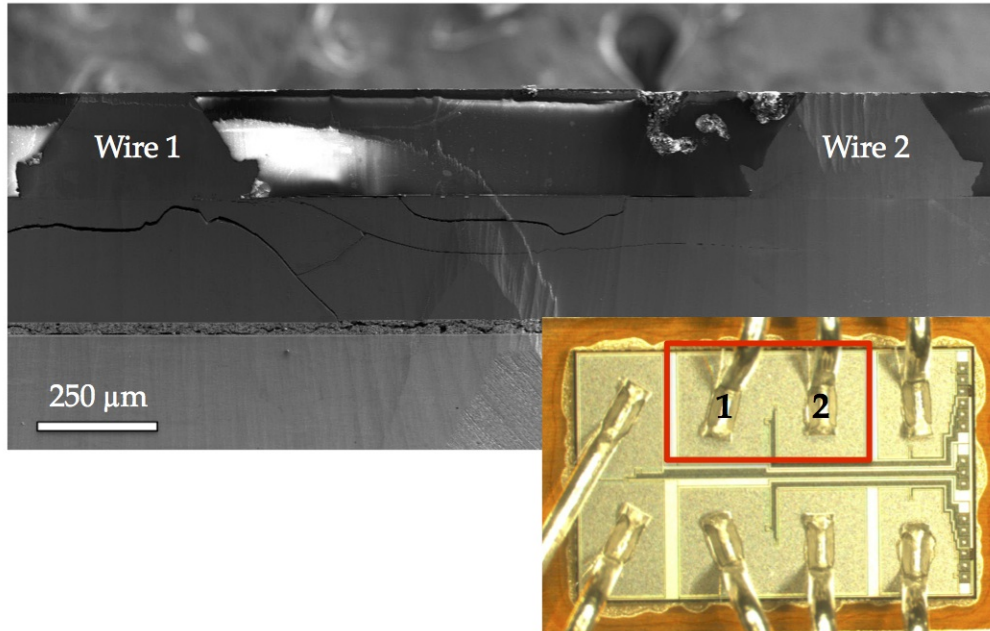
Figure 109: SEM overview of a 70°C aged module prepared by CP for the SEM/SIM inspection. In the insert, optical image image of the T07D17 device, showing the position in the aged module (in red) of wire 1 and 2 under investigation.

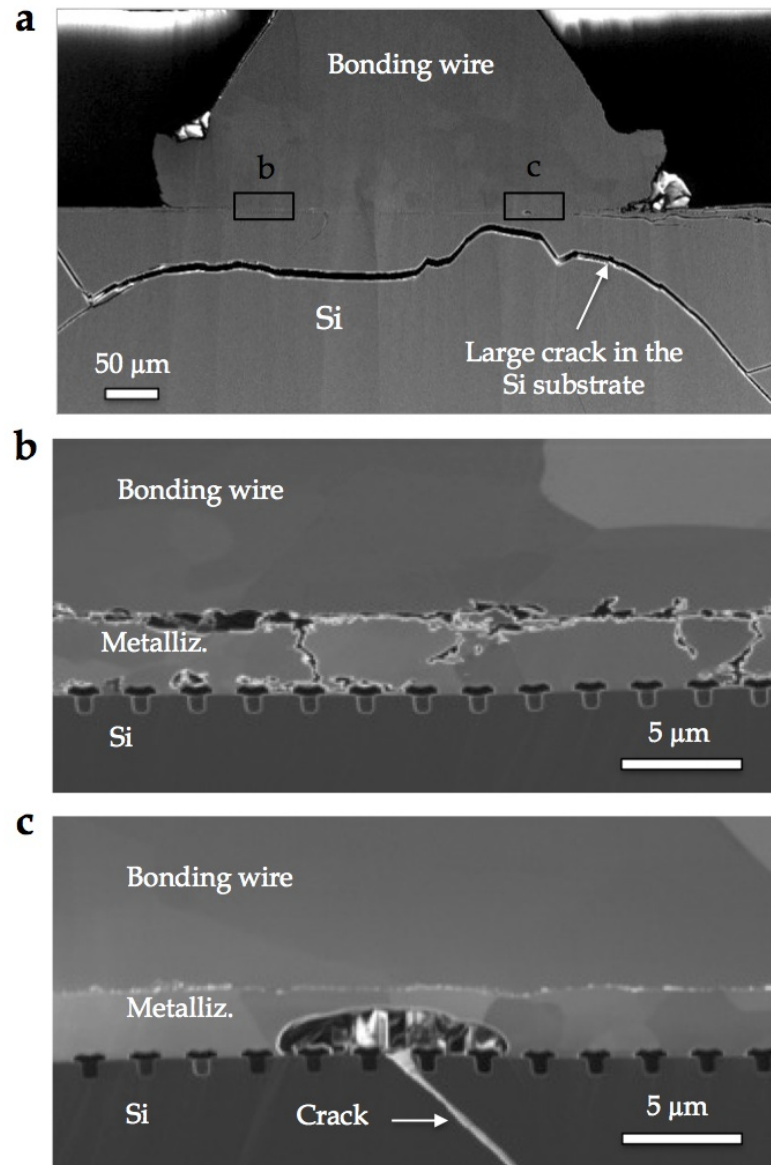
Figure 110: (a) SEM cross-sectional imaging of the bonding wire from an aged power module (70 °C aged) showing different types of cracks; (b), (c) ionic higher magnification images of the wire- metallization interface located in the boxes (b) and (c) in (a). The die crack resulted from an electro-thermal event occurring at failure time.
