# Fatigue mechanisms in Al-based metallizations in power MOSFETs

**Fatigue mechanisms in Al-based metallizations in power MOSFETs**

This thesis, a collaboration between CEMES-CNRS, Satie laboratory (ENS Cachan) and NXP Semiconductors is motivated by the comprehension of the failure mechanisms of low voltage power MOSFET devices produced for applications in the automotive industry.

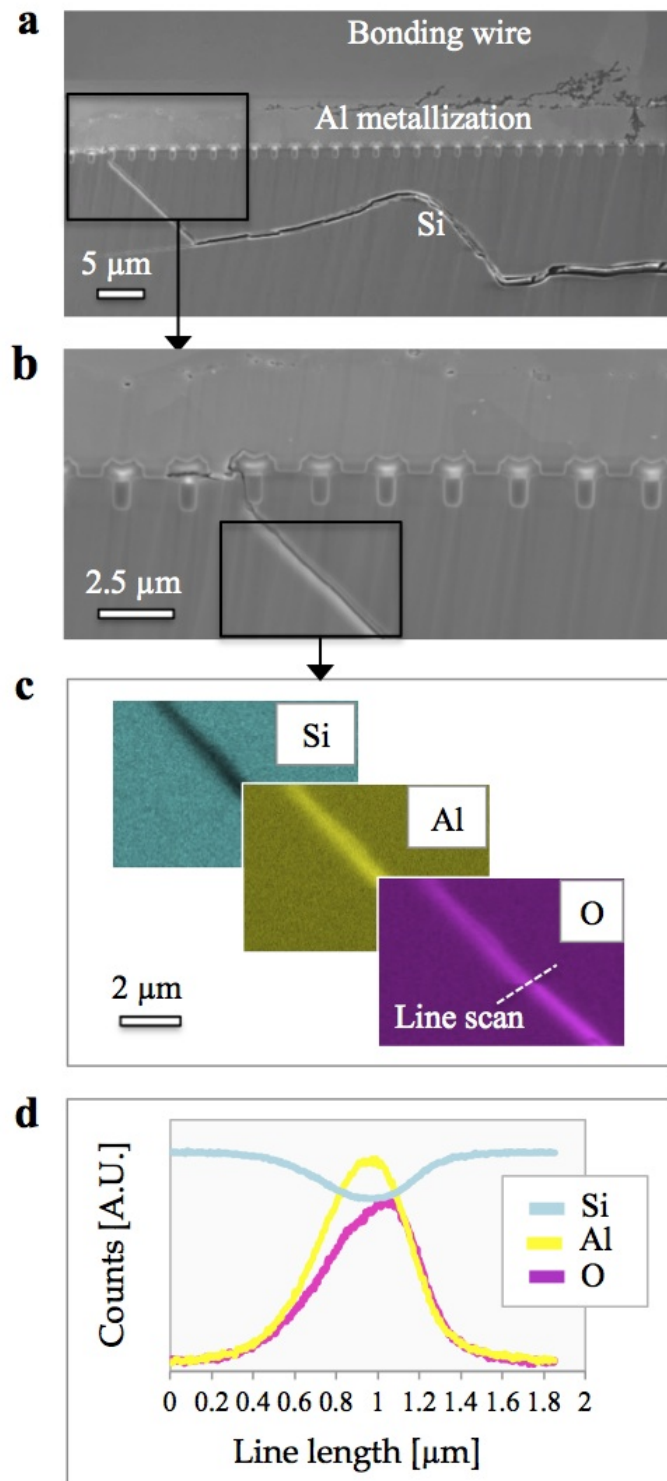
Figure 111: (a) Low and (b) high magnification SEM image of the cracked Si bulk under the bonding contact. (c) EDX mapping of the crack in the Si bulk and (d) relative line scan plot showing the element distribution along the dashed line in (c).

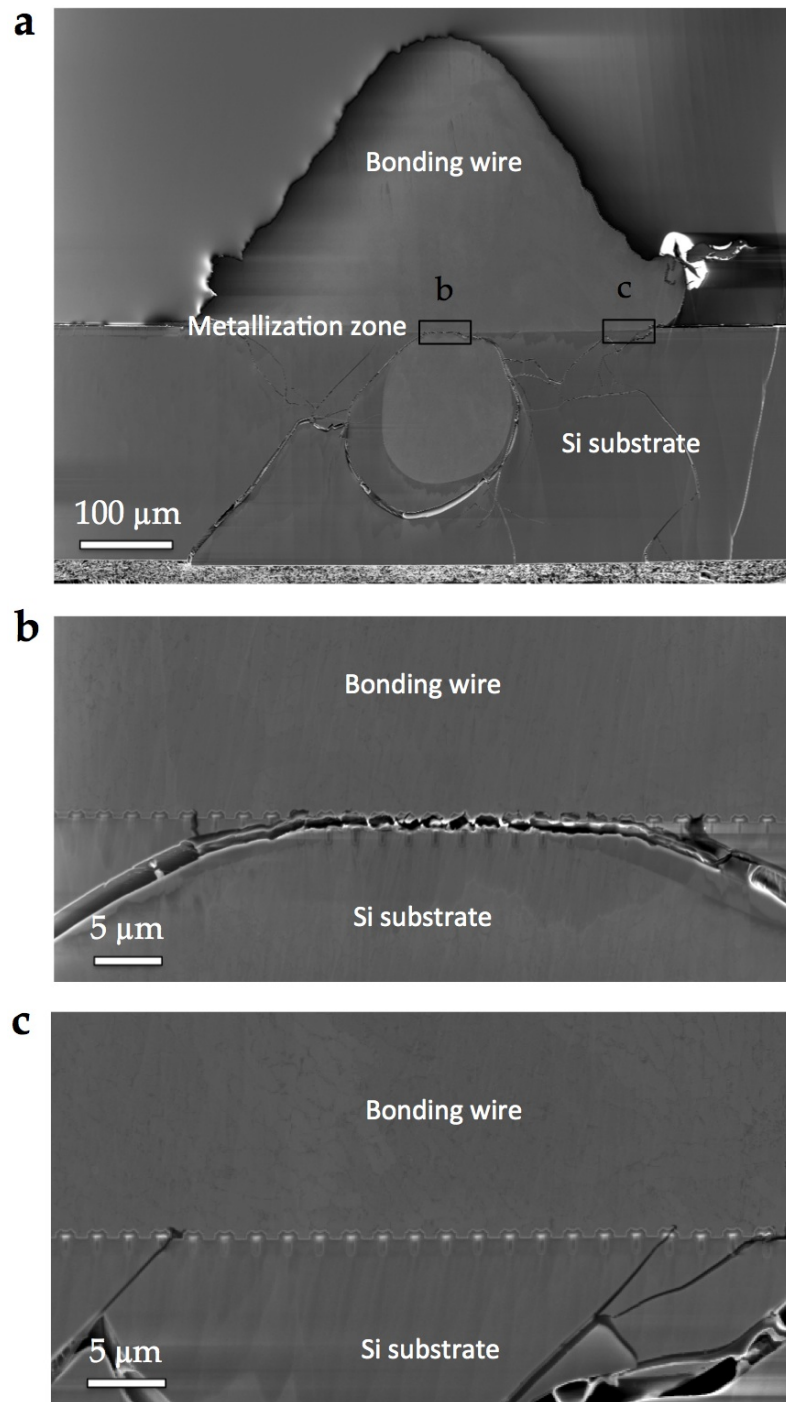
Figure 114: (a) SEM cross-sectional imaging of the bonding wire from an aged power module (25 °C aged) showing different types of cracks; (b), (c) higher magnification images of the wire- metallization interface located in the boxes (b) and (c) in (a). The die crack resulted from an electro-thermal event occurring at failure time.

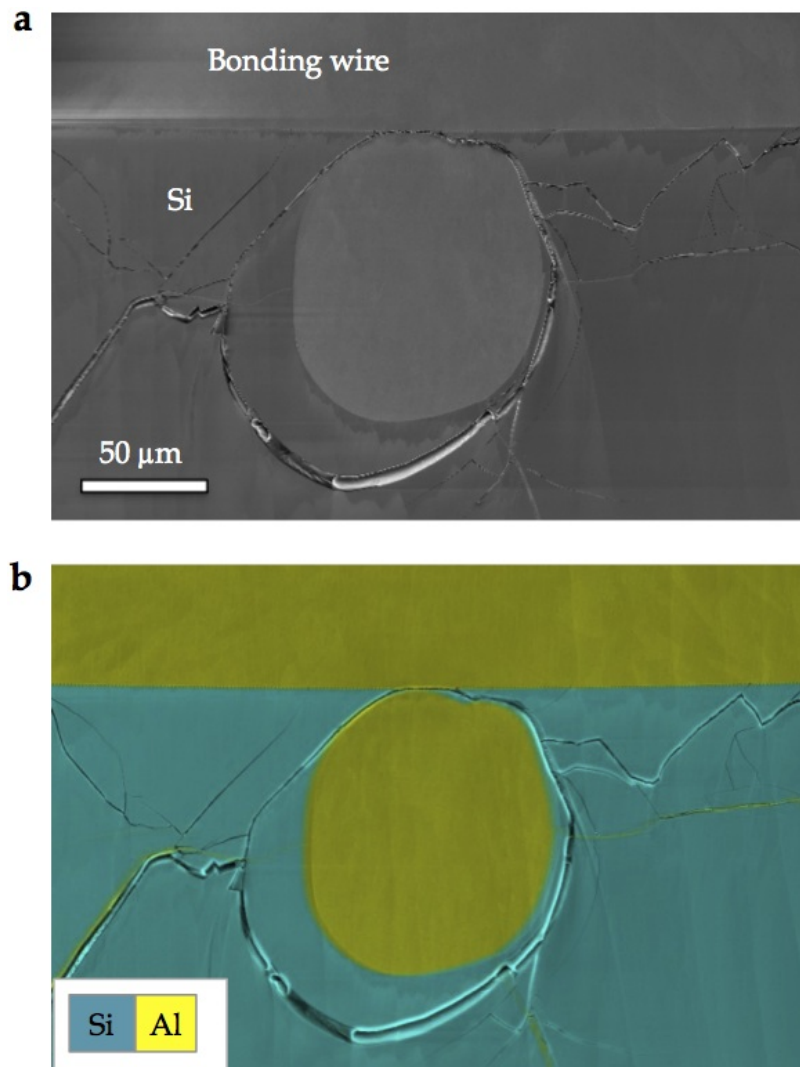
Figure 115: (a) SEM cross-sectional imaging of the round shape feature in the Si substrate (Al contrasted like) from an aged power module (25 °C aged); in (b) the corresponding EDX maps of the Si (in light blue) and Al (in yellow) are overlapped, showing that the round shape feature in the Si substrate is made out of Al. This has probably diffused from the top wire during the short-circuit event, because of the local melting of the metallic parts at high temperature.

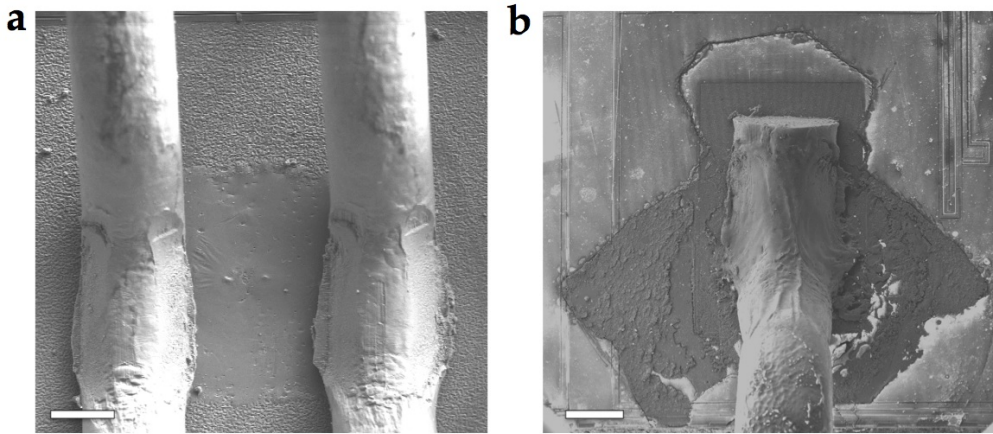
Figure 118: Burnout spots detected after failure (a) between two bond wires in a SPD06 module and (b) at the bonding connection in a To7D17 module. Scale bar: 250 $\mu$ m.

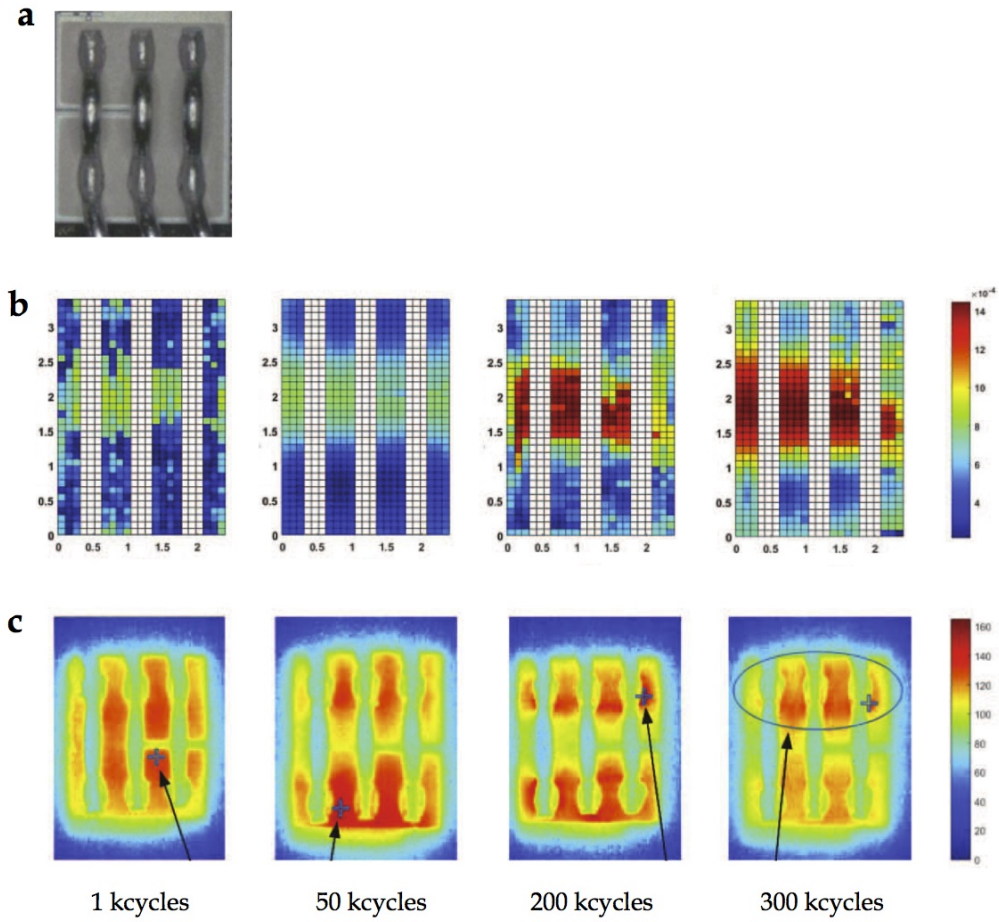
Figure 121: (a) Active module of an SPD06 device under aging test. Potential and temperature mapping of its surface have been performed during aging.  
 (b) Source voltage mapping [V] at  $I_D = 1A$  under SC conditions, after 1kcycles, 50 kcycles, 200 kcycles and 300 kcycles.  
 (c) Temperature distribution [K] under SC conditions, after 1kcycles, 50 kcycles, 200 kcycles and 300 kcycles. Areas where the temperature is lowest correspond the bonding connections, according to the picture of the active module in (a).

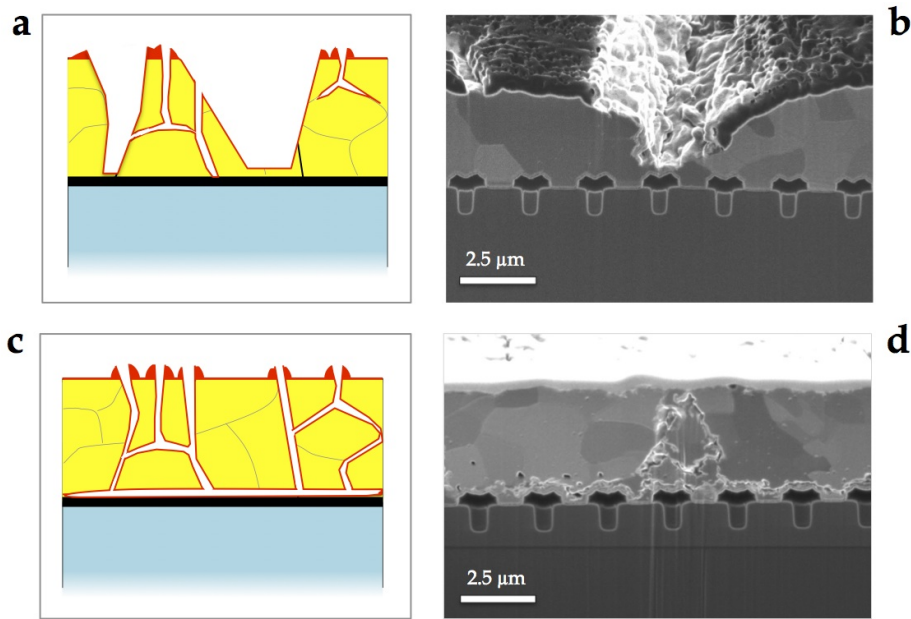
Figure 126: Crack propagation models through the Al layer at failure. (a) For SPD06 power modules at the final aging stage until failure, fatigue cracks running from the surface along the grain boundaries become broader and broader. (b) SIM cross-sectional image of the cracked metal in a failed SPD06, showing a crack width on the same order of the metallization thickness. (c) In To7D17 failed power modules, finer vertical cracks branch out and propagate horizontally all along the MOSFETs region. (d) Relative SIM cross-sectional imaging from a 70°C aged module.

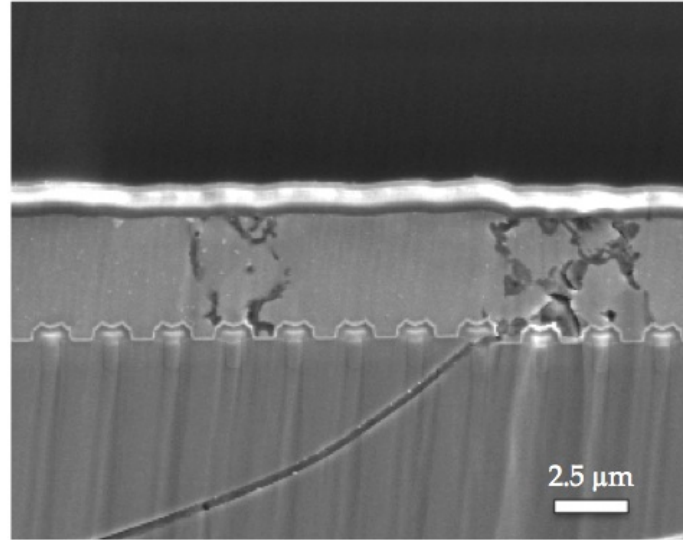
Figure 127: SEM cross-sectional image showing the whole metal-oxide-semiconductor crossed by cracks in a 70°C aged To7D17 module.

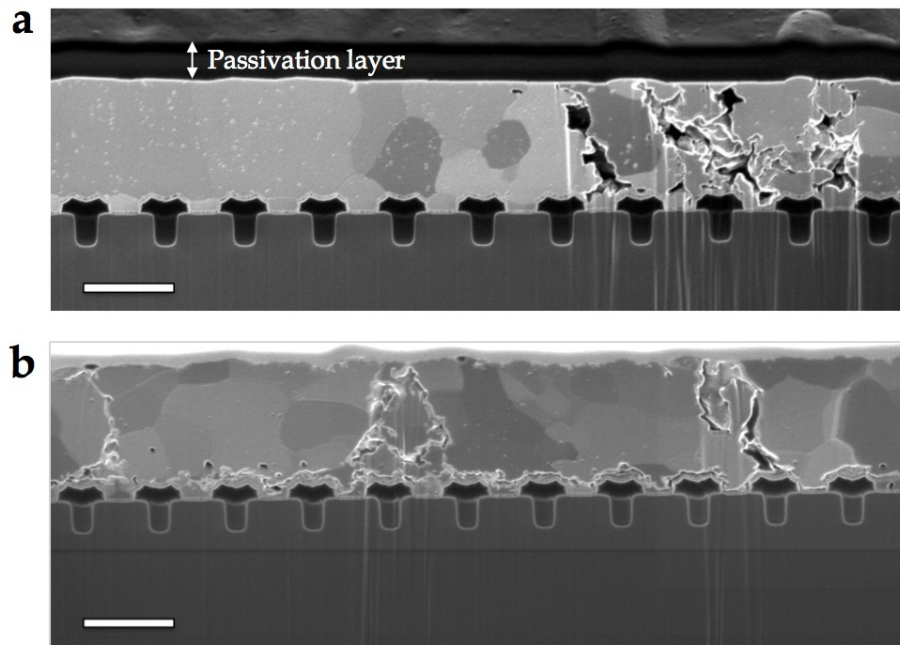
Figure 128: Cross-sectional SIM images of the (a) passivated and (b) bare Al source metallization, showing a localized propagation of vertical cracks in the first one and a generalized degradation in the second one, with horizontal cracks branching out all along the metal-transistor interface. Scale bar: 2.5μm

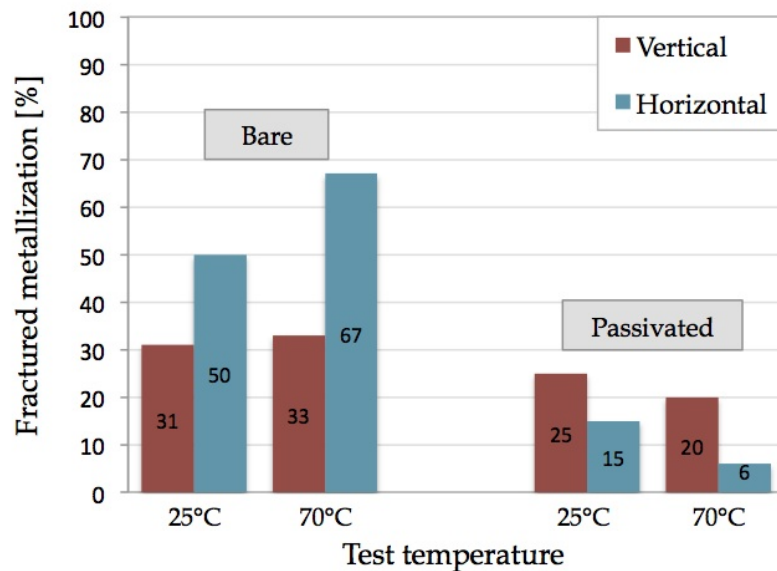
Figure 129: Metallization crack statistics for a To7D17 module aged at 25 °C and 70 °C, in non passivated –bare– (left) and passivated (right) zones.

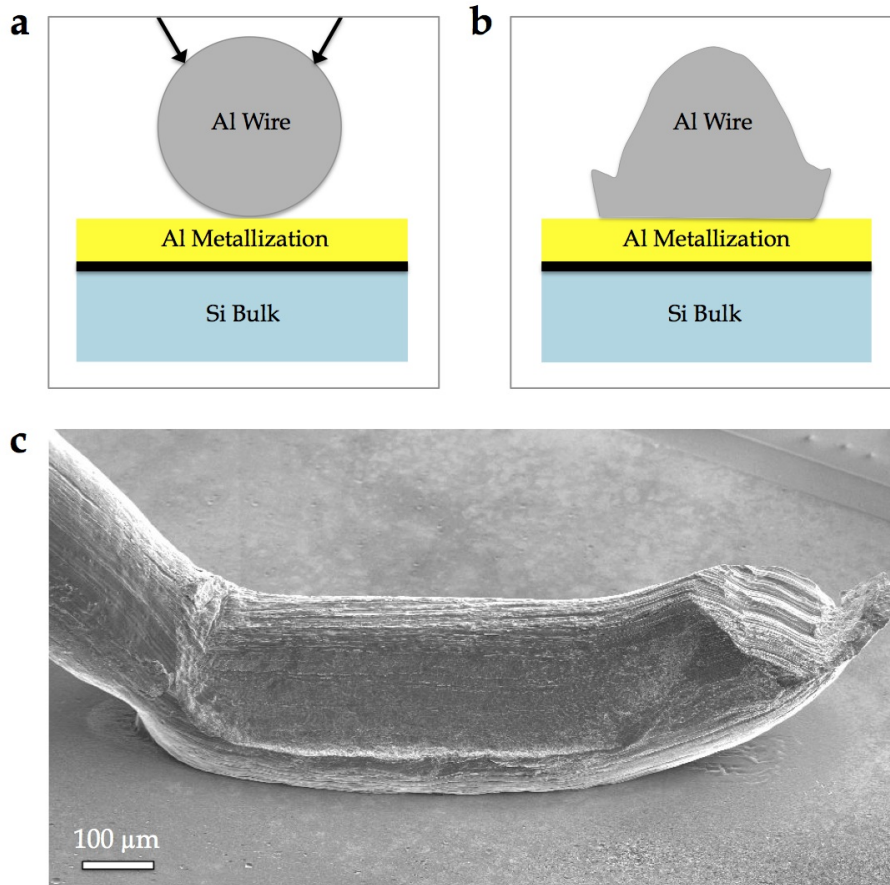
Figure 130: Cross-sectional schema of the cylindric wire on the top metallization (a) before and (b) after bonding process. The black flashes in (a) represent the force direction during the bonding process. (c) Lateral view SEM image of the elliptical bond area.
