# Fatigue mechanisms in Al-based metallizations in power MOSFETs

Roberta Ruffilli. Fatigue mechanisms in Al-based metallizations in power MOSFETs. Condensed Matter [cond-mat]. Université Paul Sabatier (Toulouse 3); École doctorale Sciences de la Matière, 2017. English. NNT: . tel-01666437v2

**Fatigue mechanisms in Al-based metallizations in power MOSFETs**

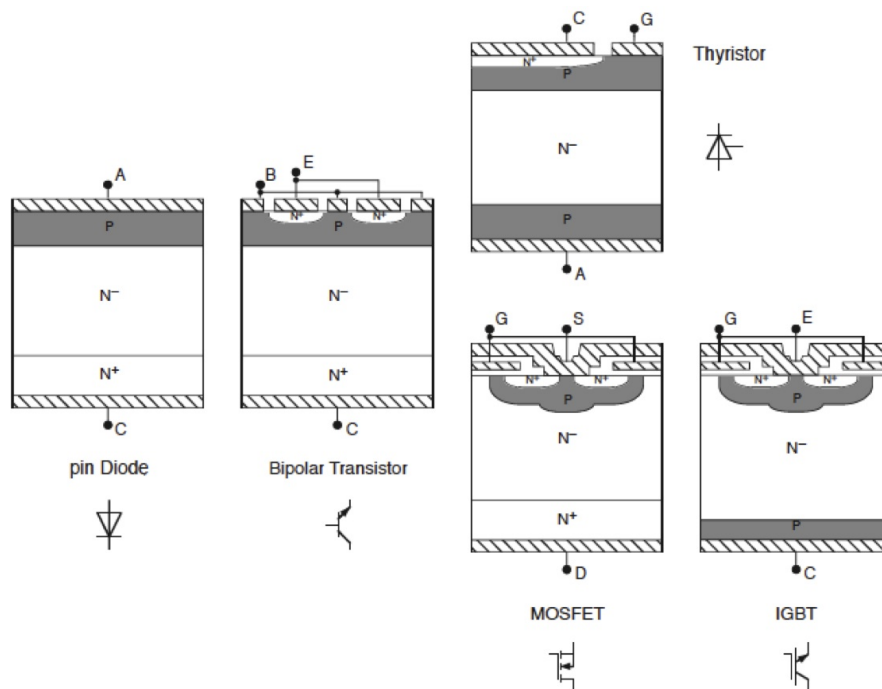
Figure 1: Basic structures of common power semiconductor devices [Lut11].

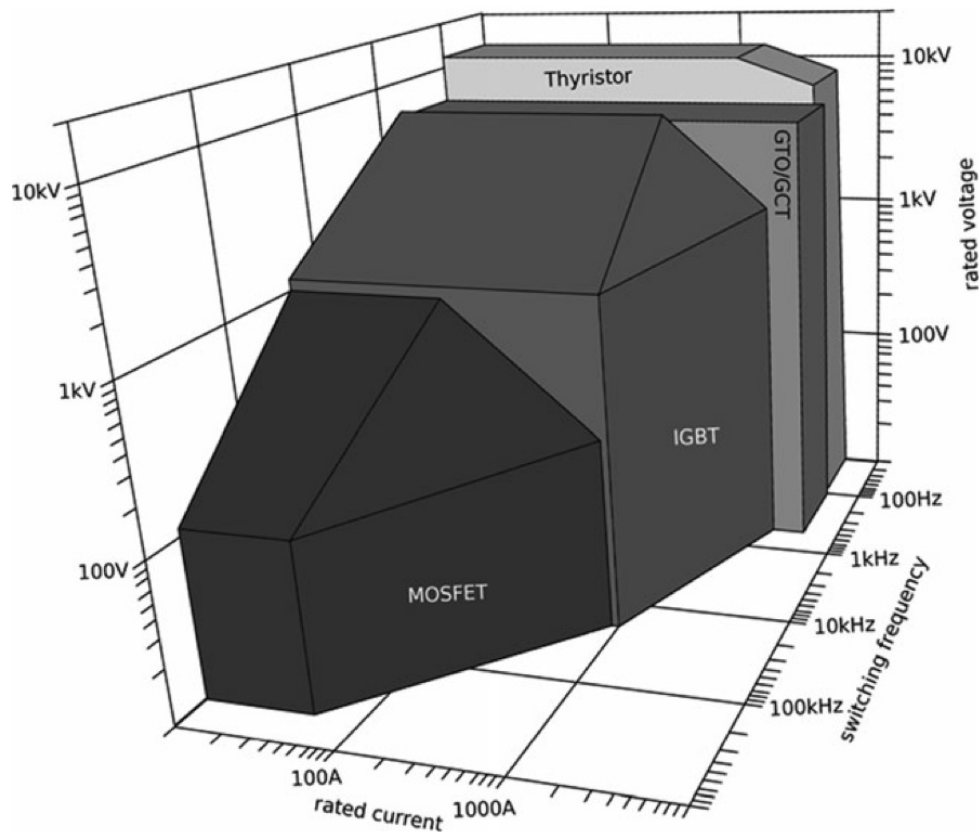
Figure 2: Operating range of silicon power semiconductor devices [Lut11].

Fig. 2 illustrates the practical application range of each type of silicon device in classical switching power converters. Note that for these applications the operation ranges are within a hyperboloid. This suggests that the product of switching power (product of maximum voltage and current) and switching frequency that can be attained per device in practical conversion systems using silicon devices appears to be fairly constant. This frequency-power product is

a good performance indicator for how well the designer was able to maximize utilization of the power semiconductors and to improve the power density of the converter [Lut11]. For high power applications ( $> 10^3$  kW), a GTO (gate turn-off) thyristor would be the first choice. However, they will be limited by a low switching frequency. On the other hand, for lower power applications, different possibilities could be taken into account depending on the switching frequency: bipolar transistor for low frequencies ( $< 10$  kHz), the IGBT for medium frequencies (10-100 kHz) and MOSFET for high frequencies ( $> 100$  kHz).

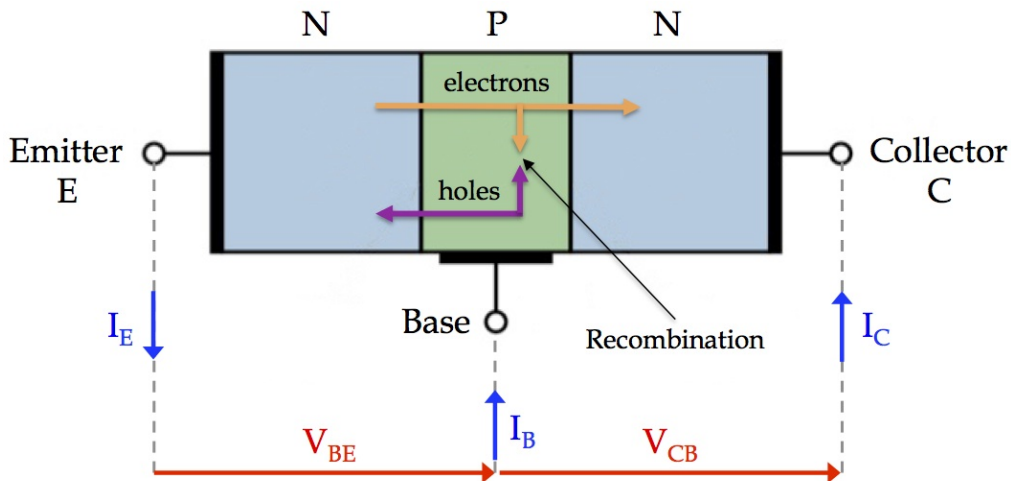
Figure 3: Bipolar transistor general structure.

A bipolar transistor consists of a three-layer sandwich of doped semiconductor materials, either NPN or PNP, separated by two PN junctions. The N areas contain an excess of electrons, whereas the P area an excess of holes (or a lack of electrons). The principle of operation of the two transistor types, PNP and NPN, is exactly the same the only difference being in their biasing and the polarity of the power supply for each type. A BJT has three terminals connected to the three doped regions: emitter, collector and base. In a NPN transistor, represented in Fig. 3, the base terminal is connected to the central P-type region, whereas in the PNP type to the central N-type one. The electrical parameters of a BJT are the  $I_E$ ,  $I_C$  and  $I_B$  that are respectively the emitter, collector and base current and  $V_{BE}$  and  $V_{CB}$  that are the emitter base voltage and collector base voltage respectively.

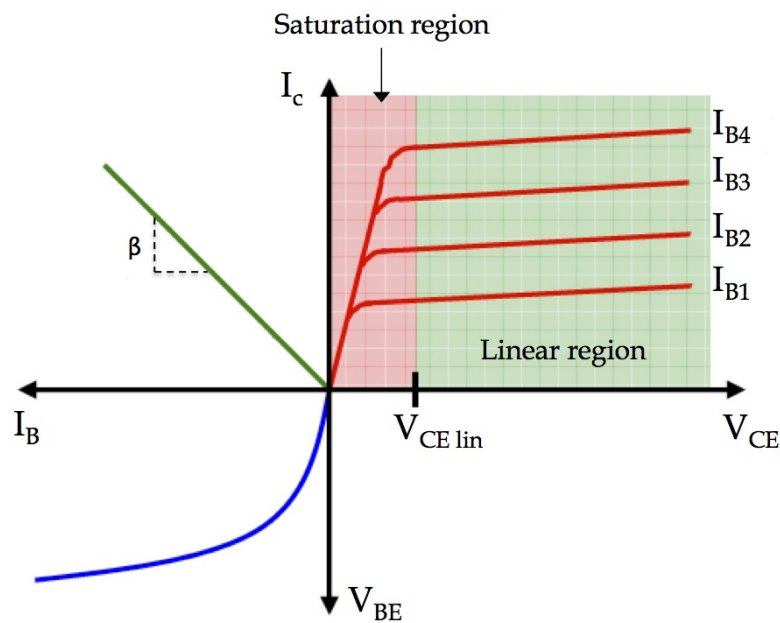
Figure 4: Electrical characteristic curves of a NPN bipolar junction transistor. The blue curve corresponds to  $V_{BE} = f(I_B)$ . The red curves correspond to  $I_C = f(V_{CE})$  at increasing  $I_B$  values. The red area ( $V_{CE} < V_{CE\ lin}$ ) indicates the saturation region whereas the green one ( $V_{CE} > V_{CE\ lin}$ ) the linear region. The green curve corresponds to  $I_C = f(I_B)$ .  $\beta$  is the curve slope, that is the device gain.

Fig. 4 shows the qualitative characteristic curves of a BJT. The plot summarize the three regions of operation: the saturation, the cutoff, the active (each family of curves is drawn for increasing  $I_B$  values):

1. Cutoff region: the base-emitter junction is reverse biased, then no current flows in the device.
2. Saturation region ( $V_{CE} < V_{CE\ lin}$ ): the base-emitter and collector-base junctions are forward biased, with  $V_{CE} < V_{BE}$ .  $I_C$  reaches a maximum value which is independent from  $V_{CE}$ .
3. Linear region ( $V_{CE} > V_{CE\ lin}$ ): the base-emitter junction is forward biased, while the collector-base junctions is reverse biased, with  $V_{BE} < V_{CE} < V_{CC}$ .  $I_C$  is proportional to  $I_B$ ,  $I_C = \beta I_B$ . The transistor can be considered as a current amplifier with gain  $\beta$ .

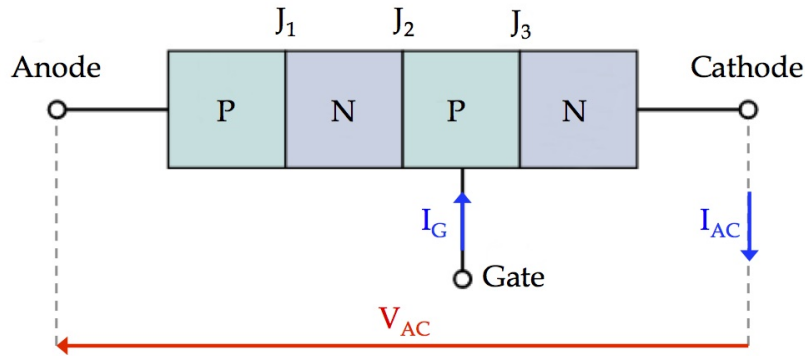
Figure 5: Thyristor general structure. Without the application of any voltage, it has three diffusion regions. If we apply a positive voltage at the anode with respect to the cathode, the junctions  $J_1$  and  $J_2$  become forward biased while  $J_2$  is reverse biased. In this state, if a positive signal is applied at the gate terminal,  $J_2$  turns to forward biased state and current starts to flow. On removal of gate signal, the current continues to flow as charge is drifted from anode to cathode.

Thyristor is basically a four layered pn junction device, with two p and two n portions and three p-n junctions  $J_1$ ,  $J_2$ ,  $J_3$  (Fig. 5). It has three terminals, the anode and the cathode across the four layers, and the gate attached to the p-type layer near the cathode. As represented in Fig. 6, the thyristor operates in three different modes:

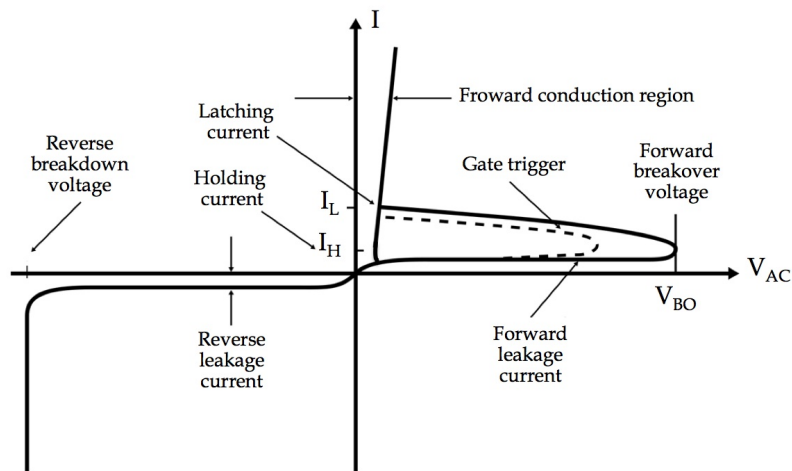
Figure 6: Thyristor static characteristic curve. The thyristor works under three modes: forward conducting mode, forward blocking mode and reverse blocking mode. The minimum anode current that causes the device to stay at forward conduction mode as it switch from forward blocking mode is called the latching current. If the SCR is already conducting and the anode current is reduced from forward conducting mode to forward blocking mode, the minimum value of anode current to remain at the forward conducting mode is known as the holding current.

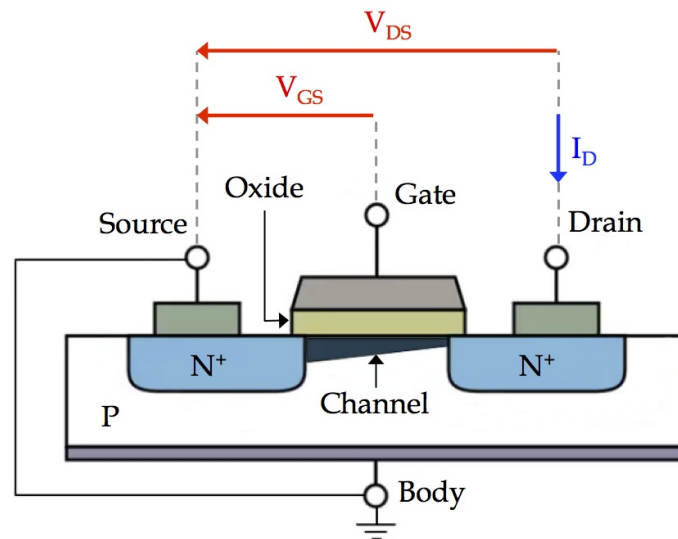
Figure 7: General structure of a nMOSFET. Under a positive  $V_{GS}$ , the charge carriers flow through the channel between source and drain.

A MOSFET transistor consists in four electrodes, represented in Fig. 7: source (S), drain (D), gate (G) and the body (B). It is composed primarily by a large block, the body, of p-type silicon. Into the body, two regions of heavily doped n-type silicon are created to form the source and the drain. Gate is the controlling terminal and it is isolated from the rest of the transistor by an oxide layer sitting between the gate and the channel. This prevents current from flowing into/out of the gate, resulting in a high input impedances ( $10^{12} - 10^{14} \Omega$ ) and a low power consumption, which make the MOSFET the fastest component during switching operations.

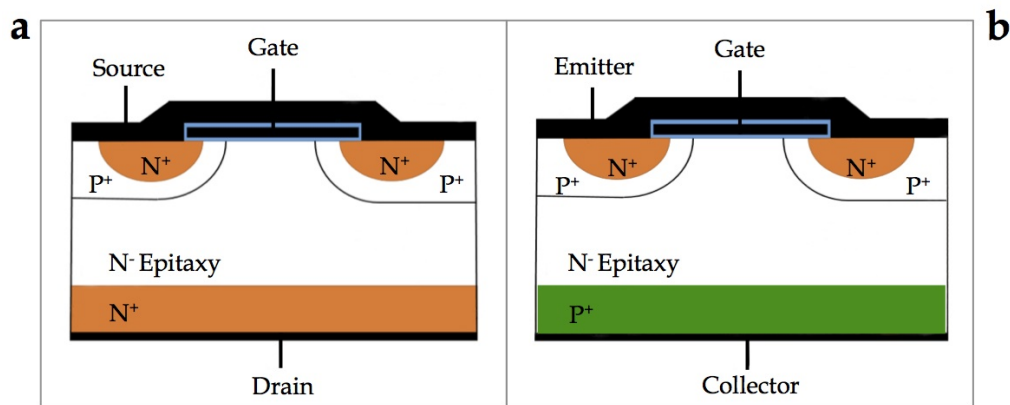
Figure 9: Comparison between (a) a vertical MOSFET and (b) an IGBT. The main difference consists in a n-type substrate in the vertical MOSFET and a p-type substrate in the IGBT (respectively in orange and green).

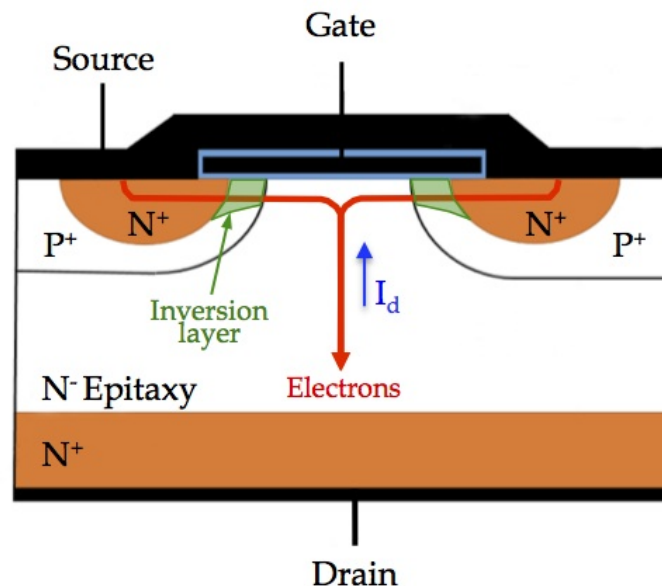
Figure 10: Schema of a VDMOS.

As suggested by the name, vertical MOSFETs (or VDMOS, Vertical Diffused MOS) differ from the lateral MOSFETs (Fig. 7) for their vertical structure (Fig. 10): the source electrode is placed over the drain, resulting in a current mainly vertical when the transistor is in the on-state [Mor96]. More precisely, the source is connected to a highly doped N<sup>+</sup> region that is confined inside a P region under the gate. The vertical channel is then formed between the latter and the N<sup>-</sup> region below, connected to the drain electrode by a N<sup>+</sup> layer. The working principle and electrical characteristic curves of a VDMOS are exactly the same of a planar MOSFET (Section 2.1.3):

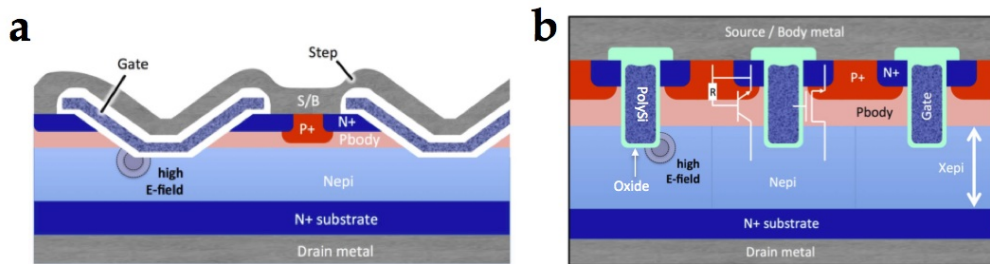
Figure 11: Cross section of (a) a v-groove VDMOS (or VMOS) and (b) of a trench gate vertical MOSFET (or trench VDMOS) [Wil17].

In a trench MOSFET, also called UMOS, the gate electrode is buried in a trench etched in the silicon. The comparison between a vertical v-groove structure (VMOS) and a trench structure is depicted in Fig. 11.

The fabrication process of a trench MOSFET is shortly described by Williams et al. [Wil17]. As shown in Fig. 11b after forming the VDMOS source and body regions, an etched trench of narrow width (e.g., 0.8 to 1.5  $\mu\text{m}$  across) is oxidized to form a gate oxide lining the trench and subsequently filled with phosphorus in situ doped polysilicon. A polysilicon CVD deposition completely fills the trench, overflowing the etched trench onto the silicon surface. Except for a small masked area needed for gate contact, the polysilicon is then "etched back" so that the top surface of the polysilicon gate is recessed, but still overlapping the  $\text{N}^+$  source. Subsequent thermal oxidation caps and seals the recessed polysilicon with a protective layer of oxide. A contact mask then selectively exposes the transistor's surface gate and its numerous cellular source/body regions to an oxide etch (while protecting the oxide above the trench). After contact etch, metal deposition and photolithographic patterning are performed interconnecting a series of separate and distinct trench VDMOS cells into a single three-terminal trench power MOSFET. Except for the polysilicon gate contact, the resulting die surface is nearly planar, so that problematic step coverage issues of the v-groove structure (Fig. 11a) are completely eliminated. The resulting cell pitch was half that of any other vertical device, improving channel-resistance, epitaxial current uniformity, and total  $R_{\text{DS(on)}}$ . As represented in the graph of Fig. 12, increasing cell density of a trench MOSFET decreases the devices  $R_{\text{DS(on)}}$  hyperbolically. In contrast, planar VDMOS or VMOS exhibit a U-shaped dependence, declining in  $R_{\text{DS(on)}}$  with increasing density before reaching a minimum, then rising rapidly at higher densities as a result of a decrease in channel packing density and poor current uniformity in the epitaxial layer [Wil17].

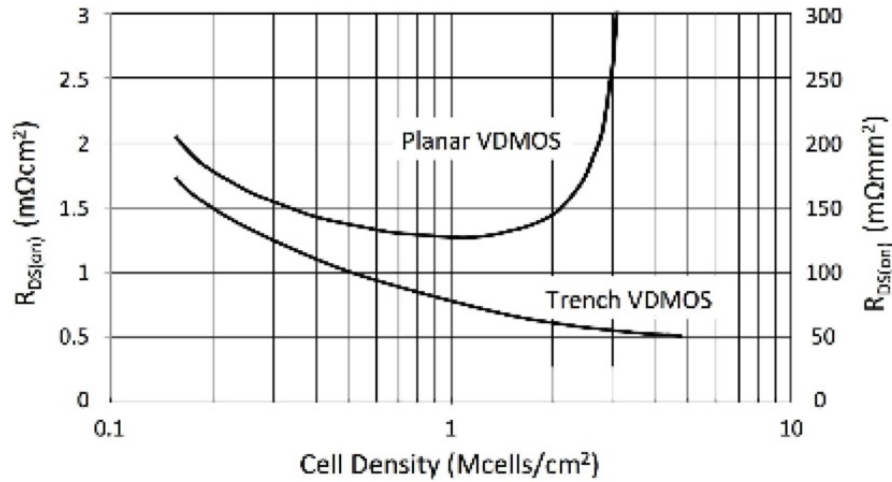
Figure 12: Impact of cell density on  $R_{DS(on)}$ . Planar VDMOS exhibits a minimum while trench VDMOS benefits from scaling [Wil17].

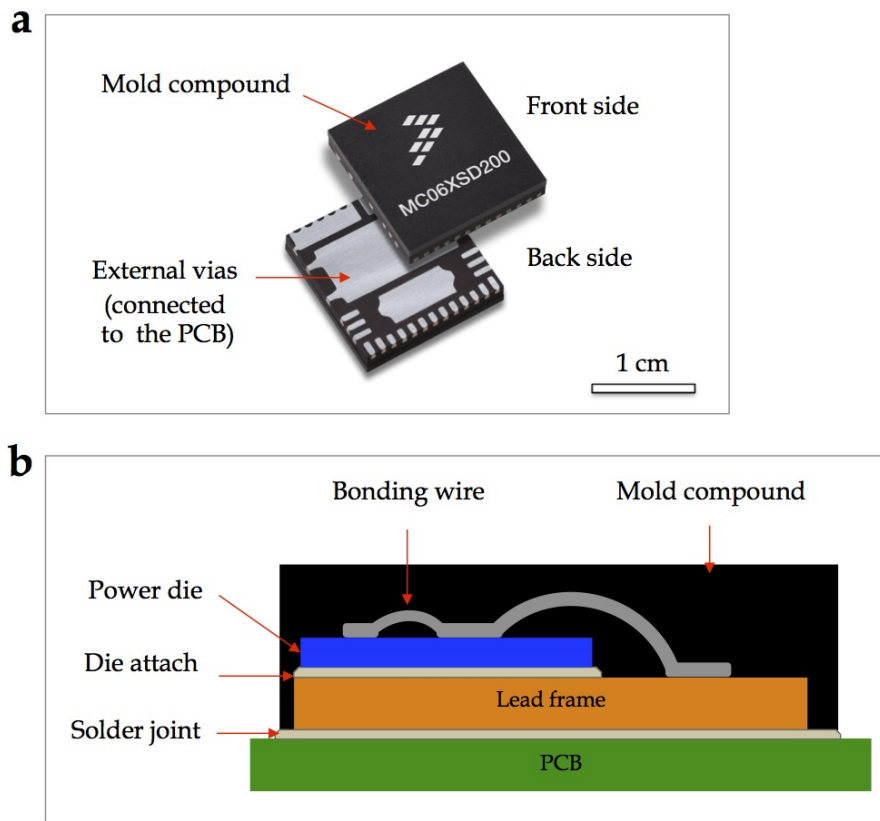
Figure 13: (a) Power MOSFET device from NXP Semiconductors for low voltage applications. (b) Schematic representation of the cross-section of the power MOSFET. The lead frame, made out of Cu, serves as heat sink and is directly soldered on the PCB. The bonding wires are cold welded on the Al top metallization by ultrasonic process. The device is encapsulated in a plastic mold compound.

In this work we focus on low voltage MOSFET-based smart power devices used as lightning switches in car and truck applications. Fig. 13a shows an example of e-switch smart power MOSFET from NXP Semiconductors.

Fig. 13b represents the main parts composing the layered structure of a power device for standard low voltage applications:

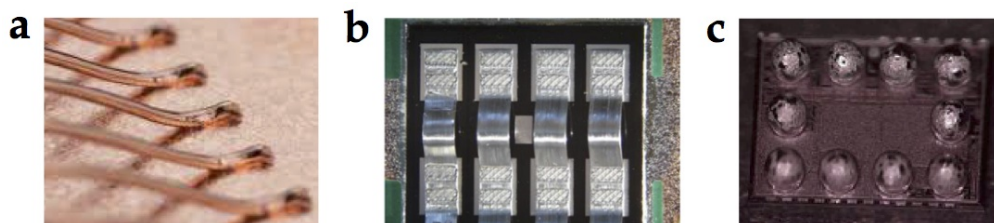
Figure 14: Examples of internal bonding connections in a low voltage power module. (a) Cu bonding wires, (b) Al ribbons, (c) ball-bonding [San17].

- Internal bonding connections. They allow a low-resistance current flow through the power die. Al or Cu bonding wires (Fig. 14a) are one of the most common solutions used at the moment. Several wire bondings, which have a standard diameter that varies from a few tens of micrometers to a maximum of 500  $\mu\text{m}$ , are connected in parallel in order to support and distribute high currents. Ribbon (Fig. 14b), clips and ball-bonding (Fig. 14c) are other examples of bonding internal connections that we can find in the commercial power devices.

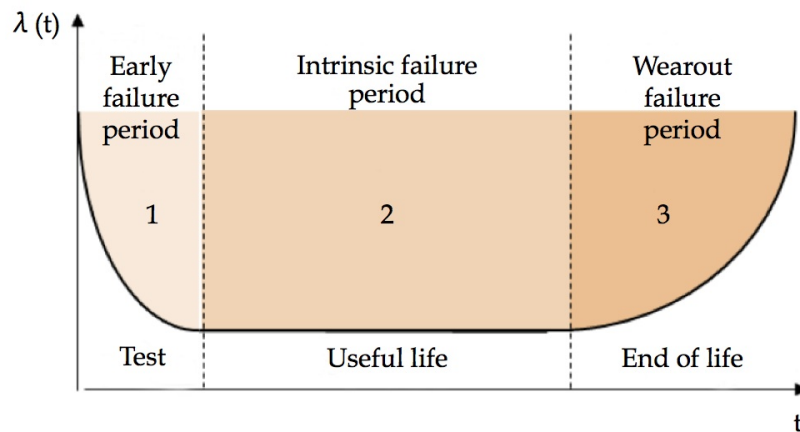
Figure 15: Bathtub curve of failure rate.

[Ele12] [Wan13]. Power device failure or degradation can be caused by external factors, such as moisture, temperature, vibrations, mechanical shock, etc. (see previous section 2.2.1), or internal factors, such as, for instance, the normal usage of the component or repetitive high current cycles, associated to thermal cycles (due to the Joule effect), that result in fatigue degradation of the main parts composing the device. These kinds of degradation or failure correspond then to the final part of the typical failure rate profile ("bathtub" curve - Fig. 15) as a function of the device life-time. The failure rate in this stage increases with the usage duration and the device aging and this defines the life-time of the device.

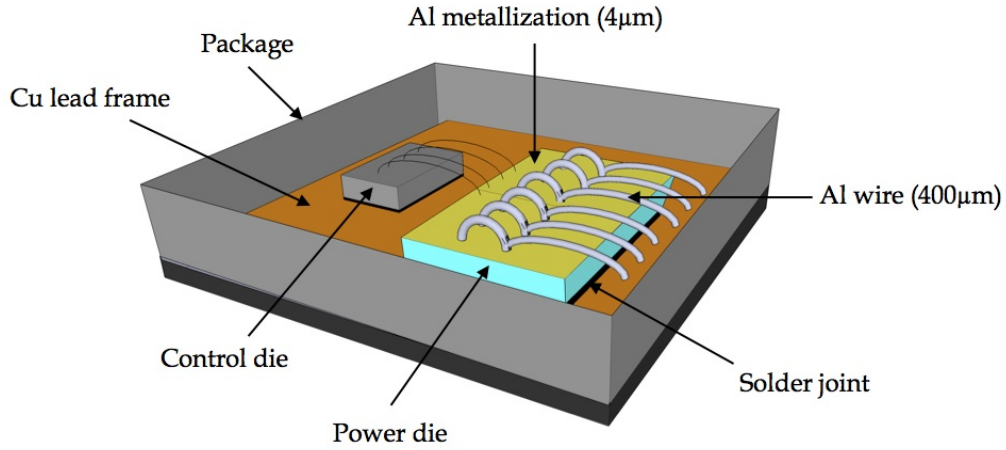
Figure 16: Schematic representation of a LFET<sub>1</sub>T-like smart MOSFET power device. The critical points subject to electro-thermal stress are: die/leadframe solder joint, Al source metallization, bonding wires.

Fig. 16 shows a schema of a smart power device with the main critical parts during electro-thermal aging: the solder joint and the metallic parts (source electrode metallization and bonding wires). In the following the associated failure mechanisms are described. In this work, we will focus on the failure mechanisms of the metallic parts.

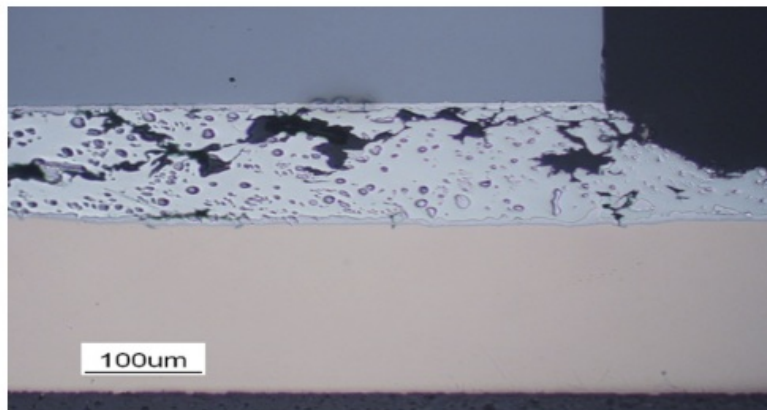
Figure 17: Delamination of a lead-free solder joint between the die Si substrate and the Cu lead frame [Bou08].

The solder joint between the Si substrate of the power die and the Cu lead frame ensures their thermal, electrical and mechanical contact. At increasing temperature, the power die heating is transferred through this connection to the lead frame where it is dissipated. Since 2006, after the restriction of the use of hazardous substances in electronic equipments, the lead-based soldering process has been replaced by high temperature ( $> 270\text{ }^{\circ}\text{C}$ ) process and Pb-free solders, consisting essentially in Sn-Ag-Cu alloy, are more and more used from the electronics manufacturers. The low elastic limit of these materials induces deformation in the solder layer even at low stress. In addition, the CTE mismatch between Si and Cu can strain the solder joint connection, and over the component lifetime can contribute to mechanical solder joint fatigue failure [Lee00]. Two phenomena can then occur during the electro-thermal aging of the device: cavities multiplication and delamination starting from the edges of the solder towards the center (Fig. 17). Both of them limit the current flow in the solder layer, increasing the  $R_{DS(on)}$  of the device. It has been demonstrated that the less is the solder thickness the more fragile is the solder [Hay02] [You15] [Gué02]. However, an increase in the thickness results in a increase in the thermal resistance of the solder layer, because of the low thermal conductivity of the materials constituting the solder. A trade-off between thermal conductivity and mechanical strength is then required in phase of design of the solder interface.

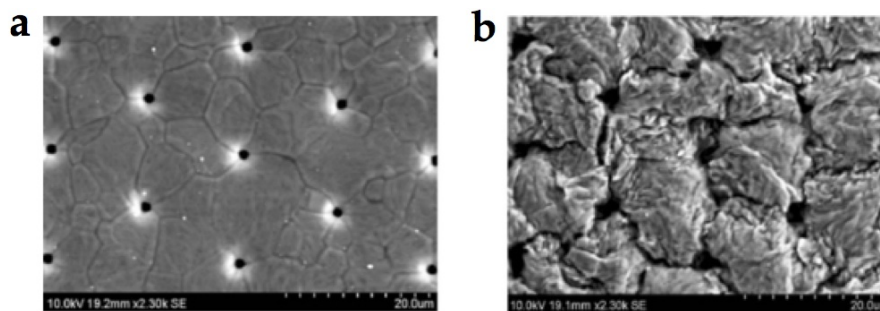
Figure 18: Electro-thermal ageing of the source electrode metallization in a smart power MOSFET. Scanning electron micrograph of the (a) fresh metallization and (b) at failure [Pie11].

Reconstruction of the aluminum metallization is an effect observed since the early times of microelectronics [San69] [Phi71]. During thermal cycling of IGBT and MOSFET devices, periodical compressive and tensile stresses are introduced in the thin metalization film by the different CTEs of the aluminum and of the silicon chip, due to the large thermo-mechanical mismatch between both materials and due to the stiffness of the silicon substrate [Ciao2]. The thermo-mechanical stresses in the Al results in the gradual change in its granular structure. Fig. 18 shows the comparison between the Al metallization surface in a power MOSFET before and after electro-thermal cycles. The aged metal is characterized by an higher roughness and cracks along the grain boundaries.

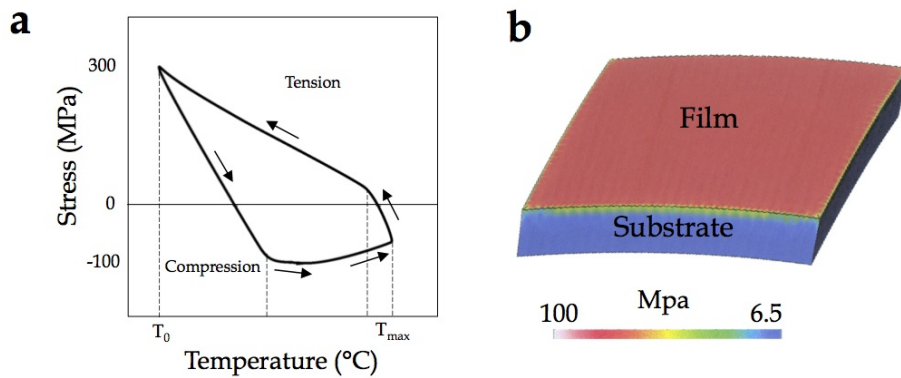
Figure 19: (a) Typical stress-temperature cycle for a 1- $\mu\text{m}$ -thick poly-crystalline Al film on oxidized Si substrate ( $T_{\text{max}} \sim 450^\circ\text{C}$ ). (b) Finite element simulation showing the Von Mises stresses generated by a temperature change of 50 °C in a 1 cm x 2 cm x 0.5 mm specimen (typical size used in wafer curvature) [Leg09].

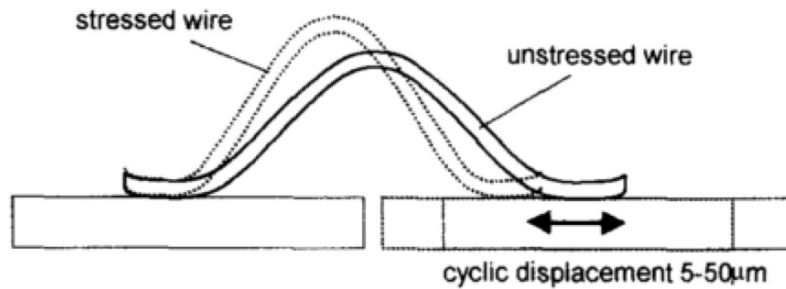
Figure 20: Bonding wire subjected to cyclic mechanical stress applied by lateral displacement of one bonding area relatively to the other in Rammingner et al. experiments [Ram00].

Reliability of bonding connections in power modules, and in particular of wire bonds soldered on the source electrode metallization by cold-bonding process, is an important issue for the reliability of power systems because of extending operation temperatures (due to the Joule effect in the wire itself and to the power dissipation in the Si substrate) which induce high levels of thermo-mechanical stress in the bonding area [Ciao2] [Gla04] [Dup07]. Ramminger et al. [Ram00] described and modeled this cyclic stress as wire flexure by thermal expansion or wire deformation under mechanical shock loading if the bond surfaces are able to move relatively to each other (Fig. 20).

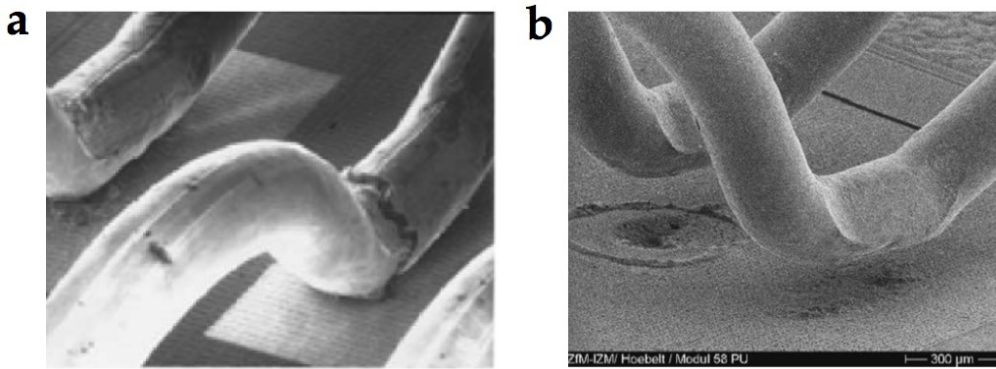
Figure 21: Examples of bond failures in power components: (a) heel crack failure [Ciao2] and (b) wire lift-off [Den17].

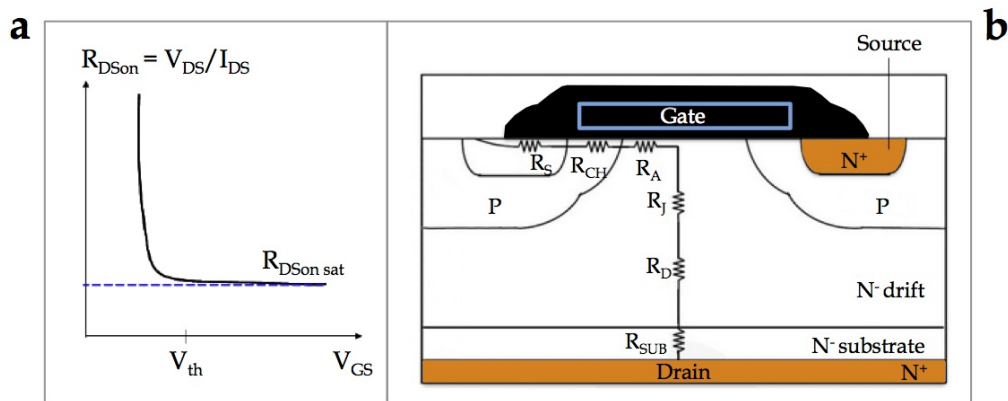
Figure 22: MOSFET vertical structure, showing the total resistances that make up  $R_{DS(on)}$ .

The on-state resistance  $R_{DS(on)}$  can be considered as the sum of several components as shown in Fig. 22b:

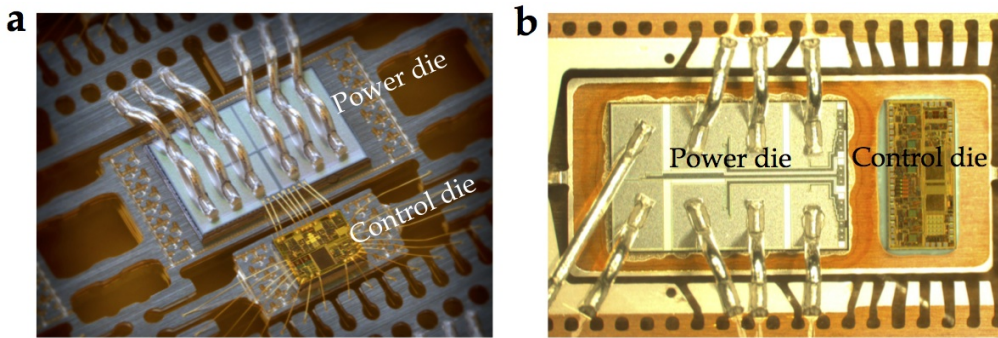
Figure 23: LFET<sub>1</sub>T smart power MOSFET device from NXP Semiconductors. (a) 45V, 12V SPD06, (b) 65V, 24V T07D17.

1. 12V SPDo6 (Fig. 23a), designed for 12 V batteries in car applications, with breakdown voltage of 45V. They consists in 2 MOSFET sectors, each one connected by 3 bonding wires and having a  $R_{DS(on)}$  of 6 m $\Omega$ .

2. 24V To7D17 (Fig. 23b), designed for 24V batteries in truck applications, with breakdown voltage of 65V. They consists in 5 MOSFET sectors, connected by 8 bonding wire and having a  $R_{DS(on)}$  of 17 m $\Omega$  and 7 m $\Omega$ .

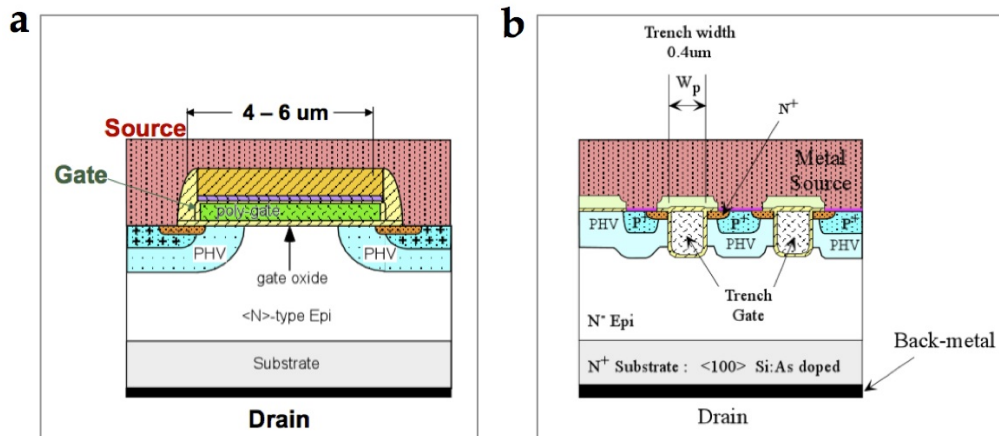
Figure 24: (a) planar vs (b) trench MOSFET structure in NXP power devices.

The trench MOSFET structure, with a small cell pitch of  $\sim 1 - 2\mu\text{m}$  (Fig. 24b) allows the LFET1T modules to get three times higher channel current densities ( $> 1000\text{mA}/\text{in}^2$ ) compared to the previous generation of NXP power MOSFET devices based on a planar structure (Fig. 24a), together with a reduction in die and package sizes (and thus cost). However, this also implies a higher possibility of thermal instability of the device. For this reason, an isolated polydiode for temperature sense has been integrated in the technology. The details of the technology are summarized in table 2, showing a comparison between the 12V SPDo6 and 24V To7D17 modules. The composition and thickness of the source metallization and bonding wire are the same in both modules. The source metallization consists in an aluminum (Al) film of 0.5 wt% of copper (Cu) and tungsten (W), coated (only in the 24 V devices) by a  $0.5\mu\text{m}$  thick  $\text{SiO}_2$  passivation layer everywhere, except in the bonding areas. The wire bonds are made out of pure Al and have a diameter of  $400\mu\text{m}$ . The Al bonding wires are contacted to the Al source metallization by a classical cold-bonding process by ultrasound [Bro15] [Goe12]. The bonding parameters are reported in table 3. The bonding force of 10 N applied to an area of  $450 * 750\mu\text{m}^2$  results in a bond stress of  $\sim 30\text{MPa}$ . These values are in line with the bonding parameters optimized by Goehre [Goe12].

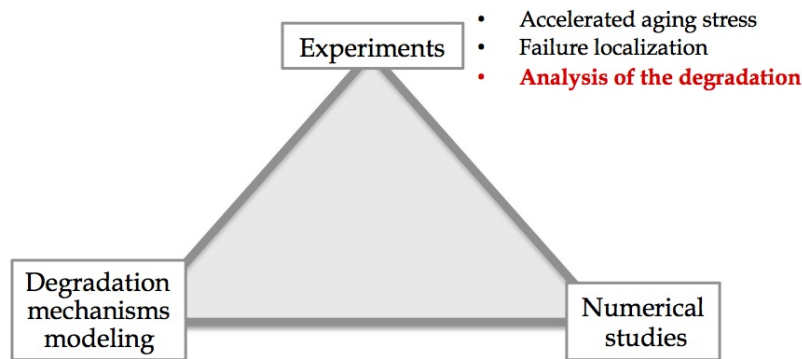
Figure 25: Methodology used to assess the reliability of power devices. In this work we use an experimental approach to assess the degradation of the metallic parts of LFET1T power devices under repetitive accelerated aging conditions.

The reliability assessment of power devices is a complex issue that can be addressed following different approaches. Fig. 25 shows a methodology schema representing the three approaches that are currently adopted to study the robustness of power electronics systems:

1. Experimental testing. The reliability assessment is addressed experimentally by:
  - Accelerating aging test to reproduce the stress at which the device is subject.
  - Localization and identification of the failure.
  - Degradation analysis of the critical points.
2. Degradation mechanisms modelling. The goal is to determine:
  - Accelerating aging factors.
  - Life-time predictive laws.
  - New design strategies.
3. Numerical study, to simulate:
  - The stresses undergone by the device.
  - The correlation between the stresses and the degradation mechanisms.

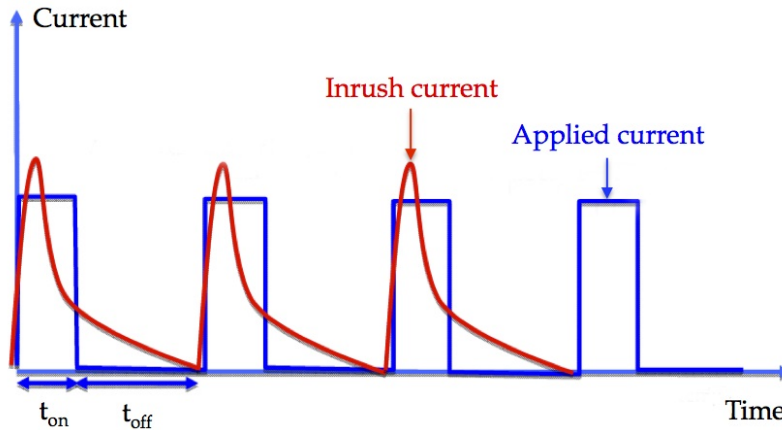
Figure 26: IOL (Intermittent Operating Life) test: the device undergoes electrical pulses during the time interval  $t_{on}$ . The test current and  $t_{on}$  values are generally limited by the control die, that protects the control die from "bulb inrush" phenomena.

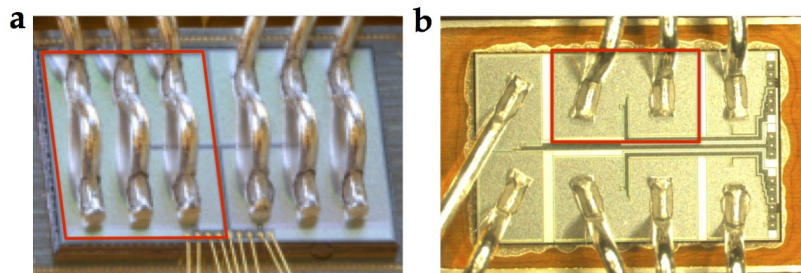
Figure 27: Localization of the MOSFET sector under accelerated aging test (red rectangle) in a (a) LFET<sub>1T</sub> 45V (SPDo6) and (b) LFET<sub>1T</sub> 65V (To7D17) power device.

During both tests, only one sector undergoes the electrical pulses, the one inside the red rectangle in 45V LFET<sub>1T</sub>s (Fig. 27a) and 65V LFET<sub>1T</sub>s (Fig. 27b), so we could use the others as reference during the microstructural characterizations.

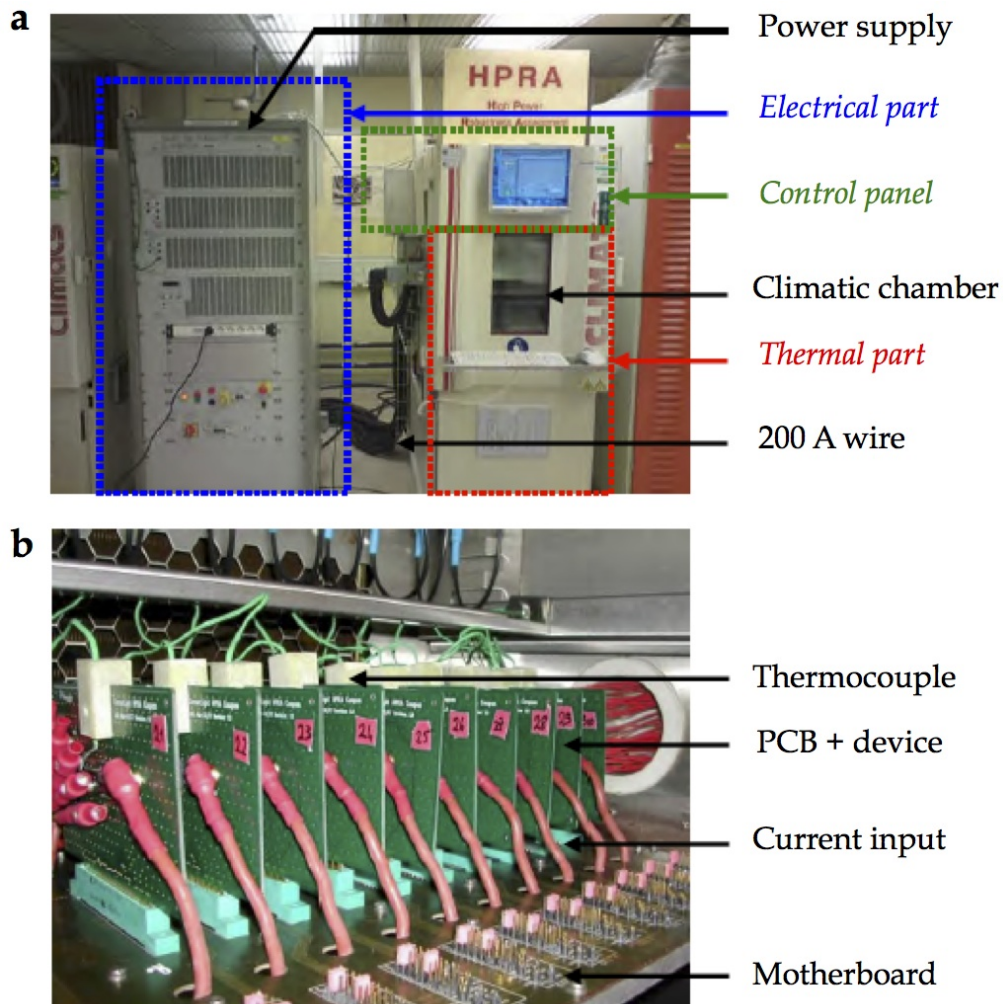
Figure 28: (a) Climats Sapratin Excal 2223-TE test bench at NXP Semiconductors. it consists in an electrical part (in blue), equipped with a 80 V, 200 A power supply and an active charge (5 - 200 A), a climatic chamber ( $-80^{\circ}\text{C}$  -  $180^{\circ}\text{C}$ ) containing the devices under test (in red), and a control panel (in green) with an electronic board that control the devices switching.

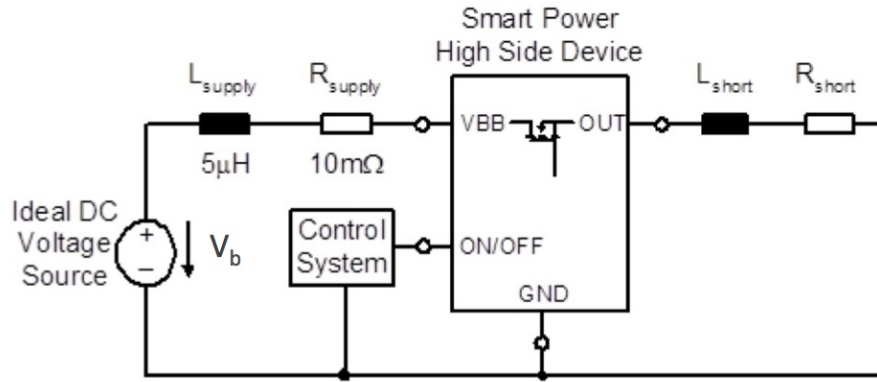
Figure 29: Accelerated aging test circuit.

Electrical test circuit and waveforms (according to the AECQ100-12 standard [Kelo6]) are depicted respectively in Fig. 29 and Fig. 30. The supply resistance and inductance are fixed at  $R = 10\text{m}\Omega$  and  $L = 5\mu\text{H}$ , which correspond to an output of  $R_{short} = 50\text{m}\Omega$  and  $L_{short} = 5\mu\text{H}$ . The current threshold, that is the overload value at which the control die shuts the power die down is set at

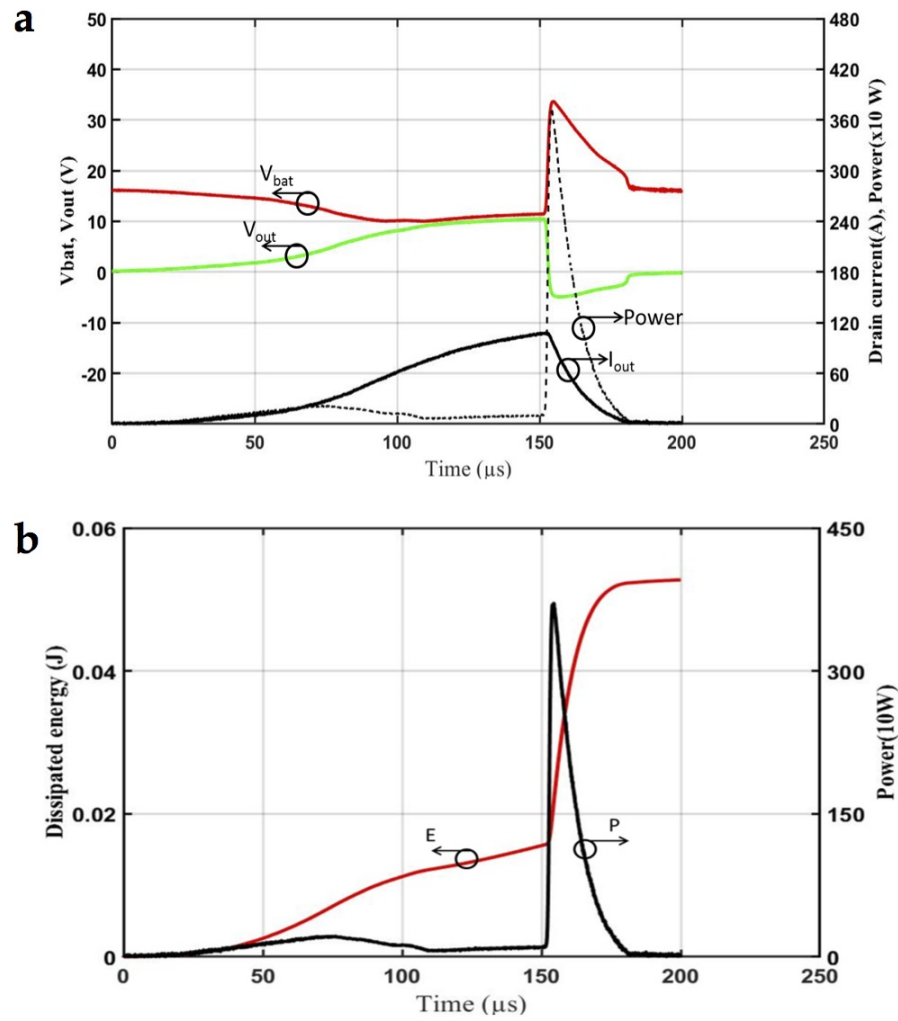
Figure 30: (a) Typical signals during a short cycle event in the power MOSFET by activation of overload protection. (b) Dissipated energy (E) and power (P) during the SC phase.

$I = 120\text{A}$ . The dissipated energy leads to an increase in the device temperature up to  $250 - 300^\circ\text{C}$ . Under these conditions, T07D17 devices have been aged at room temperature and at  $70^\circ\text{C}$ , in order to investigate the catalytic role of the temperature in the device failure. In the first case, the components failed at  $\sim 5.3$  million cycles, whereas at higher temperature at  $\sim 300\text{kcycles}$ .

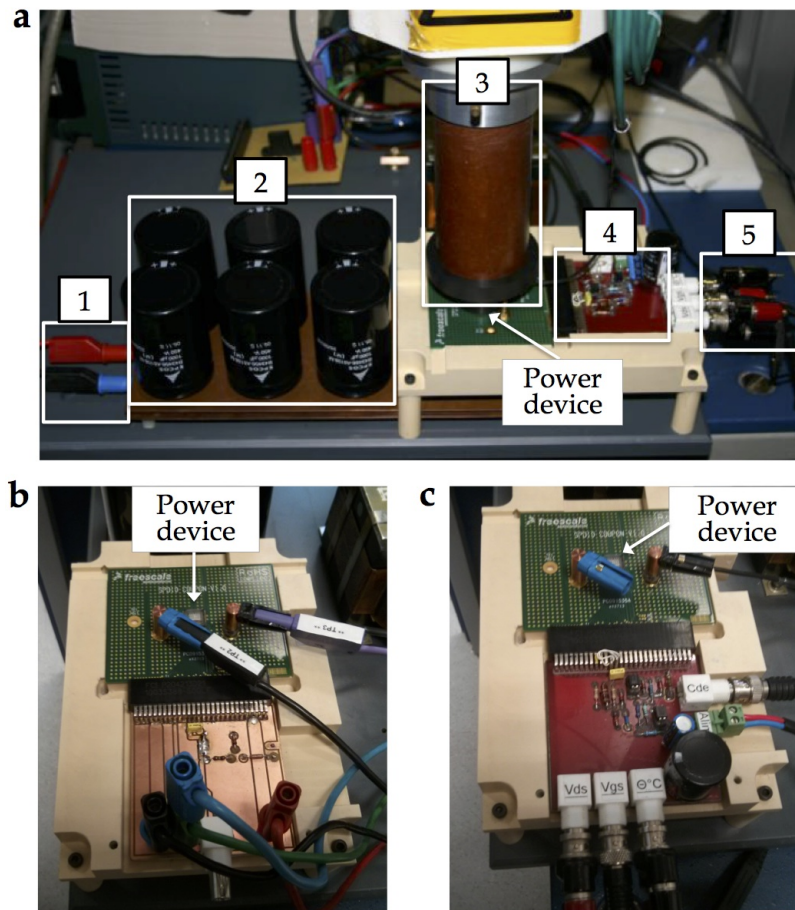
Figure 31: (a) Accelerated aging test bench set up at the Satie laboratory. The device under test can be connected to (b) a measuring board or to (c) the driving board.

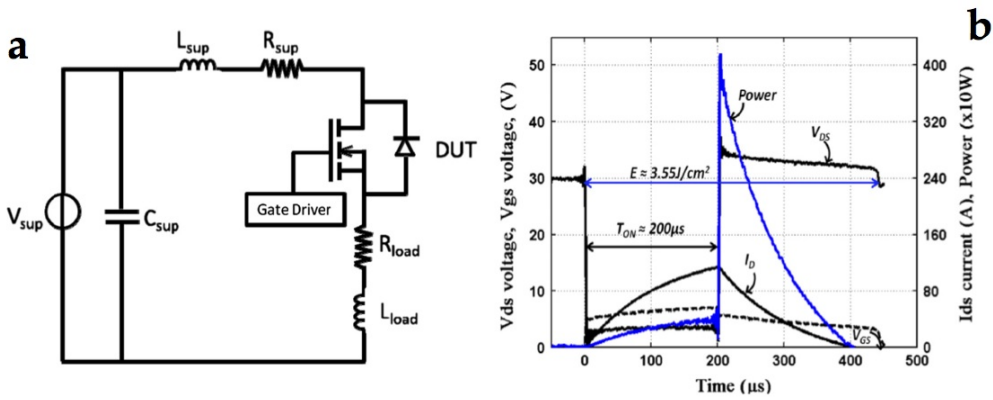
Figure 32: (a) Normal protection mode circuit and (b) waveforms,  $V_{SUP} = 30V$ ,  $T_{ON} = 200\mu s$ ,  $T_{AMB} = 25^\circ C$ .

- Normal protection mode (Fig. 32a).  
It simulate the "normal" over-current protection function of the control die. This mode is, then, equivalent to the qualification tests previously described (section 2.3.1). The current is limited by a resistive and inductive load.
- Avalanche switching mode (Fig. 33a).  
Power converter switches off under inductive current load.
- Short-circuit (SC) switching mode (Fig. 34a). It is performed by switching the power die directly on the power source voltage.

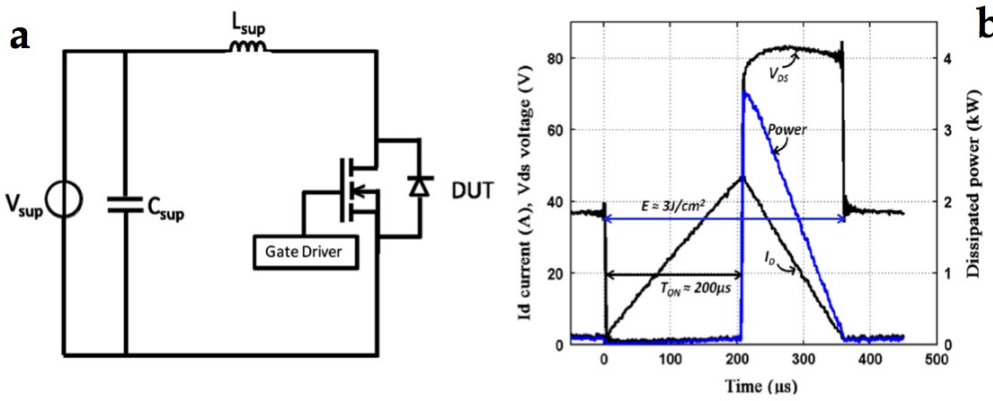
Figure 33: (a) Avalanche switching mode circuit and (b) waveforms,  $V_{DSmax} = 84V$ ,  $I_{Dmax} = 50A$ ,  $T_{ON} = 200\mu s$ ,  $E = 300mJ$ ,  $T_{AMB} = 25^\circ C$ .

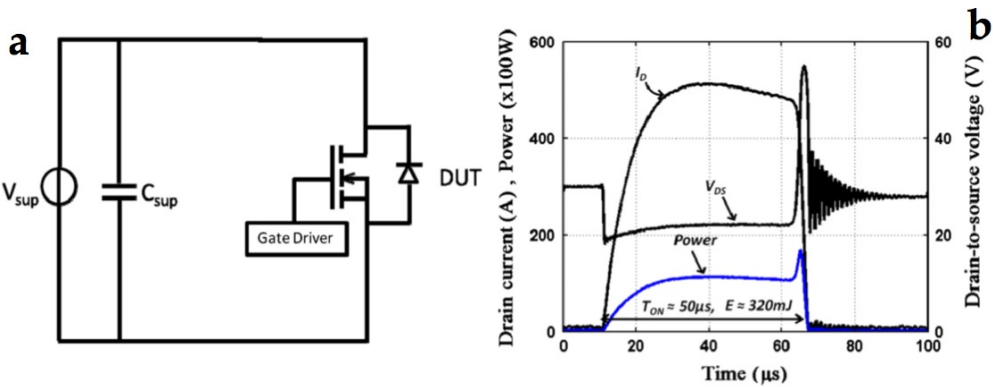
Figure 34: (a) Short-circuit mode circuit and (b) waveforms,  $V_{SUP} = 24V$ ,  $T_{SC} = 50\mu s$ ,  $E = 320mJ$ .

On the base of Rostaing et al. results [Ros13] (previous section 2.3.2.1), in this work we have decided to use the test bench in SC mode, in order to put the device under the most extreme and accelerated conditions possible.

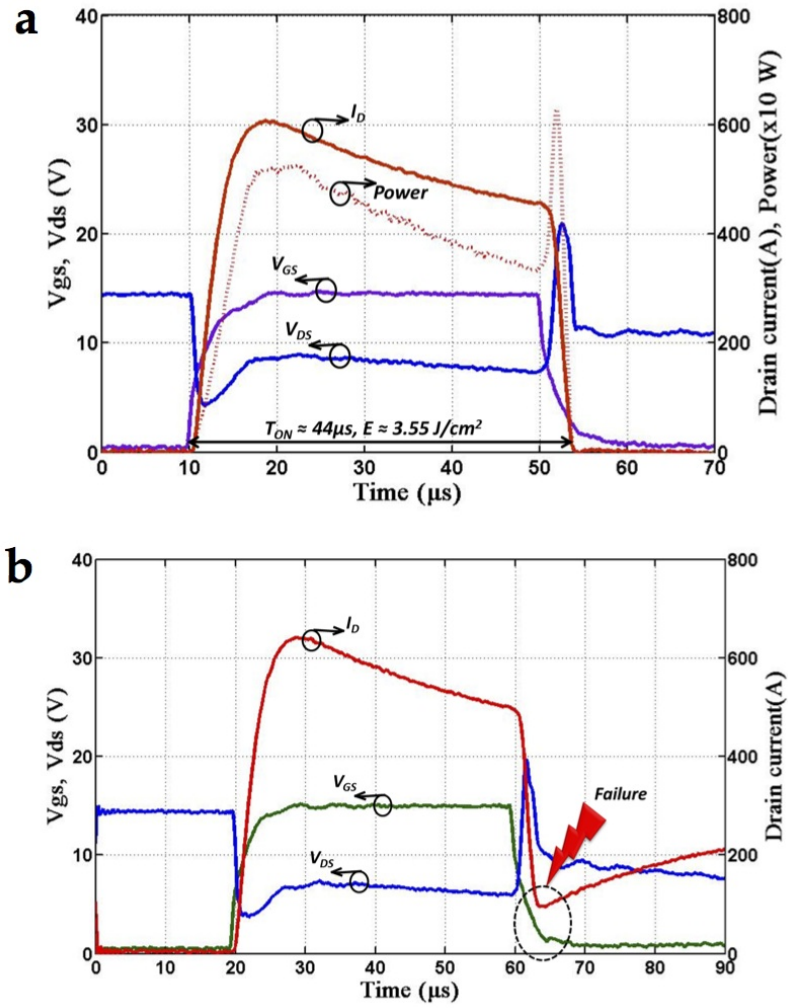
Figure 36: SC characteristics (a) just before failure (after 300 kcycles) and (b) at failure (330 kcycles).  $V_{DS} = 15V$ ,  $f = 5Hz$ ,  $T_{ON} = 40\mu s$ .
