# Fatigue mechanisms in Al-based metallizations in power MOSFETs

Roberta Ruffilli. Fatigue mechanisms in Al-based metallizations in power MOSFETs. Condensed Matter [cond-mat]. Université Paul Sabatier (Toulouse 3); École doctorale Sciences de la Matière, 2017. English. NNT: . tel-01666437v2

**Fatigue mechanisms in Al-based metallizations in power MOSFETs**

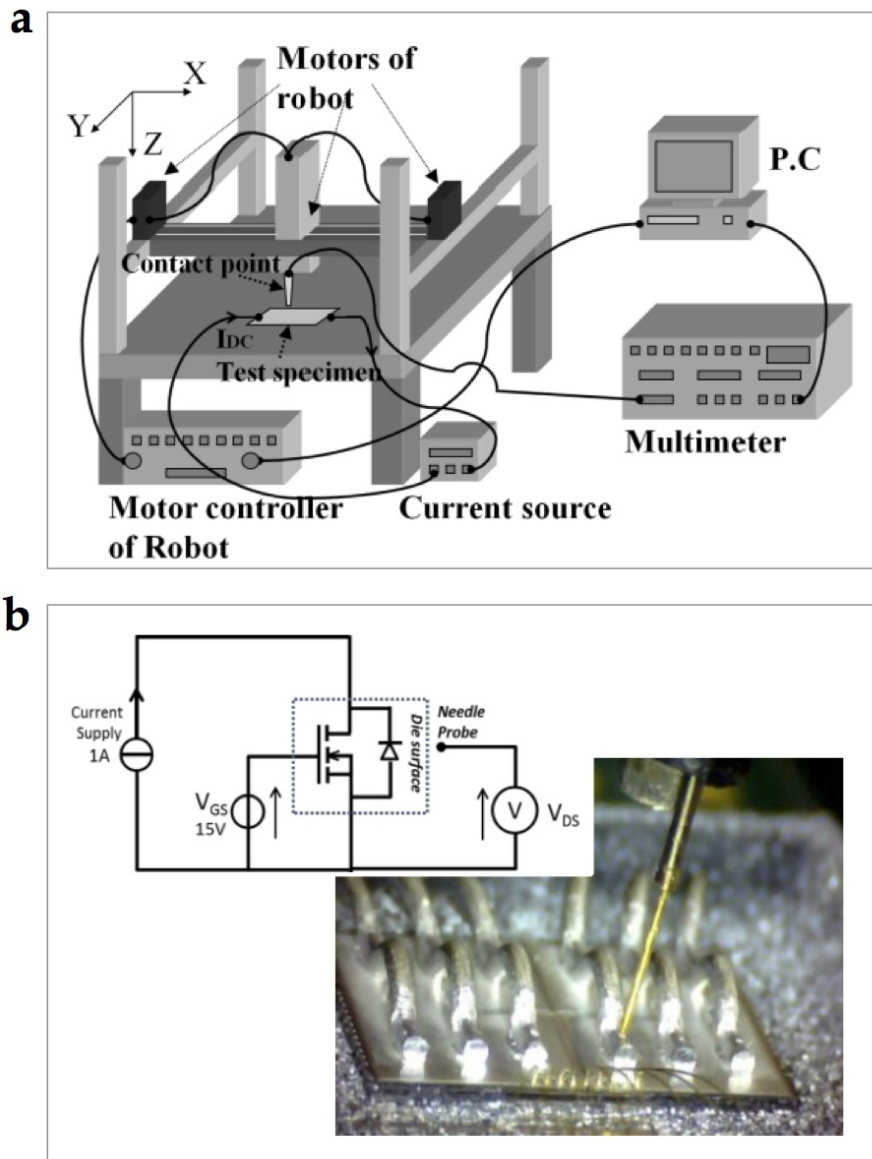
Figure 37: (a) Experimental set-up for source potential mapping of the power die. (b) Spring probe for source potential mapping,  $V_{GS} = 15V$ ,  $I_{DS} = 1A$ .

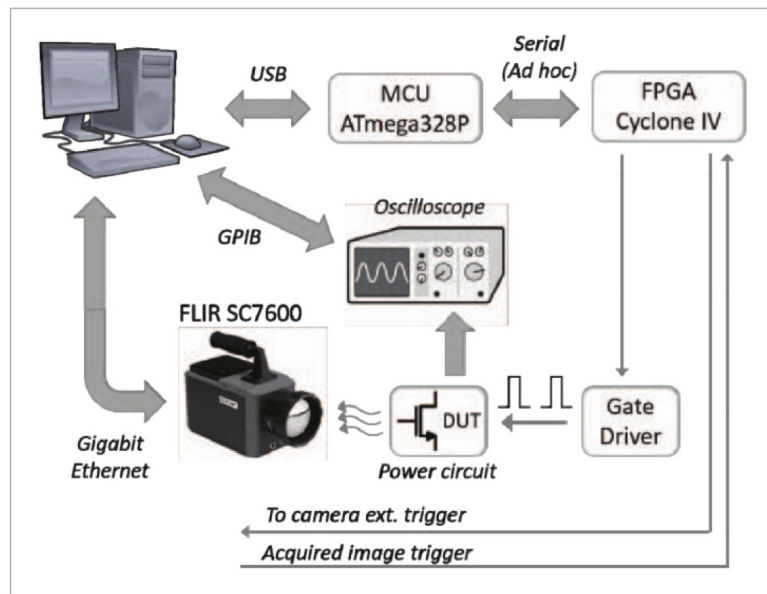
Figure 38: Schema of the IR setup showing the connections between the different parts of the system.

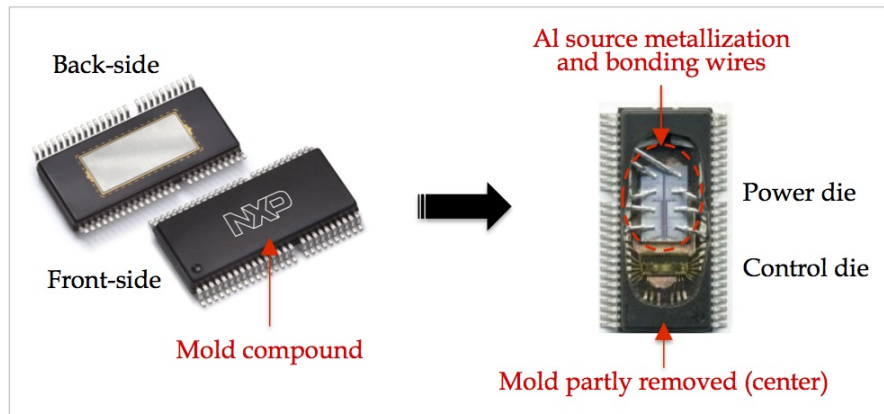
Figure 39: Decapsulation of epoxy-packaged semiconductor devices. Al source metallization and bonding wires are beneath the front epoxy side.

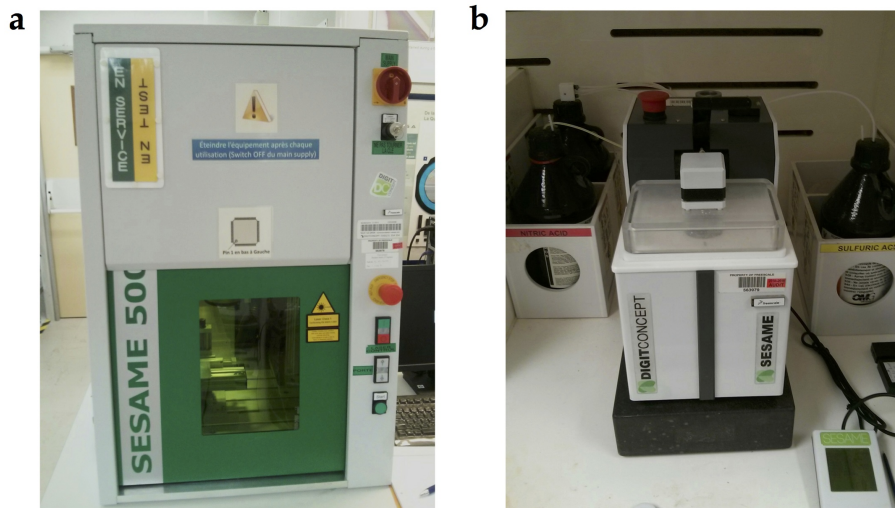
Figure 40: Equipment used for the decapsulation semiconductor devices. (a) IR laser decapsulation system. (b) Pressurized jet system.

Each semiconductor company optimizes its own method for the decapsulation of epoxy-packaged semiconductor devices. Generally laser-based or chemical methods are used [Wen83] [Low08]. We coupled the two techniques, roughly removing a first part of the packaging by IR laser decapsulation system (Fig. 40a) in order to decrease the time of the final step which consists in a chemical attach of the remaining package by a mixture 3:1 of nitric and sulfuric acid in a pressurized jet system (Fig. 40b). Finally, the decapsulated device is rinsed in an ultrasonic bath of cleaning solvents, in order to remove undesired residues from the die surface.

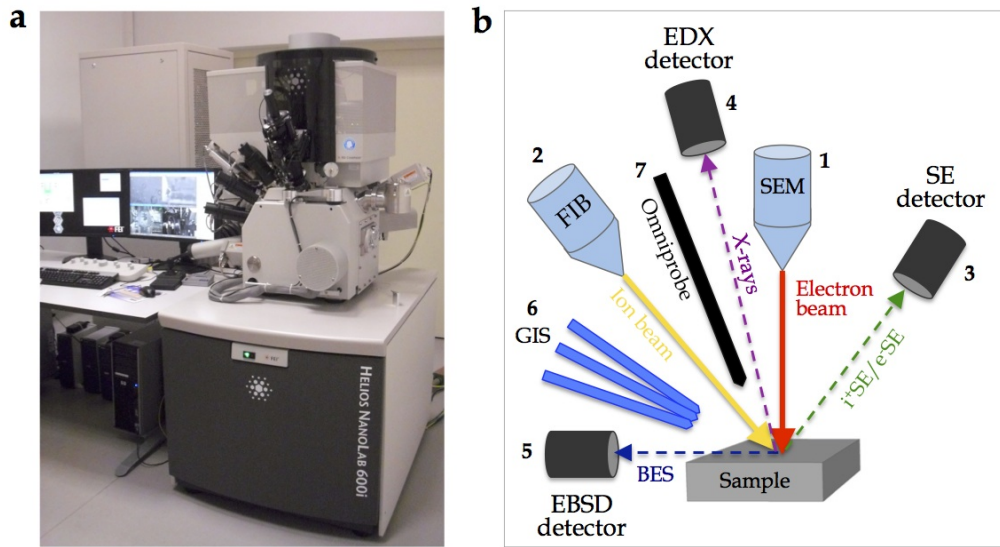
Figure 41: (a) FEI Helios dual beam microscope. (b) Schema of the main components of the microscope.

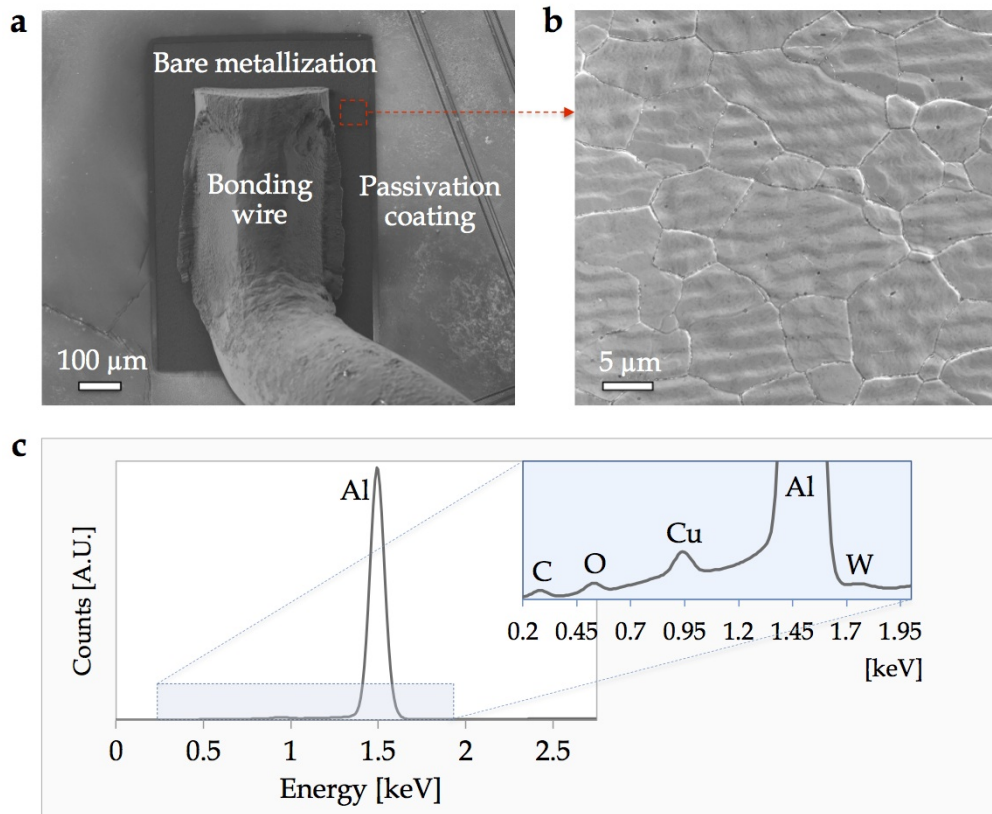
Figure 42: (a) SEM image of an Al bond wire welded on the Al source metallization. (b) At higher magnification, bare metallization of a reference module. (c) EDX spectrum from the Al metallization.

3. Several detectors for the emitted signals are installed in the sample chamber. The majority of SEM images presented in this thesis was collected by using an Everhart-Thornley (ETD) detector for SE signal. The detector consists mainly of a scintillator, surrounded by a Faraday cage, which specifically attracts the SE and converts them in photons. Then, the electrical signal is conducted to a photomultiplier outside the SEM and amplified to form a 2D topographic image of the device surface at different magnifications, as in Fig. 42a and Fig. 42b.

4. The Helios is also equipped with a X-MaxN Silicon (Lithium) Drift Detector (SDD) from Oxford, installed in 2016, for the Energy Dispersive X-Ray Spectroscopy (EDS), used for the chemical characterization of the sample surface. The detector collects the x-rays emitted from the interaction of the primary electron beam with the specimen. Since the x-ray energy is characteristic of the element from which it was emitted, thanks to a dedicated software (AZtecHKL from Oxford Instruments) we can determine the elemental composition of the scanned source metallization (Fig. 42c), with a sub 10 nm spatial resolution.

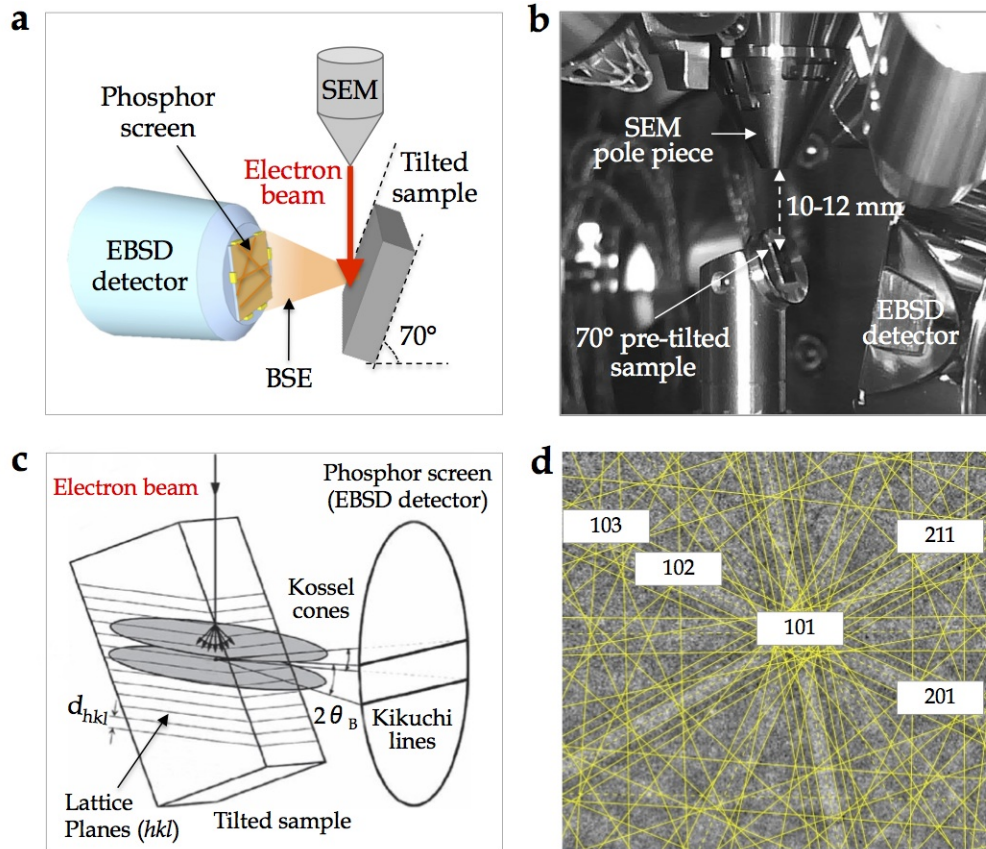
Figure 43: (a) SEM-based EBSD schema and (b) Helios microscope chamber configuration during an EBSD experiment. (c) Kikuchi lines formation schema. (d) Pattern recognition by AZtechKL

lines or Kikuchi bands) produced by low energy loss backscattered electrons arising from the interaction of the primary beam with the crystal lattice at the Bragg angle (Fig. 43c), according to the Bragg law:

Hence, an automated SEM-based EBSD system consists in three main parts: the SEM, the pattern detector and the software for the indexing procedure. (Fig. 43b) shows the set-up of our experiments: we used the dual beam FEI Helios microscope, in SEM mode (acc.  $V = 20$  kV,  $I = 11$  nA), equipped with a  $70^\circ$  pre-tilted sample holder. The sample is placed at a working-distance of about 10-12 mm from the SEM pole piece. The EBSD signal is collected by a NordlysNano detector from Oxford Instruments. It consists in a CCD camera with four forescatter detectors mounted to the top and bottom of a phosphor screen, giving both orientation and phase contrast of the sample. The detector has motorized insertion and retraction, and can be placed as close as possible

to the sample to maximize the intensity of the acquired diffracted signal. Finally, the camera communicates with the AZtecHKL acquisition software from Oxford Instruments. During the acquisition, the software matches the information from each point of the scanned source metallization with a database of simulated orientations and returns the orientation of each grain (Fig. 43c).

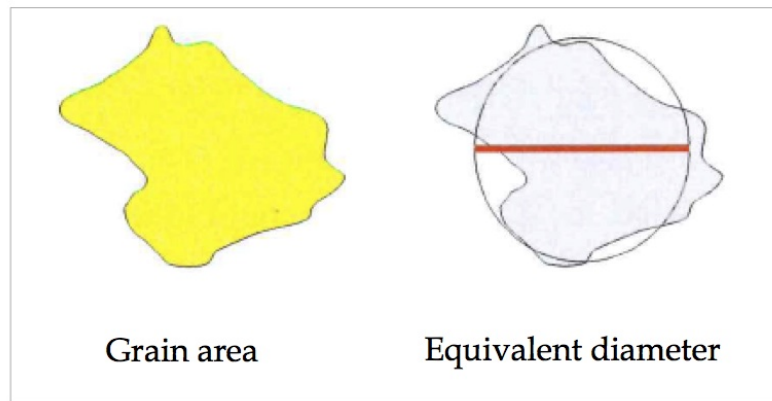
Figure 44: Approximation of a single real grain to a circle shape one for the measurement of a equivalent diameter.

Thanks to a post-processing software (HKL Channel5, Oxford instruments) dedicated to the off-line manipulation and analysis of the EBSD data, we could build orientation maps along the three axis  $x$ ,  $y$ ,  $z$ . We could also determine the misorientation and grain size distributions of the scanned areas. The sizes are obtained by either grain reconstruction method, approximating each grain to a circle and measuring the equivalent diameter (Fig. 44), or by lineal intercept method [Humo1]. In the former approach, a prior decision about which misorientation constitutes a grain boundary must be taken ( $15^\circ$  is often used).

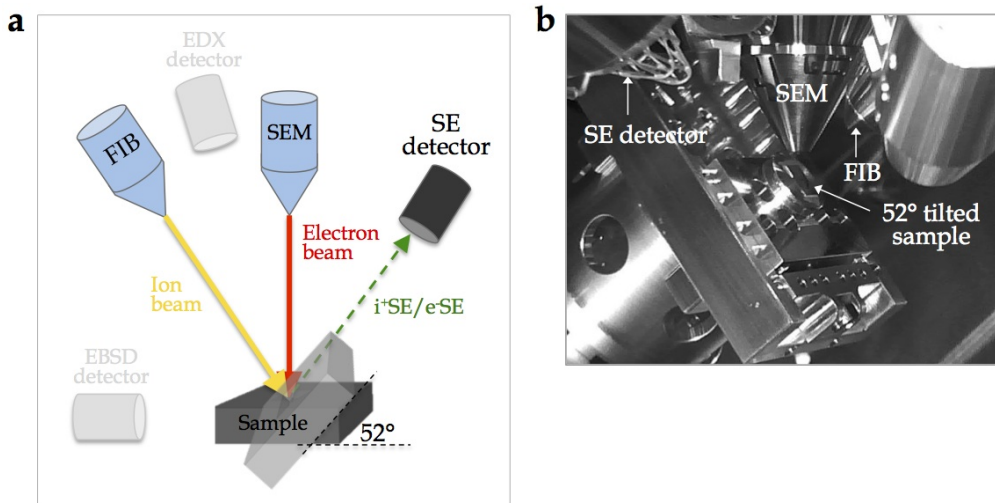
Figure 45: (a) Schematic representation of the dual beam FIB/SEM operational mode. (b) Helios microscope chamber configuration during the cross-section experiments.

For these experiments we used the FEI Helios microscope (Fig. 41a) in its dual-beam functionality, which combines a scanning electron beam produced by a field emission gun (previously used for the surface analysis), with a focused ion beam of gallium ions. Since the electron and ion columns are  $52^\circ$  tilted with respect to each other, the sample is placed at the eucentric position, that is the position where the ion and the electron beam converge with an angle of  $52^\circ$ , as in Fig. 45a and Fig. 45b.

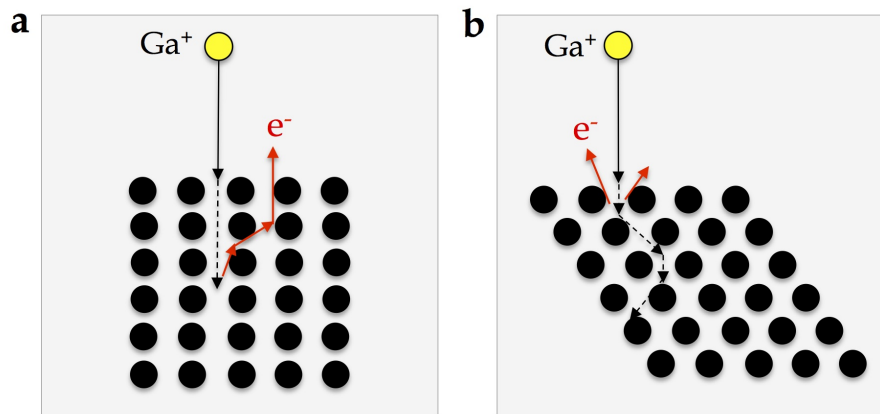
Figure 46: Secondary electrons emission by ion-solid interaction for two different oriented crystals. The ion channeling contrast is darker in (a), where the ion trajectories are parallel to crystallographic planes, whereas is brighter in (b), where the angle between the ion direction and the crystallographic planes increases.

Ion channeling behavior is a well-known phenomenon where the ion-solid interactions change drastically with crystal orientation, affecting the sputter yield of the emitted secondary electrons ( $i^+SE$ ) and imaging contrast [Kem01]. Generally, darker grains sputter more slowly than brighter grains [Gia11]. The dark grains are consistent with ion trajectories parallel (or nearly parallel) to low index crystallography planes where ions will travel long distances prior to losing energy and interacting with the target (Fig. 46a). Since most of the ion-solid interactions occur deeper in the sample, the sputter yield is lower and the gray-scale signal is darker. On the other side, grains, which are oriented greater than the critical angle to the ion trajectory (Fig. 46b), will cause the ions to interact closer to the surface, losing energy more quickly and yielding a brighter signal. Therefore, ion channeling contrast images give us visual information about the grain orientation and, as previously mentioned, they are useful to access the deformation of the Al metallization during aging.

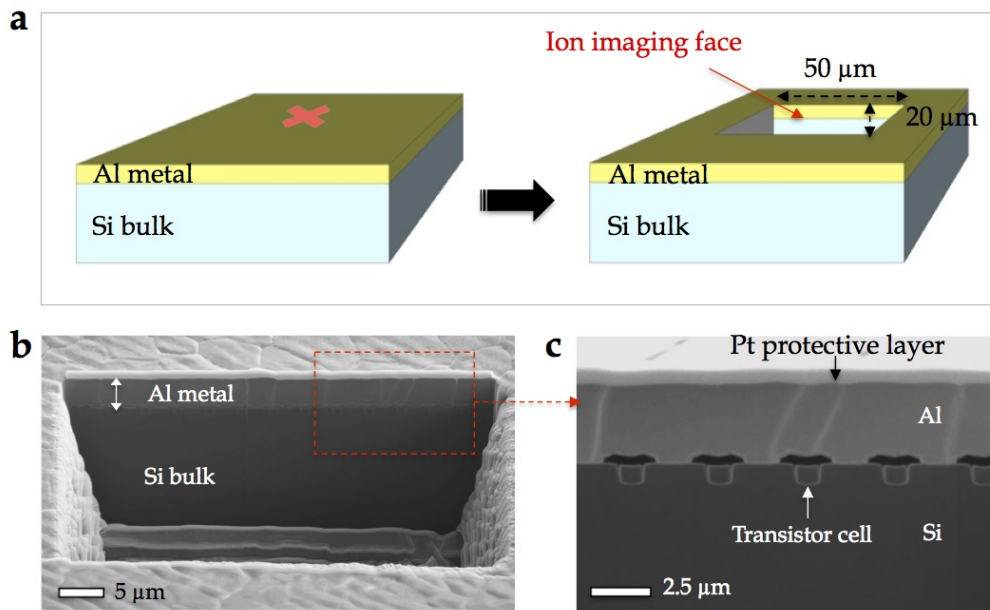
Figure 47: (a) Schematic representation of FIB cross-section from a region of interest (red cross) of the power die naked metallization. (b) SEM image of a FIB cut from a reference module and (c) relative higher magnification of the Al metallization bamboo structure, with the MOSFET area, on the Si substrate.

To prepare the imaging cross-sectional face of the naked metallization, a rectangular patterned region measuring  $\sim 1000 \mu\text{m}^2$  is milled (Fig. 47a). Essentially, the ion beam (with an energy of 30 KeV) scans the surface and when ions collided with the atoms of the material they are ejected away, until a  $50 \times 20 \mu\text{m}$  face had been milled and all the bulk in the path of the ion beam removed. This has been done in two steps:

In parallel, the cross-section preparation progress is monitored by SEM. Fig. 47b shows a SEM image of the final milled area. At higher magnification (Fig. 47c), we can distinguish the layered structure of the power module, including the top source metallization, the MOSFET area and the Si bulk.

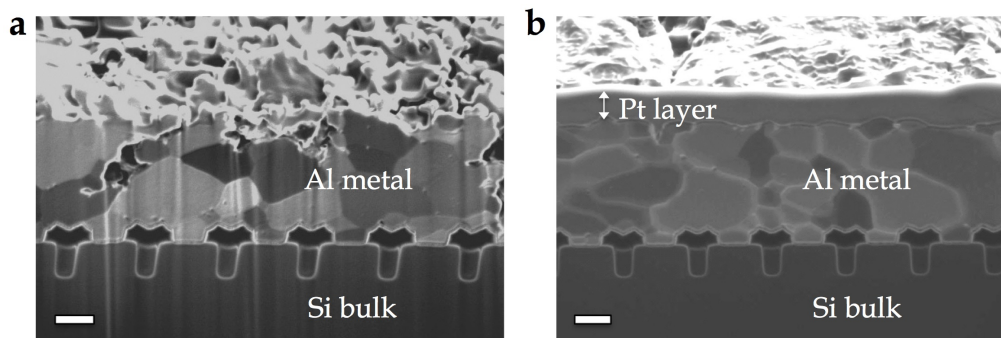
Figure 48: Cross-sectional SEM images of the Al metallization in an aged modules (a) without and (b) with Pt protective layer. Scale bar 1  $\mu\text{m}$ .

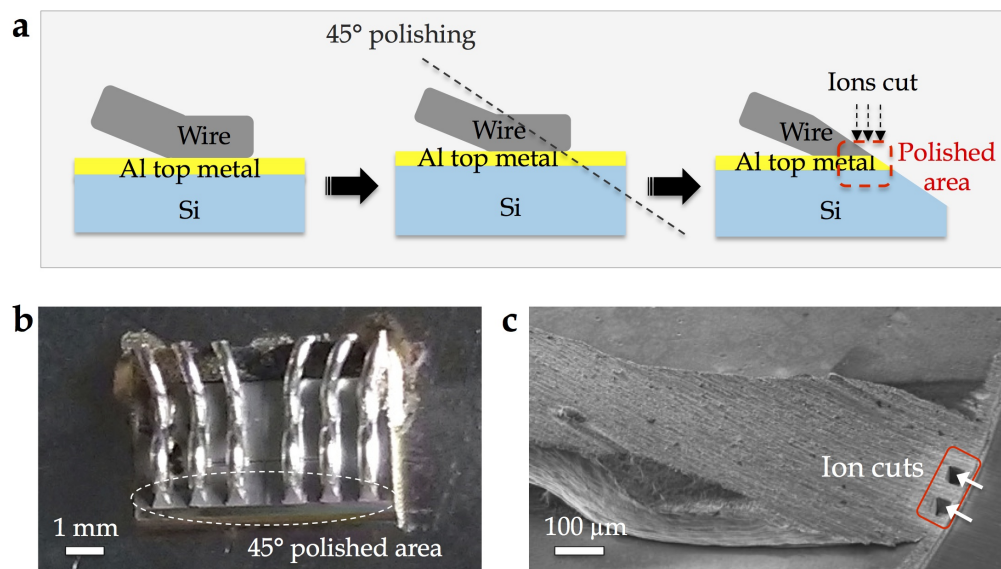
Figure 49: (a) Schematic representation of the preliminary sample preparation for the wire-metal interface FIB inspection. The wire is cut and polished at  $45^\circ$  before being cut by FIB for interface observation. (b) Front-view photograph of a power die prepared for the FIB and (c) relative lateral-view SEM image of a  $45^\circ$  polished wire. The white arrows indicate the imaging direction of the FIB-prepared cross-sectional faces (in red).

The original preparation procedure that we have set up for this study combines a mechanical grinding of the bonding wires at  $45^\circ$ , in order to locally reduce the wires thickness, and a final ion polishing by FIB at various locations (Fig. 49a). In particular, we used a precision diamond wire saw (Fig. 50a) to take the power die out (and get rid of the remaining resin and the control die), and then a polishing machine (Fig. 50b) with silicon carbide papers at decreasing roughness for the manual polishing of the wire-metallization interface at  $45^\circ$ . Fig. 49b and Fig. 49c show respectively a front-view photograph of a power die prepared for FIB milling and the correspondent higher magnification SEM image (lateral-view) of a  $45^\circ$  polished wire-metal interface. The white arrows in Fig. 49c indicate the imaging direction of the FIB sections (inside the red area). Thanks to this preparation we have been able to inspect the metallization both under the bonding wire and in naked locations at the same time. If we embedded the device in resin we would have lost most of the naked metallization parts that are essential to compare them to the metallization beneath the wire.

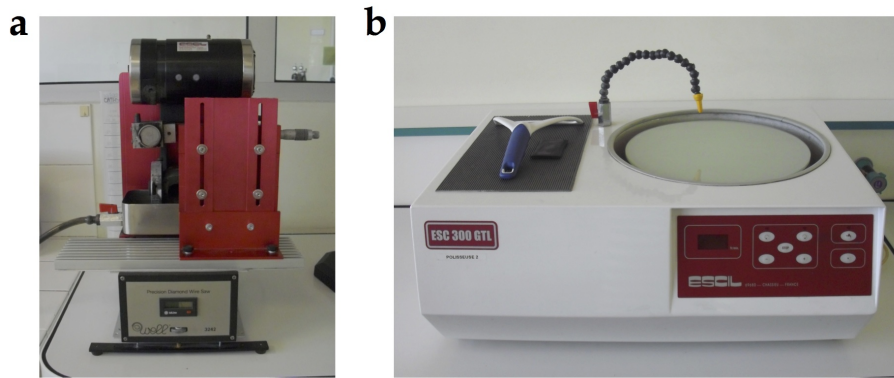
Figure 50: Sample preparation equipment: (a) diamond wire saw and (b) polishing lapping machine.

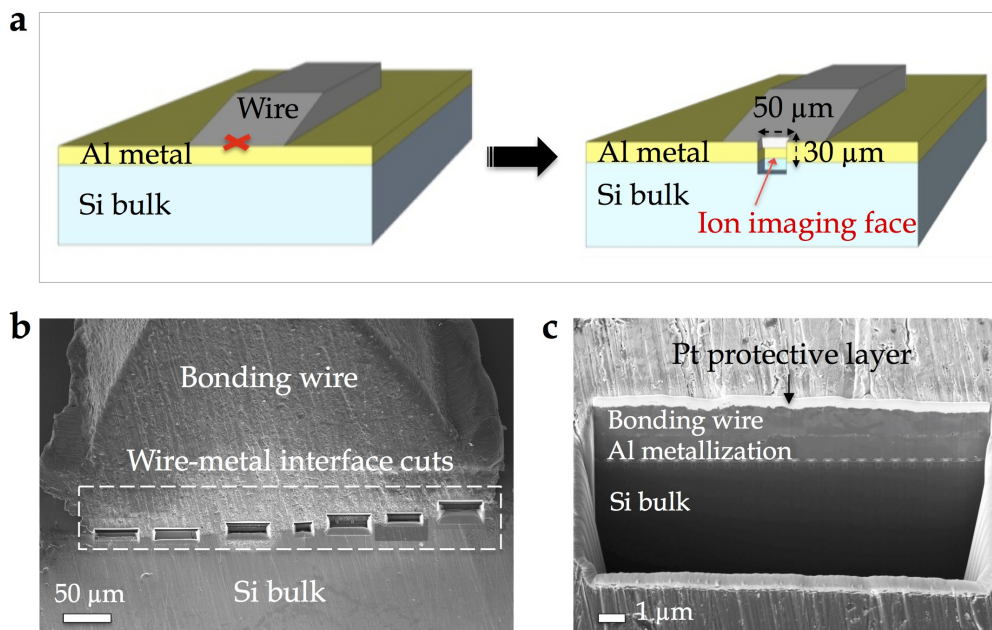
Figure 51: (a) Schematic representation of FIB cross-section from a region of interest (red cross) of the power die wire-metal interface. (b) SEM image of FIB cuts along the wire-metal interface and (c) higher magnification of a single cut, showing the layered structure: Al bonding wire, Al top metallization, MOSFET area and Si substrate.

Once the wires thickness is locally reduced, the wire-metal interface is ready for the FIB milling. Fig. 51a shows the preparation schema of the polished face for the ion imaging. Since the wire-metal interface is too wide ( $\sim 400 \mu\text{m}$ ) to be entirely milled (because the ion beam would take too long and the redeposition would prevent the observation of the area of interest), several smaller rectangular patterned region  $\sim 1500 \mu\text{m}^2$  are milled all along the interface (Fig. 51b and Fig. 51c). We followed the same preparation procedure previously explained for the naked metallization:

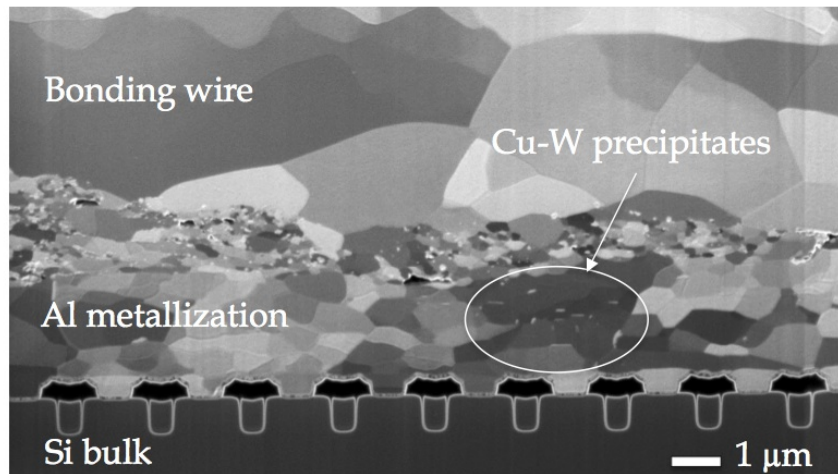
Figure 52: SIM image of the wire-metallization interface. In the Al metallization some Cu-W precipitates are visible in white contrast.

At this location, the deposition of a Pt (or W) protective layer (step 1) and the final polishing (step 3) are even more critical because the face to be polished, which includes also a piece of the bonding wire, is higher. Fig. 52 shows a ion image of the Al metallization under the bonding wire, where we can notice the presence of Cu-W precipitates detected also at the naked metal surface by EDX.

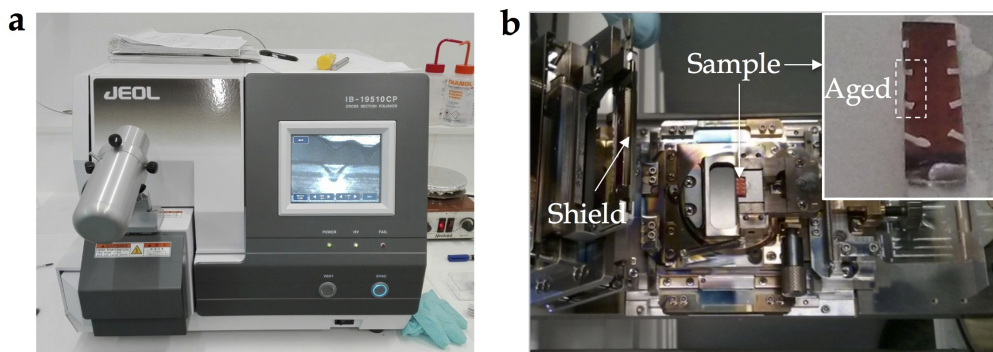
Figure 53: (a) Cross Section Polisher IB-09010CP from JEOL USA. (b) CP inner chamber: the shielding plate is in its lifted position to allow the sample (also visible at higher magnification in the upper-right insert) to be positioned.

In order to increase the observation area without damaging the sample, an alternative to the FIB cross-sectional preparation could be an ion milling by cross-polisher system. In particular, we used a Cross Section Polisher IB-09010CP from JEOL USA (Fig. 53a). The cross polisher (CP) operating principle is based on a broad argon ion ( $\text{Ar}^+$ ) beam with selectable acceleration voltage range of 2 to 6 kV. The beam irradiates the region of interest and creates a mirrored face for the FIB/SEM inspection, by placing a masking plate across the selected area (Fig. 53b).

Once we have mechanically polished the device-epoxy block from both sides (insert in Fig. 53b), according to the preparation previously explained, the sample presents eight wire-metal interfaces that can be finer polished by CP. Two of them, in the aged module, underwent the repetitive electro-thermal cycles and can be investigated by SEM and SIM in comparison to the corresponding non-aged ones.

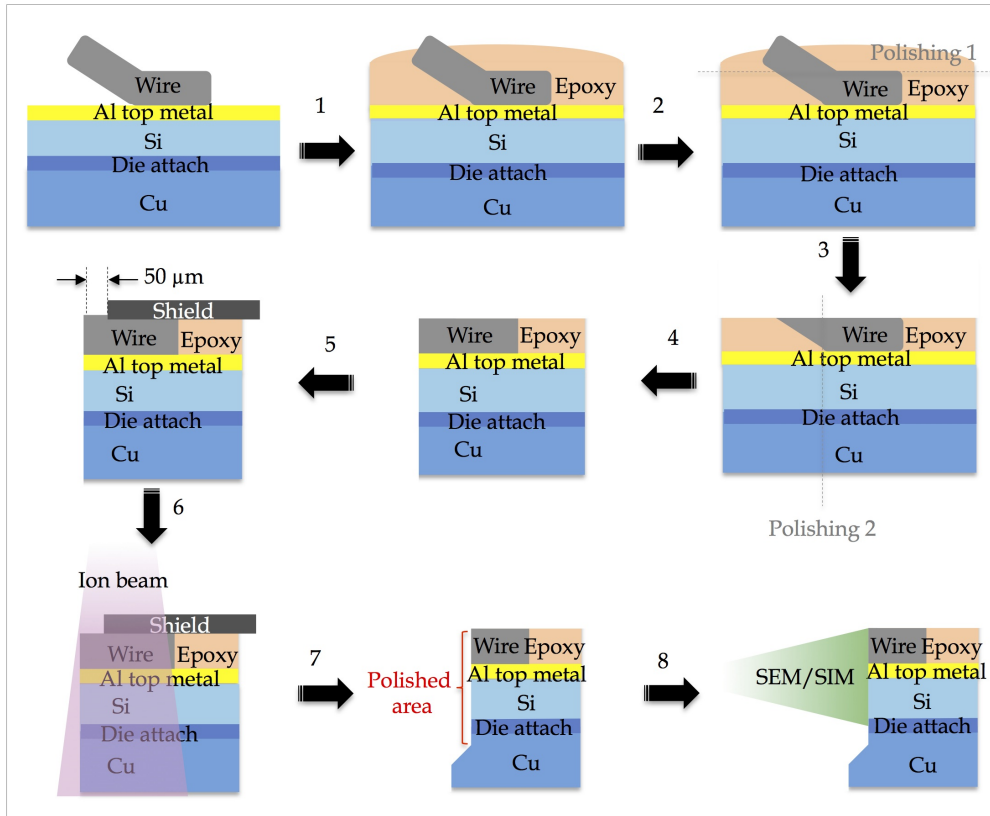
Figure 54: Schema of the sample preparation prior to CP cross-section.

Fig. 54 shows a schema of the whole CP procedure, from the preliminary preparation of the power die for the cross polisher (steps 1-7) to the investigation by FIB/SEM of the polished face (step 8).

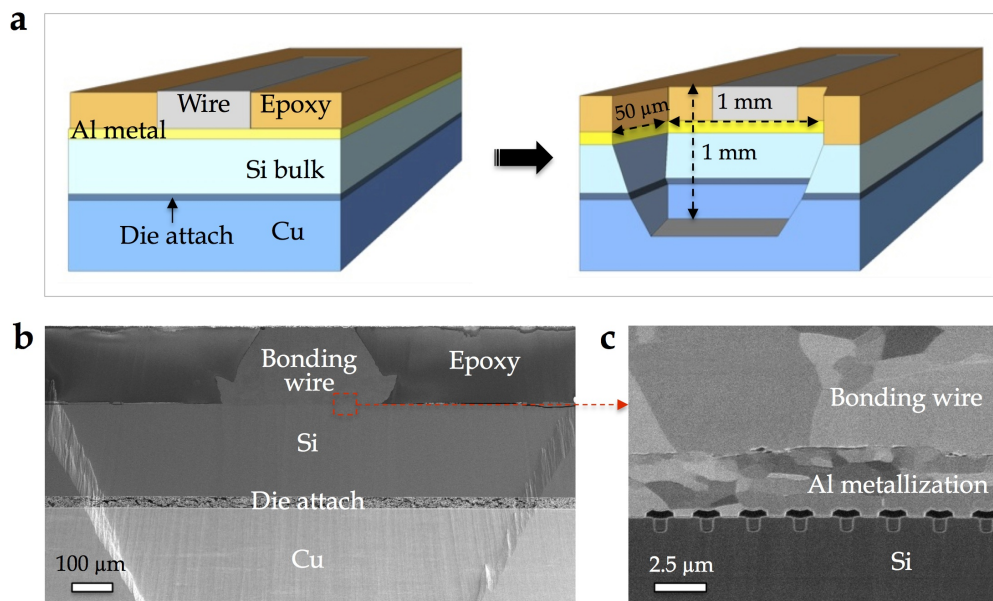
Figure 55: (a) Representation of the solid epoxy-device block (only one wire is represented for sake of simplicity) before and after CP sectioning. (b) SEM low-magnification image of the polished face, showing the layered structure: Al bonding wire, Al top metal, Si substrate, die attach and Cu radiator. (c) In the SIM higher magnification image also the MOSFET area is visible.

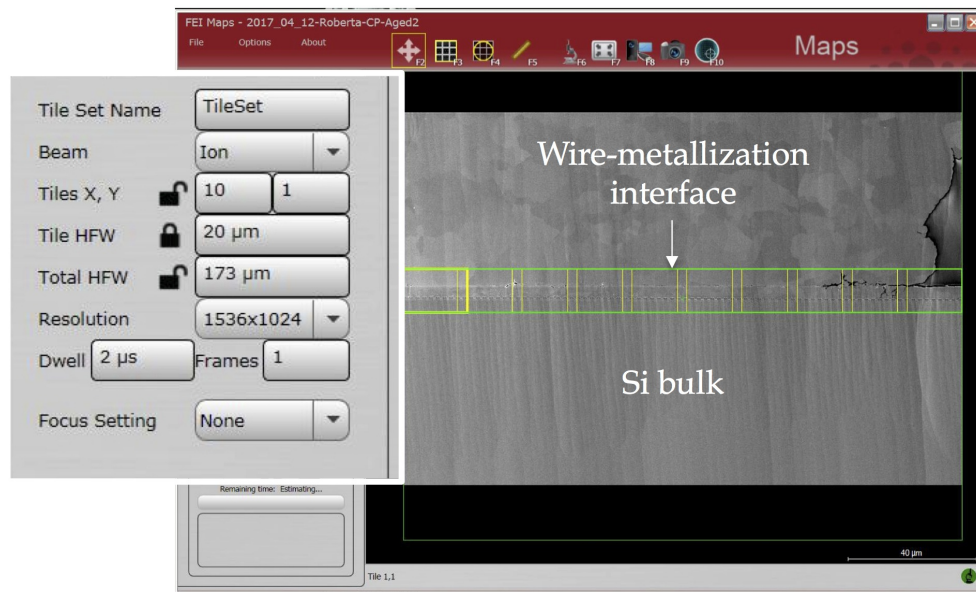
Figure 56: MAPS program interface. The wire-metal interface is split in consecutive tiles (green rectangles) of user-defined size, superposed of few microns. Each tile corresponds to a high resolution SIM image.

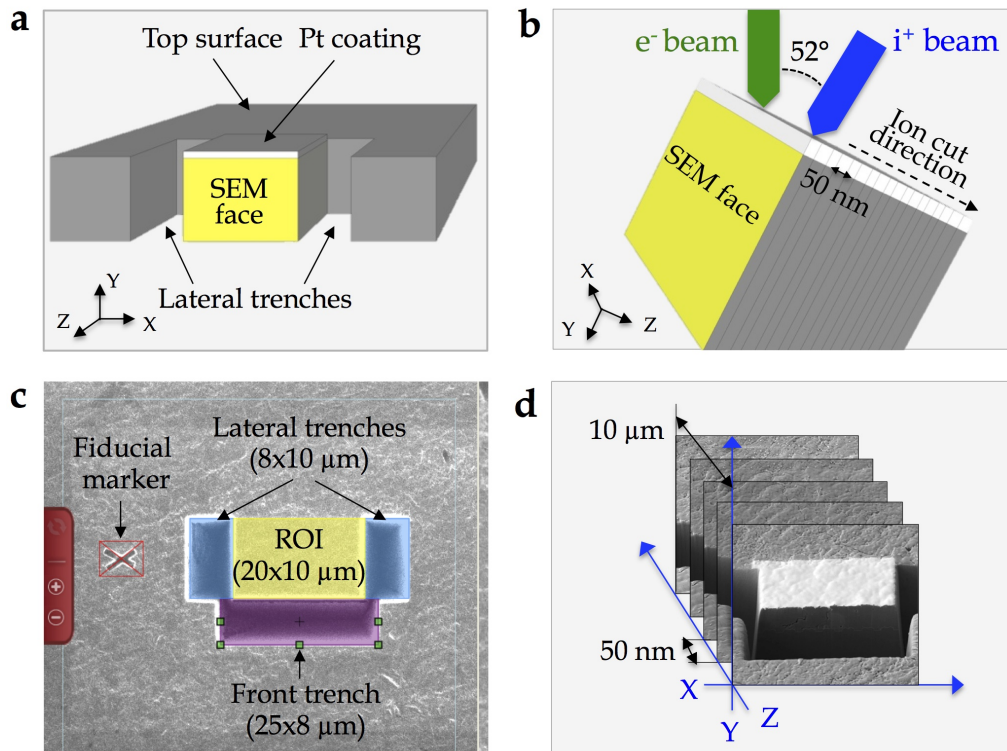
Figure 57: Schematic illustration of the serial sectioning procedure by dual-beam FIB: (a) front view and (b) lateral view of the 52°-tilted sample inside the FIB chamber. (c) Slice and View FEI software interface for the preliminary trenching preparation. (d) Stack of SEM images with a z-spacing of 50 nm, through 10 μm (200 images in total).

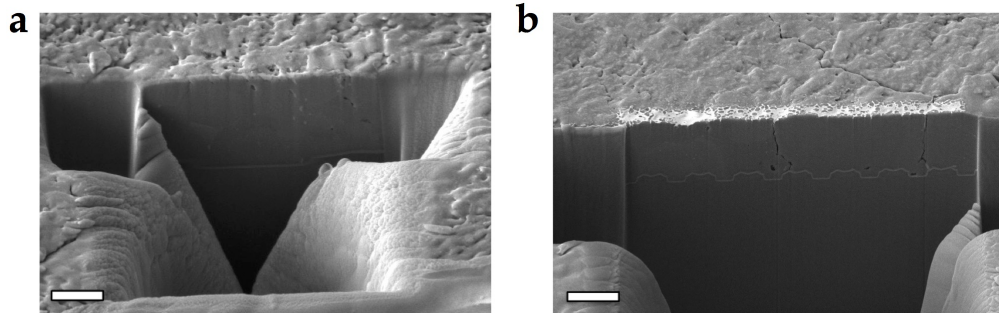
Figure 58: Comparison between two SEM imaging faces during the last steps of the serial milling. (a) The redeposition hides part of the face to be inspected because of a bad preliminary trenching. (b) The imaging face is redeposition-free thanks to an adequate trench size setting. Scale bar 2  $\mu\text{m}$ .

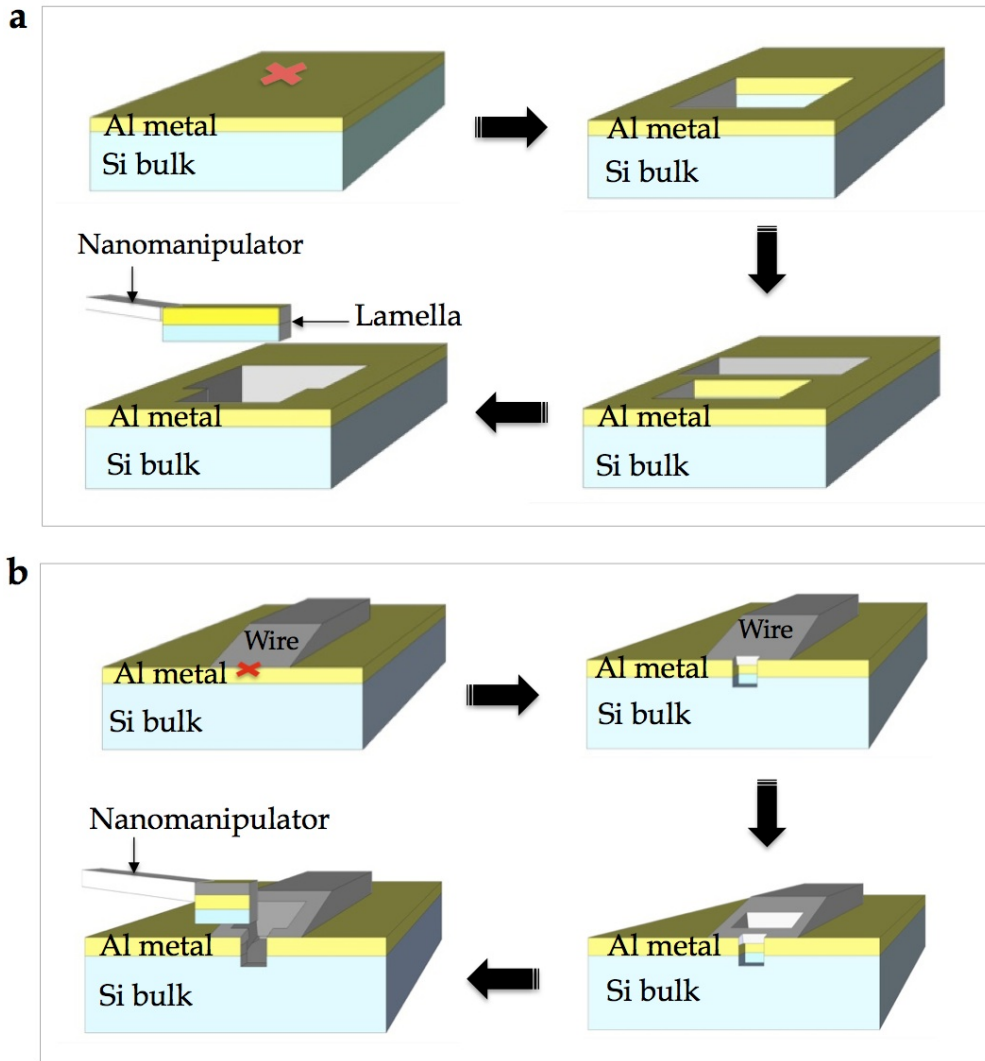
Figure 59: Schematic representation of FIB lamella preparation of the metallization (a) away and (under) the bonding wire.

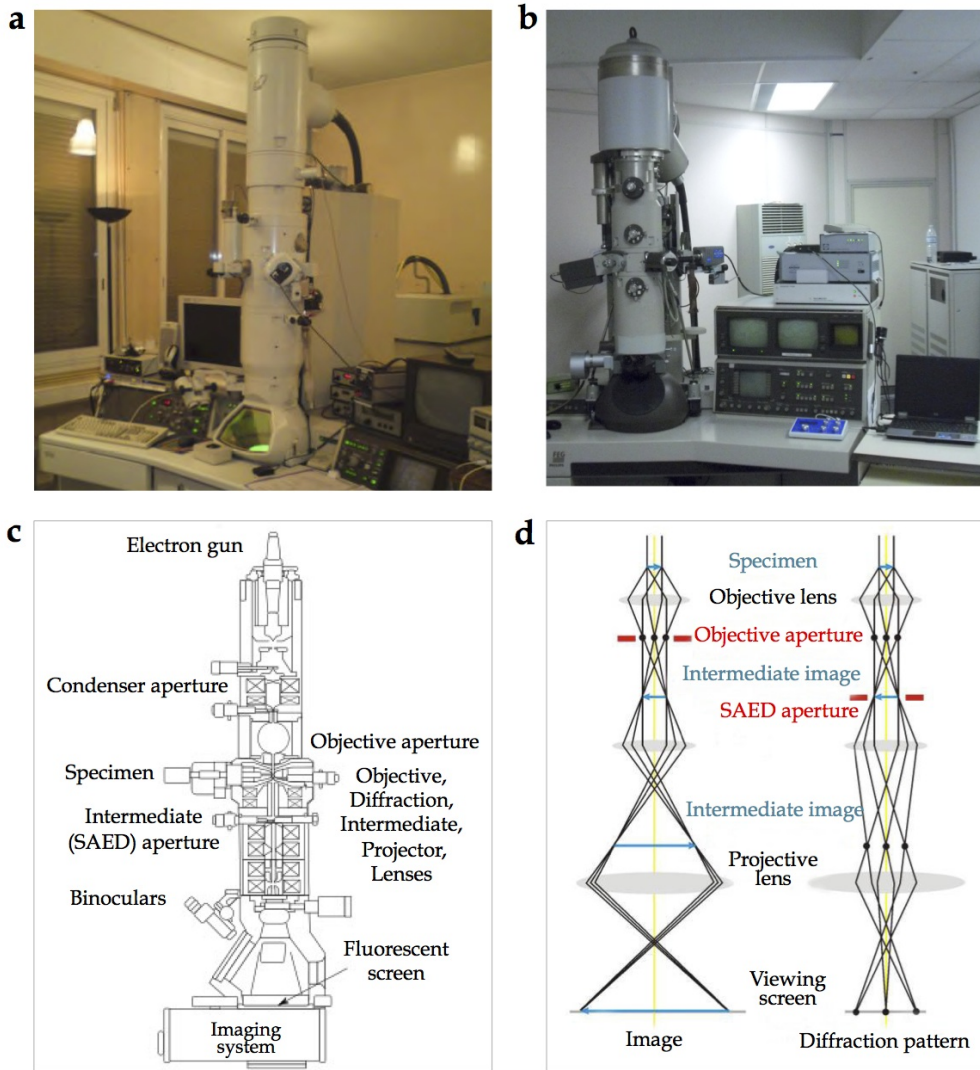
Figure 60: (a) Jeol 2010 HC and (b) Philips CM20 FEG installed in the CEMES laboratory. (c) Schema of a TEM inner column. (d) Conventional TEM imaging mode vs diffraction mode.

Transmission electron microscopy (TEM) is an imaging technique in which an electron beam is transmitted through an ultra-thin specimen and focused onto an imaging system to form a grey-scale image with nanometric resolution. Fig. 60a and Fig. 60b show two of the transmission electron microscopes installed in the CEMES laboratory, used for our analysis: they are respectively a Jeol 2010 HC and a Philips CM20 FEG, both operating at 200 kV and equipped with several sample holders (e.g. heating in-situ holder, single and dual-axis rotation holder, etc.).

Fig. 60c represents a typical TEM column inner structure. The emission source (electron gun) consists in a thermionic lanthanum hexaboride ( $\text{LaB}_6$ ) tip in the Jeol 2010, and a field emission tungsten (W) filament in the Philips

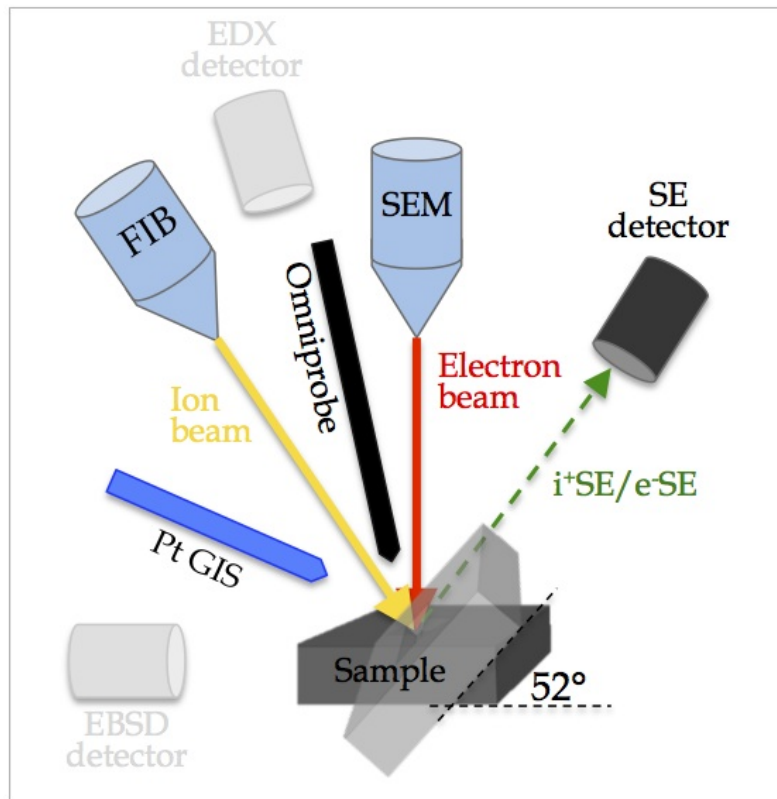
Figure 61: Schematic representation of the dual beam FIB/SEM during the TEM lamella preparation.

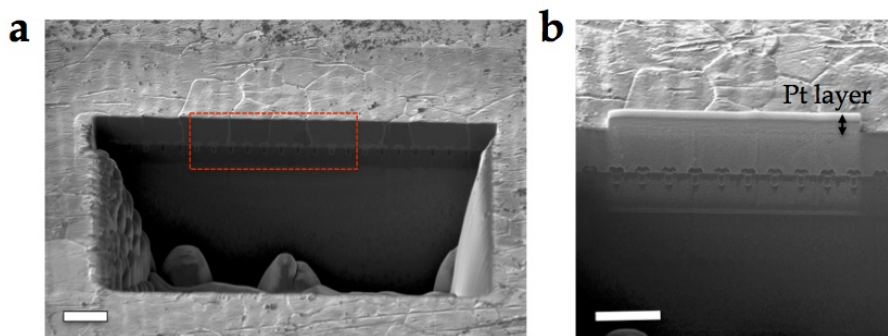
Figure 62: SEM images of the step 1: (a) selection of the region of interest and (b) Pt deposition above it.)

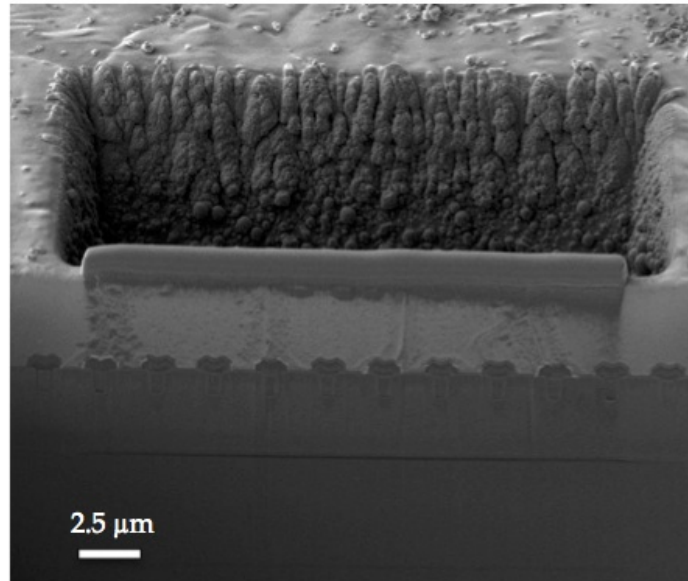
Figure 63: SEM image of the step 2: preparation of a  $\sim 2 \mu\text{m}$  thick lamella, by removing matter behind the region of interest.

A sample piece  $\sim 2 \mu\text{m}$  thick, containing the final lamella, is cut by removing matter behind the region of interest (Fig. 63). This is done in two steps: we dig close to the lamella by a fast rough milling at high ion beam current (30 kV, 9.3 nA) and we complete with a finer milling at lower ion beam current (30 kV, 2.5 nA).

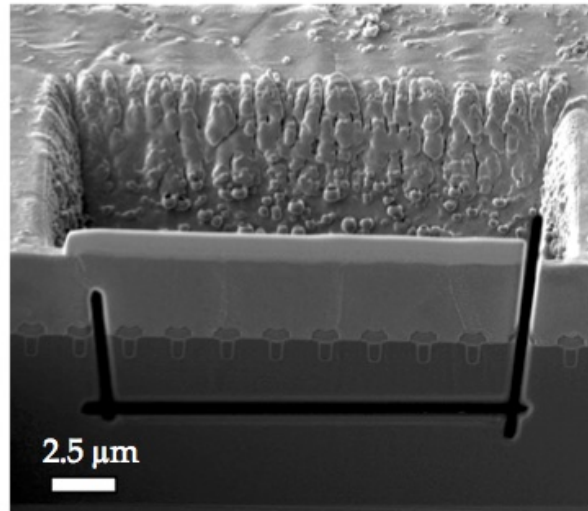
Figure 64: SEM image of the step 3: lamella U-cut prior to the lift-out.

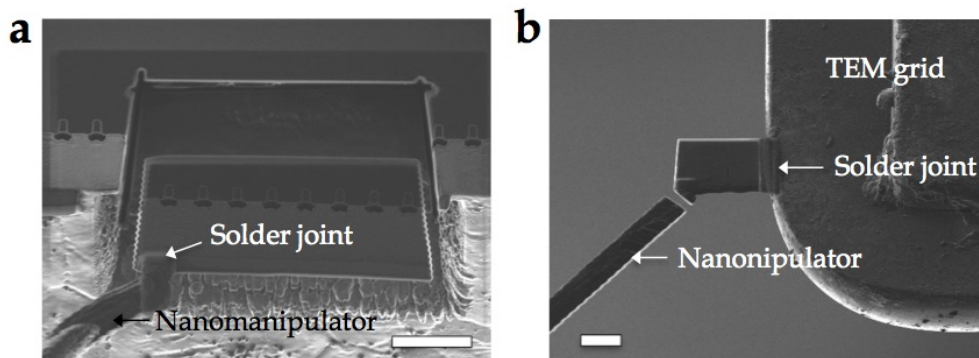
Figure 65: FIB images of the step 4: (a) lamella lift-out and (b) lamella bonding to the TEM grid. Scale bar 5  $\mu\text{m}$ .

In this step the lamella is welded to a dedicate TEM support (TEM grid). The transfer is done by a nanomanipulator Omniprobe, consisting in a W tip with the extremity curvature radius of  $\sim 500 \text{ nm}$ . Fig. 65 shows the main steps of the transfer. The GIS is inserted and the Omniprobe is put in contact with the lamella, so that a Pt/W welding deposition fixes the lamella to the Omniprobe (Fig. 65a). Once the lamella is totally cut, the nanomanipulator is moved to the TEM grid for the lamella welding, again by Pt/W deposition. Now the lamella is fixed to the TEM support, so the Omniprobe tip can be cut away and retracted (Fig. 65b).

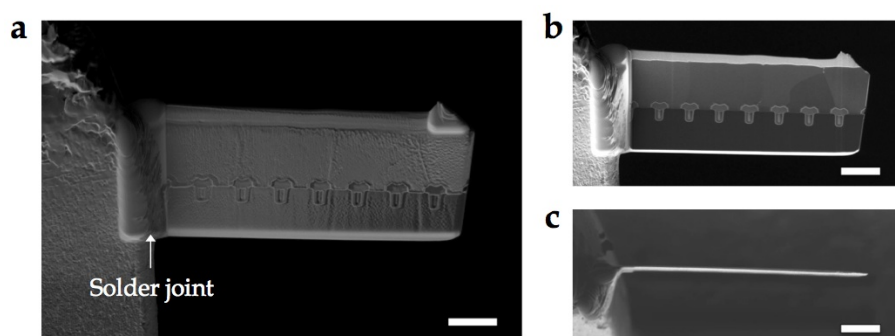
Figure 66: Front-view SEM image of the lamella (a) before and (b) after thinning/polishing step (step 5). (c) Top-view of the final lamella (after step 6 and 7) to check the required thickness of 100-150  $\mu\text{m}$ . Scale bar 2.5  $\mu\text{m}$ .

At this stage, the lamella is  $\sim 2 \mu\text{m}$  thick with both faces contaminated by amorphous material, due to the previous ion beam machining (Fig. 66a). This step consists in removing the amorphous from both faces and thinning the lamella until  $1 \mu - 500 \text{ nm}$  (Fig. 66b), by using a quite intense

It consists in removing part of the amorphous on each lamella face by a finer low-energy ion polishing (5 kV, 15 pA) at an incident angle of  $3^\circ$  to the normal to the sample surface. Thanks to the possibility of constantly monitoring the preparation process, we can check the final thickness and make sure that the thin lamella is perfectly straight (Fig. 66c).

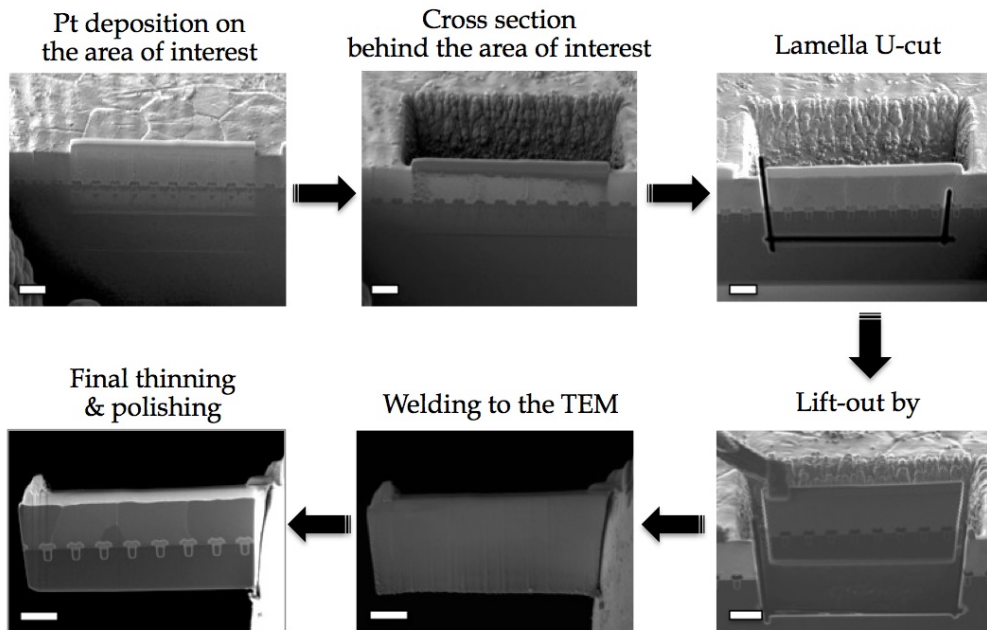
Figure 67: Summary of a FIB lamella preparation for the TEM inspection of the device top Al metallization. Scale bar 2.5  $\mu\text{m}$ .

The entire procedure is summarized in Fig. 67.

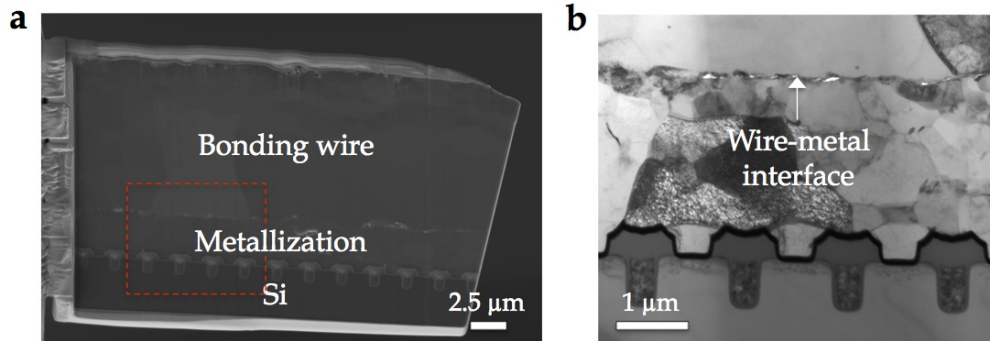
Figure 68: (a) SEM image of a wire-metallization interface lamella prepared by FIB and (b) relative high-magnification TEM image.

The most critical step when we want to prepare a TEM lamella that includes the wire-metallization interface (Fig. 68) is the matter digging behind the region
