# Fatigue mechanisms in Al-based metallizations in power MOSFETs

Roberta Ruffilli. Fatigue mechanisms in Al-based metallizations in power MOSFETs. Condensed Matter [cond-mat]. Université Paul Sabatier (Toulouse 3); École doctorale Sciences de la Matière, 2017. English. NNT: . tel-01666437v2

**Fatigue mechanisms in Al-based metallizations in power MOSFETs**

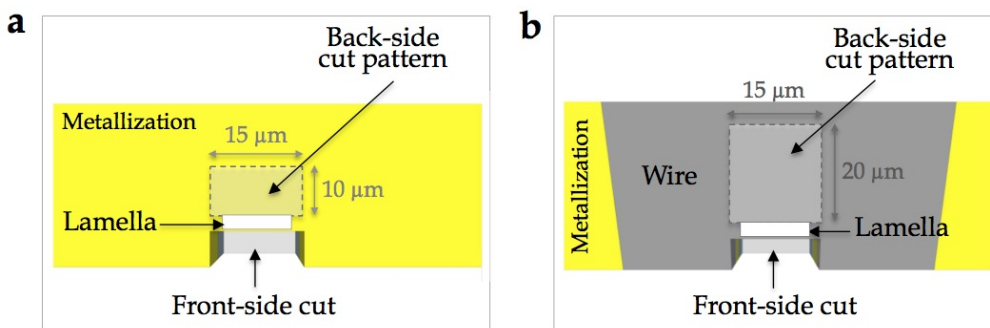
Figure 69: Top view schematic representation of the metallization (a) naked and (b) under the bonding wire, during the lamella preparation by FIB. The dashed rectangular patterns represent the sample area to be milled behind the region of interest, in order to obtain a  $1\mu\text{m}$  thick lamella prior to the lift-out and the final polishing. The pattern in (b) is higher because the area to be milled is deeper, due to presence of the bonding wire.

It is therefore mandatory to increase the cut pattern high behind the wire-metallization lamella (Fig. 69), in order to provide sufficient space for the redeposited matter to spread out in the cut area. In this way, making a rotation of  $180^\circ$  with respect to the front-face, we could also monitor the cut progress and directly check the lamella back-face polishing.

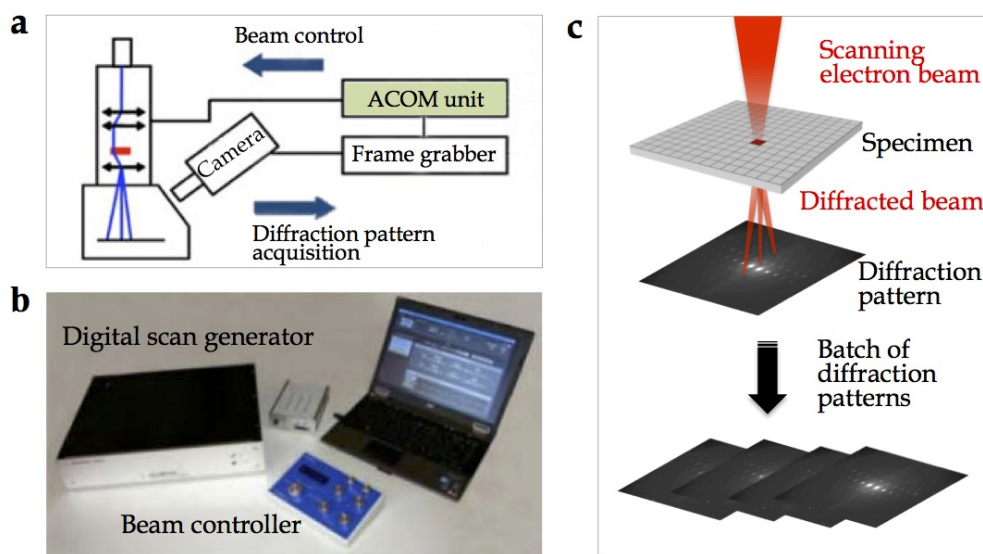
Figure 70: Automated Crystal Orientation Mapping (ACOM).

- (a) The NanoMEGAS ACOM unit collects the diffraction signal, acquired by an external fast-rate camera, and controls the electron beam in the TEM.
- (b) The NanoMEGAS ACOM unit consists in a digital scan generator, a beam controller console and a computer with the pattern-recognition software.
- (c) The digital scan generator controls the electron beam which scans the sample to generate a diffraction pattern from each point of the area of interest.

The NanoMEGAS ACOM unit (Fig. 70b) is installed in the Philips CM20 FEG microscope, operating in micro-diffraction mode: it controls the deflection coils, making sure that the electron beam scans the sample, to generate a diffraction pattern from each point of the area of interest (Fig. 70c). At the same time an external fast-rate camera acquires the diffraction signal and send it to a computer, equipped with a software dedicated to the pattern recognition (Fig. 70a).

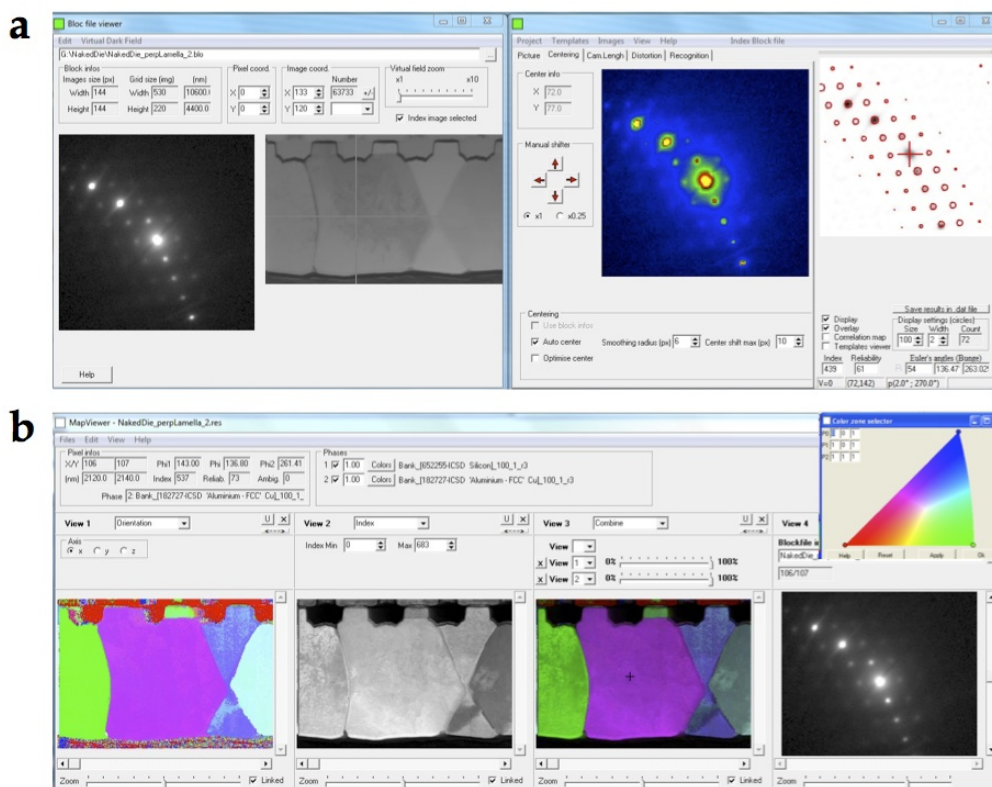
Figure 71: ACOM pattern recognition software windows.

- (a) The diffraction image from each point of the area of interest is digitized and compared with simulated diffraction patterns of a databank.
- (b) The result of the matching can be visualized in an orientation map, where each color represents a specific crystallographic orientation.

The software matches the diffraction patterns from the sample with a database of simulated diffraction patterns to identify the most plausible crystallographic orientation of each point (Fig. 71a). The result is then an orientation map of the region of interest, as in Fig. 71b.

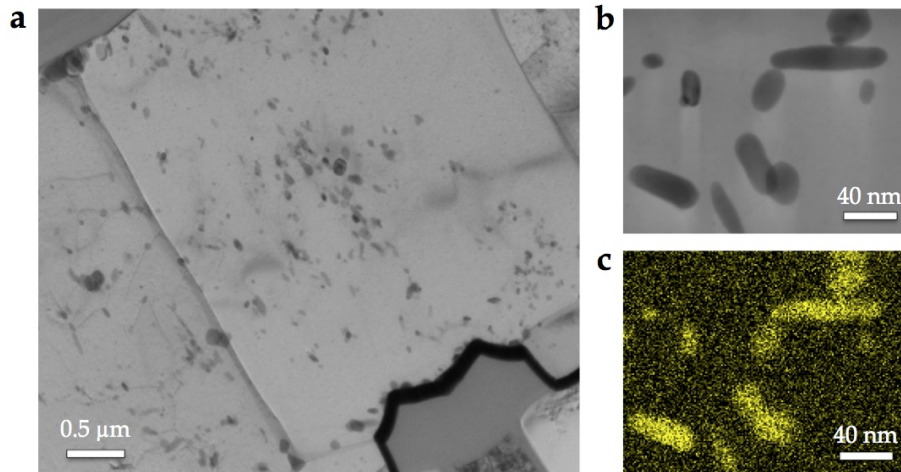
Figure 72: (a) TEM image of the Al metallization decorated with Cu/W precipitates. (b) Higher magnification TEM image of some of these precipitates and (c) relative EDX map, corresponding to the Cu element.

top metallization. For instance, we could exploit the higher resolution of the TEM to image the Cu-W precipitates in the metallization (Fig. 72a and Fig. 72b) and perform a compositional mapping of the elements present in the region of interest (e.g. Cu in Fig. 72c).

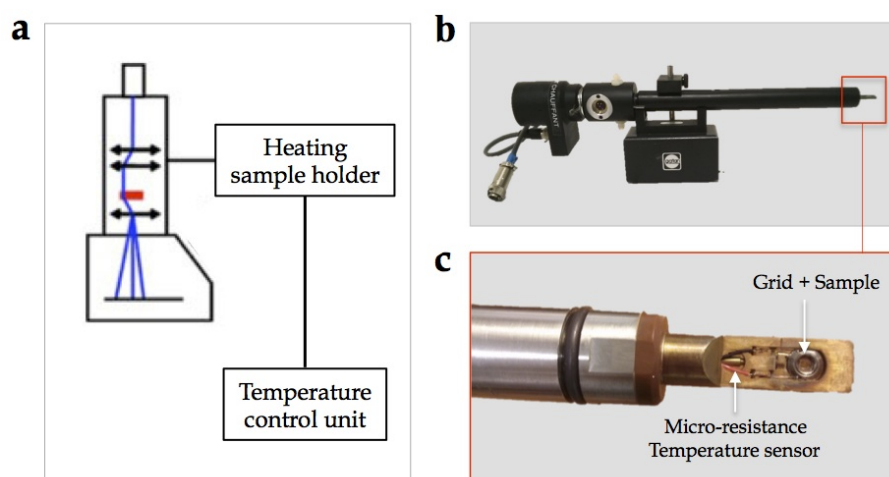
Figure 73: In situ heating TEM settings. (a) The JEOL 2010 is equipped with a (b) double tilt heating holder (Gatan) connected to a temperature control unit. (c) The TEM grid containing the sample is placed at the extremity of the sample holder and it is connected to a heating micro-resistance and a temperature sensor.

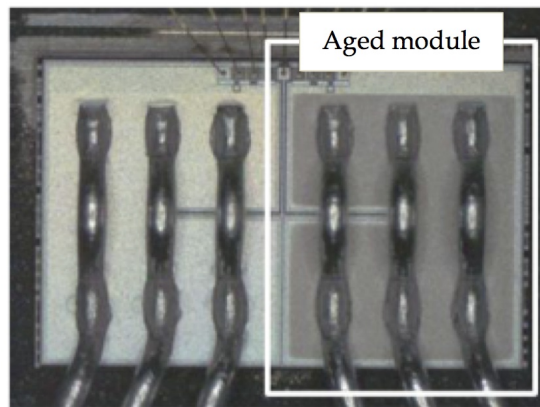
Figure 74: Optical image of an SPDO6 power die after accelerated aging test (300 kcycles at room temperature). Only one module underwent the electro-thermal cycles, whereas the other one serves as reference for the microstructural characterization of the critical points.

A closer inspection by SEM of the Al top metallization confirms the optical result (Fig. 74): the Al microstructure image at failure (Fig. 75b, c) is significantly different to the relative as-is part (Fig. 75a) and reveals a heavy surface reconstruction, which is not uniform in the analyzed module. Some zones, close to the central wire contacts, presents a higher roughness (Fig. 75b), in others the Al grain structure is still visible but large cracks propagate along the grain boundaries (GBs) (Fig. 75c), or a mix of the two.

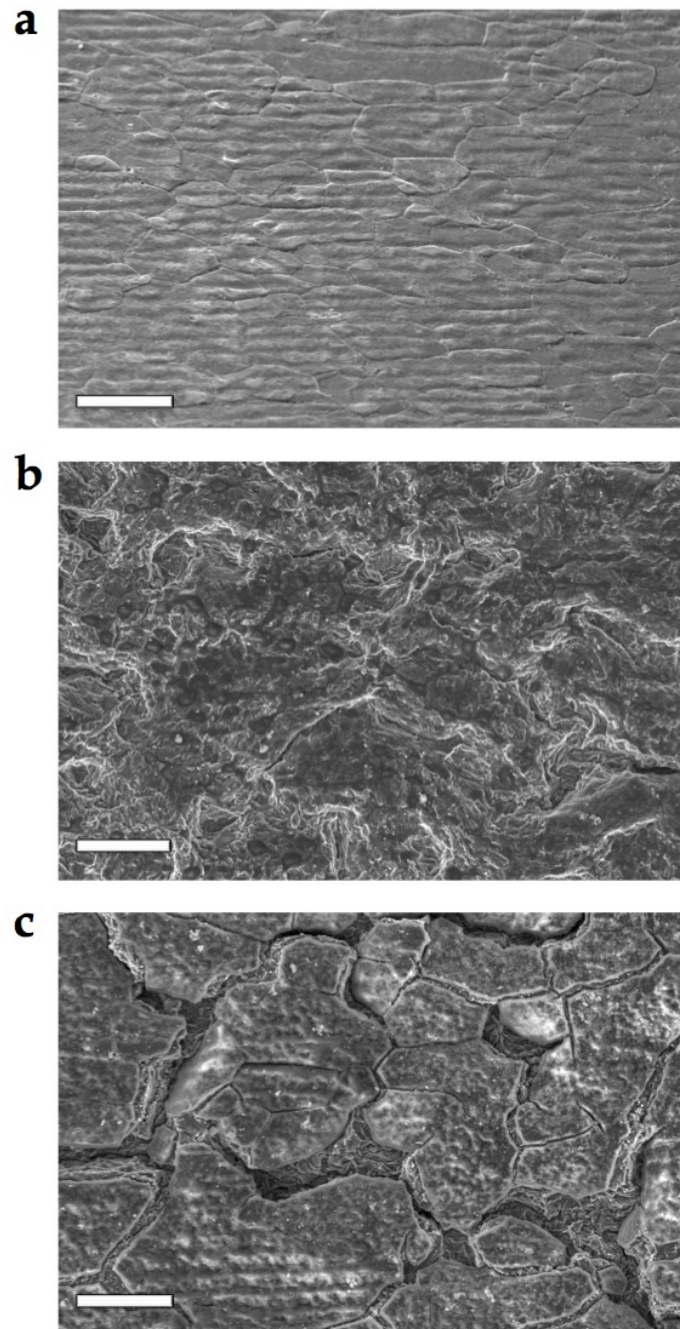
Figure 75: Top view SEM images showing the Al metallization of (a) an as-is module and (b), (c) a failed one at two different locations. The grain structure is visible in all of them as GBs are slightly grooved in (a) and more heavily cracked in (b) and (c). Scale bar 10  $\mu\text{m}$ .

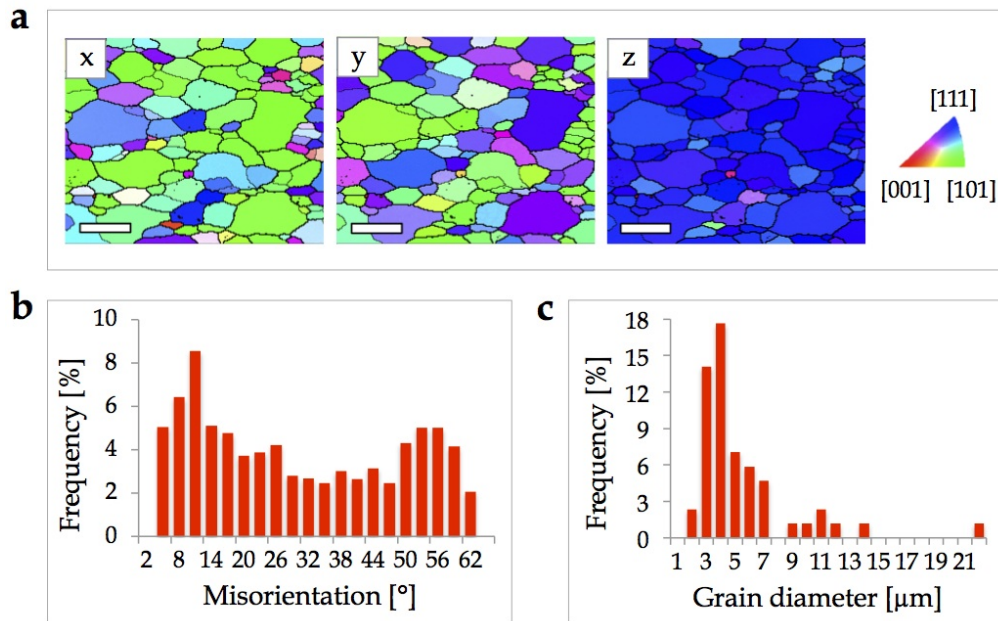
Figure 76: (a) EBSD orientation mapping along x, y and z axis of the Al metallization of a reference module and relative histograms of the (b) grain misorientation and (c) grain size (equivalent diameter).

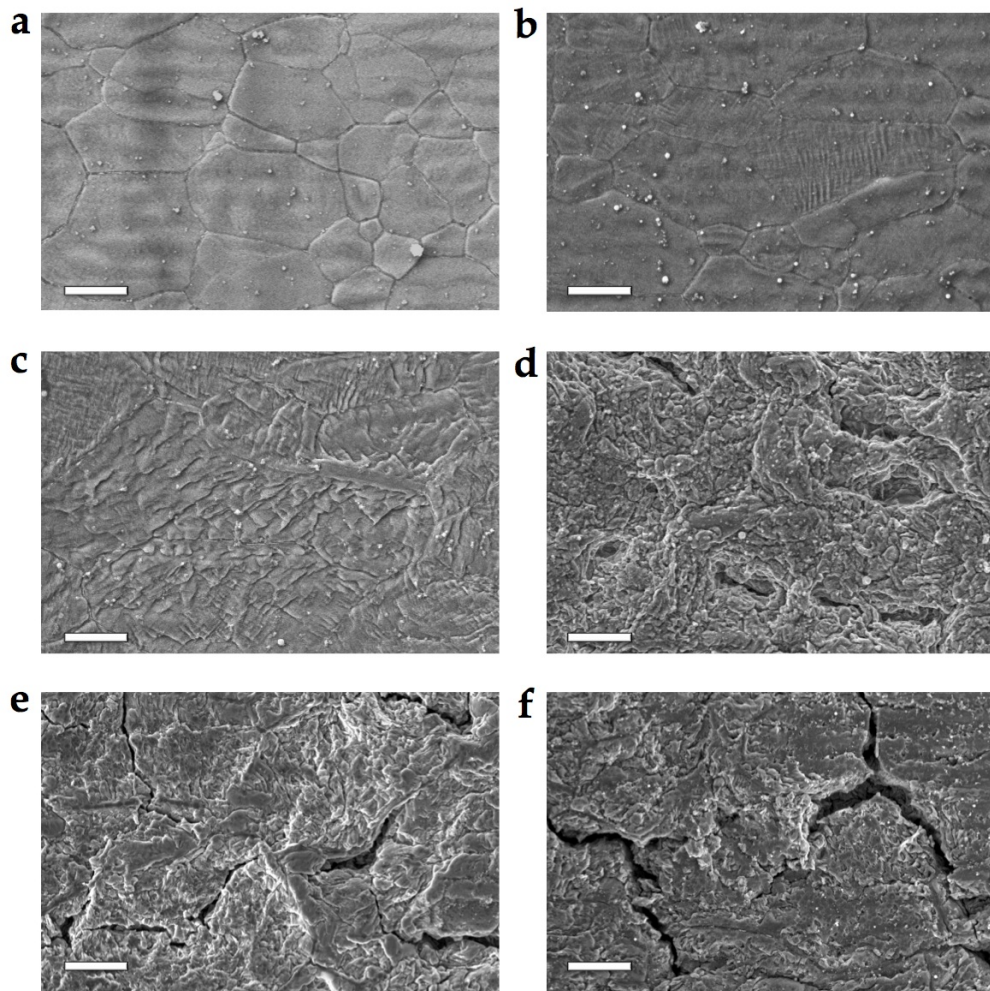
Figure 77: Top view SEM images showing the evolution of the Al source metallization surface. Grain structure (a) before starting the accelerated aging and after (b) 1 kcycles, (c) 10 kcycles, (d) 100 kcycles, (e) 200 kcycles and (f) 300 kcycles. Scale bar 5  $\mu\text{m}$ .

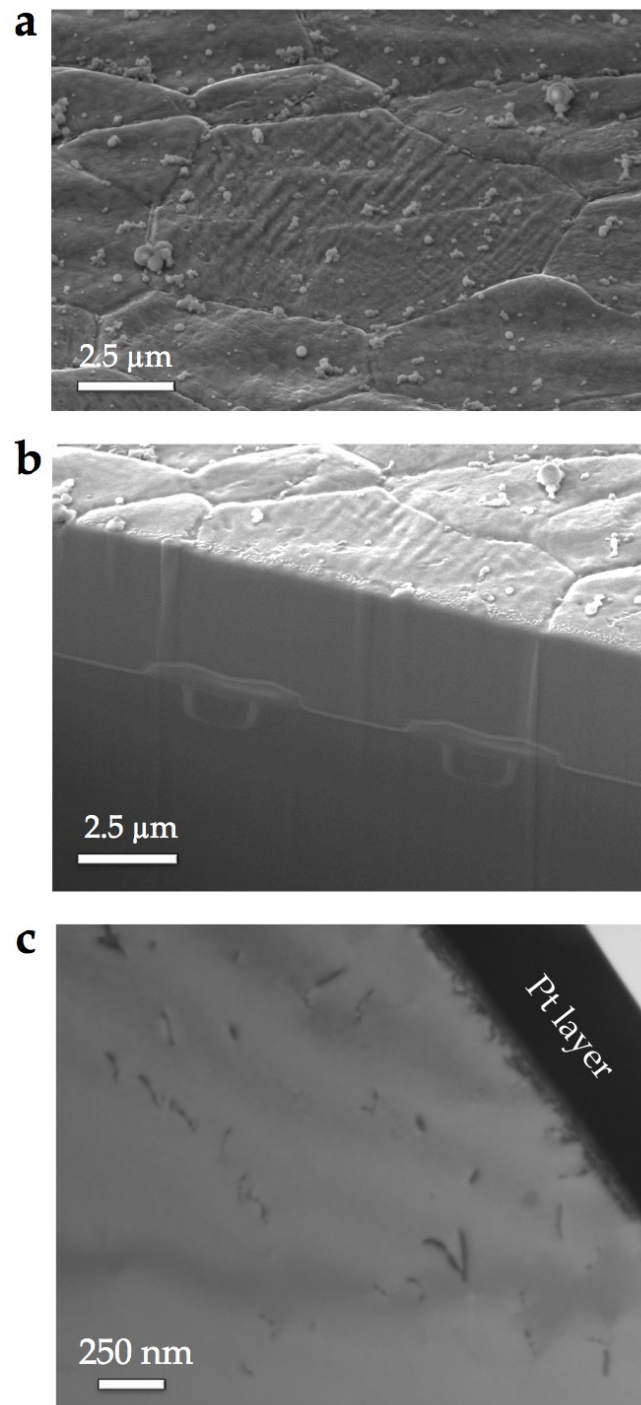
Figure 78: (a) SEM image of the Al metallization from a 1kcycles aged module. The bigger central grain is characterized by a ridge-notch pattern. We have investigated the dislocation distribution beneath this area by TEM, preparing an ultra-thin lamella by FIB. The first step of the preparation (a cross-sectional cut perpendicular to the surface, ahead of the region of interest) is depicted in (b). (c) The TEM image just below the Al metallization surface (covered by a dark-contrasted Pt protective layer) reveals the presence of few uniformly distributed dislocations (dark lines) and the absence of slip bands.

- After 1kcycles (Fig. 77b) we do not observe any sign of surface reconstruction, the grain structure is preserved and the horizontal transistor wave pattern is still visible. However, some grains are characterized by a sort of ridge-notch pattern (white arrows). It is evident at higher magnification in Fig. 78a (in the big central grain). This could remind the intrusions and extrusions formation at the basis of fatigue cracks initiation in metals under stress cycles [Sur98]. If so, the inner Al structure beneath the ridges should be characterized by slip bands along the  $\langle 111 \rangle$  direction, containing stack of several aligned dislocations. However, the TEM image (Fig. 78c) of a FIB lamella perpendicular to the ridge-notch pattern from the grain of interest (Fig. 78b) does not present these features: only

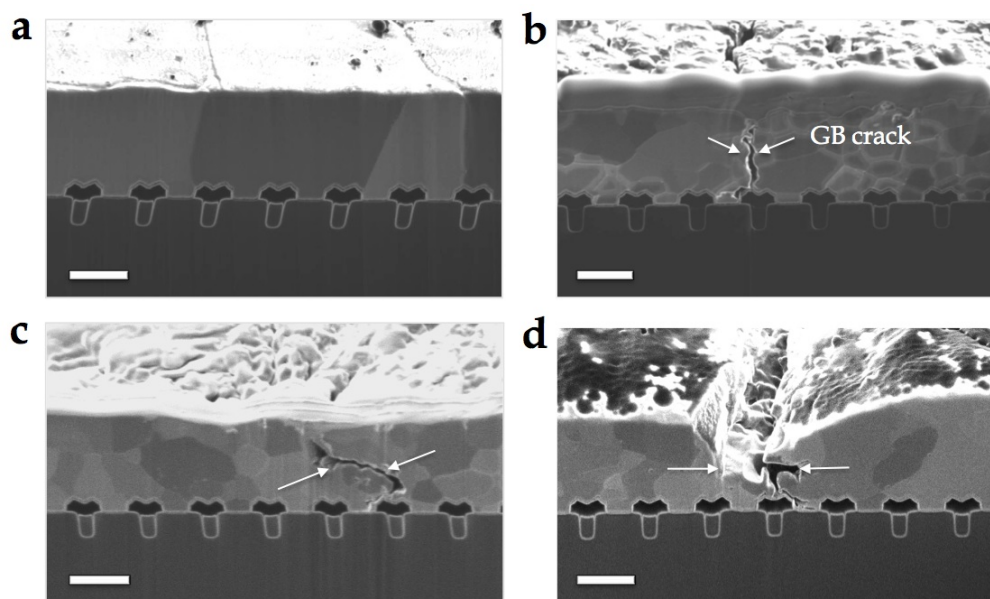
Figure 79: SIM imaging of the Al source metallization of an (a) as-is and (b) 100, (c) 200 and (d) 300 kcycles aged power modules. Scale bar 2  $\mu\text{m}$ .

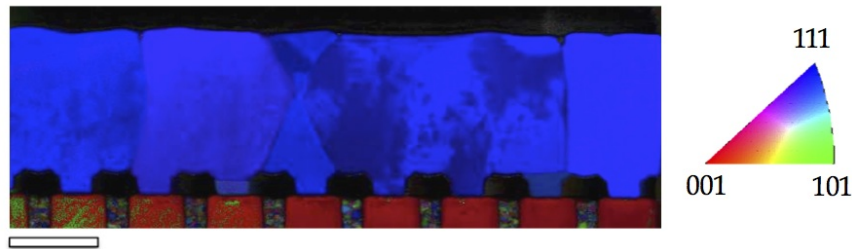
Figure 80: ACOM mapping of the cross-section of an as-is module, showing a strong  $\langle 111 \rangle$  texture of the Al grains along the deposition direction. The standard stereographic triangle gives the color codes of the grain orientations, taken here along the vertical growth direction. Scale bar  $2.5 \mu\text{m}$ .

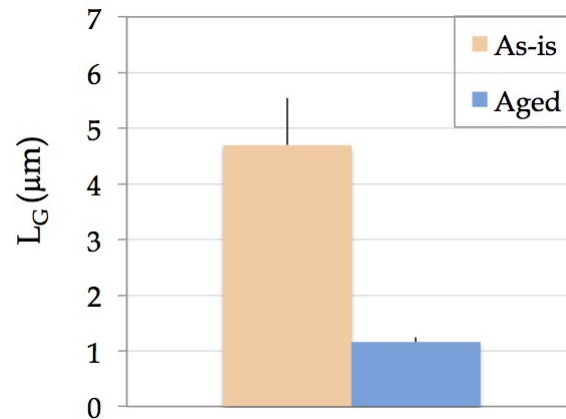
Figure 81: Grain size calculated by lineal intercept method in 10 FIB cross-sections of each analysed module, both aged at 130 kcycles (in blue) and as-processed (in orange).

In Fig. 79b-d we can observe the metallization cross-sections of aged modules, respectively at 100, 200 and 300 kcycles. Aging seems to lower the grain size, as also observed by Bernoux [Ber09] and Martineau [Mar14]. We tried to measure the average grain size in a tens of SIM images from as-is and aged modules by lineal intercept method. This method take into account the number of times that a series of uniformly distributed lines drawn on the SIM images intercepts the grain boundaries and returns a mean lineal intercept length, which can be associated to the grain size [Tom45]. The result for a 100kcycles aged device is reported in Fig. 81, showing that the average grain size is  $\sim 4$  times lower in the aged metallization compared to the as-is one.

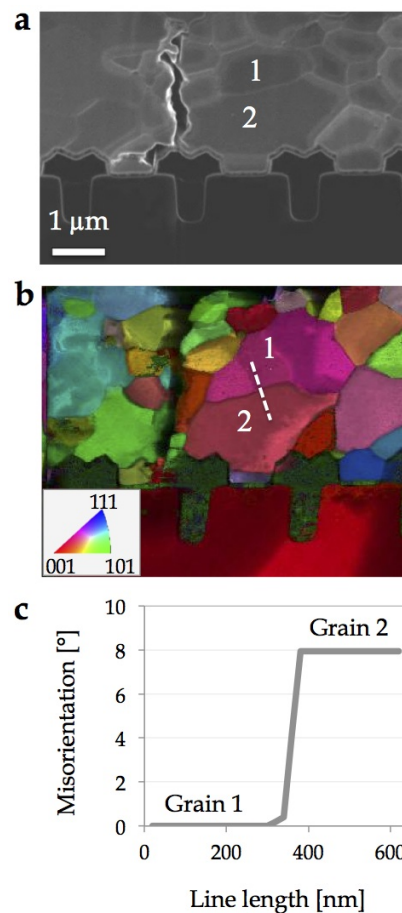
Figure 82: (a) FIB imaging and (b) ACOM orientation mapping of the source metal of an aged module (short circuit, 130k cycles) at the interface with the Si substrate. The standard stereographic triangle gives the color codes of the grain orientations, taken here along the horizontal direction. (c) The plot represents the misorientation between the grains 1 and 2 along the white line in b).

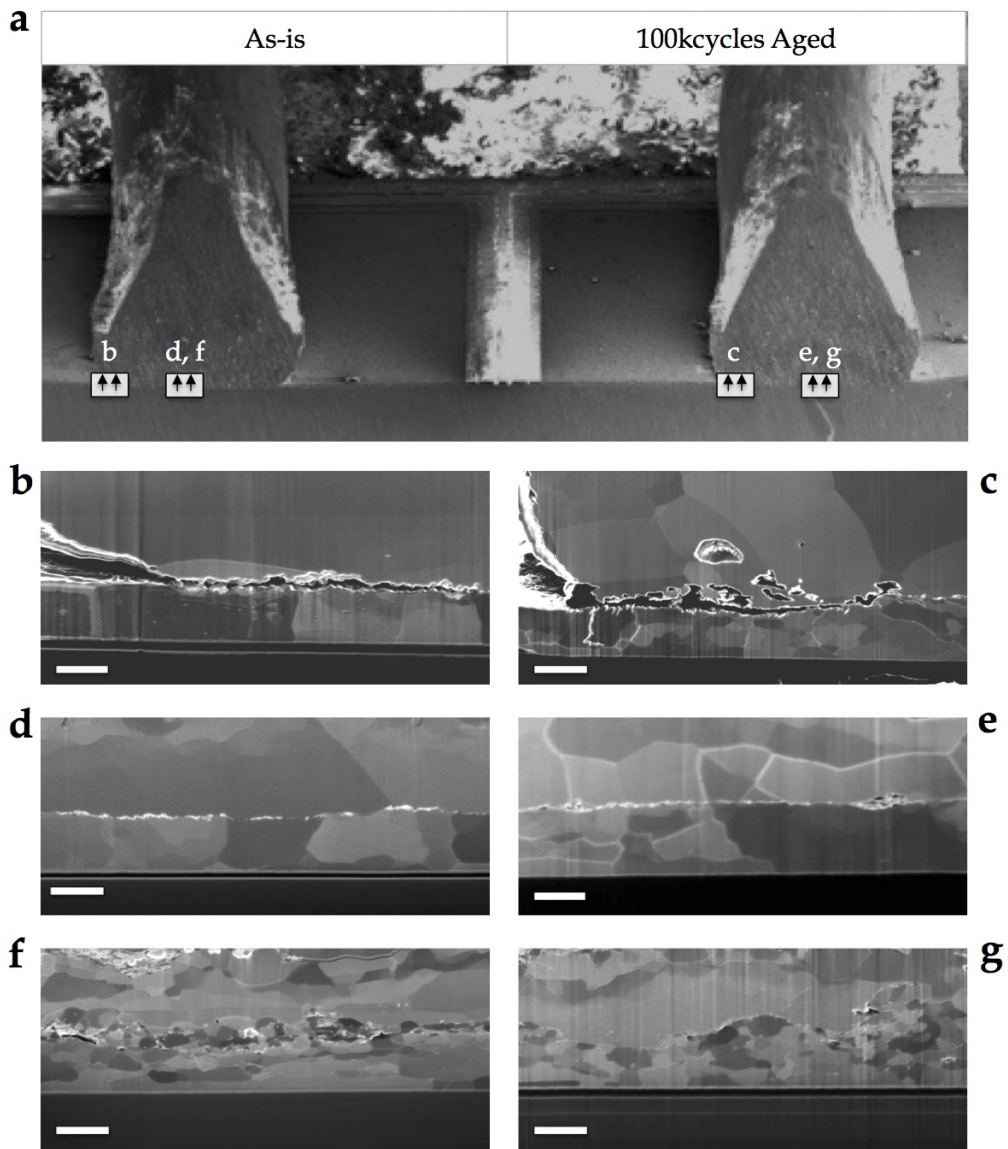
Figure 83: (a) FIB cross-sectioning schema under a  $45^\circ$  polished bonding wire from an as-is module (left) and an aged one (right). The arrows indicate the imaging direction.

The relative SIM images have been collected from the edge of the bonding wire of the (b) as-is and (c) aged (100 kcycles) module, and at the center of the bonding wire of the (d,f) as-is and (e,g) aged (100 kcycles) module. Scale bare  $2.5 \mu\text{m}$ .

Fig. 83 shows SIM images of the wire-metallization interface from the side of the bonding contact (Fig. 83b and c) and at the center (Fig. 83d-g) for an as-is module (left) and a 100kcycles aged one (right), according to the larger view in Fig. 83a. Under the wire, the initial Al metallization has endured plastic deformation, due to the cold-bonding process, and the initial grain size seems systematically smaller compared to the bamboo structure of the naked metallization (Fig. 79a).

- The contact between the two metals is systematically absent at the two edges (for  $\sim 10\mu\text{m}$  towards the inside) even prior to aging (Fig. 83b and c). This demonstrates that only a fraction of the nominal metallization area impacted by the bonding ( $0.25\text{mm}^2$ , according to the LFET1T standard specifications) is truly in contact with the wire of metallization surface is truly in contact with the wire. A very coarse estimation would lead to a third of the metallization being impacted by wire-bonding plastic deformation <sup>1</sup>.

- In the central area (Fig. 83d-g), the bonding between the metallization and the wire shows initial imperfections, probably due to Al oxide (appearing in white contrast in SIM imaging) and small cavities. Moreover, the plastic deformation is highly uneven along the applied stress of the wire bonding, which is perpendicular to the wire-metal interface. Some section shows a straight interface (Fig. 83d and e), whereas in other ones (Fig. 83f and g) the source metallization is more deformed.

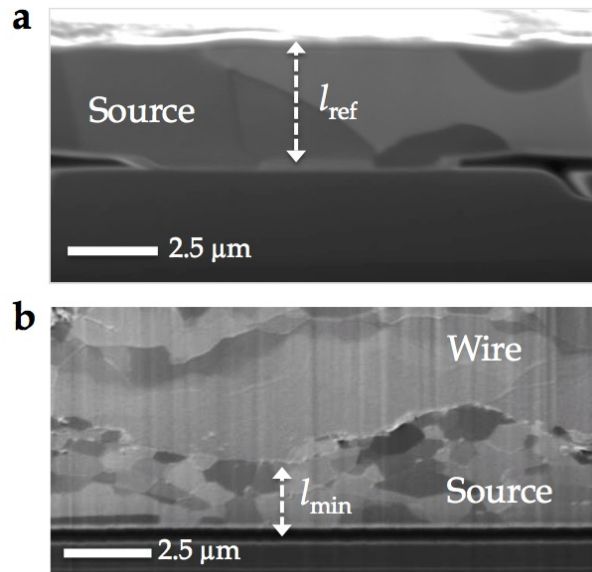
Figure 84: SIM images of the Al metallization (a) away and (b) under the bonding wire. The naked metal thickness ( $l_{ref}$ ) serves as reference for the measurement of the minimum thickness ( $l_{min}$ ) in the deformed sections under the bonding wires.

We tried to quantify the plastic deformation of the source metallization under the wires, by measuring the minimum metallization thickness in the FIB sections (Fig. 84b) and taking the initial metallization thickness (away from the

wire) as a reference (Fig. 84a). The deformation is then locally calculated as follow:

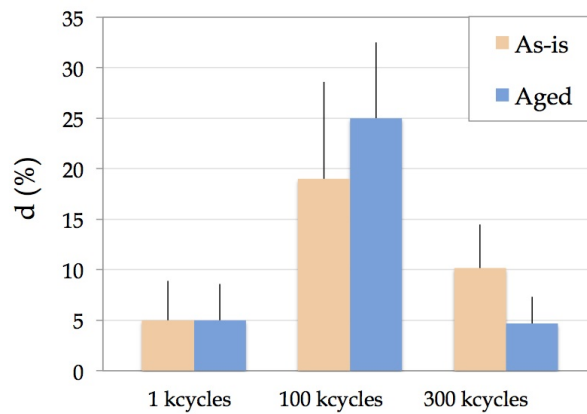
Figure 85: Plastic deformation of the Al metallization under the bonding wires of the as-is and the aged module of three different devices: aged at 1, 100 and 300 kcycles. The deformation has been calculated as the minimum metallization thickness in the wire-metallization FIB sections (7 for each analyzed module, each one  $\sim 15\mu\text{m}$  wide), taking the initial metallization thickness (away from the bonding wire) as a reference.

<sup>1</sup> To estimate the effective imprint of the wire on the metallization, we made the following calculation and assumption: The plastic deformation of the metallization imposed by the bonding process is about 10% in average in compression (Fig. 85). If we assume that the yield stress of the metallization is only dictated by its grain size (which is an underestimate because we neglect the effect of alloying), it should have deformed at stresses between 100 to 150 MPa (values given by Tsuji et al [Tsu02]). The force imposed to the  $0.25\text{mm}^2$  metallization by the wire is on the order of 10 N which correspond to a stress of 40 MPa only. This should not be sufficient to deform the metallization unless only a portion of the metallization is impacted. A simple rule of mixture leads to about  $1/3$ rd of the surface of the wire imprint ( $40 * 3 = 120\text{MPa}$ ).

Fig. 85 shows the plastic deformation values of the Al metallization under the bonding wires of as-is and aged modules for three devices: aged at 1, 100 and 300 kcycles. Plastic deformation ranges from 5% to 25% in the measured sections (7 for each analyzed module, each one  $\sim 15\mu$  m wide). This wide range may be due to the fact that the number of measured cross-sections (7 for each sample) is not enough to have consistent statistics or to the fact that the wire-metallization interface is highly uneven along the wire-metal interface (in line with the high standard deviation relative to each data set). Moreover, we can notice that the metal under the bonding wire is severely deformed prior to aging and upon electro-thermal cycles the amount of plastic deformation perpendicular to the interface does not change significantly. However, grain growth is observed, at variance with what happens outside the wire-bonding area. The initial dislocation density is also higher in this zone, which forecasts larger rearrangements, cell formations and subsequent grain boundaries creation.

Fig. 101 shows the mean deformation percentages in a 25°C and 70°C aged module, and in the relative as-is parts. Here, we found out that plastic deformation ranges between 21% and 12% in average in the measured sections. This range is narrower than the one obtained for the SPD06 devices (Fig. 85), probably due to the fact that we measure a higher number of T07D17 sections. However, the standard deviation of the sets of values is comparable, or even higher, compared to the SPD06 data sets, confirming that the wire-metallization interface is highly uneven.

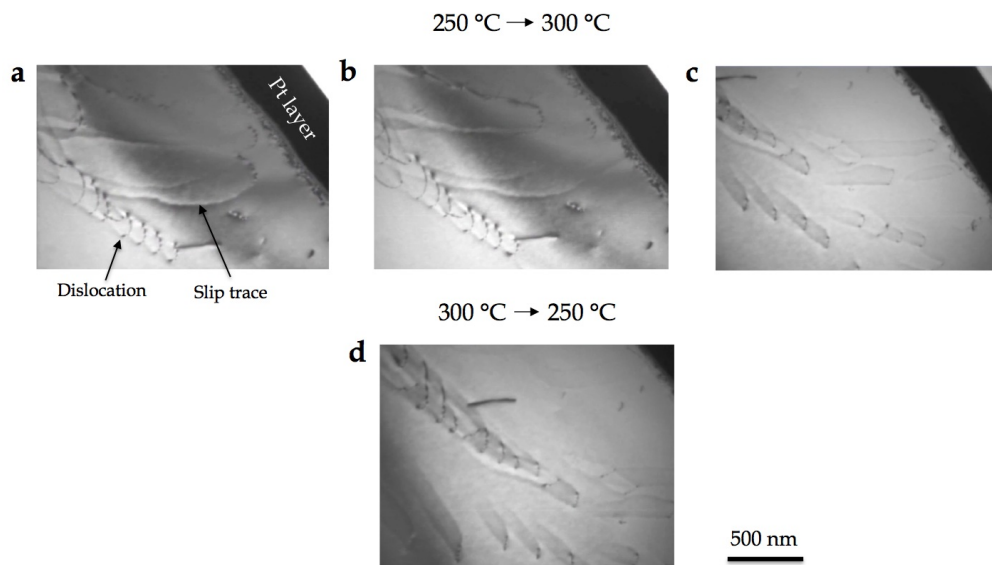
Figure 86: In situ TEM thermal cycling of a device FIB-prepared cross-section from 25°C to 450°C. (a)-(c) are snapshots captured during the heating up phase from 250°C to 300 °C, showing curved slip traces associated to a combination of dislocation climbing and gliding. Once the dislocations are dispersed, during the correspondent cooling down phase (d), no reverse motion is observed because the Si substrate is too thin to induce significant stress in the Al film.

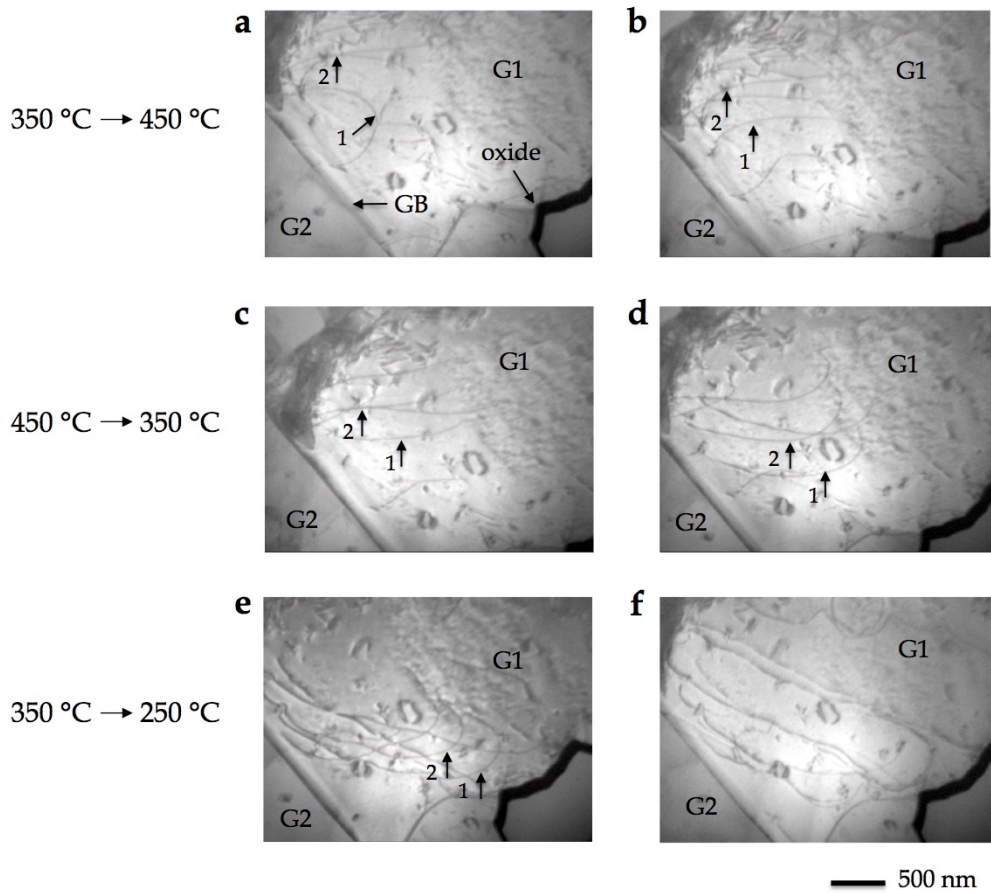
Figure 87: In situ TEM thermal cycling from 25°C to 450°C of a device cross-section prepared by tripod. The Si substrate is preserved, inducing a reversible motion, according to the stress inversion for a Al/Si substrate thin film in the stress-temperature curve [Fli87]. (a)-(b) are snapshots captured during the heating up phase from 350°C to 450 °C, showing the dislocation activation. During the cooling down phase, the reversible motion is characterized by an initial dislocation straightening (c) followed by a bowing in the opposite direction (d), towards the oxide (d)-(e).

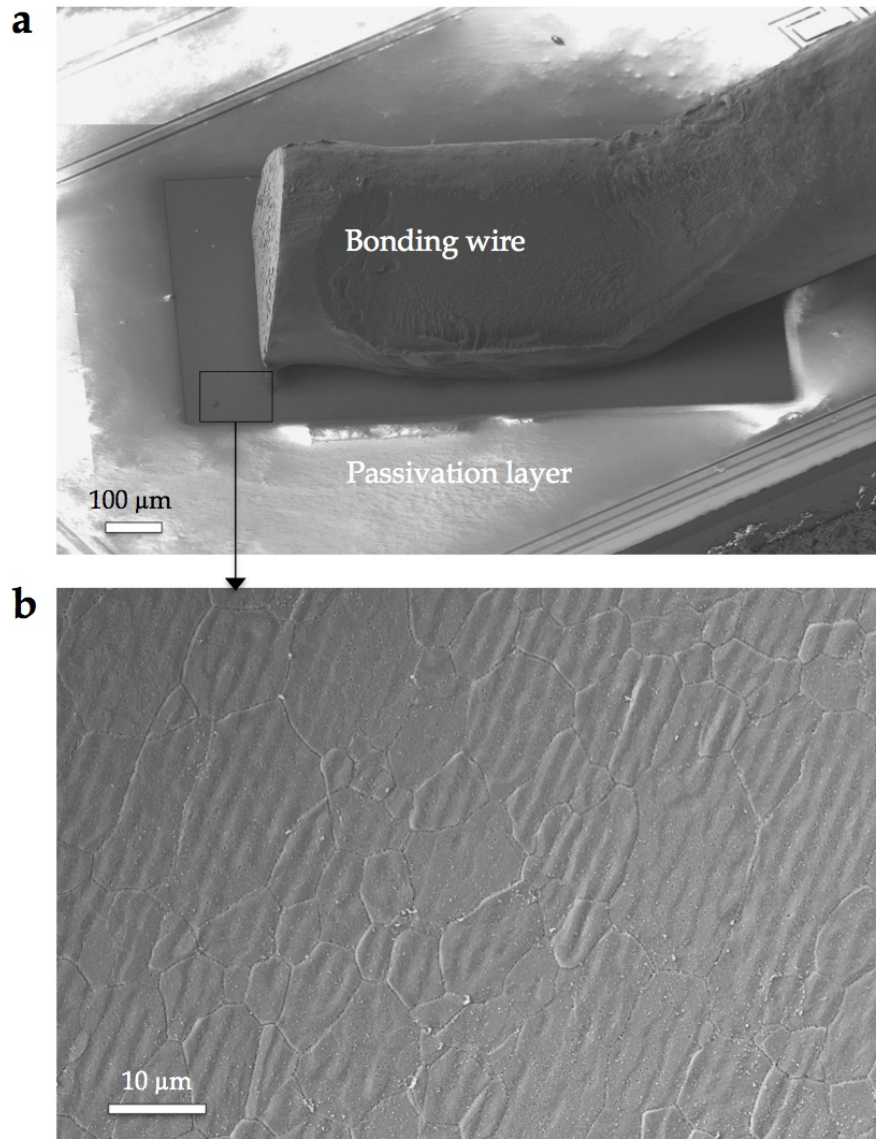
Figure 88: (a) SEM image of an Al bond wire welded on the Al source metallization on an as-is module. Away from the bonding area the metallization is coated by a  $\text{SiO}_2$  passivation layer. (b) Higher magnification of the bare metallization close to the bonding wire.

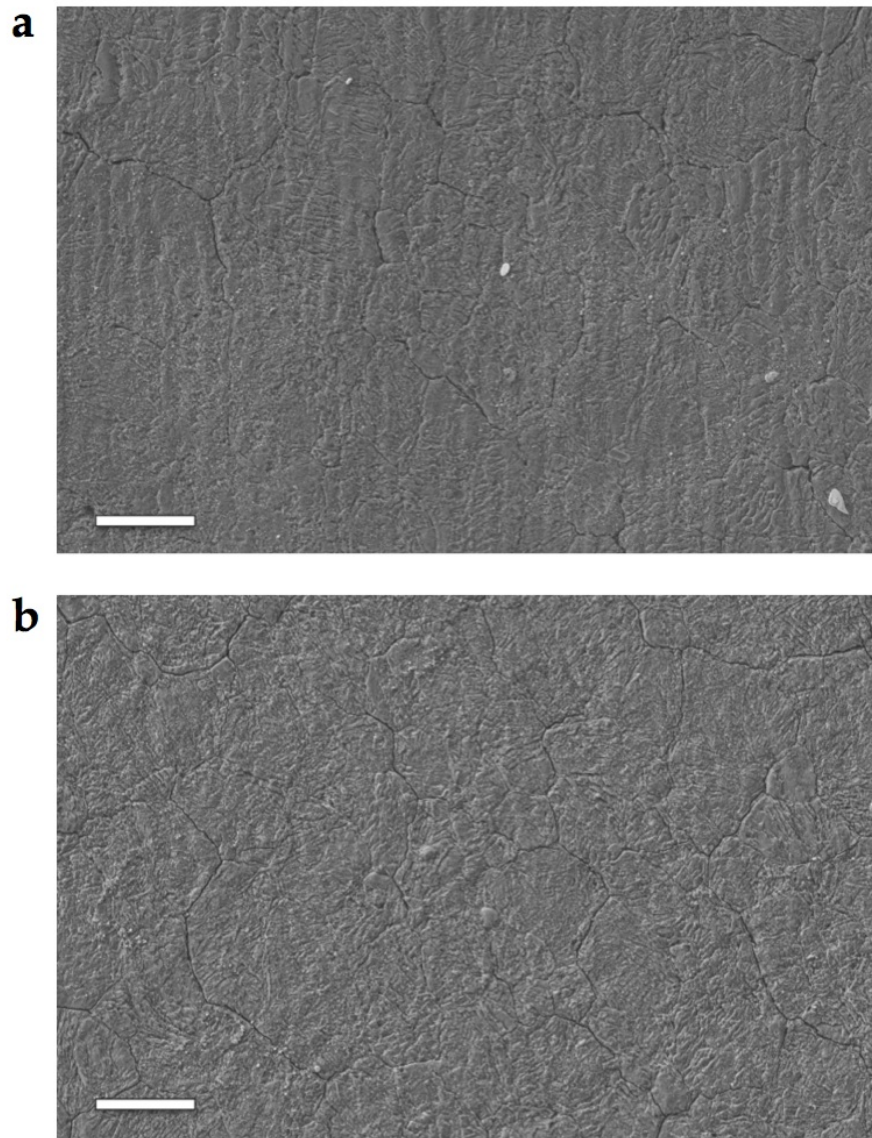
Figure 89: SEM images of the Al metallization close to the bonding wire in a (a) 25°C aged module (failed after 5.3 million cycles) and in a (b) 70°C aged one (failed after 300 kcycles). Scale bar 10  $\mu\text{m}$

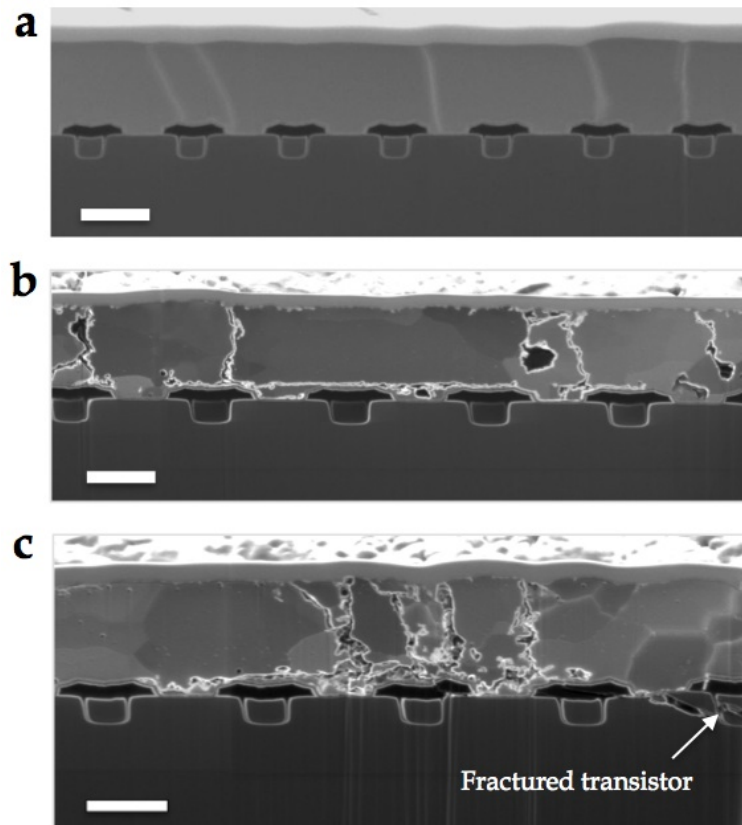
Figure 90: SIM images of the naked metallization cross-sections of (a) as-is, (b) 70°C aged and (c) 25°C aged power modules. The top layer ( $\sim 1\mu\text{m}$  thick) is the Pt protective coating to prevent curtaining artefacts on the imaging faces. Scale bar  $2.5\mu\text{m}$ .

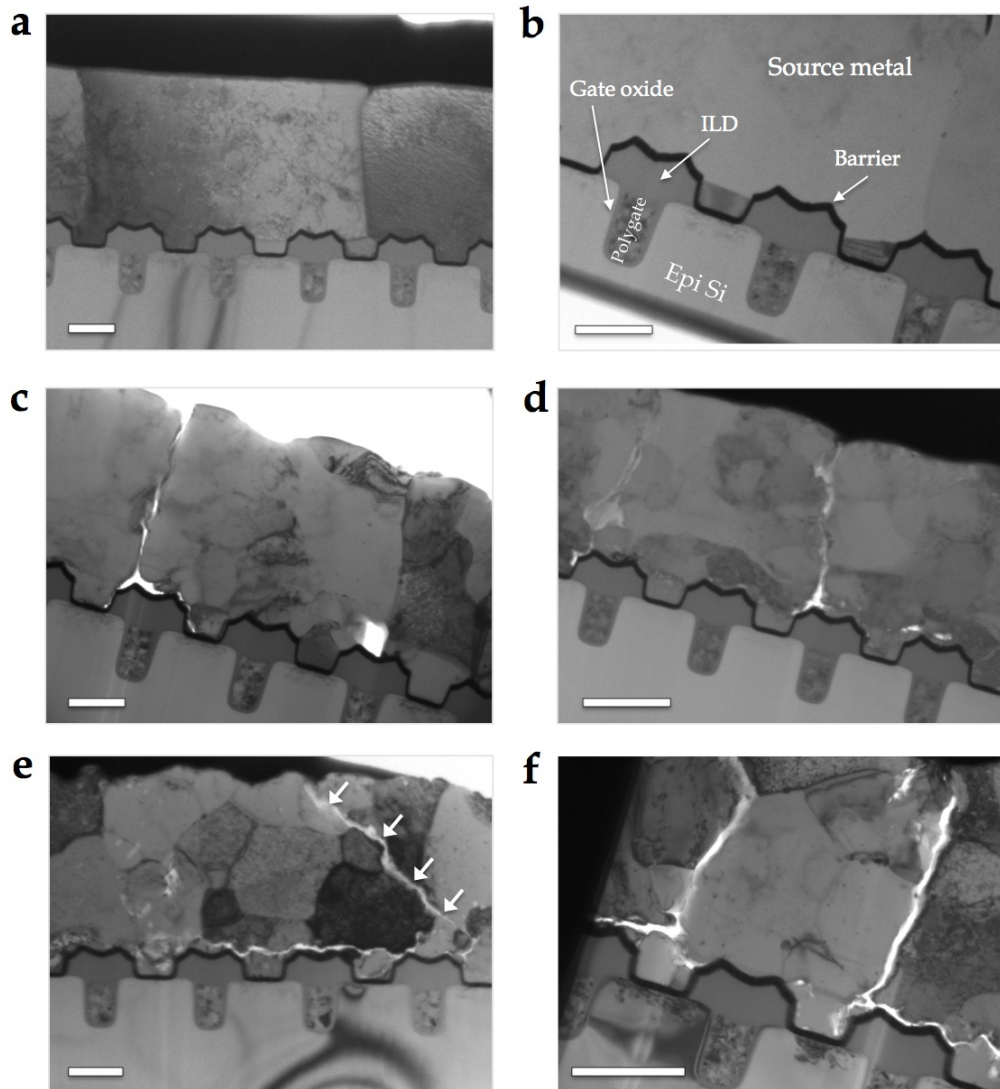
Figure 91: TEM images of some details of the transistor/metallization area from the naked metallization of an (a, b) as-is, (c, d) 25°C aged and (e, f) 70/degree C aged power modules. The trench MOSFET layered structure is described in (b) and consists in: source metal, inter-layer dielectric (ILD), gate oxide and polySi (Polygate), epitaxial Si. Scale bar: 1  $\mu\text{m}$ .

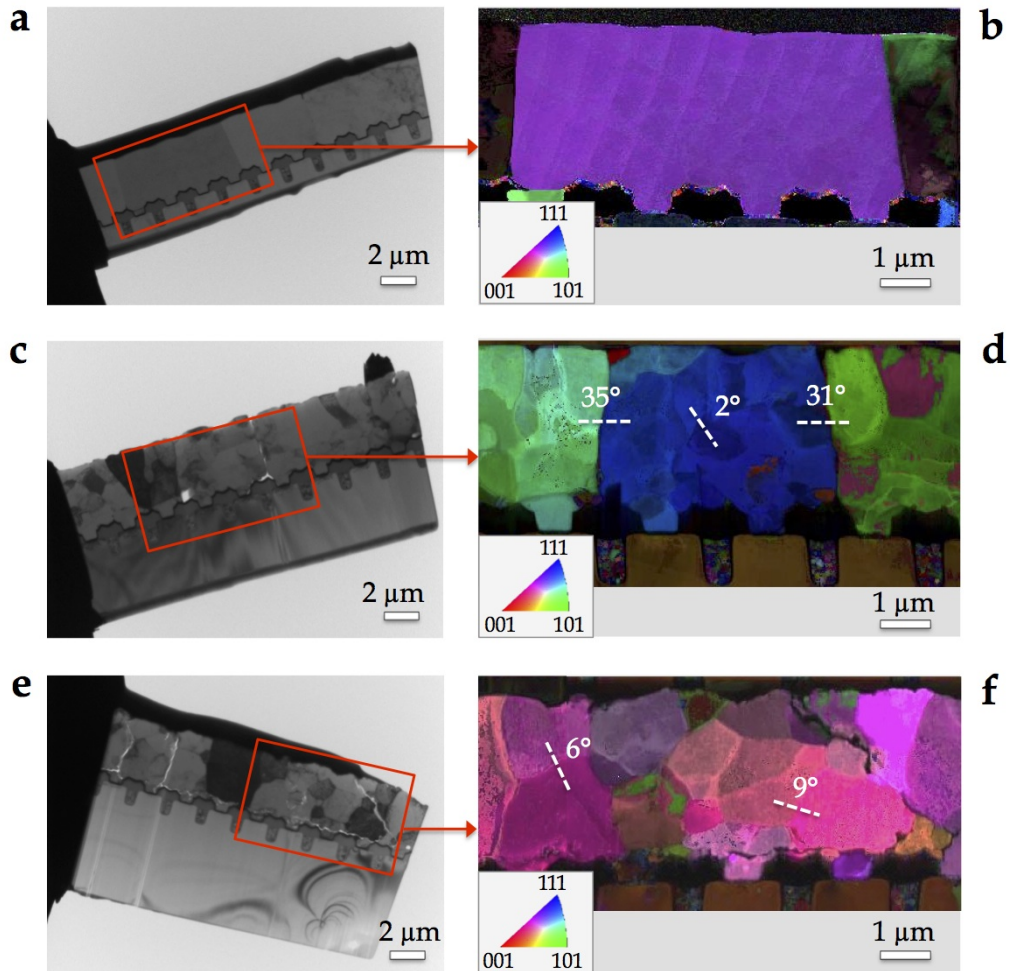
Figure 92: TEM images of FIB lamella extracted from the naked metallization of an (a) as-is, (c) 25°C aged and (d) 70°C aged power modules.

ACOM mapping relative to the red area in the TEM images for the (b) as-is, (d) 25°C aged and (f) 70°C aged lamella. The standard stereographic triangle gives the color codes of the grain orientations, taken here along the horizontal direction, perpendicular to the growth direction, in order to have better visibility (the relative misorientation between subgrains does not change along the three axis).

The previous images (Fig. 90, Fig. 91) show also a grain shrinkage upon aging. However, as we also see for the SPDo6 components, the orientation mapping by ACOM-TEM system (Fig. 92) reveal that most of the grain domains in the aged metallization (at 25°C in Fig. 92d and 70°C in Fig. 92f) have a small misorientation as they have very similar colors. We reported directly in the figures the misorientations between a few grains. These misorientations are less than 10°. This means that most of the grains with different gray scale colour in the FIB and TEM images are subgrains, probably formed by the gathering of pre-existing dislocations inside a single initially large bamboo grain (Fig. 92b) at the beginning of the electro-thermal cycles [Mar14]. This is clearly visible for the 25°C aged module (Fig. 92d), where we can recognize three bamboo domains (the misorientations between them are higher, ~ 30°) with vertical cracks along the grain boundaries, and smaller subgrains inside each domain. These images confirm again that cracks propagate along the GBs and not along the sGBs.

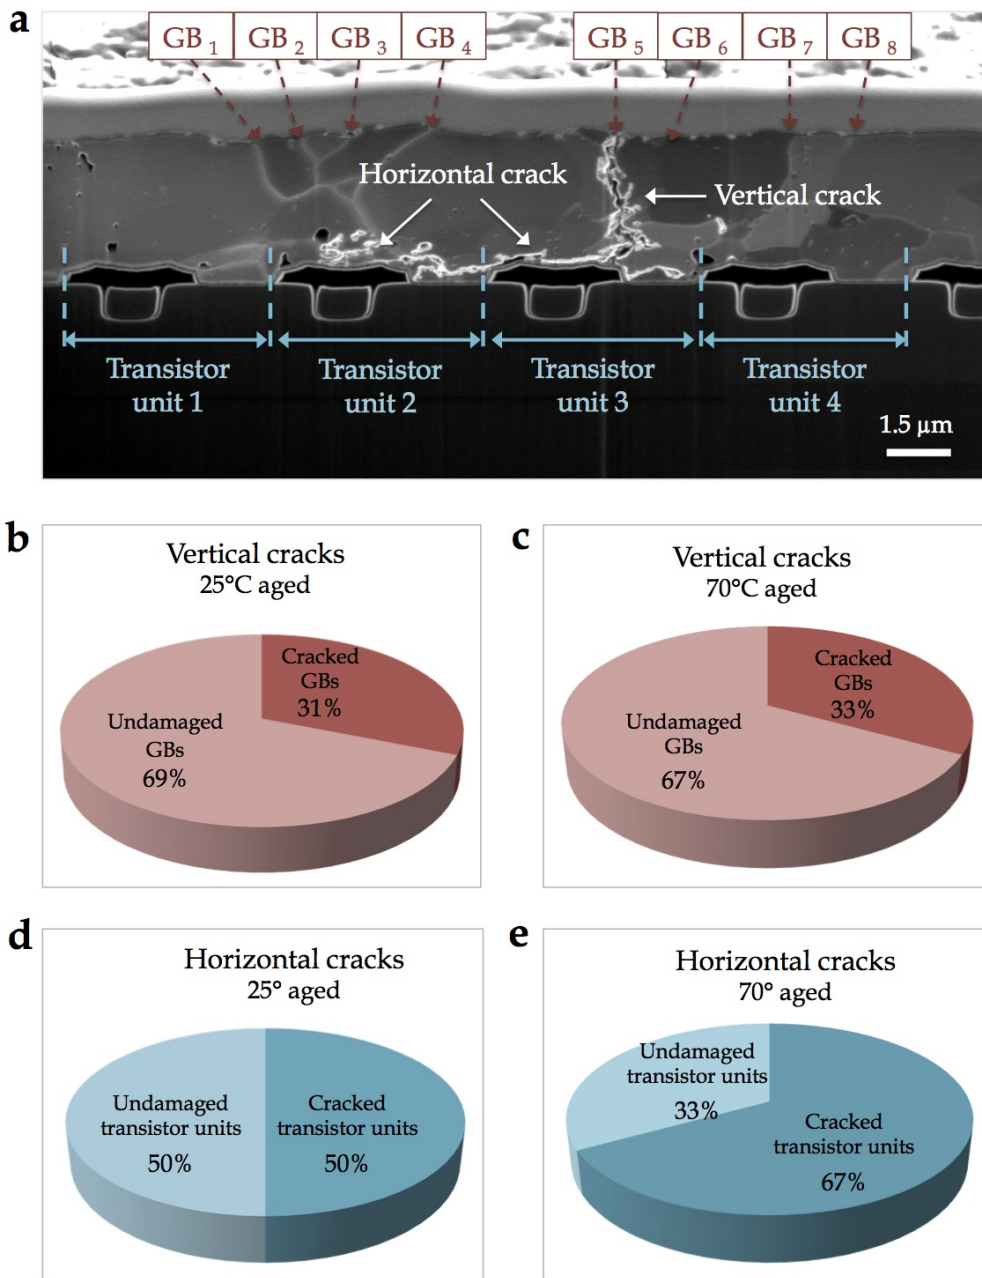
Figure 93: Horizontal and vertical cracks statistics in a 25°C and 70°C aged module. (a) Vertical cracks are evaluated by counting at the metal surface the number of cracked (GB<sub>5</sub>) and undamaged (GB<sub>1</sub> – GB<sub>4</sub> and GB<sub>6</sub> – GB<sub>8</sub>) grain boundaries . Horizontal cracks are evaluated by counting the number of transistor units with cracks on top (Transistor unit 2 and Transistor unit 3) with respect to the undamaged ones (Transistor unit 1 and Transistor unit 4). The ratio of cracked vs undamaged GBs is showed in (b) for a 25°C aged module and in (c) for a 70 °C aged one. The ratio of cracked vs undamaged transistor units is showed in (d) for a 25°C aged module and in (e) for a 70 °C aged one.

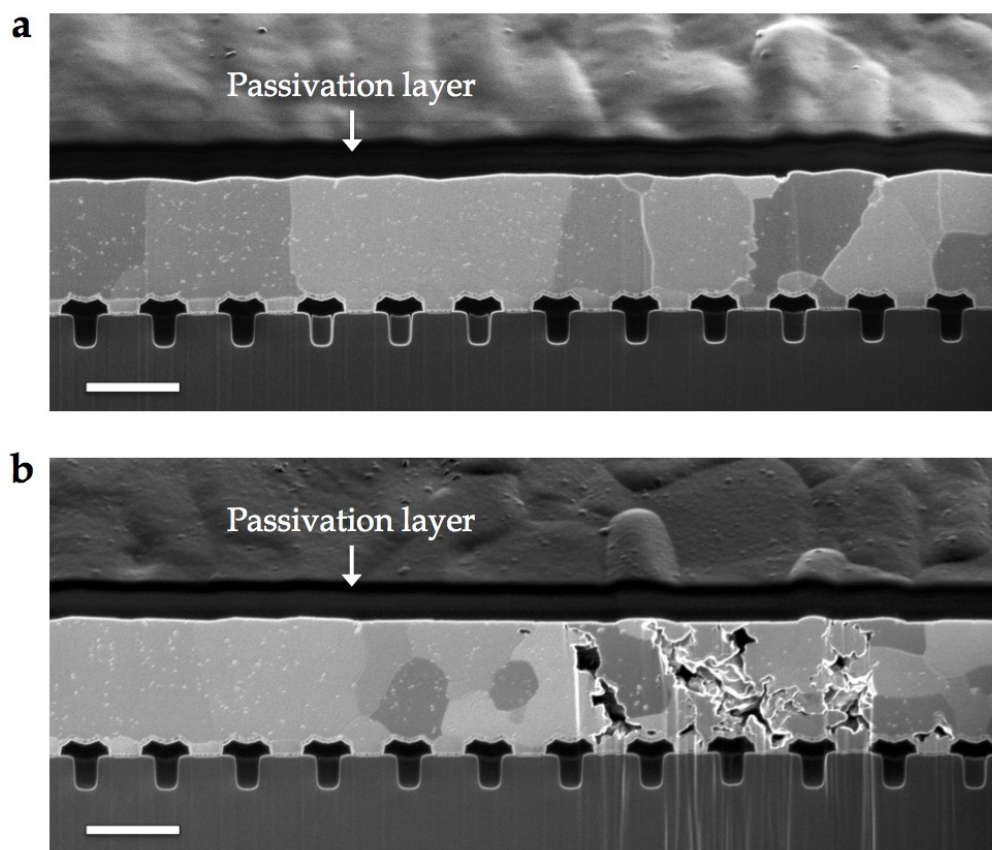
Figure 94: SIM image of the Al top metallization coated by SiO<sub>2</sub> passivation from two close cross-sections in a 70°C aged module.
