# Fatigue mechanisms in Al-based metallizations in power MOSFETs

Roberta Ruffilli. Fatigue mechanisms in Al-based metallizations in power MOSFETs. Condensed Matter [cond-mat]. Université Paul Sabatier (Toulouse 3); École doctorale Sciences de la Matière, 2017. English. NNT: . tel-01666437v2

**Fatigue mechanisms in Al-based metallizations in power MOSFETs**

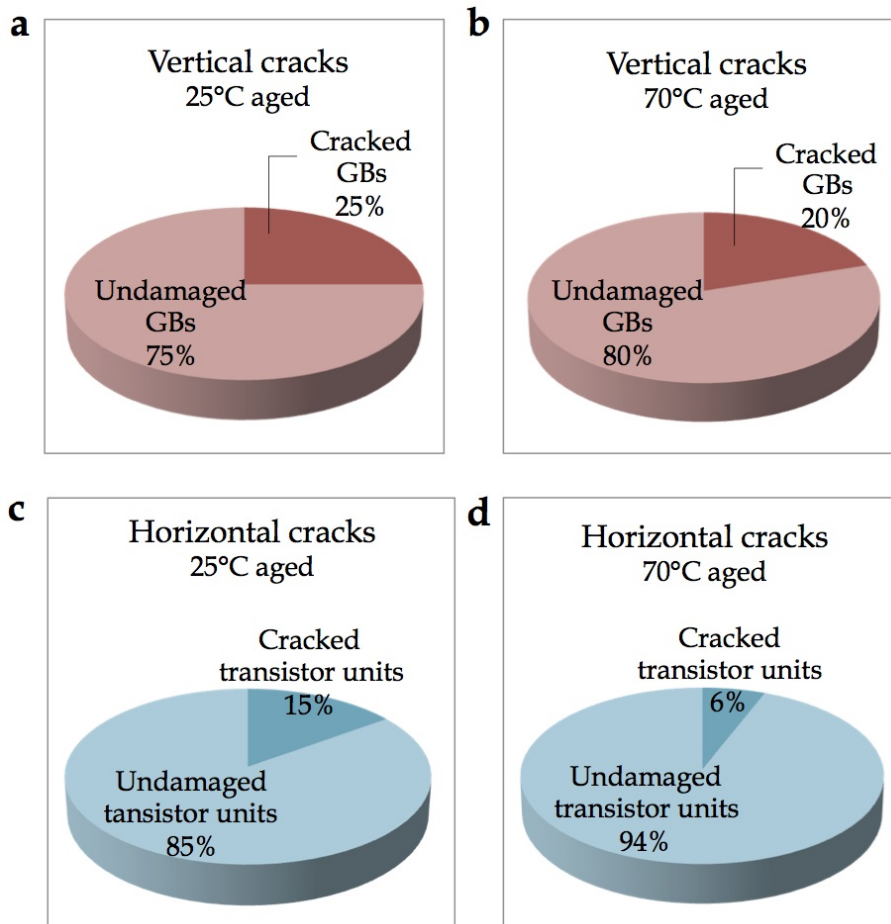
Figure 95: Ratio of cracked vs undamaged GBs in (a) a 25°C aged module and in a (b) 70 °C aged one.

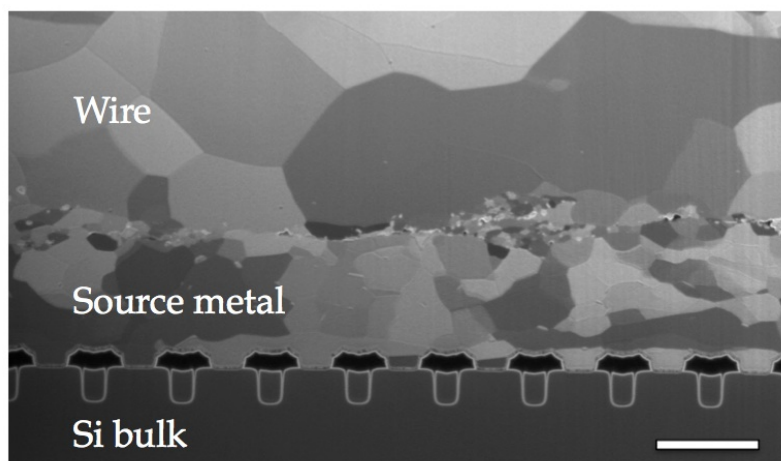
Figure 96: SIM images of the wire-source metallization interface, at the center of the bonding wire, in an as-processed module. Scale bar  $2.5\ \mu\text{m}$ .

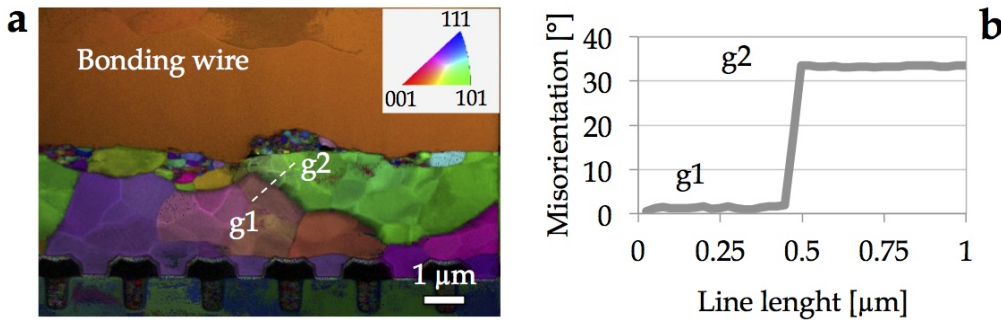
Figure 97: (a) ACOM map of the wire-metal interface of an as-processed module. (b) Misorientation between the grains 1 and 2 along the white dashed line respectively in (a). The standard stereographic triangle gives the color codes of the grain orientations, taken here along the horizontal direction.

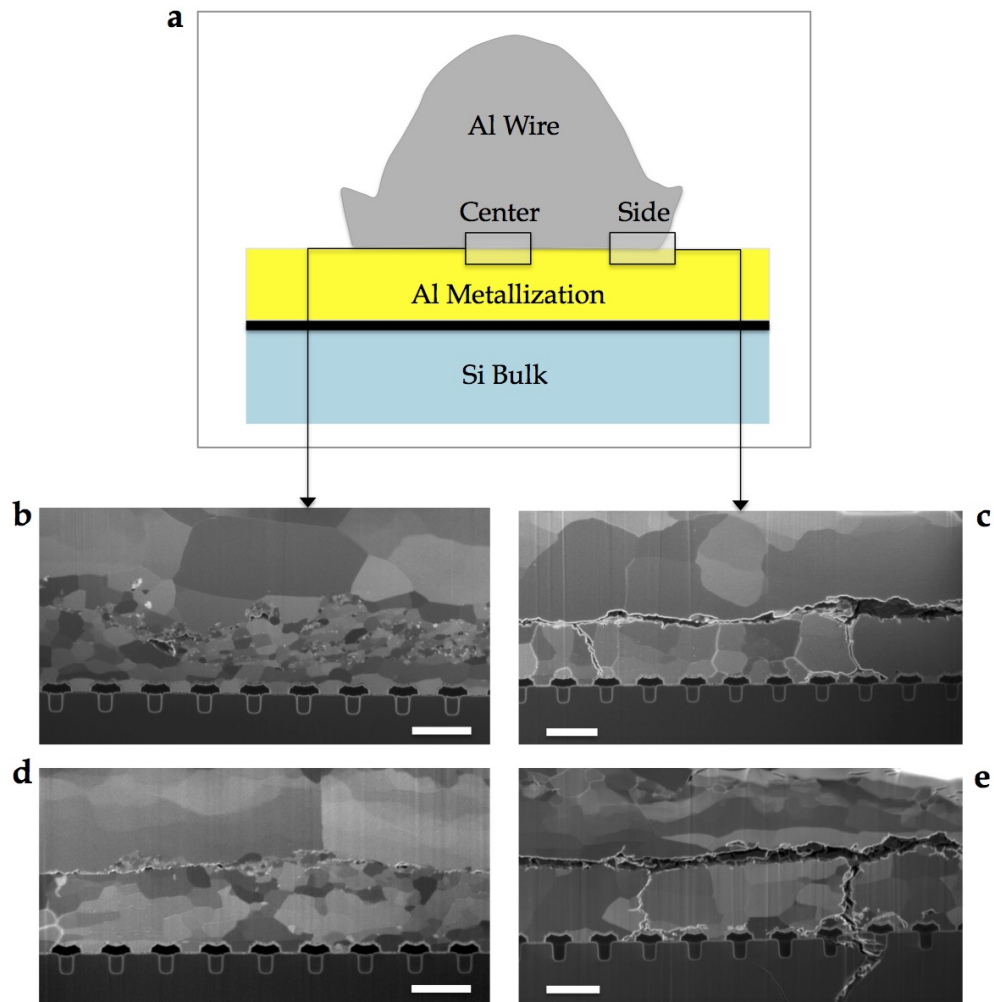
Figure 98: (b) Central and (c) side SIM images of the wire-metallization interface in a 25°C aged module. (d) Central and (e) side SIM images of the wire-metallization interface in a 70°C aged module. The images correspond to the FIB cross-section locations ("center" and "side") in the schema in (a). Scale bar 2.5 μm.

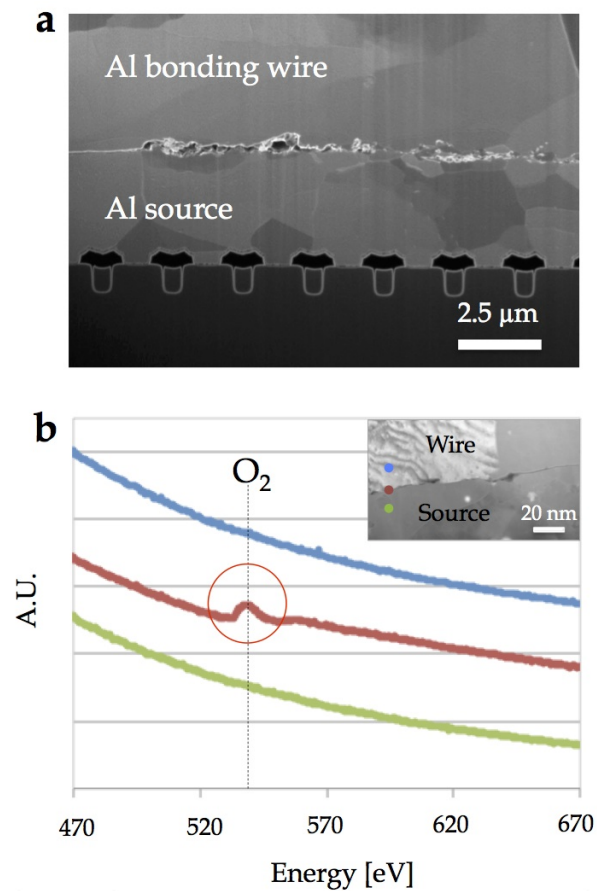
Figure 99: (a) SIM image of the initial artifacts which characterize the wire-metallization bonding of an as-is module. (b) EELS spectra from the wire (in blue), the metallization (in green) and the wire-metallization interface (in red). The red spectrum at the wire-metallization interface reveals the presence of oxygen.

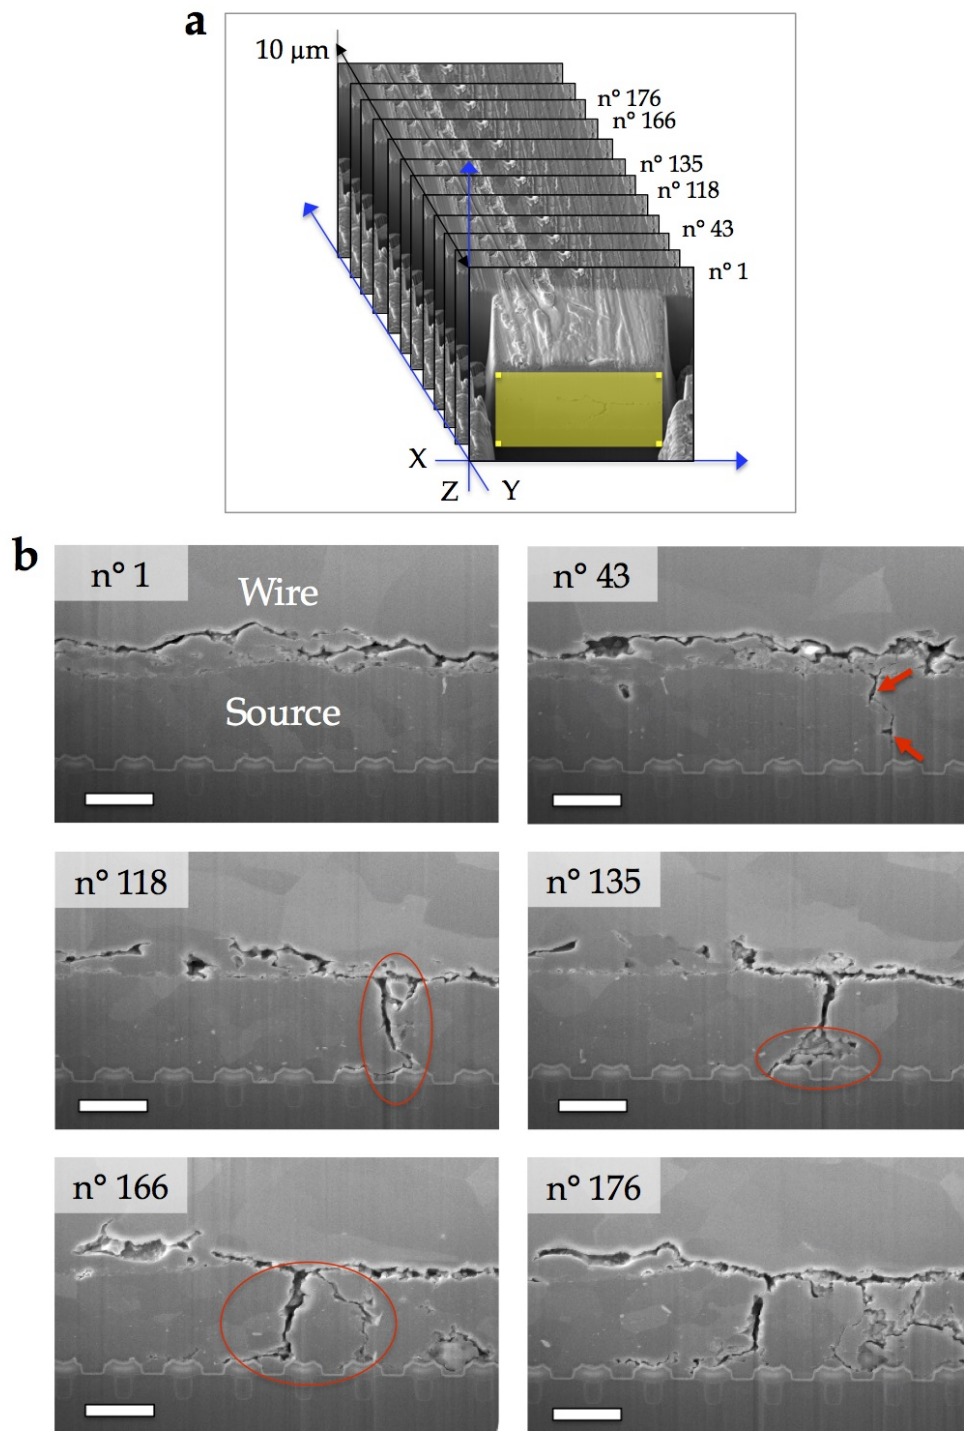
Figure 100: (b) Selection of six non consecutive SEM images from the data stack of the wire-metalization interface (according to the schema in (a)) of a 70 °C aged device (slicing distance 50 nm). The yellow rectangle in (a) represents the milled imaging face. Scale bar 2.5  $\mu\text{m}$ .

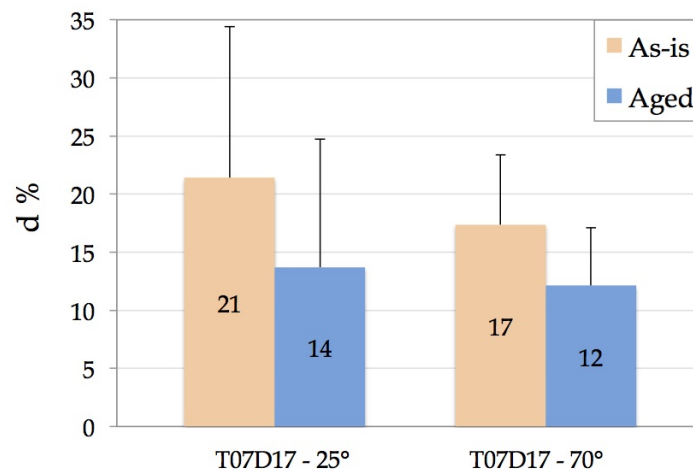
Figure 101: Plastic deformation of the Al metallization under the bonding wires of the as-is and aged modules in a 25°C and 70°C aged device. The deformation has been calculated as the minimum metallization thickness in the wire-metallization FIB section, taking the initial metallization thickness (away from the bonding wire) as a reference.

Fig. 101 shows the mean deformation percentages in a 25°C and 70°C aged module, and in the relative as-is parts. Here, we found out that plastic deformation ranges between 21% and 12% in average in the measured sections. This range is narrower than the one obtained for the SPD06 devices (Fig. 85), probably due to the fact that we measure a higher number of T07D17 sections. However, the standard deviation of the sets of values is comparable, or even higher, compared to the SPD06 data sets, confirming that the wire-metallization interface is highly uneven.

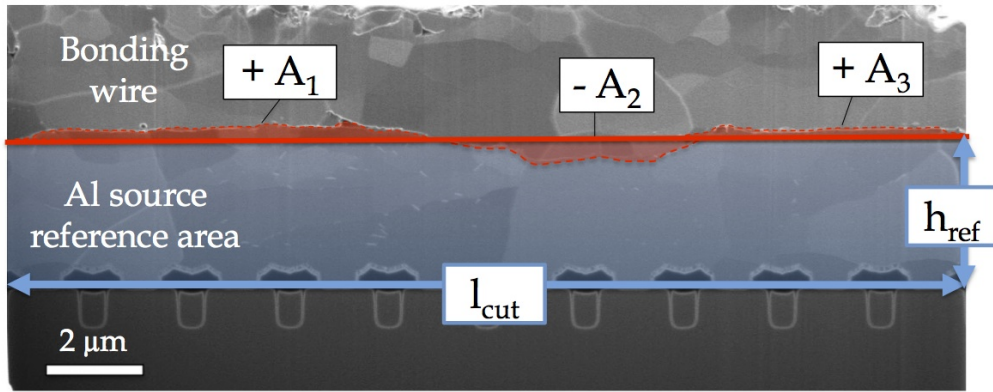
Figure 102: Schematic illustration of the area-based measurement method of the plastic deformation imposed to the Al source metallization by the bonding process.  $h_{\text{ref}}$  = initial metallization thickness,  $h_{\text{ref}}$  = image width.

$$\text{Area}_{\text{def}} = \sum_i A_i \quad (8)$$

$$\text{Area}_{\text{ref}} = l_{\text{cut}} * h_{\text{ref}} \quad (9)$$

The method takes in account the fact that the initial deformation is not uniform along the wire-metallization interface, that the interface is not straight, and that both extrusion and compression of the metallization occur during the bonding process. This is clearly seen in Fig. 103, showing

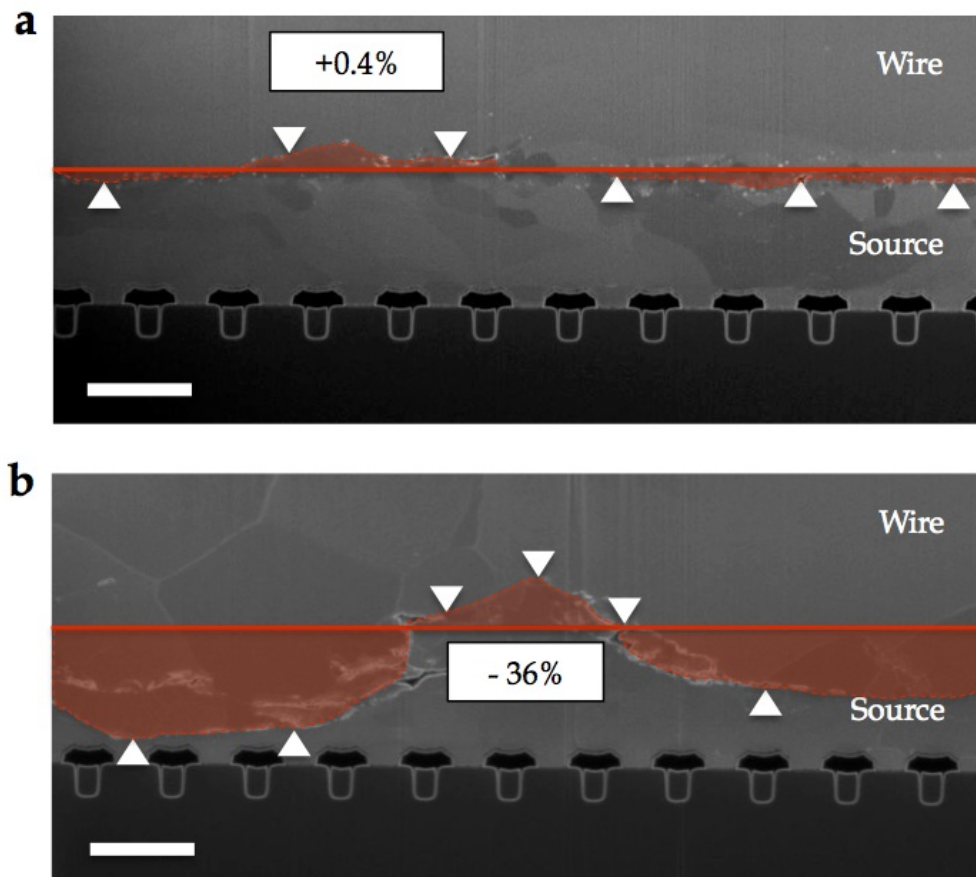
Figure 103: SIM images of the wire-metallization interface in two close areas under the same bonding wire. The images refer to a non-aged module. The red straight line represents the initial metallization surface. White arrows show how the interface moved from this initial position after wire bonding. Scale bar 2.5 μm.

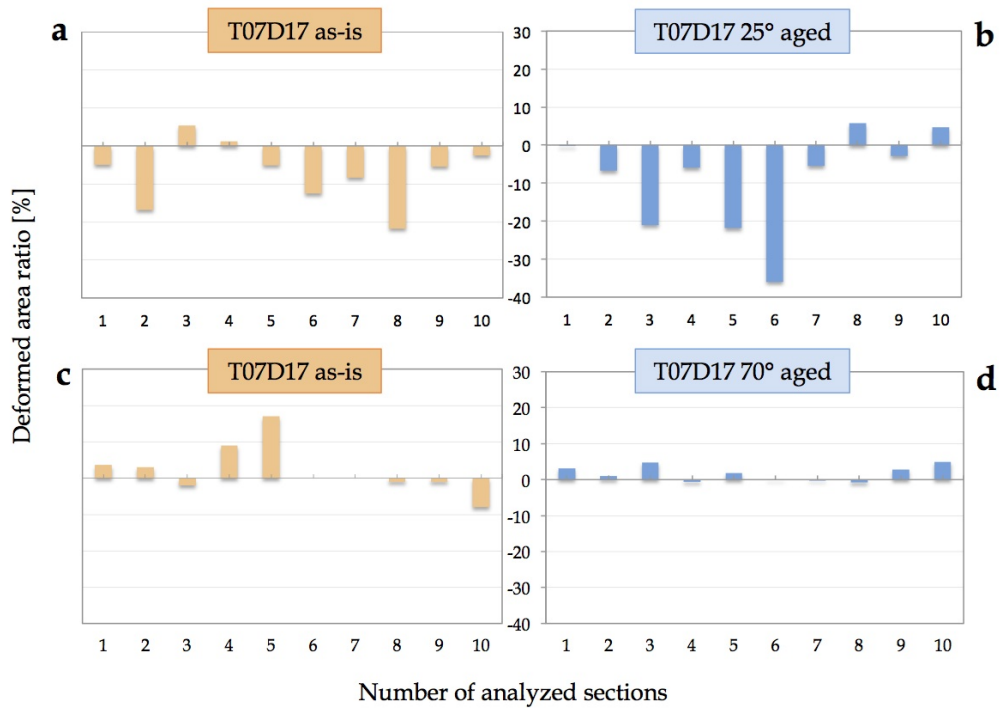
Figure 104: Deformed area ratio of the Al metallization under the bonding wires of a module aged at 25°C (b), with the relative as-is part (a), and of a 70°C aged module (d), with the relative as-is part (c). The deformation has been measured in 10 sections for each analysed module according to the method represented in Fig. 102.

The wide deformation ranges obtained with the two proposed methods confirm that the wire-metal interface is highly uneven in the measured sections and that the plastic deformation is also very non uniform. But they also prove that these measurements strongly depend on the location of the sections along the bonding interface. However, FIB preparation does not allow to cut the entire bonding area, and so measuring the total deformation in the whole cross-section was impossible until recently.

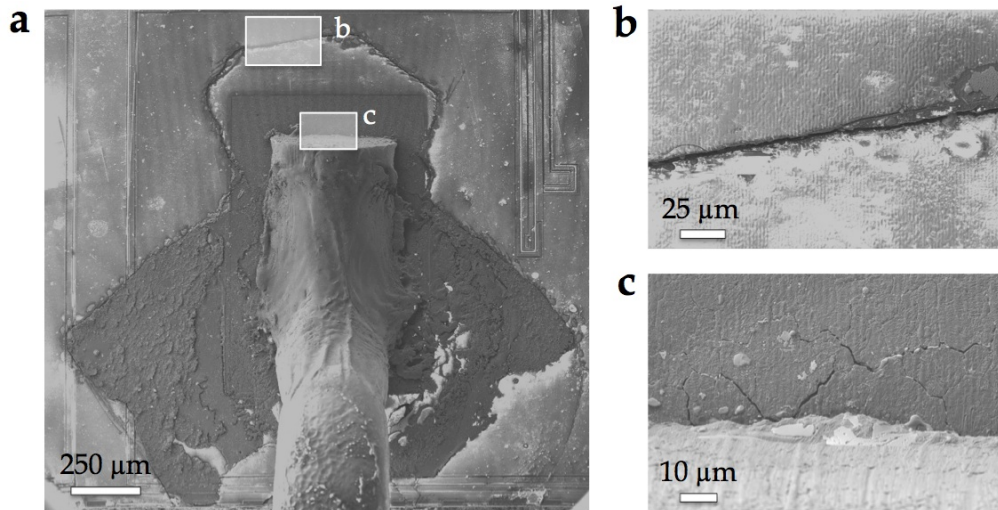
Figure 105: (a) Top view SEM image of an Al bond wire welded on the Al source metallization in a 25°C aged device, after a short-circuit event. At higher magnification, big cracks propagating in (b) the passivated metallization and (c) next to the bonding wire (located in the boxes (b) and (c) in (a)).

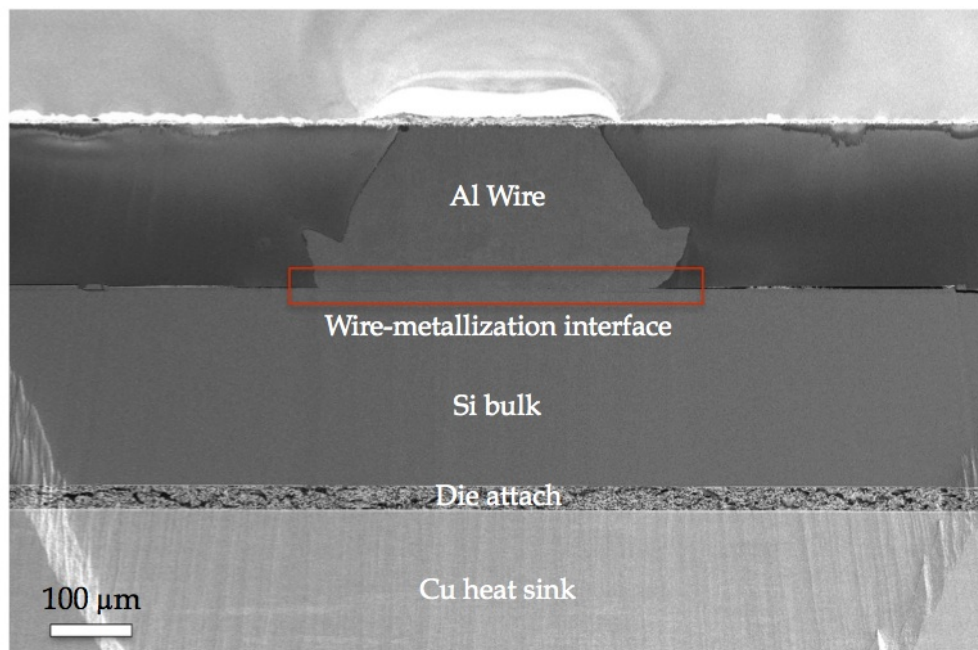
Figure 107: SEM image of a cross-section prepared by Cross Polisher system in an as-is module. The large cut area shows the power die layered structure: Al wire, Si bulk and Cu heat sink. The Al source metallization on the transistor area, at interface with the semiconductor, is not visible at this scale. The red area indicates the location of the Al wire-metallization interface that is shown in detail in Fig. 108a - n.

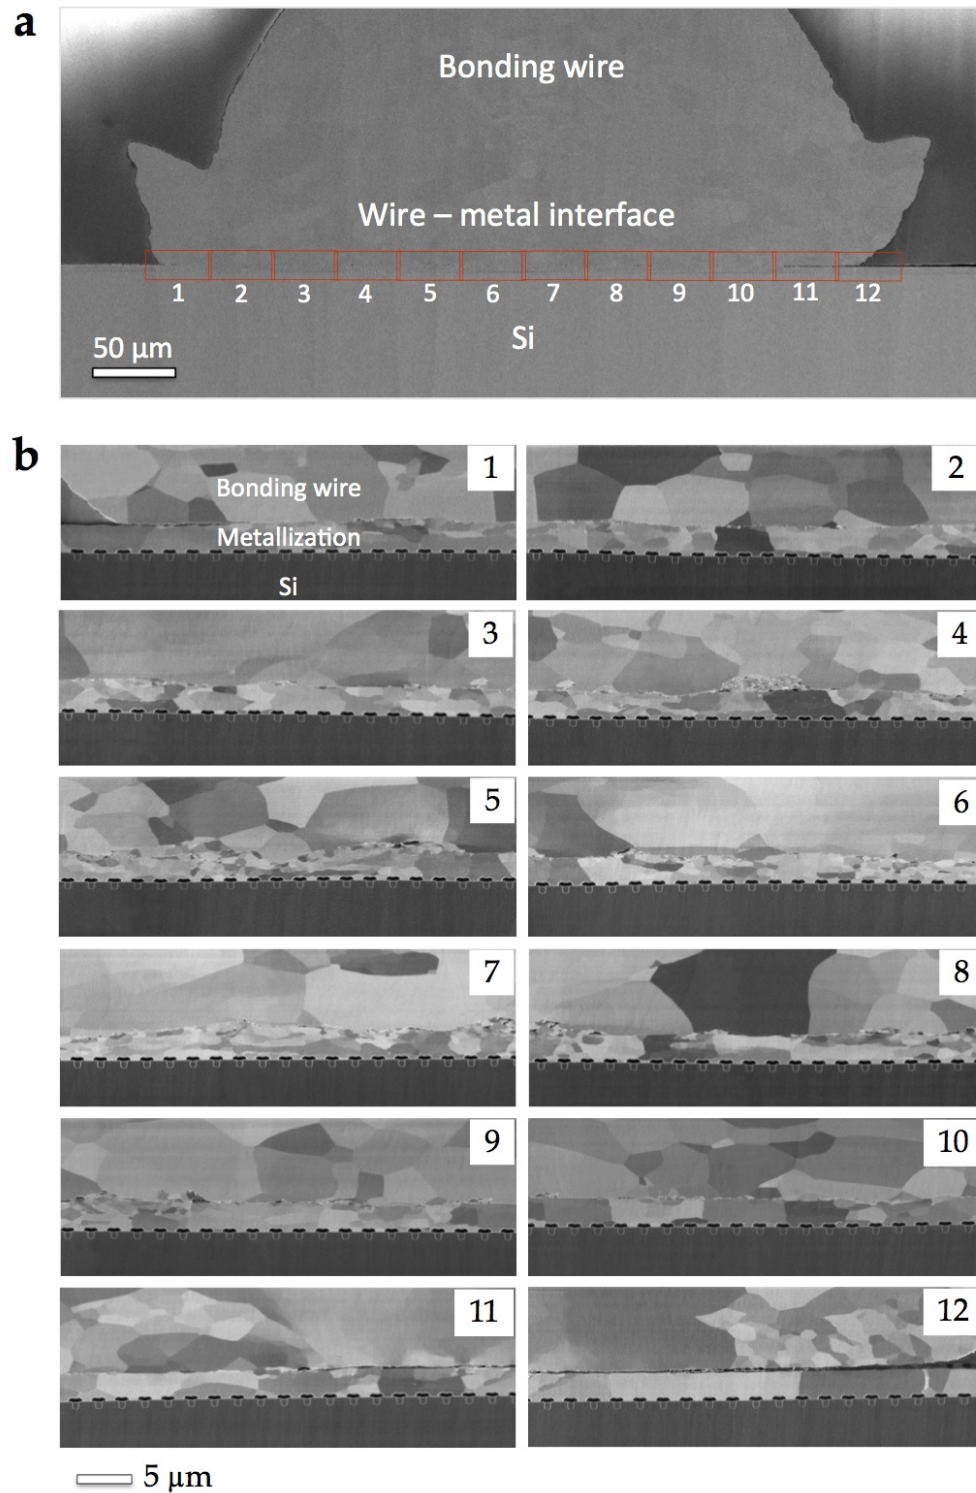
Figure 108: (b) SIM images mosaicing of the whole wire-metallization cross-section prepared by cross-polisher, according to the schema in (a). The images sequence offers a global vision of the metallization grain structure under the bonding wire and of the wire metallization interface. It can be used to calculate the total amount of deformed area due to the bonding process.

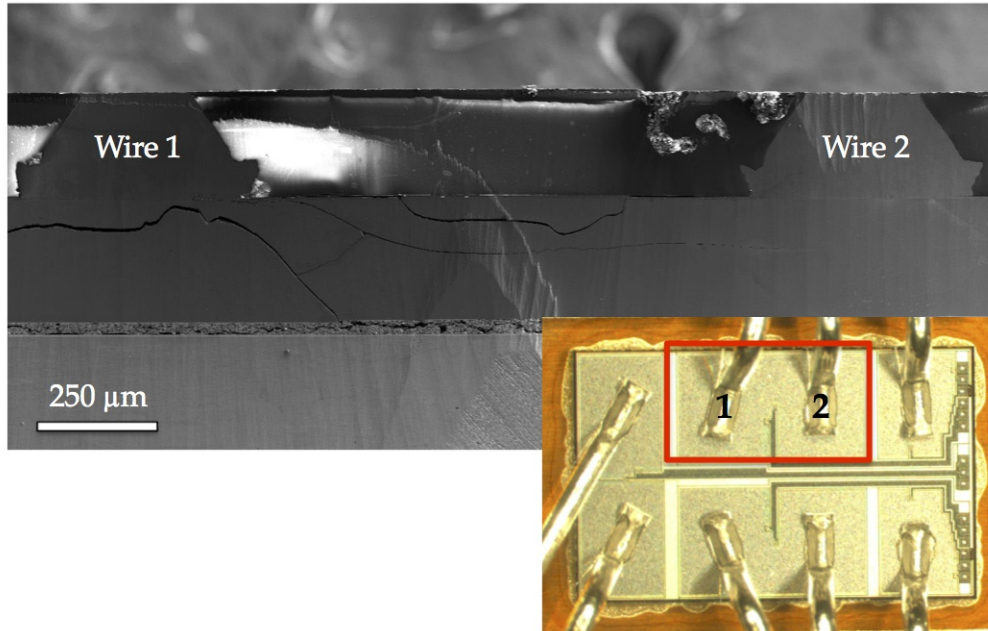
Figure 109: SEM overview of a 70°C aged module prepared by CP for the SEM/SIM inspection. In the insert, optical image image of the T07D17 device, showing the position in the aged module (in red) of wire 1 and 2 under investigation.

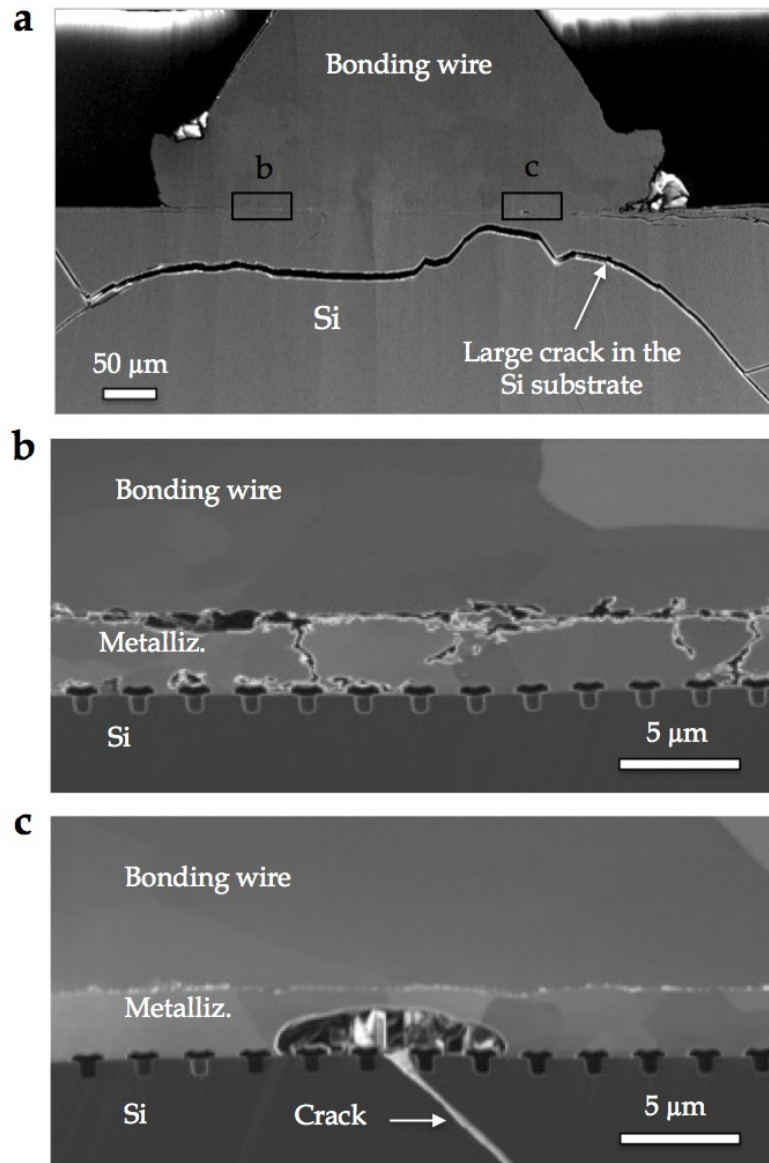
Figure 110: (a) SEM cross-sectional imaging of the bonding wire from an aged power module (70 °C aged) showing different types of cracks; (b), (c) ionic higher magnification images of the wire- metallization interface located in the boxes (b) and (c) in (a). The die crack resulted from an electro-thermal event occurring at failure time.

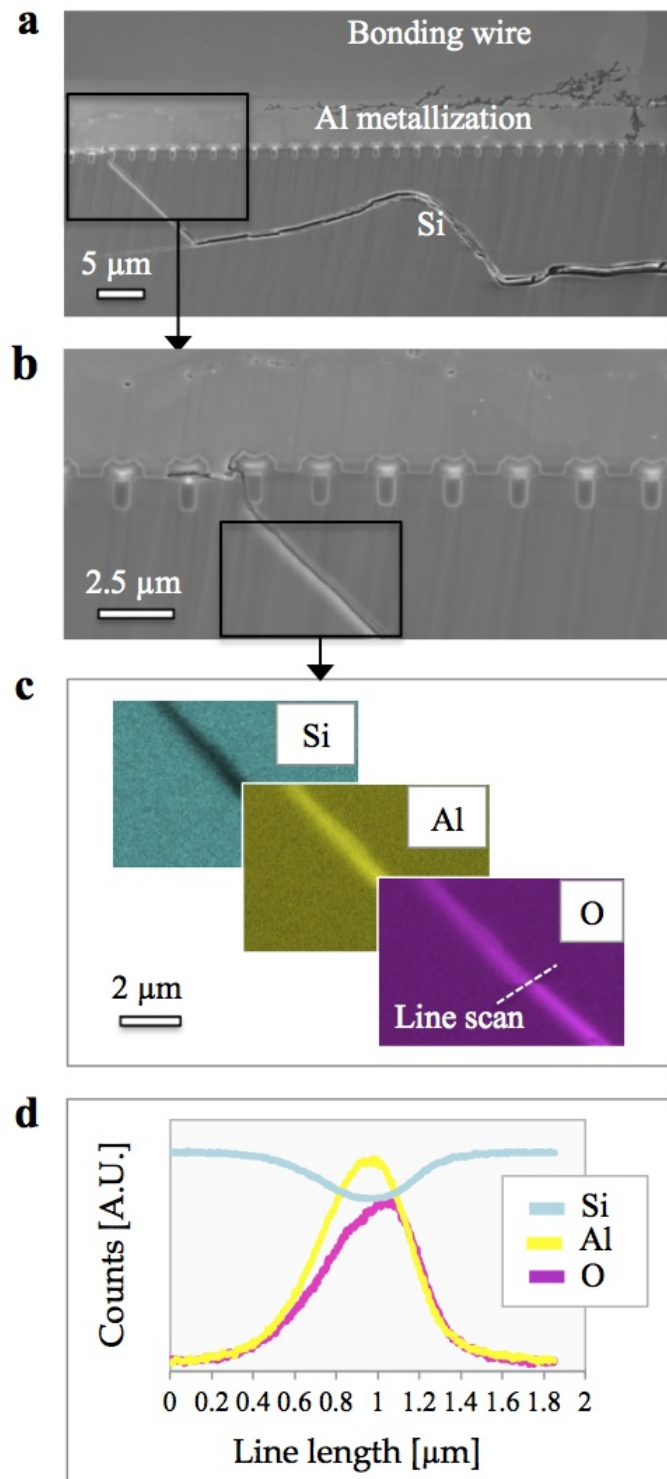
Figure 111: (a) Low and (b) high magnification SEM image of the cracked Si bulk under the bonding contact. (c) EDX mapping of the crack in the Si bulk and (d) relative line scan plot showing the element distribution along the dashed line in (c).

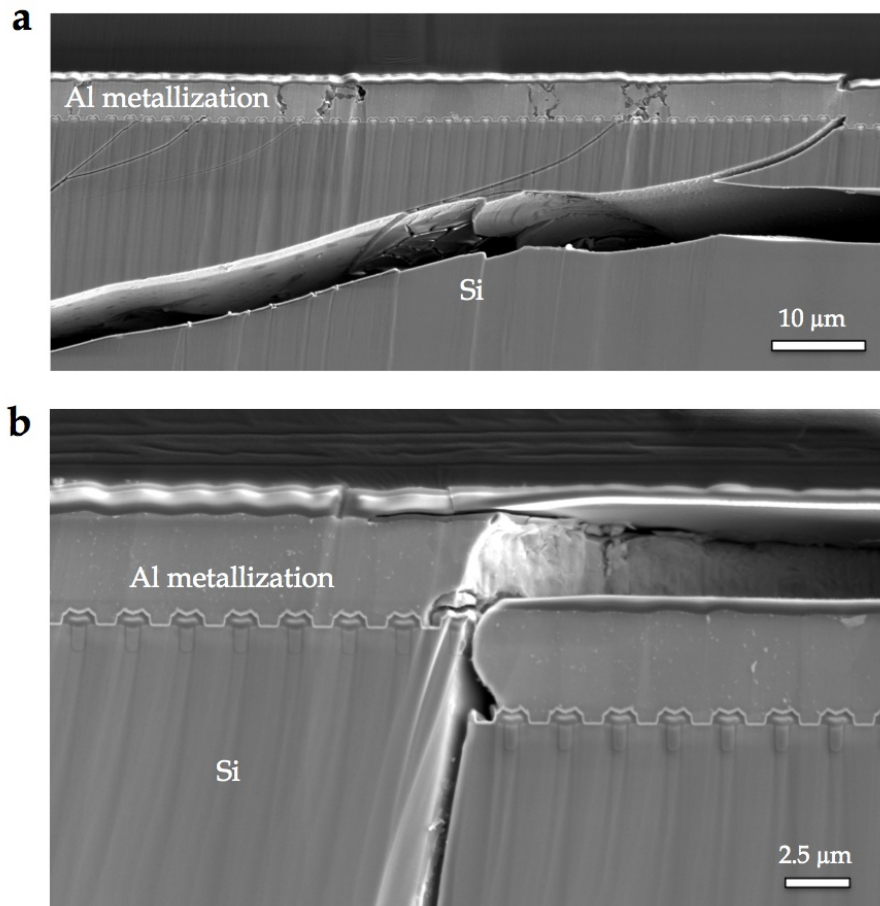
Figure 112: (a) SEM cross-sectional imaging of the naked metallization between the two bonding wire of the 70 °C aged module, showing different types of cracks: fatigue cracks in the metallization layer and fragile cracks in the Si substrate; (b) at higher magnification, the Al top metallization continuity results abruptly compromised as result of the crack propagation in the Si substrate until the surface.

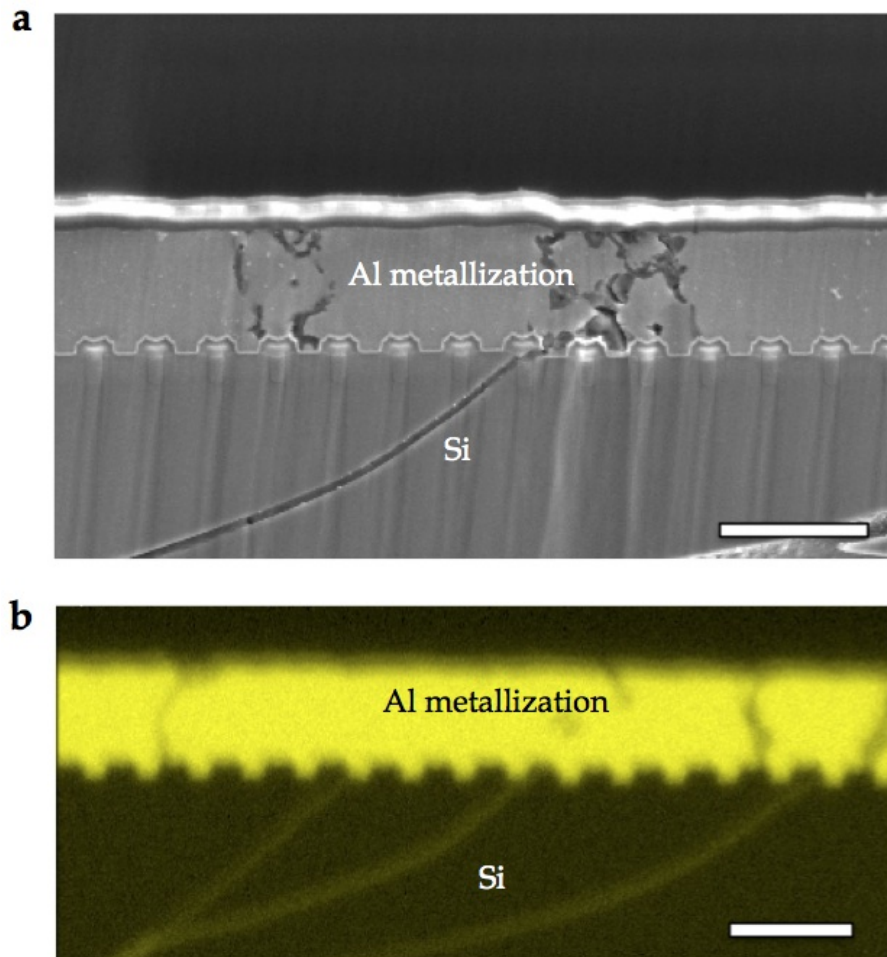
Figure 113: (a) SEM cross-sectional image of a fine crack in the Si layer contacted to the Al metallization in a 70°C aged module. (b) Al mapping by EDX showing some of these Si fine cracks filled with Al. Scale bar 5µm

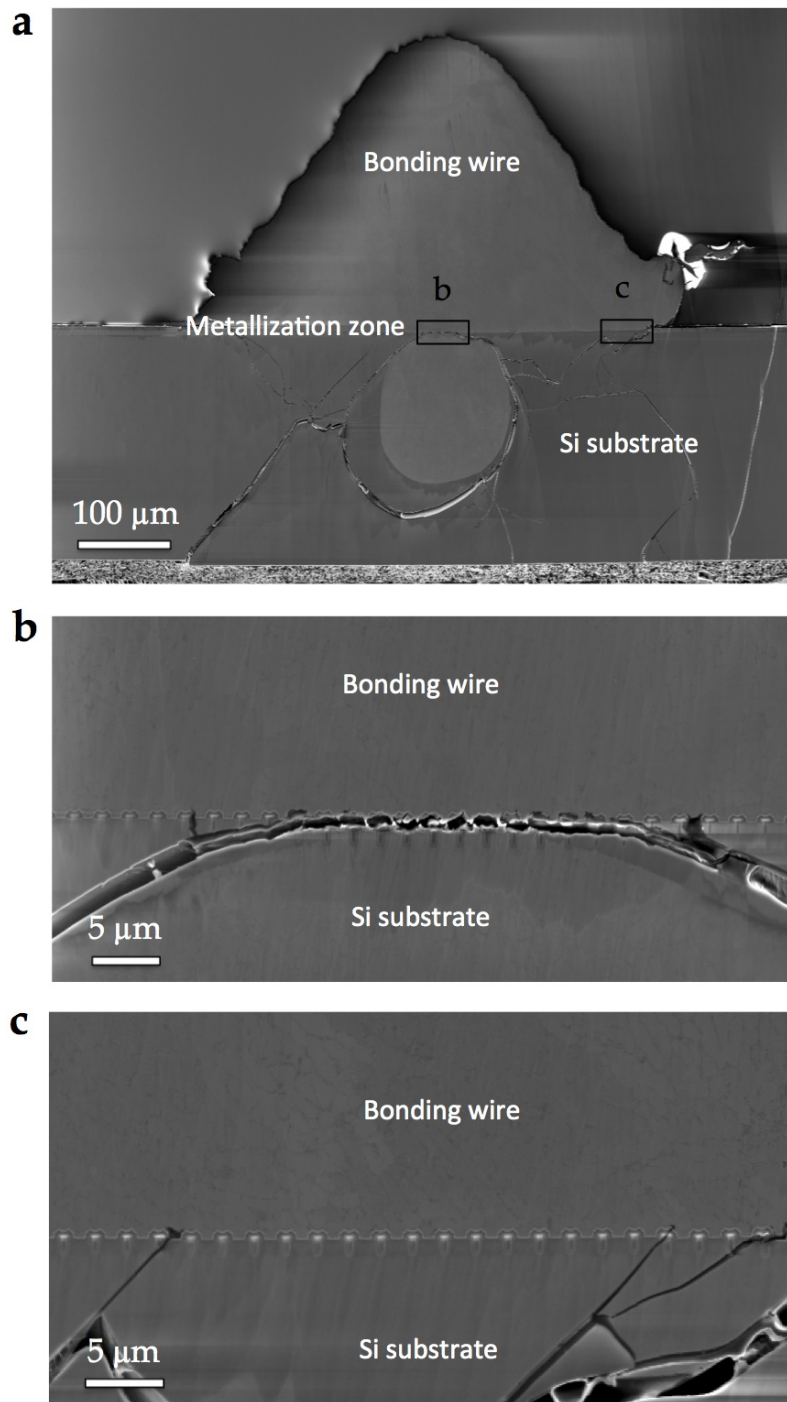
Figure 114: (a) SEM cross-sectional imaging of the bonding wire from an aged power module (25 °C aged) showing different types of cracks; (b), (c) higher magnification images of the wire- metallization interface located in the boxes (b) and (c) in (a). The die crack resulted from an electro-thermal event occurring at failure time.

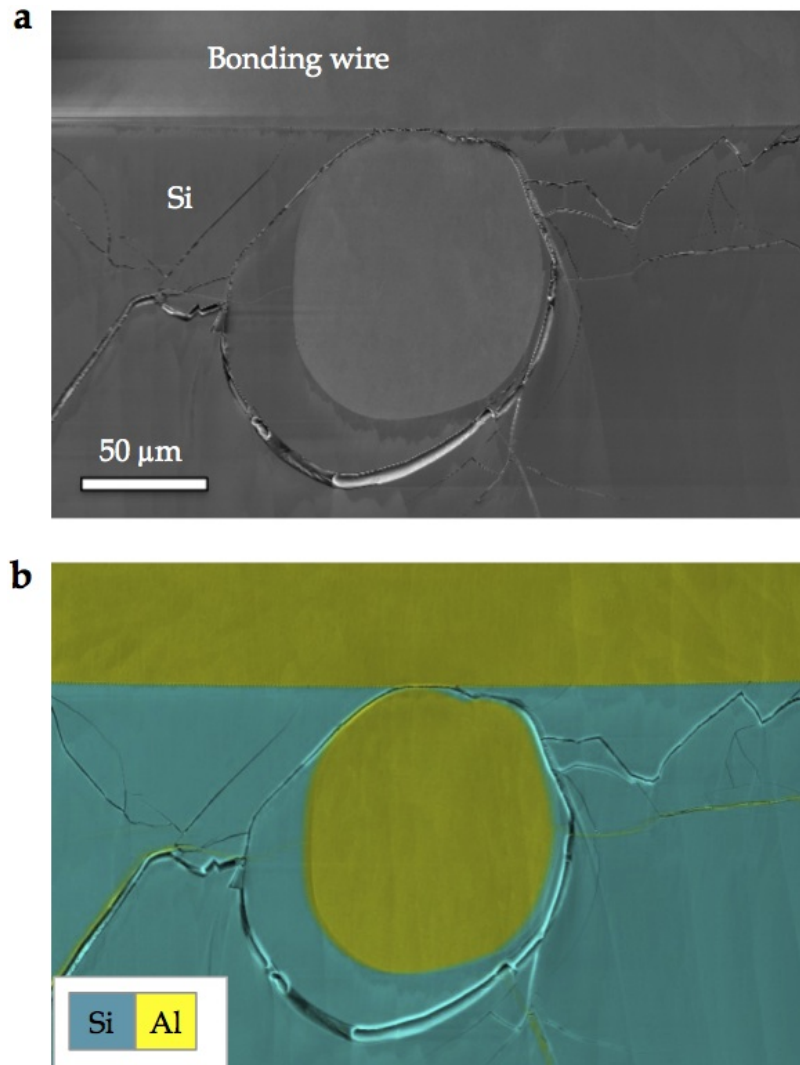
Figure 115: (a) SEM cross-sectional imaging of the round shape feature in the Si substrate (Al contrasted like) from an aged power module (25 °C aged); in (b) the corresponding EDX maps of the Si (in light blue) and Al (in yellow) are overlapped, showing that the round shape feature in the Si substrate is made out of Al. This has probably diffused from the top wire during the short-circuit event, because of the local melting of the metallic parts at high temperature.

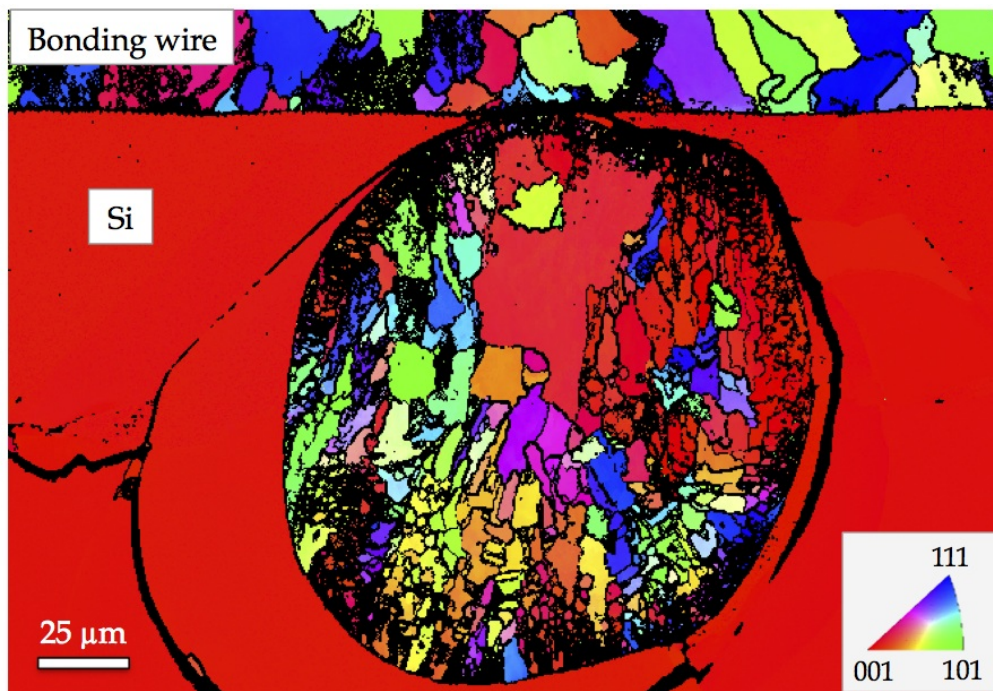
Figure 116: EBSD map of the melted area at the wire-metal cross-sectional interface from a 25 °C aged module. The standard stereographic triangle gives the color codes of the grain orientations, taken here along the horizontal direction.

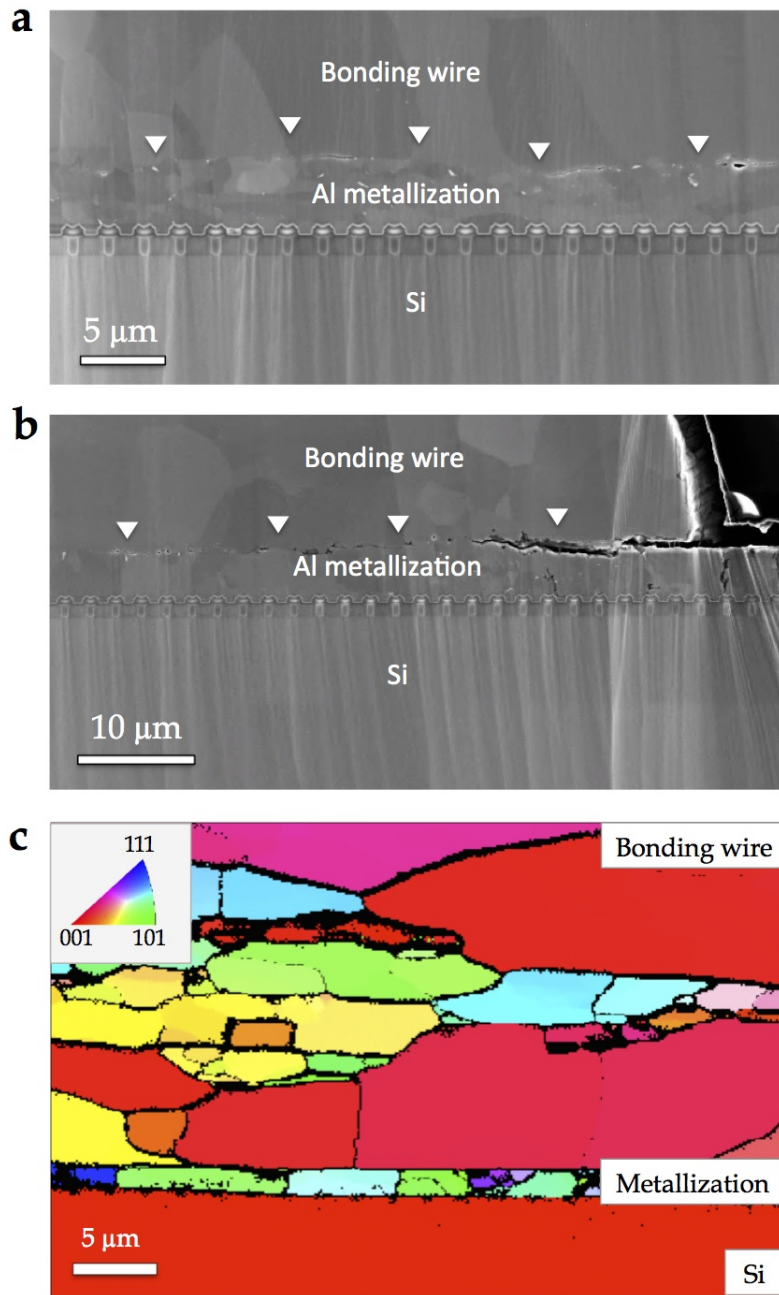
Figure 117: (a) SEM cross-sectional imaging of the wire-metallization interface pointed by the white arrows, (a) at the center and (b) at the extremity of the bonding area. (c) Relative EBSD map of the wire-metallization-semiconductor layered structure. The standard stereographic triangle gives the color codes of the grain orientations, taken here along the horizontal direction.

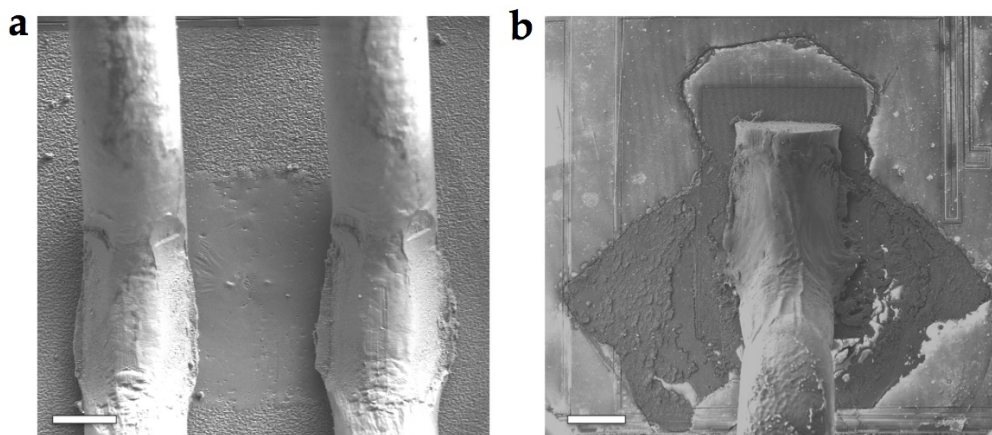
Figure 118: Burnout spots detected after failure (a) between two bond wires in a SPD06 module and (b) at the bonding connection in a T07D17 module. Scale bar: 250 $\mu$ m.

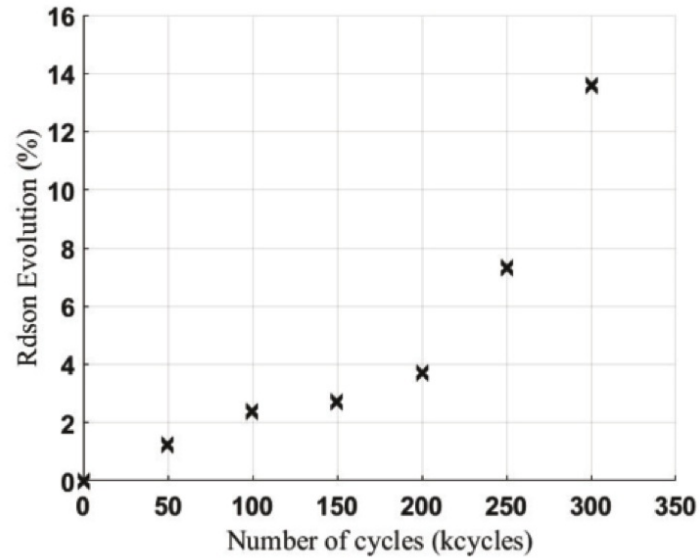
Figure 119: Increase of about 14% in the on-state resistance after repetitive SC events ( $3.55 \text{ J/cm}^2$ ) at ambient temperature. At 300kcycles the device failed.

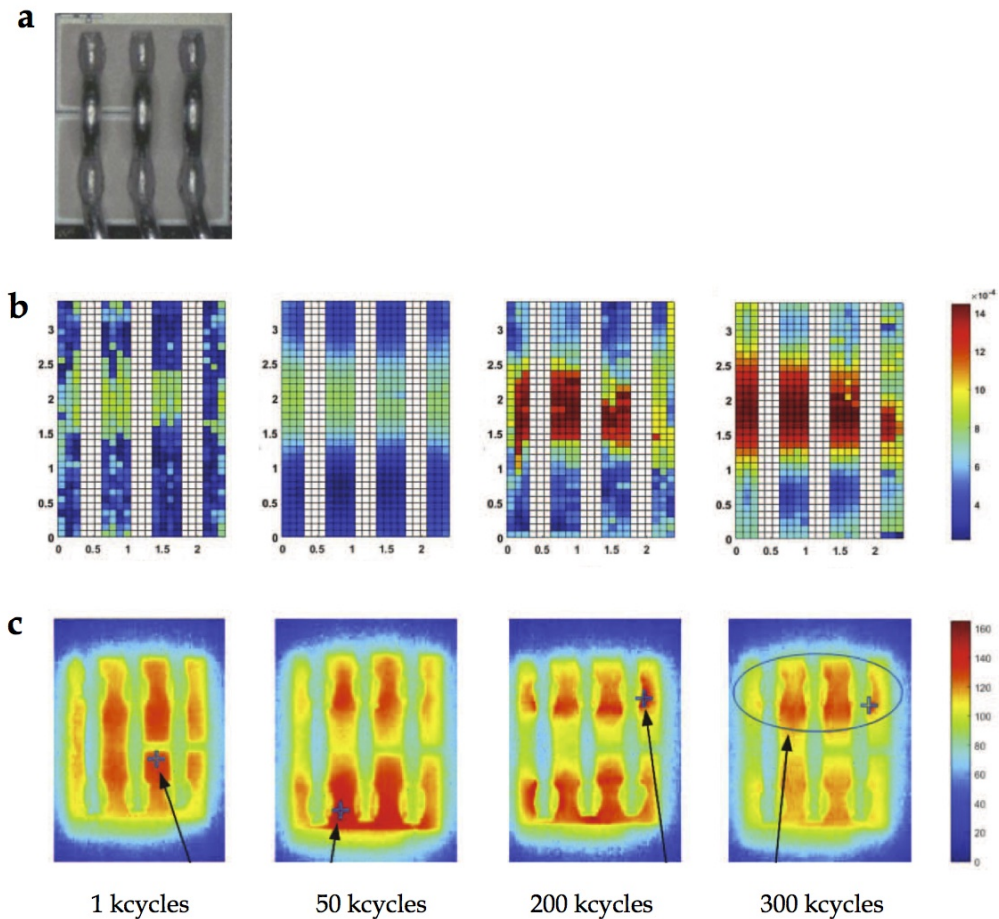
Figure 121: (a) Active module of an SPD06 device under aging test. Potential and temperature mapping of its surface have been performed during aging.  
 (b) Source voltage mapping [V] at  $I_D = 1A$  under SC conditions, after 1kcycles, 50 kcycles, 200 kcycles and 300 kcycles.  
 (c) Temperature distribution [K] under SC conditions, after 1kcycles, 50 kcycles, 200 kcycles and 300 kcycles. Areas where the temperature is lowest correspond the bonding connections, according to the picture of the active module in (a).

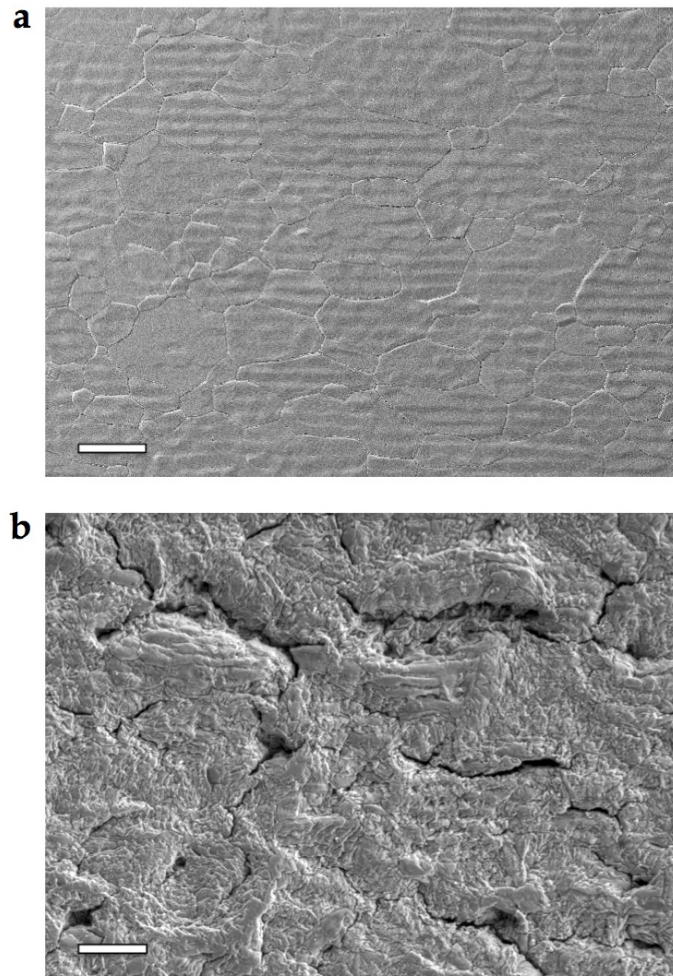
Figure 122: Al source metallization top view. (a) The initial Al structure is smooth and fits the underlying MOSFETs structure. (b) After electro-thermal aging the metallization roughness increases and many cracks propagate along the grain boundaries. The grain structure and the transistor pattern are almost no longer visible. Scale bar:  $10\mu\text{m}$ .

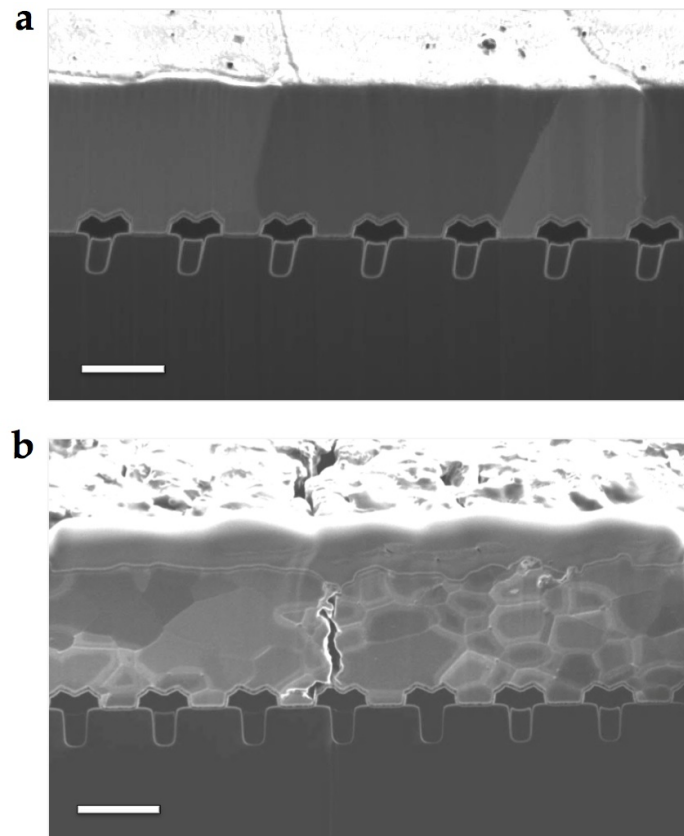
Figure 123: Cross-sectional cuts through the Al source metallization. (a) Before aging, bamboo Al grains fill all the metallization volume. After electro-thermal aging, an apparent grain shrinkage and crack propagation along the grain boundaries are observed. Scale bar: 2.5 μm.
