# Fatigue mechanisms in Al-based metallizations in power MOSFETs

Roberta Ruffilli. Fatigue mechanisms in Al-based metallizations in power MOSFETs. Condensed Matter [cond-mat]. Université Paul Sabatier (Toulouse 3); École doctorale Sciences de la Matière, 2017. English. NNT: . tel-01666437v2

**Fatigue mechanisms in Al-based metallizations in power MOSFETs**

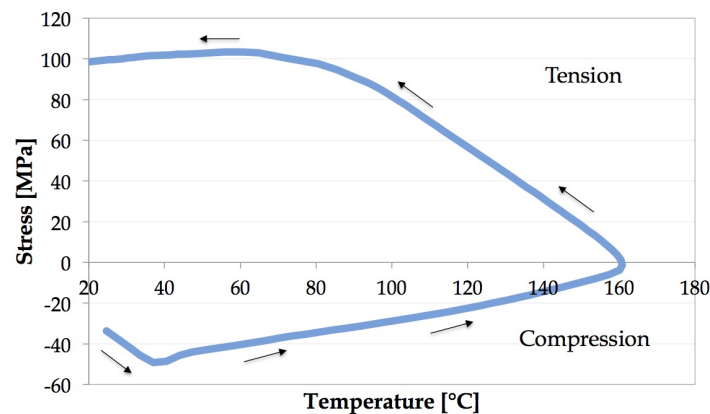
Figure 124: Stress-temperature plot for a 20-160 °C temperature cycle performed on a naked SPDo6 die. The stress is directly deduced from the die curvature (measured by laser reflectometry - see Appendix B ) using the Stoney equation (chapter 2, section 2.2.2).

- From 40 to 160°C in compression
- From 80 down to 25°C in tension

The stress amplitude is lower than 150MPa. If we refer to the Frost and Ashby maps for these stress and temperature, the mechanism predicted is clearly dislocation-based plasticity.

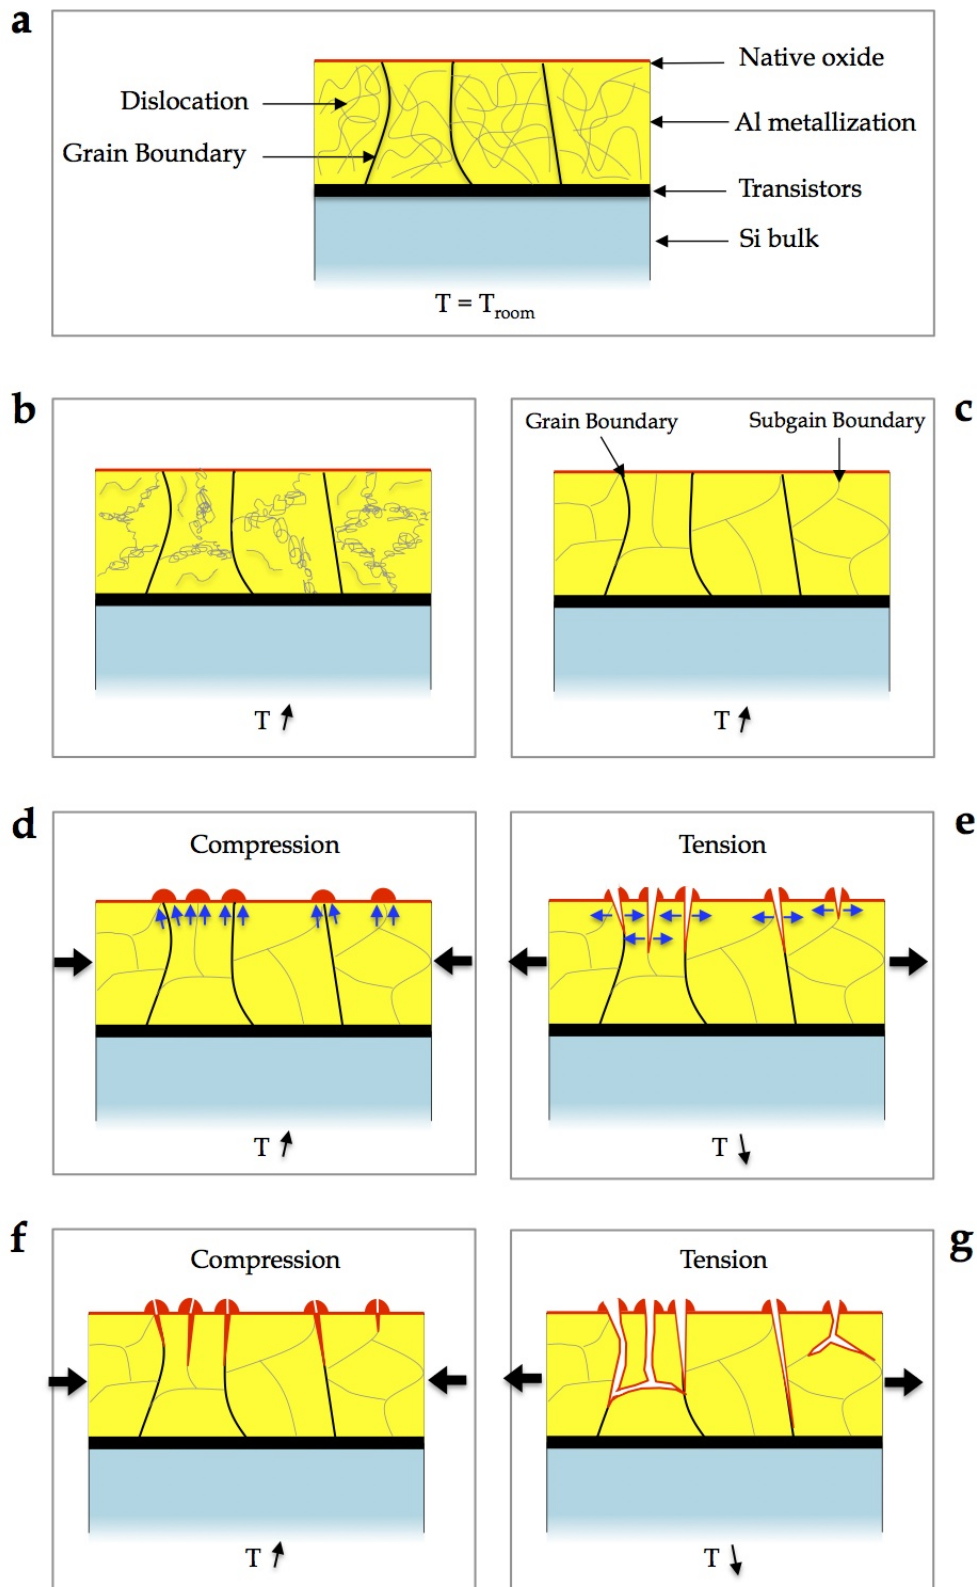
Figure 125: Gao's model extended to Al layers undergoing tension and compression stresses during thermal cycles [Mar14]. (a-c) The dislocation density decreases by recombination in sub grain boundaries and absorption at GB interfaces. (d-g) Al diffusion along grain boundaries, and subsequent oxidation causing crack propagation through the Al layer.

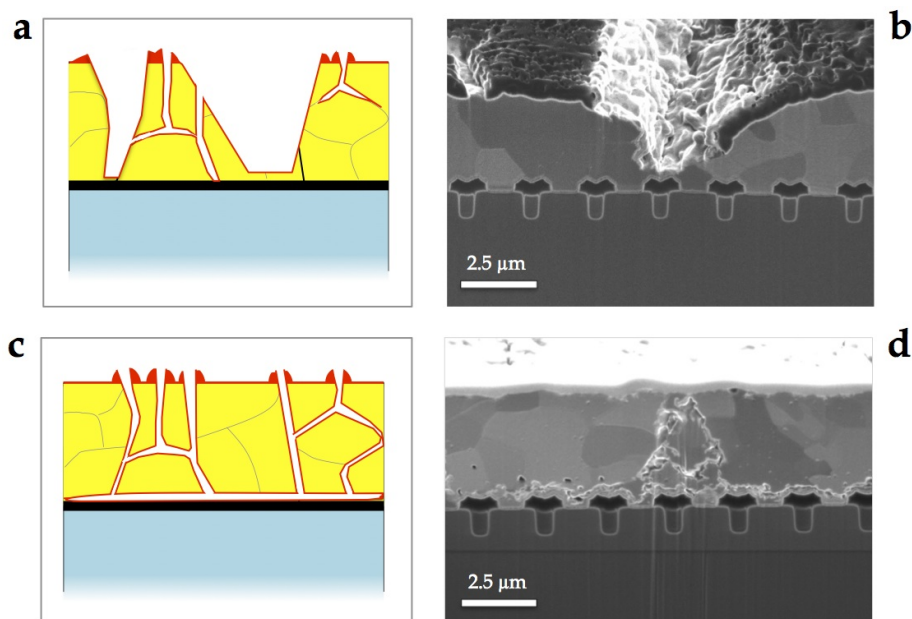
Figure 126: Crack propagation models through the Al layer at failure. (a) For SPD06 power modules at the final aging stage until failure, fatigues cracks running from the surface along the grain boundaries become broader and broader. (b) SIM cross-sectional image of the cracked metal in a failed SPD06, showing a crack width on the same order of the metallization thickness. (c) In To7D17 failed power modules, finer vertical cracks branch out and propagate horizontally all long the MOSFETs region. (d) Relative SIM cross-sectional imaging from a 70°C aged module.

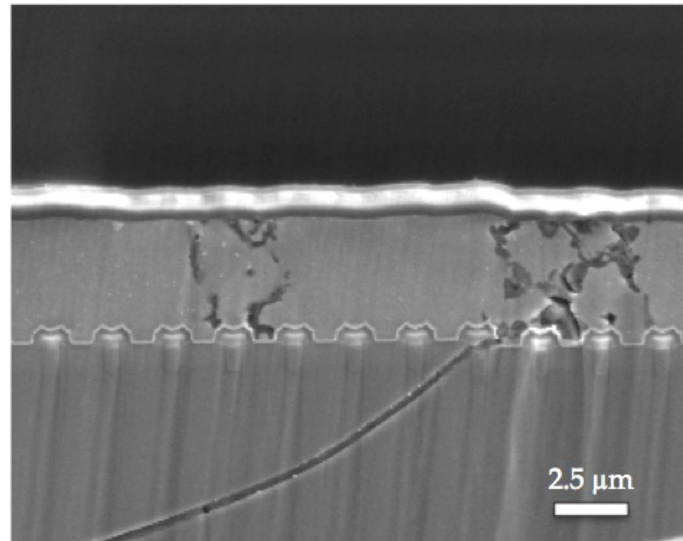
Figure 127: SEM cross-sectional image showing the whole metal-oxide-semiconductor crossed by cracks in a 70°C aged To7D17 module.

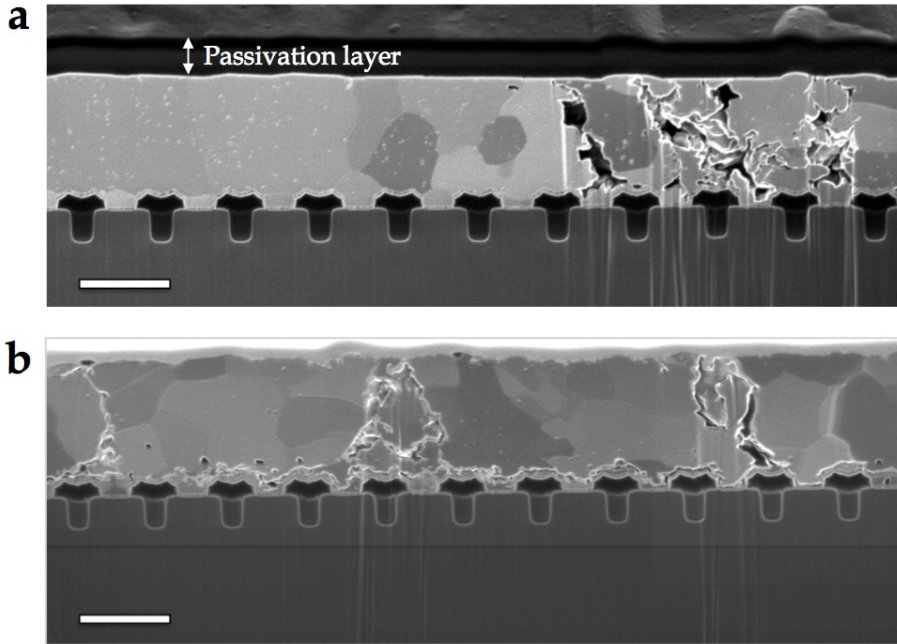
Figure 128: Cross-sectional SIM images of the (a) passivated and (b) bare Al source metallization, showing a localized propagation of vertical cracks in the first one and a generalized degradation in the second one, with horizontal cracks branching out all along the metal-transistor interface. Scale bar: 2.5µm

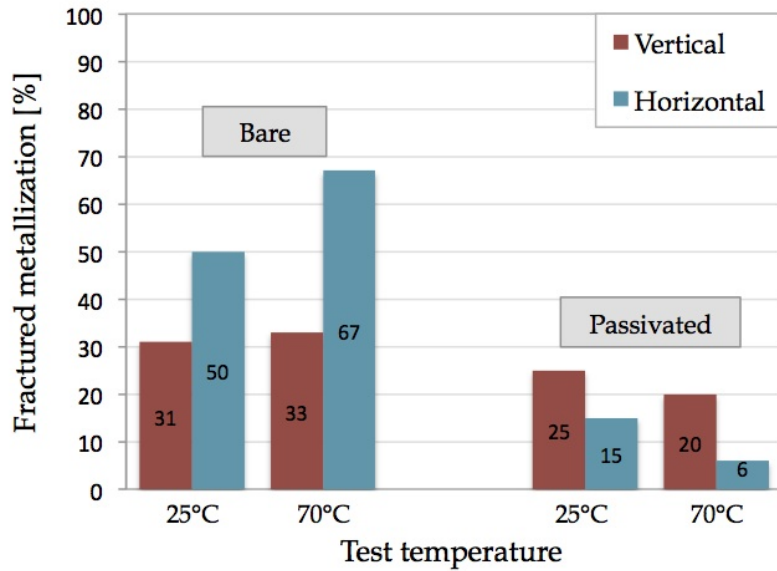
Figure 129: Metallization crack statistics for a To7D17 module aged at 25 °C and 70 °C, in non passivated –bare– (left) and passivated (right) zones.

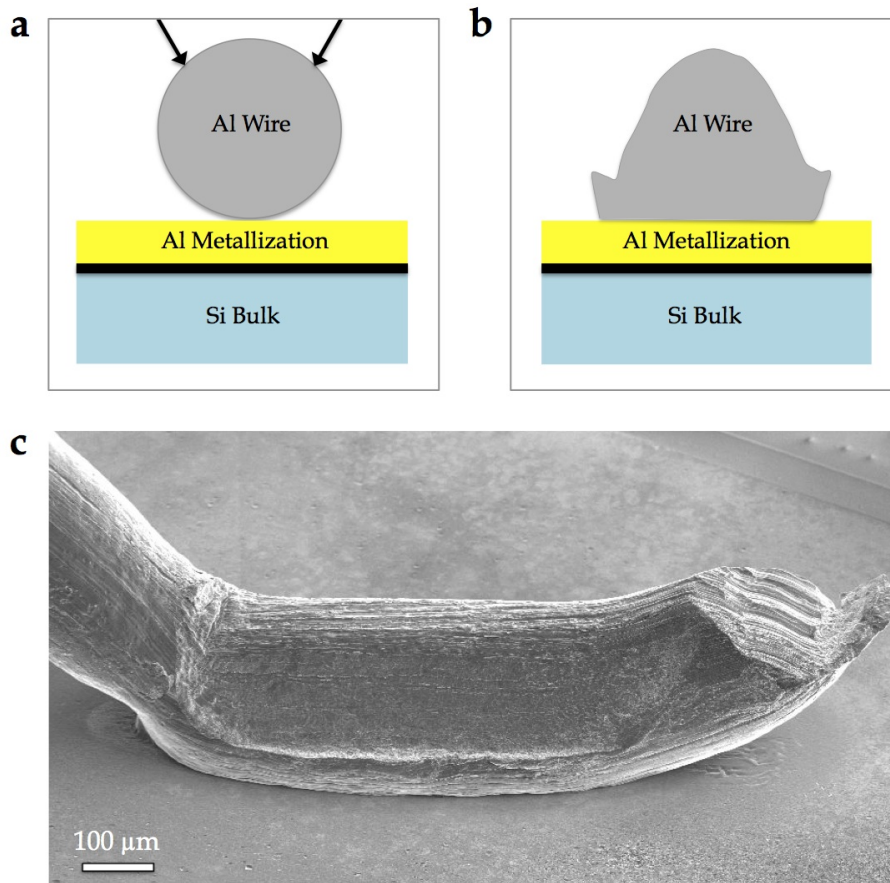
Figure 130: Cross-sectional schema of the cylindric wire on the top metallization (a) before and (b) after bonding process. The black flashes in (a) represent the force direction during the bonding process. (c) Lateral view SEM image of the elliptical bond area.

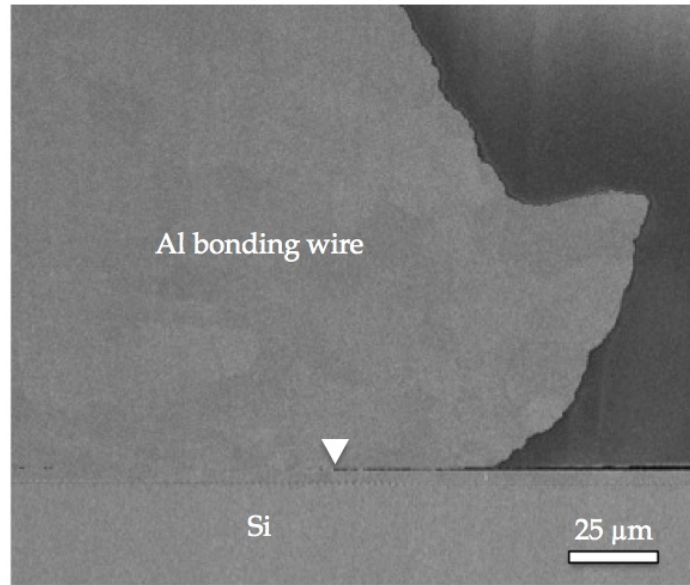
Figure 131: SEM Cross-sectional image of the tail side of an as-processed wire on Al metallization, showing the transition from the non-bonded to the welded region

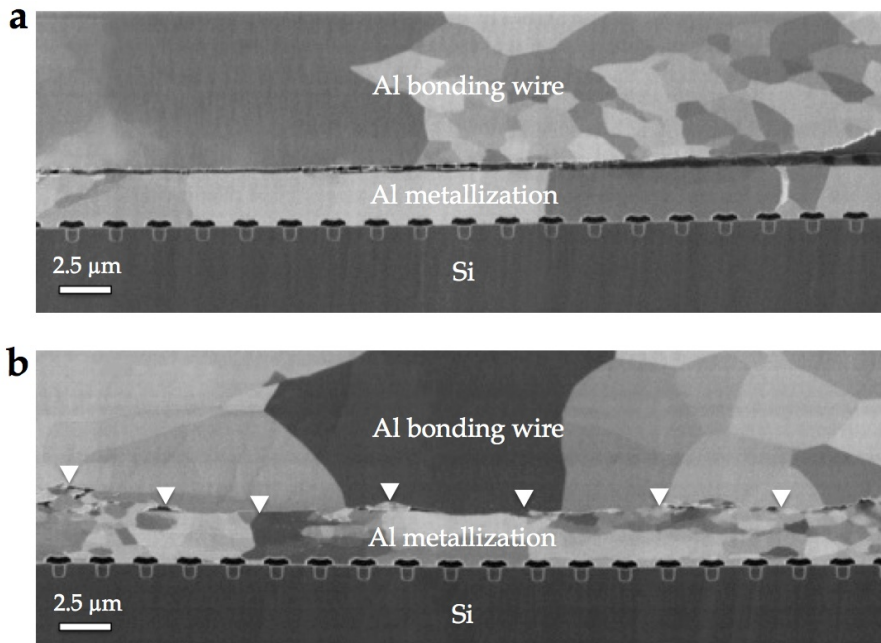
Figure 132: High magnification SIM image of the (a) non-bonded region and (b) the welded one, showing that no Al-Al interdiffusion between the two metallic parts occurred during the bonding process.

On the basis of the previous considerations, SIM and SEM cross-sectional images gave us a useful feedback about the bonding process in the as-processed LFET<sub>1</sub>T devices: the Al-Al bond is not perfect and the two metal structures remain overall separated by a finer interface composed by native Al oxide residues and small cavities. Moreover, due to the bonding process, the metallization layer undergoes a severe plastic deformation prior to aging. These images give also a useful feedback about the stress distribution during the bonding process. According to the schema in Fig. 130a, the maximum stress in the bond wire concentrates in the center, resulting in a uniform distribution of the stress in the metallization under the wire. This is demonstrated by the fact that overall the Al metallization thickness is uniform all along the wire-metallization interface in the analyzed sections (Fig. 133a, c). If not, we would have observed an ellipsoidal profile similar to the one in Fig. 133b, with a significant and non-uniform thinning of the central part of the metallization under the wire, compared to the initial metallization thickness away from the bonding wire (represented by the red dashed line as a reference). In our case, instead, we have observed an uneven wire-metallization interface profile characterized by the succession of straight segments and extrusion and compression parts (Fig. 133c). As proof of this, the difference between the thinning and bulging metallization areas is almost zero in the analyzed cross-sections. This also means that plastic deformation is not uniform along the applied stress of the wire bonding perpendicular to the wire-metal interface. It is  $\sim 5\%$ , if we consider entire sections and ranges between 5% and 25% in average if we calculate the deformation in smaller FIB sections, confirming that plastic deformation in the metallization under the bond wires is variable and the wire-metallization profile is highly uneven. These values are obtained on a total section area of  $\sim 1300\mu\text{m}^2$ , which is small compared to the volume impacted by the wire bonding ( $\sim 0.3\text{mm}^2$ ), but not negligible. Taking in account the pressure applied during the ultrasonic process, the average compressive stress on the metallization is  $\sim 30\text{MPa}$ . This stress is much smaller than the yield stress of a commercially pure Al with a grain size in the range of  $1 - 2\mu\text{m}$ , typically in the range of  $100 - 150\text{MPa}$  [Tsu02]. To explain that significant plastic deformation occurred under this small load, we have to assume that only a fraction of the  $0.3\text{mm}^2$  of the metallization surface was truly in contact with the wire. A very coarse estimate would lead to a third of the metallization being impacted by wire-bonding plastic deformation. This also explains why the surface is deformed very inhomogeneously. The fact that only a portion of the wire is welded to the metallization and that this portion decreases upon aging is supported by previous experiments [Goe10]. Knowing more precisely the

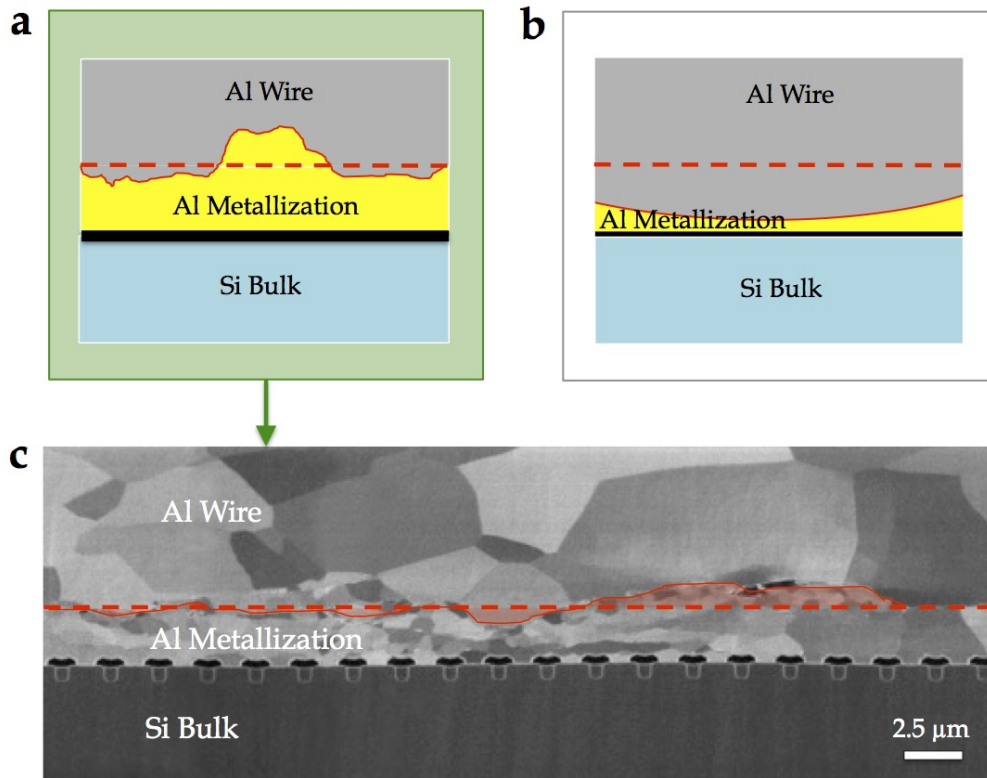
Figure 133: (a) Schema of the wire-metallization interface corresponding to (a) a uniform and (b) non uniform bonding stress along the interface. (c) SEM image of the uneven wire-metallization interface of a LFET<sub>1T</sub> power device, according to the schema in (a).

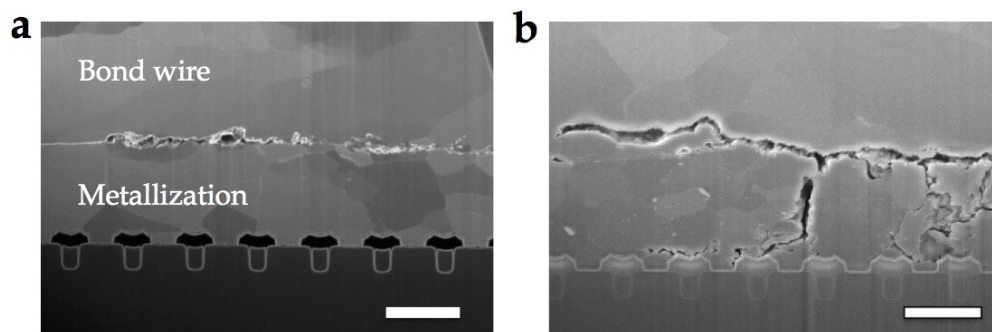
Figure 134: Wire-metallization interface (a) before and (b) after aging (at  $70^{\circ}\text{C}$ ). The Al-Al interface of as-processed modules presents initial imperfections, consisting in small cavities and native Al oxide residues. During aging, cracks propagate along these imperfections, causing a reduced contact between the wire and the metallization. Scale bar  $2.5\mu\text{m}$

High resolution imaging by ion and electron microscopy shows that the metallization under the bond wires is significantly different from the naked metallization, as the bonding process induce plastic deformation prior to aging. Moreover, during the bonding process, the native Al oxide covering the metallization layer is not fully broken. The result of the bonding is therefore an Al-Al interface, consisting in small cavities and Al oxide residues (Fig. 134a),

which prevents the interdiffusion of Al atoms between the two metallic parts. This is a possible explanation of the fact that no signs of bond wire fatigue, heel cracking or complete lift off [Ciao2] have been detected in the failed modules. During aging, all the electro-thermal and/or thermo-mechanical load is transmitted to the metallization beneath the bonding area and affects the wire-metallization interface. This basically occurs by propagation of fatigue cracks along the initial bonding imperfections, causing a reduced contact between the wire and the metallization (Fig. 134b). Cracks also run perpendicularly to the interface under the wires along the grain boundaries, as in the metallization away from the bonding area.

This is a strong indication that this interface is weak. Indeed, if the Al-Al bonding were initially perfect, the crack would deviate to the softer material that is here the wire, because of its larger grain size. This is only observed scarcely, and often the crack deviates again towards the interface, creating small cavities above it, as showed in Fig. 134b. Further statistical analysis is required to better assess the proportion of weak interface vs perfectly welded Al-Al contact area, but our study clearly show that weak bonding is linked to the presence of oxide, and this favor an horizontal crack propagation at the interface.

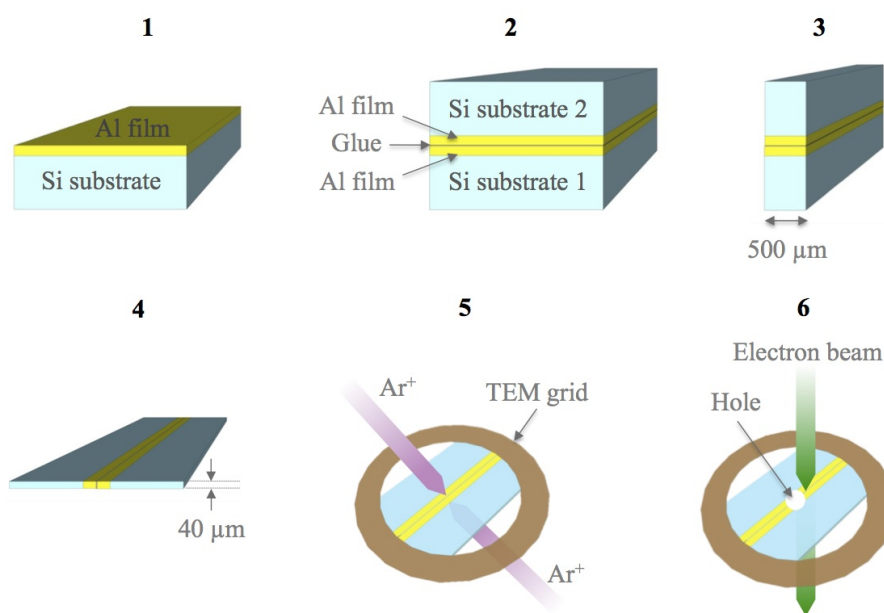
Figure 135: Sketch of the conventional TEM sample preparation procedure.

The main steps of the preparation are shown in Fig. 135 and described in the following. It consists in a mechanical thinning by tripod system and a final ion milling by precision ion polishing system (PIPS).

1. The sample surface is carefully cleaned in solvent in order to obtain a perfectly clean surface.
2. Two pieces of substrate-film are glued together using an epoxy glue (G1 from Gatan), in order to prevent polishing damages on the metallic film. The sandwich is introduced in a press to obtain a very thin glue film and the whole mounting is placed in a oven at  $80^{\circ}\text{C}$  for 2 hours to ensure a proper glue polymerization.

6. By playing on the beam angle and energy parameters (generally we start the milling at  $\pm 6^\circ$  and 6 keV and then we finish at  $\pm 4^\circ$  and 3 keV), at the edge of the hole the sample should thin enough to be electron transparent for the TEM observation.

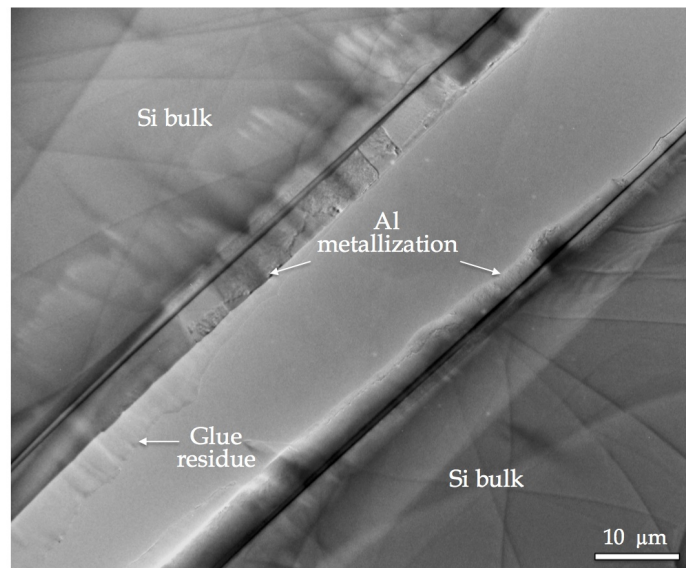
Figure 136: Low magnification TEM image showing the electron transparent cross-section of two bulk-film-film-bulk sandwich prepared by tripod and ion milling.

Classical tripod polishing may skip this ion-beam final milling by using finer diamond papers (0.5 $\mu\text{m}$ ) and colloidal silica, but involves more risk in obtaining an artifact-free Al layer (mechanical damages). Fig. 136 represents a low magnification TEM image of the electron transparent region around the PIPS hole: we can notice the two metallization films on the Si bulks and small glue residues between them. During heating in the TEM, both epoxy glues are temperature-resistant enough (450°C is generally considered slightly above their temperature application range, but since there is no large stresses on the sample, adhesion remains sufficient). If this would not be the case (heating above 500°C for instance), a small drop of alumina- or zirconia-based cement is used to attach the sample to its grid.

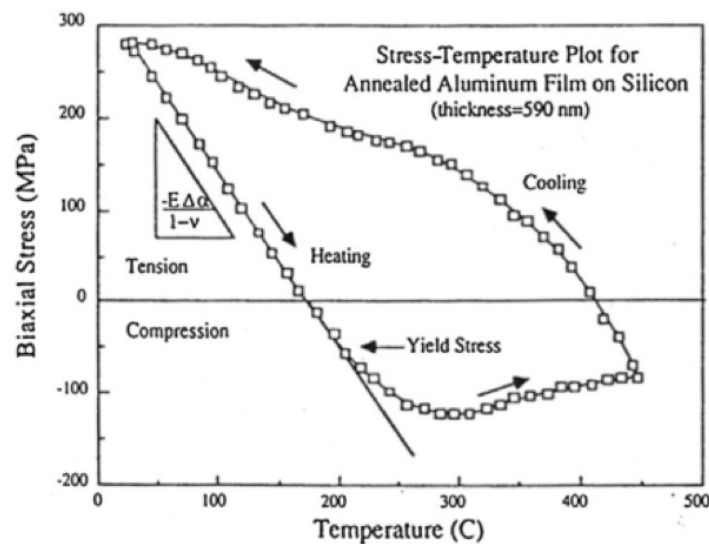
Figure 137: Typical stress-temperature cycle for a 590 nm thick poly-crystalline Al film on oxidized Si substrate ( $T_{max} \sim 450^\circ\text{C}$ ) [Fli87].

where  $\sigma_f$  is the average biaxial stress in the film,  $E_s$ ,  $\nu_s$  and  $t_s$  are, respectively, the Young's modulus, Poisson's ratio and thickness of the substrate;  $R$  is the curvature measured by the laser;  $t_f$  is the film thickness. The robustness of this equation and measurement method is in the fact that no assumption is needed regarding the film's elastic properties, as only those of the substrate are needed [Leg03] [Fli87]. A typical thermal cycle where the film yields first in compression (during heating) before being stressed in tension (upon cooling) is shown in Fig.137.

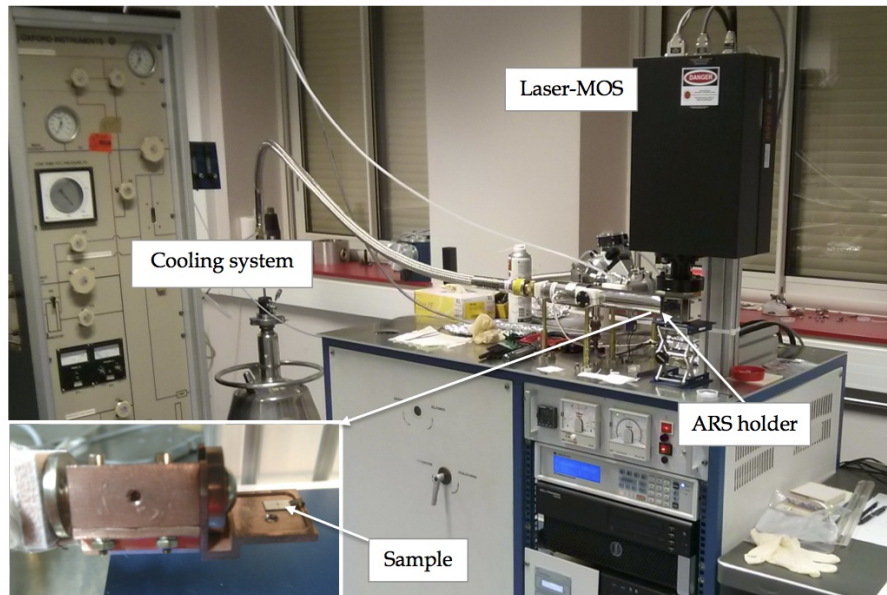
Figure 138: Laser reflectometry test bench assembled for curvature experiments. The sample (reference SPDo6, before assembly) is placed under vacuum on a Cu support, inside the ARS sample holder.

Fig. 138 represents the main parts of the experimental set-up, described in the following:

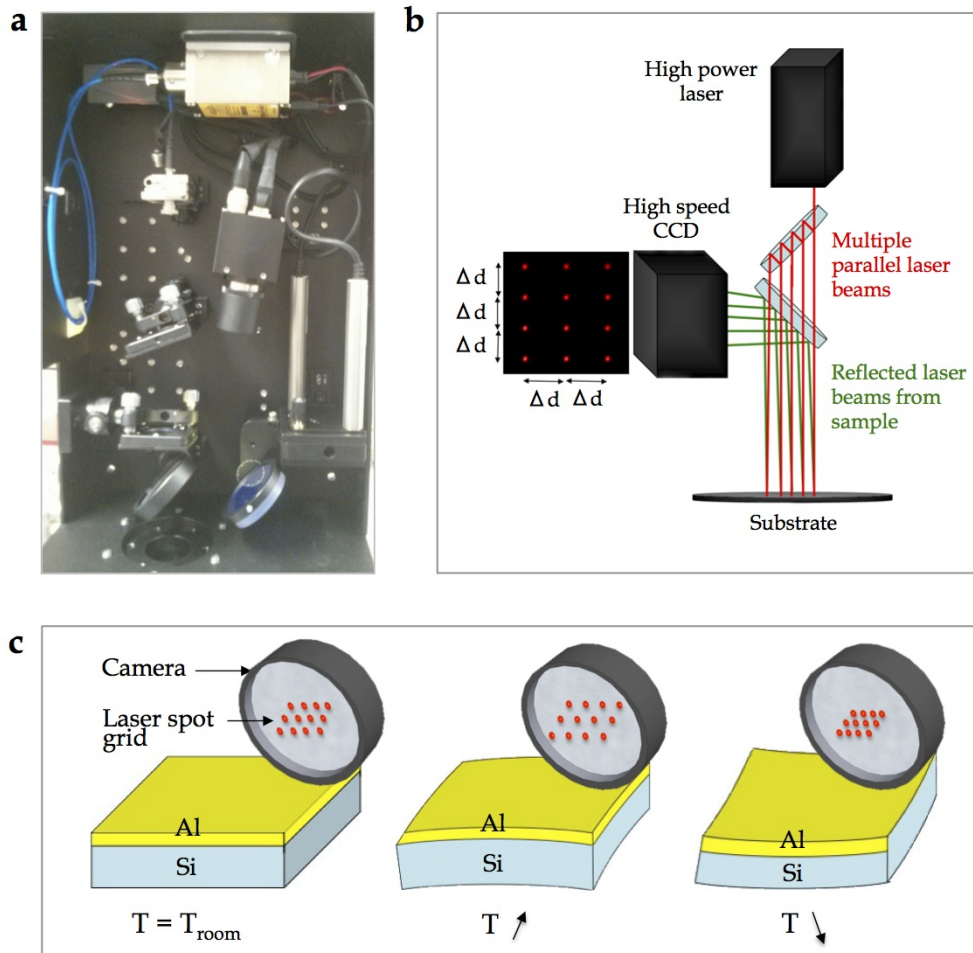
Figure 139: (a) MOS K-space module interior and (b) laser operating principle. (c) The larger CTE of the Al film compared to the Si substrate induces elastic and plastic strains in the film. The Al film is then stressed in compression during the heating phase and in tension upon cooling.

During curvature experiments, metallic films deposited onto Si or ceramic substrates undergo thermal-only cycles. The difference in CTE between bulk and film is sufficient to strain the film, first elastically and then plastically. This generates a curvature (Fig. 139b), that can be directly related to the stress variation in the film using the Stoney equation [Sto09] [Jan09].

- KSA MOS laser module, from K-Space.  
The module focuses several laser beams on the reflective surface (film) of the sample (Fig. 139b) and measure the curvature imposed by the Al film to the Si substrate by laser profilometry (on the base of the laser spots divergence or convergence - Fig. 139c). The laser unit and its operating principle are showed respectively in Fig. 139a and b.
- ARS cryogenic sample holder.  
It allows to heat the sample up to  $525^{\circ}\text{C}$  and cool it down until the liquid nitrogen temperature. This temperature range is significantly higher with respect to the real operating temperatures of power devices [Pie09].

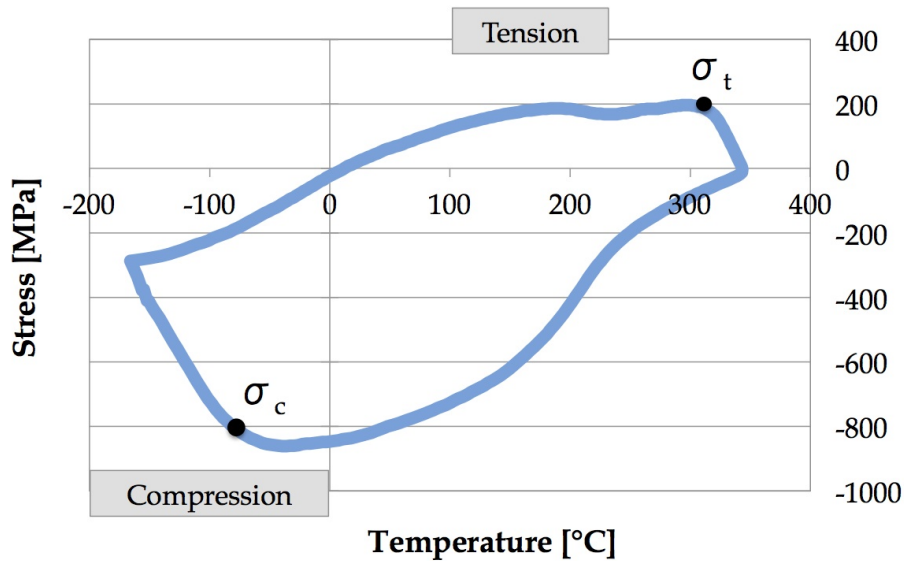
Figure 140: Stress-Temperature cycle for the Al thin film deposited onto the Si wafer. The relative stress is measured along the larger die dimension, and the zero value is here taken at  $350\text{ }^{\circ}\text{C}$ . The cycle is initiated at  $T = -190\text{ }^{\circ}\text{C}$ , and the T gradient is set to  $20\text{ }^{\circ}\text{C}/\text{min}$  during heating and cooling.

Fig. 140 shows one of the cycles that we have performed between  $-190^{\circ}\text{C}$  and  $350^{\circ}\text{C}$ . Starting the experiment at  $-190^{\circ}\text{C}$ , the metallic layer yields in compression (c) during heating, before being stressed in tension (t) upon cooling. As in Fig. 124 in Chapter 5, in absence of an absolute value of the wafer curvature prior to the die construction, we chose the zero stress state at the end of the heating ramp. Further experiments would have been necessary to understand the full physics of the deformation of the die as this figure entails several features, some expected, and some that we don't understand as for now. As expected, the elastic regime is shorter at high temperature than at low temperature. This is because the yield stress, that is probably thermally activated (most of the mechanisms described in Chapter 5 - Section 5.2.1 are thermally activated) will occur at higher values at low  $T$  and at lower values at high  $T$ . Between these elastic parts in tension and compression, most of the stress relaxes by plastic deformation. The dominant role of diffusion in the relaxation is evidenced by the much lower stress levels reached at high temperature (diffusion is more dependent on temperature than dislocation glide). However, the fact that the stress decreases in tension below  $200^{\circ}\text{C}$  and then increases again in compression below  $0^{\circ}\text{C}$  does not make sense, no matter the relaxation mechanism invoked. The film should be in tension at the end of the cooling. Right now, we don't have an explanation for this. Possible hypothesis would be that our simplified view of the die as an Al metallization over a Si substrate is oversimplified. If other layers (oxydes, poly Si, nitrides) play a significant role, we may have stresses building up in more complex ways. An artifact of the die moving during the experiment also cannot be ruled out as we haven't been able to run additional tests (power control break down of the set-up at the end of 2017).

If we consider an Al film on Si, the total strain is 1% for a cycle of  $-190\text{ }^{\circ}\text{C}$  to  $350\text{ }^{\circ}\text{C}$  (in the reflectometer) and 0.3% for a cycle from  $25\text{ }^{\circ}\text{C}$  to  $160\text{ }^{\circ}\text{C}$  (if we assume that  $160\text{ }^{\circ}\text{C}$  is a typical temperature attained in the die at the end of the ON state [Sauo8]). After about 5 cycles, no surface change (cracks, slip traces) has been observed using SEM/FIB and EBSD mapping.

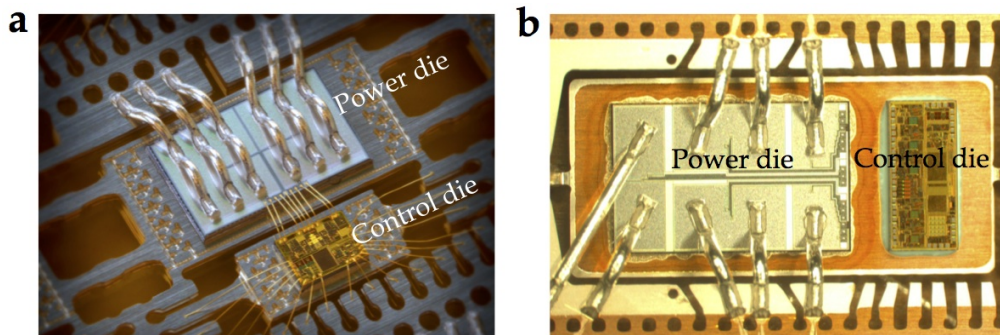
Figure 141: Composants de puissance de type LFET1T smart power MOSFET, produits par NXP Semiconductors. (a) 45V, 12V SPD06, (b) 65V, 24V To7D17.

- 12V SPDo6 power die (Fig. 141a), conçu pour les batteries 12 V (applications voitures), avec une tension de breakdown de 45V. Ils sont constitués de 2 secteurs MOSFET, chacun connecté par 3 fils de bonding et ayant un  $R_{DS(on)}$  de 6m $\Omega$ .
- 24V To7D17 power die (Fig. 141b), conçu pour les batteries 24V (applications camions), avec une tension de breakdown de 65V. Ils sont constitués de 5 secteurs MOSFET, connectés par 8 fils de bonding et ayant un  $R_{DS(on)}$  de 17m $\Omega$  et 7m $\Omega$ .

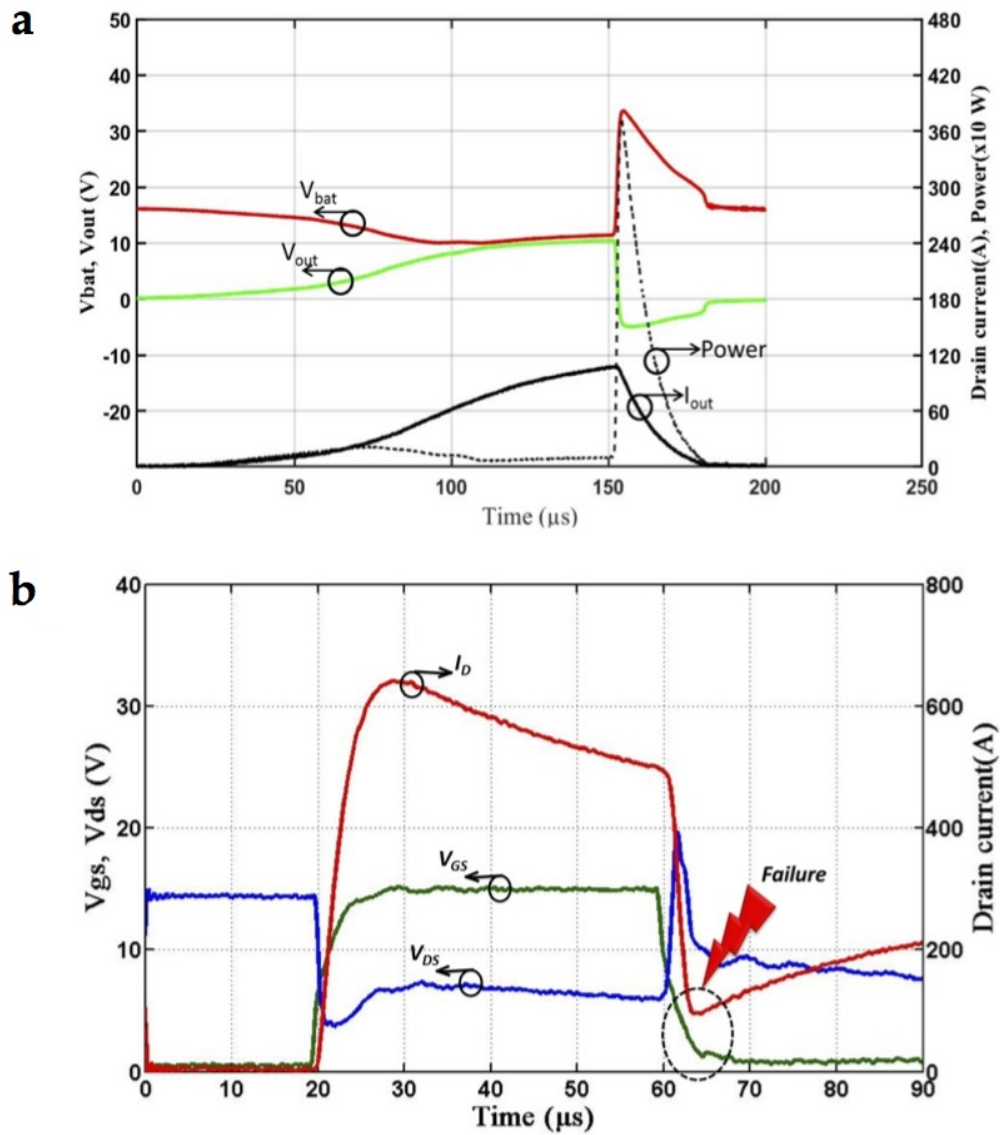
Figure 142: Formes d'onde au moment de la défaillance pour un composant (a) To7D17 soumis à des tests de qualification standard chez NXP et (b) SPD06 vieilli au sein du laboratoire SATIE par de test de court-circuit extrêmes.

Les conditions des deux types de test sont résumées dans le tableau 5 suivante et les relatives formes d'onde au moment de la défaillance sont montrée en Fig. 142.

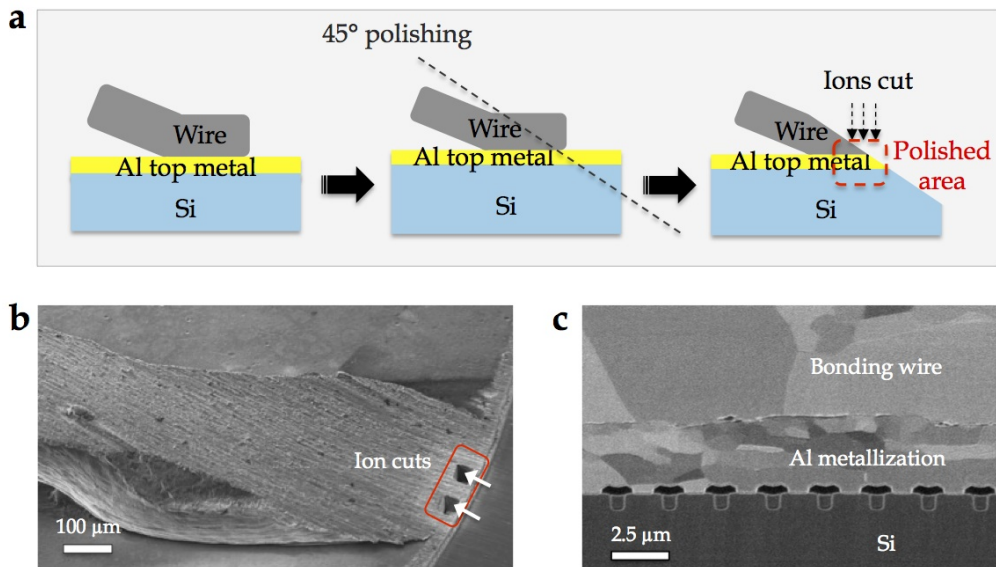
Figure 143: (a) Schématisation du procédé de préparation de l'interface métallisation-fils de bonding d'un composant LFET<sub>1T</sub>: la zone de gravure au FIB est préalablement polie à 45°. (b) Le résultat de la préparation est représenté dans l'imagerie SEM à bas grandissement, où on peut voir le fils coupé à 45° et deux gravures FIB à niveau de l'interface fil / métallisation. (c) À plus fort grandissement, l'imagerie ionique permet de montrer le bonding Al / Al: les microstructures du fil et de la métallisation sont très différentes notamment en terme de taille de grain.

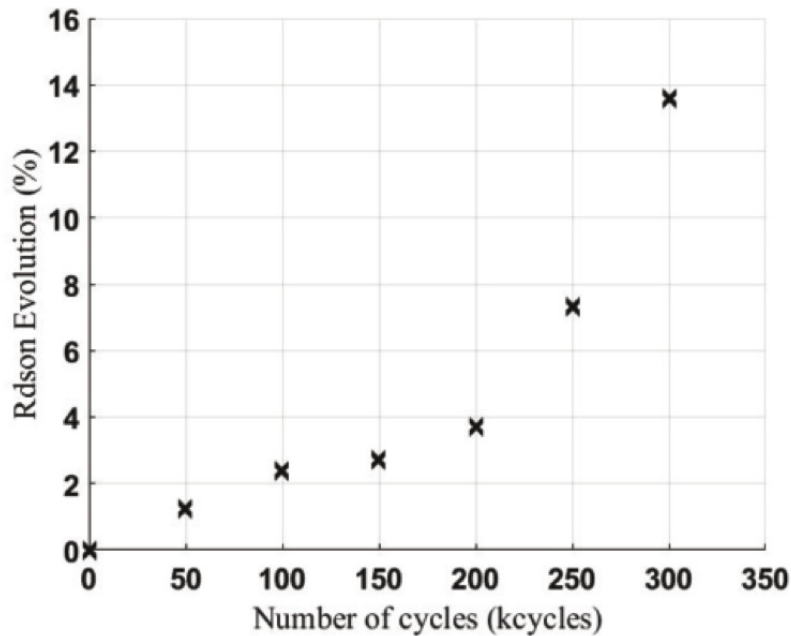
Figure 144: Evolution de  $R_{ds(on)}$  en cours de vieillissement, jusqu'à défaillance (après ~ 330kcycles).

Nous montreront dans la suite les principaux mécanismes de dégradation de la métallisation de source observés lors de nos caractérisations. Nous avons systématiquement comparé la microstructure de métallisation autour et sous les fils de connexion, avant et après vieillissement. Cette progressive dégradation des parties métalliques s'accompagne à une augmentation de  $R_{ds(on)}$ , comme il est démontré par la Fig. 144. Le graphique montre une augmentation du 14% de  $R_{ds(on)}$  pour un composant SPDo6 à défaillance (après ~ 330kcycles).

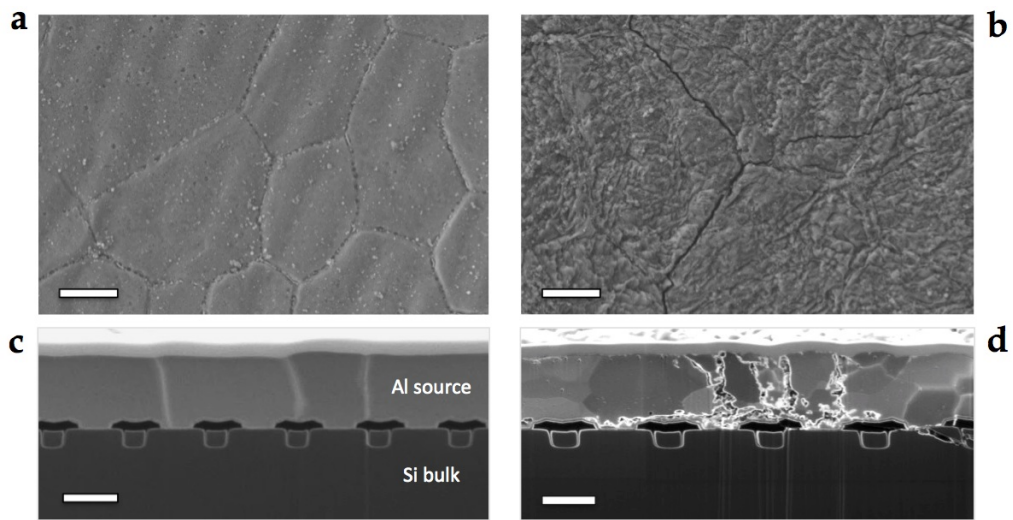
Figure 145: Évolution de la microstructure de la métallisation à base d'aluminium de SPDo6 pendant vieillissement à température ambiante. Les observations en surface (a) avant et (b) après vieillissement sont faites en SEM. Les coupes transverses (c) avant et (d) après vieillissement sont faite en FIB / SEM et les images sont faites par contraste ionique. Barre d'échelle: 2.5 $\mu$ m.

Une étude SEM et SIM systématique de la métallisation de source Al des modules SPDo6 et To7D17 qui ont subi différentes conditions de vieillissement électrothermique révèle des mécanismes de dégradation de la métallisation communs. Il s'agit d'une significative reconstruction de la métallisation au voisinage des fils de connexion. Elle se produit à niveau de surface, par une augmentation de la rugosité (Fig. 145a) par rapport à la structure granulaire initiale de l'Al (Fig. 145a) et, à l'intérieur du matériau, par un apparent rétrécissement des grains et l'apparition des fissures (Fig. 145d). Ces résultats sont

- Avant les tests, la surface de la métallisation est lisse et suit la structure des ondes des transistors (Fig. 145a). Comme pour les films Al classiques, des grains sont détectés à la surface et de petites dépressions définissent les rainures des joints de grains. À l'intérieur de la couche, l'interface entre les grains est visible par le contraste ionique (Fig. 145c): es grains d'Al bambou [Arz11] [Joo94] [Wal92b], avec un diamètre moyen de  $4\mu\text{m}$  et une hauteur égale à l'épaisseur de la couche, remplissent tout le volume de la métallisation.

- Après les test de vieillissement, la surface de la métallisation est modifiée et présente une forte altération due à la déformation plastique et aux extrusions Fig. 145b; la structure initiale des transistors n'est presque plus visible. À l'intérieur de la couche, les grains sont divisés en sous-joints (grains avec une désorientation  $< 15^\circ$ , mesurée par cartographie ASTAR, Fig. 146) et des fissures intergranulaires s'étendent de la surface jusqu'à la zone du transistor (Fig. 145d). Ces résultats révèlent que la structure granulaire a subi une déformation plastique limitée par dislocation, ce qui explique l'apparition de sous-grains conduisant à un rétrécissement

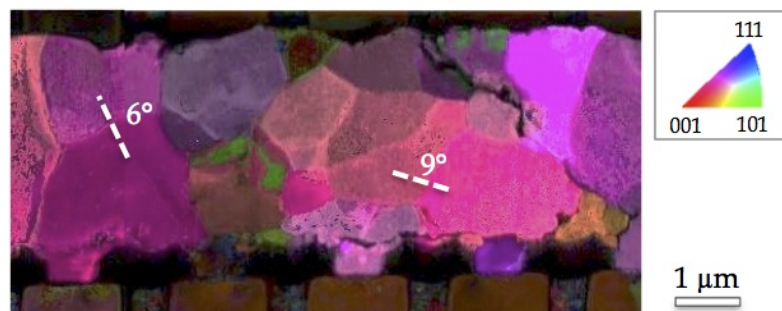
Figure 146: Mesures de taille de grains par MET-ACOM sur un module To7D17 vieilli à 25°C. Les relatives images ionique (Fig. 145d) montre parfois des domaines cristallins qui ne sont que des sous-grains (désorientation inférieure à 10°).

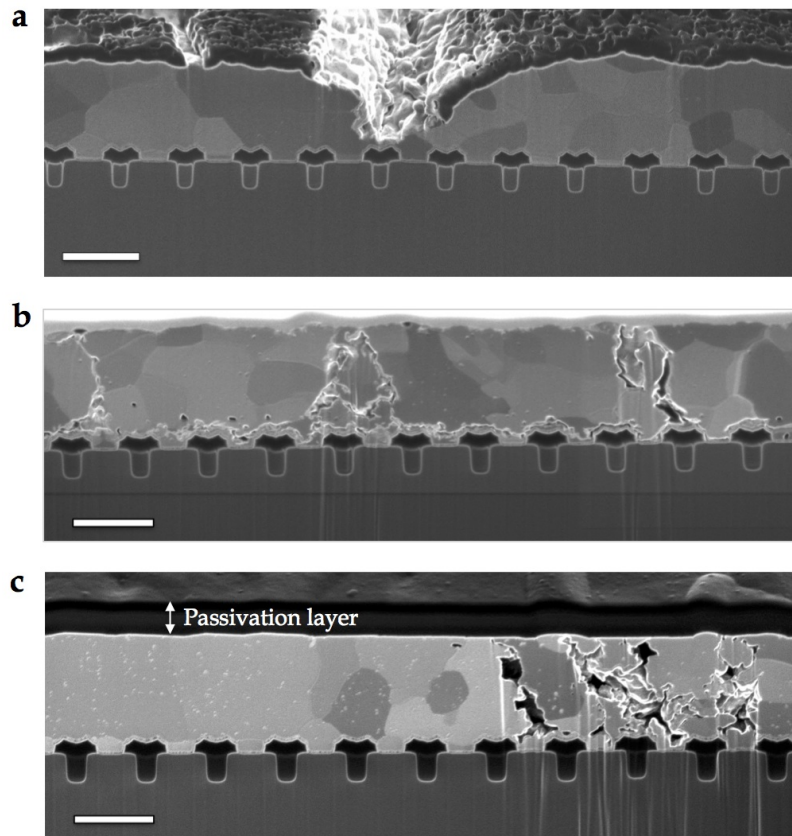
Figure 147: Fissuration de la métallisation développée dans une zone (a) non passivée, (b) passivée par mold compound et (c) passivée par  $\text{SiO}_2$  (plus mold compound). Barre d'échelle:  $2.5\mu\text{m}$ .

À défaillance, nous avons observé une différente fissuration dans la métallisation nue, passives par le mold compound et avec passivation SiO<sub>2</sub> (Fig. 147).

- Dans la métallisation nue (Fig. 147a), les rainures GB deviennent équivalentes (voire plus grandes) à l'espacement entre les transistors.
- La métallisation passivée par le mold compound (Fig. 147b) est aussi fracturée, mais les fissures sont plus fines et se propagent horizontalement à l'interface oxyde / semiconducteur.
- Une couche de passivation d'oxyde plus rigide (Fig. 147c) et plus adhérente ralentit la diffusion du GB mais ne l'arrête pas complètement. Les fissures sont plus localisées et concentrées, mais toujours présentes.

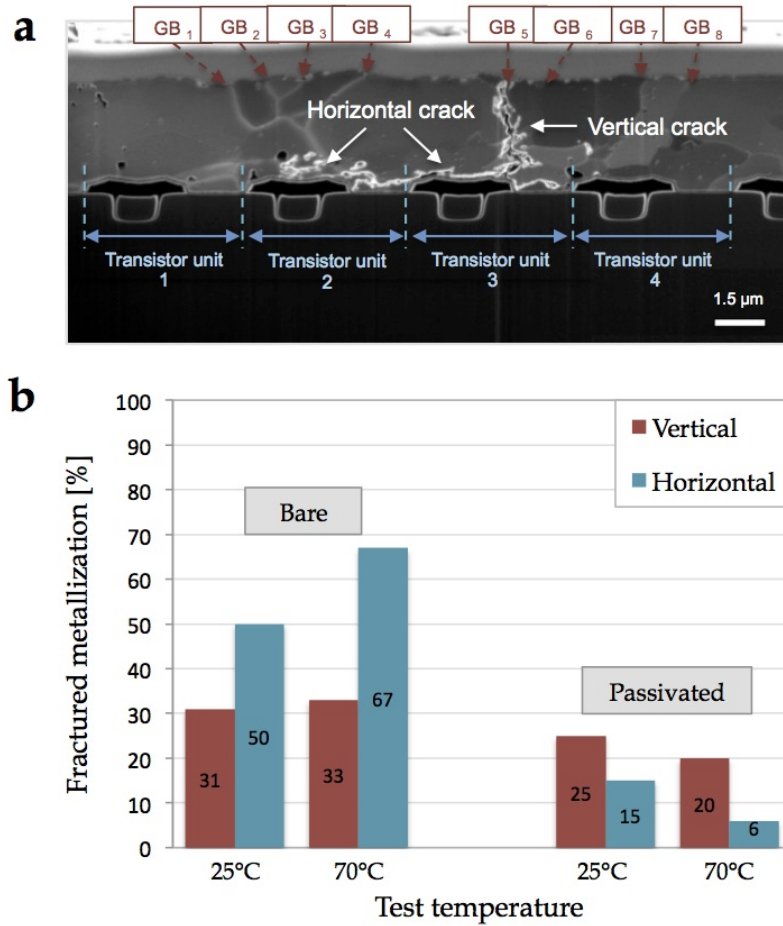
Figure 148: (a) Méthode de comptage des fissures verticales et horizontales en fonction des joints de grains (verticaux) et des cellules de transistor (pour les fissures horizontales).

(b) Statistiques de fissuration de la métallisation pour des modules To7D17 vieillis à 25°C et 70°C, dans les zones passivées uniquement par le mold compound (gauche) et passivées par une couche de SiO<sub>2</sub> (gauche).

Pour essayer de quantifier les fissuration dans les zones passivées seulement par le mold compound ("bare" dans le graphique en Fig. 148b) et par une couche supplémentaire en SiO<sub>2</sub> ("passivated" dans le graphique en Fig. 148b), nous avons inventé la méthode suivante: étant donné que la métallisation est constituée de joints de grain bambou, disposés de façon à peu près proportionnelle aux transistors, nous avons compté le nombre de joints verticaux fissurés/non fissurés et le nombres de cellules fissurées horizontalement (le long de l'interface métal/substrat) par rapport à celles ne contenant aucune fissure. Ce qui est résumé sur la Fig. 148a. Les résultats sont donnés sur la Fig. 148b. Il apparaît clairement que la fissuration est plus clairsemée dans les parties passivées avec SiO<sub>2</sub>, mais cette différence est plus marquée sur la fissuration horizontale. Les précédentes observations montrent que la fissuration horizontale se déclenche lorsque la fissuration verticale atteint la zone des transistors depuis la surface. Si on suppose que cette fissuration verticale "sature" lorsque 30% des joints sont atteints (métallisation non passivée) on peut expliquer que la fissuration horizontale soit limitée dans le cas de la métallisation passivée seulement par le mold compound, puisque 20% des joints sont atteints dans ce cas. L'effet de la température est aussi plus marqué dans le cas de la métallisation sans SiO<sub>2</sub>, puisque les fissures horizontales sont beaucoup plus développées à 70°C qu'à 25°C, effet que l'on retrouve moins dans la métallisation passivée par SiO<sub>2</sub>.

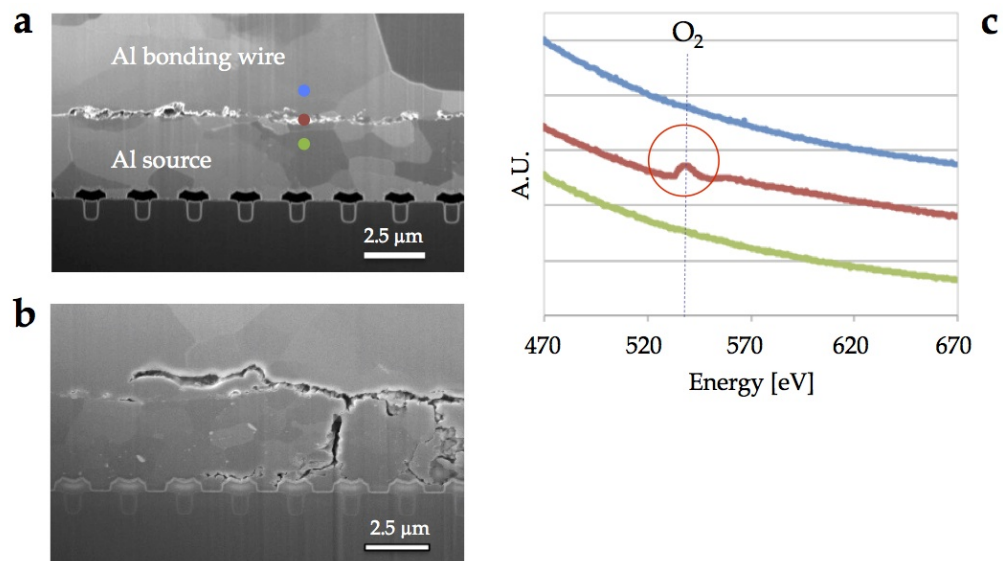
Figure 149: (b) Spectres EELS enregistrés à trois endroits, relatives aux points colorés en (a), proche de l'interface fil/métallisation dans un composé non vieilli. Le pic correspondant à l'oxygène ne ressort qu'à l'interface et prouve donc la présence d'oxyde localisé. (c) Pendant vieillissement, ces imperfections favorise la propagation de fissures le long de l'interface fil/métallisation, qui determine un détachement local de deux métal. À cette endroit, des fissures verticales along the joints de grains peuvent aussi se propager jusqu'au substrat de Si, comme dans les portions de métallisation nues.

- La zone de bonding initiale est caractérisée par la présence systématique d'une interface bien définie et irrégulière entre la métallisation et le fil (Fig. 149a), faite par de résidus d'oxyde d'aluminium (Fig. 149c) et de petites cavités. Cela signifie que le bonding n'est pas parfaite et qu'il n'y a pas d'interdiffusion Al-Al à cause de la barrière d'oxyde natif qui n'est pas casé pendant le processus de soudage à froid. Le vieillissement accentue ces défauts initiaux, qui sont le point de départ de la propagation horizontale de fissures à l'interface entre la métallisation le fil, causant une réduction de contact entre les deux métaux (Fig. 149b). Dans ces zones peu contactées, les fissures peuvent également se propager verticalement jusqu'à le substrat de Si suivant les joints de grains, comme dans les parties autour des fils. Il est important de remarquer que les fissures restent limitées à l'interface fil-métal et ne se propagent pas dans le fil. Ceci est une forte indication que l'interface Al / Al est faible et sa présence induit des phénomènes de dégradation spécifiques. Si la liaison était initialement parfaite, les fissures auraient dévié vers le matériau le plus mou qui est le fil, puisque il a des grains plus larges.
