# Fatigue mechanisms in Al-based metallizations in power MOSFETs

Roberta Ruffilli. Fatigue mechanisms in Al-based metallizations in power MOSFETs. Condensed Matter [cond-mat]. Université Paul Sabatier (Toulouse 3); École doctorale Sciences de la Matière, 2017. English. NNT: . tel-01666437v2

**Fatigue mechanisms in Al-based metallizations in power MOSFETs**

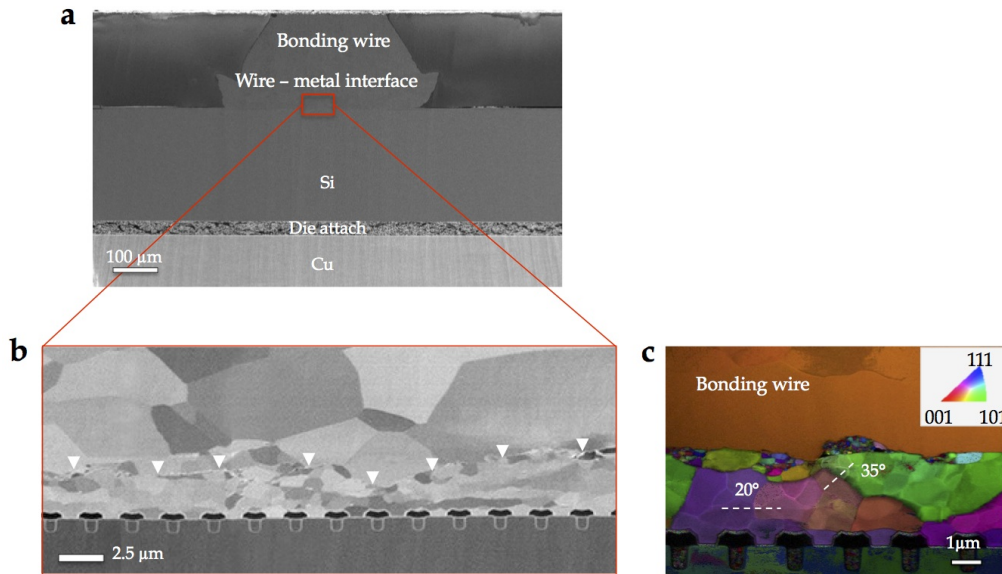
Figure 150: (a) Cross section SEM d'un module To7D17 non vieilli effectuée par un cross-polisher system. (b) L'encart est réalisé en image ionique afin d'observer les grains de l'interface fil/métallisation. (c) Mesures de taille de grains par MET-ACOM sur des sections équivalents à (b).

- Sous le fil (Fig. 150b), la microstructure de la métallisation initiale est plus fine que ailleurs (métallisation nue et fil). Le réarrangement de la structure granulaire, prouvé par l'ASTAR (Fig. 150c), est dû à une déformation plastique importante et non uniforme engendrée par le procédé de bonding sur la métallisation de source. Nous essayé pour la première fois à mesurer cette deformation. La méthode que nous avons mis au point est montrée en Fig. 151a. On compte les déformations par rapport à une référence (ligne rouge) en mesurant des aires de métal enfoncées (zone -) ou dépassant (zone +) de cette référence qui correspond à la position initiale de la surface de la métallisation. La déformation est ensuite calculée en comparant ces aires ( $Area_{Def}$ ) par rapport à l'aire initiale ( $Area_{Ref}$ ) de la métallisation dans la zone observée. La déformation plastique mesurée est de 5% en moyenne, si on considère des sections entières et varie entre 0% et 25% si l'on calcule dans des sections FIB plus petites. Ces résultats confirment que la déformation plastique induite par le procédé de bonding est très dishomogène, comme nous l'avons observé qualitativement dans les images élétroniques, qui montre une iteface fil-métallisation très irrégulière. Les valeurs précédentes sont obtenues sur une section totale de  $\sim 1300\mu m^2$ , ce qui est petit par rapport au volume impacté par le fil de bonding ( $\sim 0.3mm^2$ ), mais pas négligeable. Compte tenu de la pression appliquée pendant le processus à ultrasons, la contrainte de compression moyenne sur la métallisation

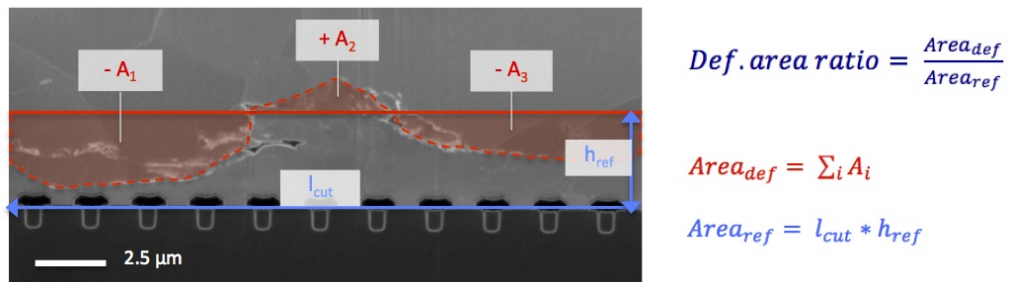
$$Def. area ratio = \frac{Area_{def}}{Area_{ref}}$$

$$Area_{def} = \sum_i A_i$$

Figure 151: Méthode de mesure de la déformation plastique imposée par les fils de bonding (en haut) à la métallisation de la source (en bas).

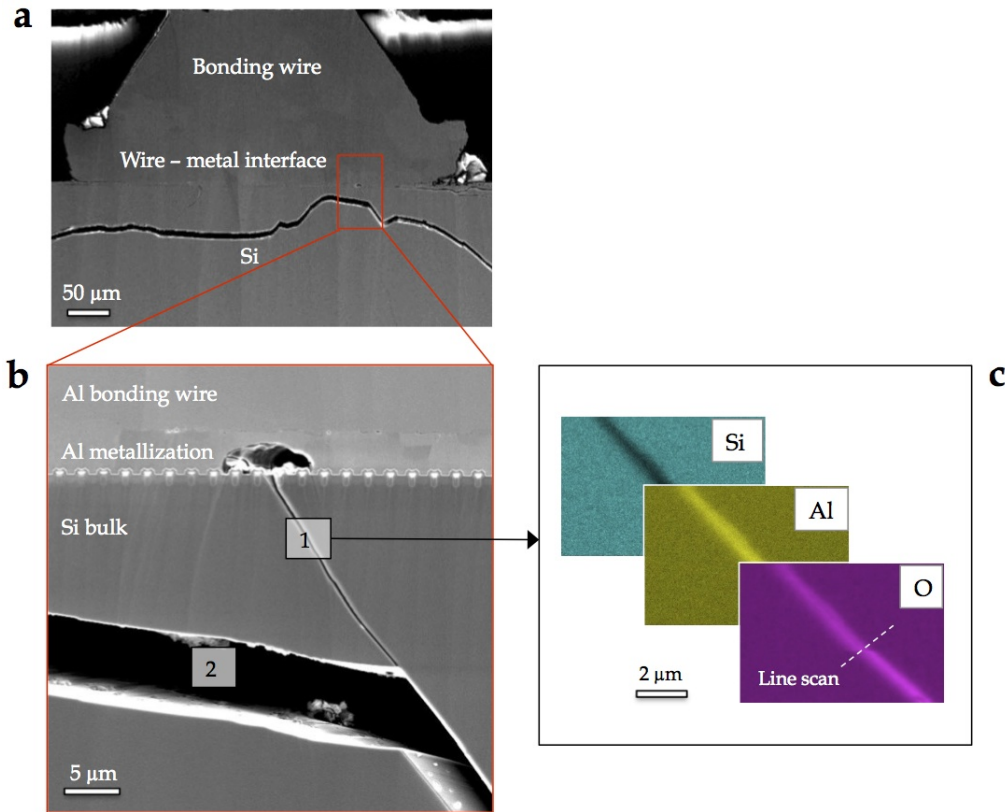
Figure 152: Image SEM à bas (a) et plus fort (b) grossissement du substrat de Si fissuré sous le fil de contact (1 = fissure primaire, 2 = fissure secondaire). (c) Cartographie EDX d'une fissure plus fine dans le Si, qui montre qu'elle est remplie d'Al.

L'augmentation local et incontrôlé de température, due à la dégradation de la métallisation et à l'augmentation de sa résistivité, semble être le mécanisme de défaillance le plus récurrent. Nous avons observé une sévère propagation de fissures dans le substrat de Si, autour et sous les fils défectueux, où des points chauds ont été détectés (Fig. 152a). Nous avons observé des fissures primaires et secondaires (Fig. 152b):

1. Les fissures primaires sont plus petites et remplies d'Al (Fig. 152c). Ceci est probablement dû à la diffusion de l'aluminium fondu à l'intérieur du substrat de Si.
2. Les fissures secondaires sont plus larges et pas remplies d'Al. Elles provoquent probablement la défaillance finale du périphérique.

Ces deux types de fissures peuvent indiquer que après la formation de fissures primaires dans le Si, le dispositif continue à conduire de la courant et reste chaud pendant une période suffisamment longue pour créer une fusion et une recristallisation d'Al à l'intérieur du substrat de Si.

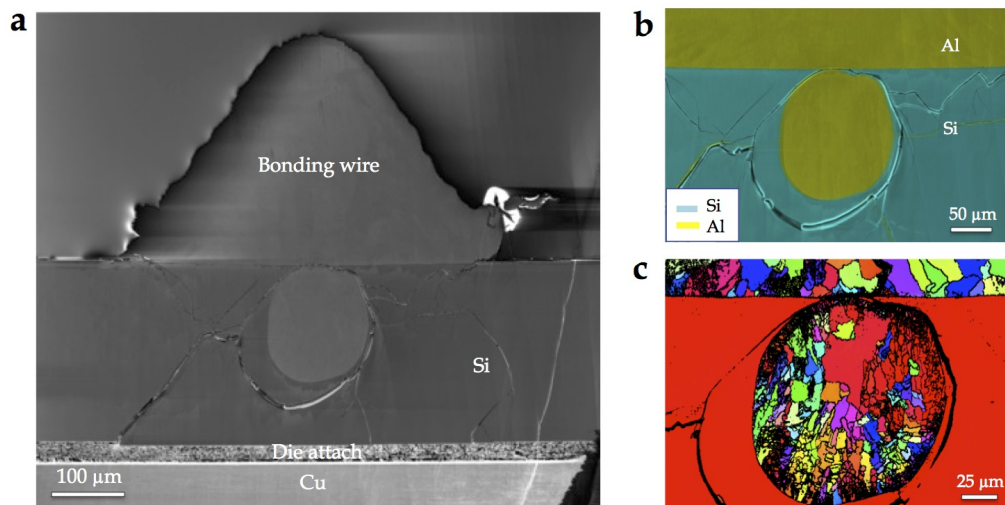
Figure 153: (a) Précipité quasi-millimétrique d'Al situé dans le substrat de Si dans un composant vieilli à défaillance. (b) Coupe FIB et cartographie EDX (Si bleu et Al-jaune). (c) Cartographie EBSD du précipité d'Al recristallisé dans le substrat. Chaque domaine de couleur correspond à une cristallite d'orientation distincte. Noter le domaine rouge au centre du grain, sans doute cristallisé en dernier.

Une preuve plus flagrante de diffusion d'Al dans le Si est montrée en Fig. 153a. Un précipité de forme circulaire est placé sous le fil. Son diamètre est d'environ 200 μm, du même ordre de grandeur que le diamètre du fil d'amenée de courant. L'analyse EDX montre sans ambiguïté que c'est de l'Aluminium, et qu'à cette échelle d'observation, il est quasi pur (Fig. 153b). Cela signifie que le fil de bonding et la couche de métallisation d'Al ont fondu et diffusé dans le Si en raison des températures élevées pendant la défaillance. La cartographie EBSD (Fig. 153c) dans la même zone révèle que le matériau d'Al diffusé dans le volume Si est caractérisé par une microstructure granulaire. Cela signifie que l'Al fondu a recristallisé lorsque l'appareil a cessé de fonctionner et s'est

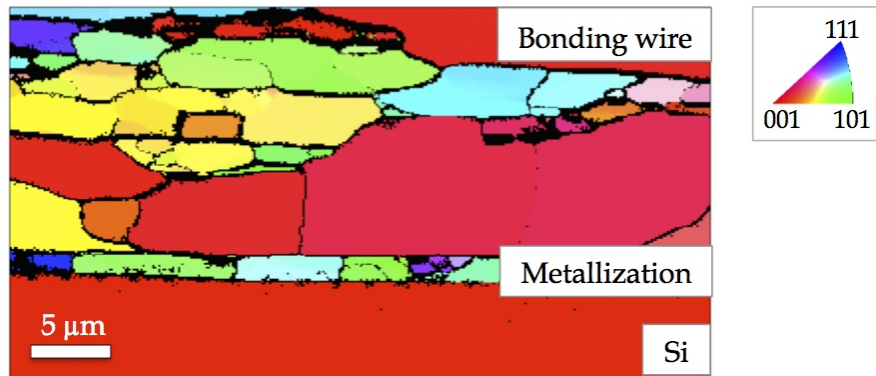
Figure 154: Cartographie EBSD d'une portion de la zone de bonding non fondue dans un module vieilli.

refroidi. À ce stade, nous pouvons remarquer que l'interface Al-Al n'est plus visible dans la zone de bonding. Au contraire, la cartographie EBSD provenant du fil adjacente dans le même module vieilli montre une structure normale (Fig. 154): on peut encore distinguer une interface de métallisation de fil bien définie avec une microstructure granulaire plus fine dans la métallisation Al et des grains plus gros dans la partie de liaison supérieure. Ceci démontre que l'échauffement a été localisé dans la première zone de bonding, où la défaillance s'est produite. Ici, la température élevée a provoqué la fusion des deux parties métalliques initiales, créant la diffusion du matériau dans le Si dessous et une nouvelle microstructure d'Al.
