# Fatigue mechanisms in Al-based metallizations in power MOSFETs

Roberta Ruffilli

**Fatigue mechanisms in Al-based metallizations in power MOSFETs**

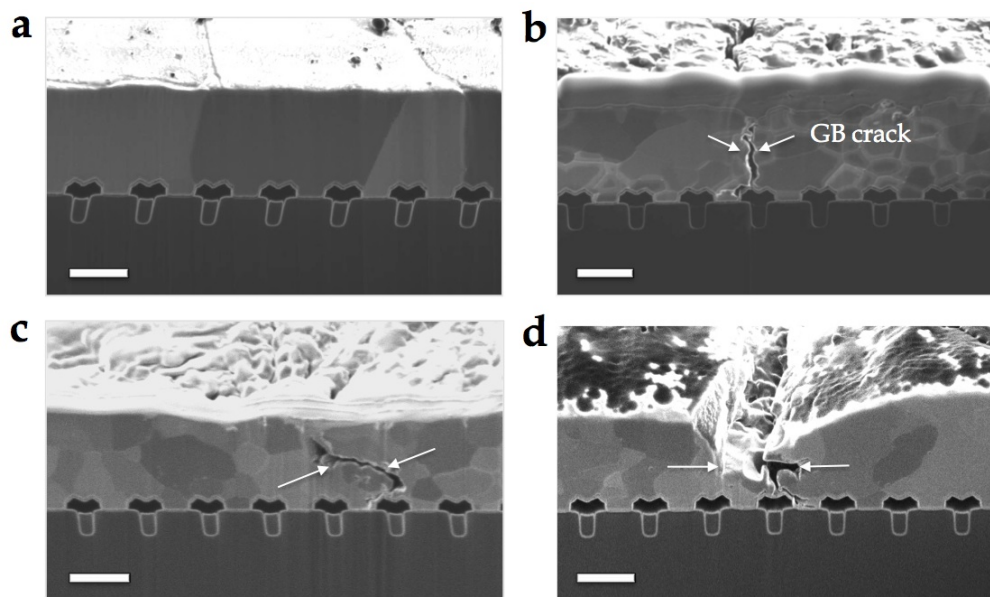
Figure 79: SIM imaging of the Al source metallization of an (a) as-is and (b) 100, (c) 200 and (d) 300 kcycles aged power modules. Scale bar 2  $\mu\text{m}$ .

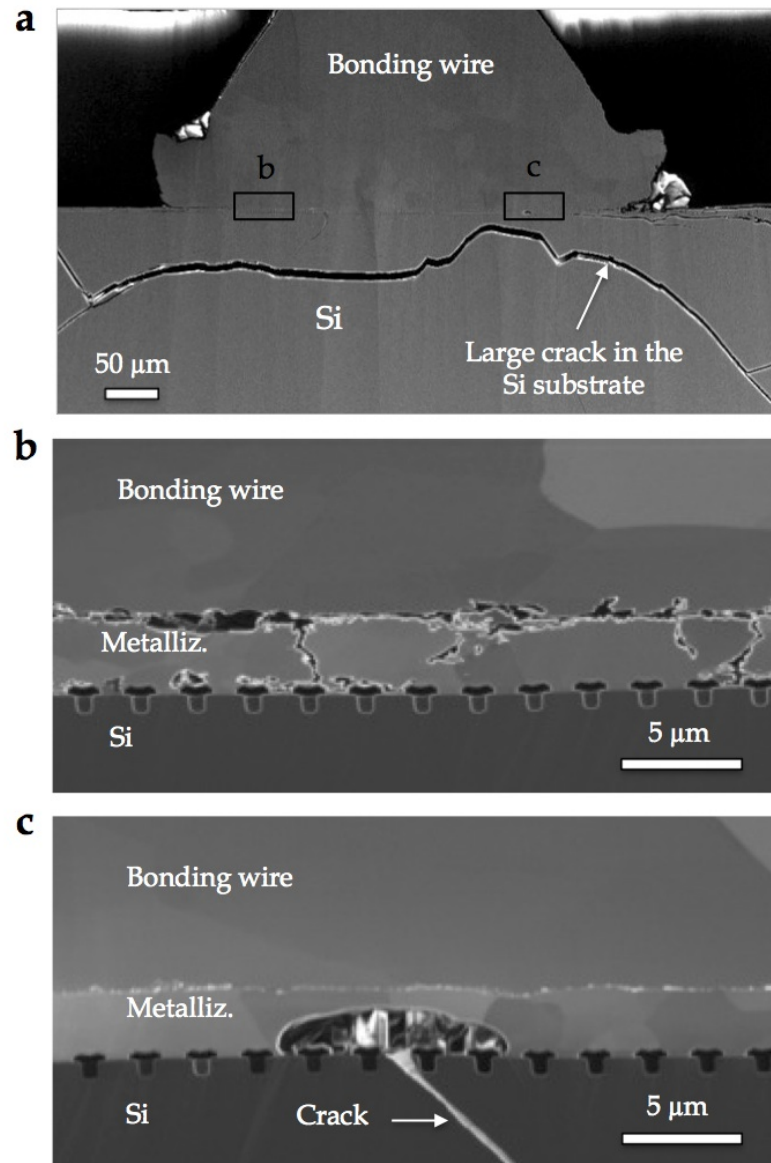
Figure 110: (a) SEM cross-sectional imaging of the bonding wire from an aged power module (70 °C aged) showing different types of cracks; (b), (c) ionic higher magnification images of the wire- metallization interface located in the boxes (b) and (c) in (a). The die crack resulted from an electro-thermal event occurring at failure time.

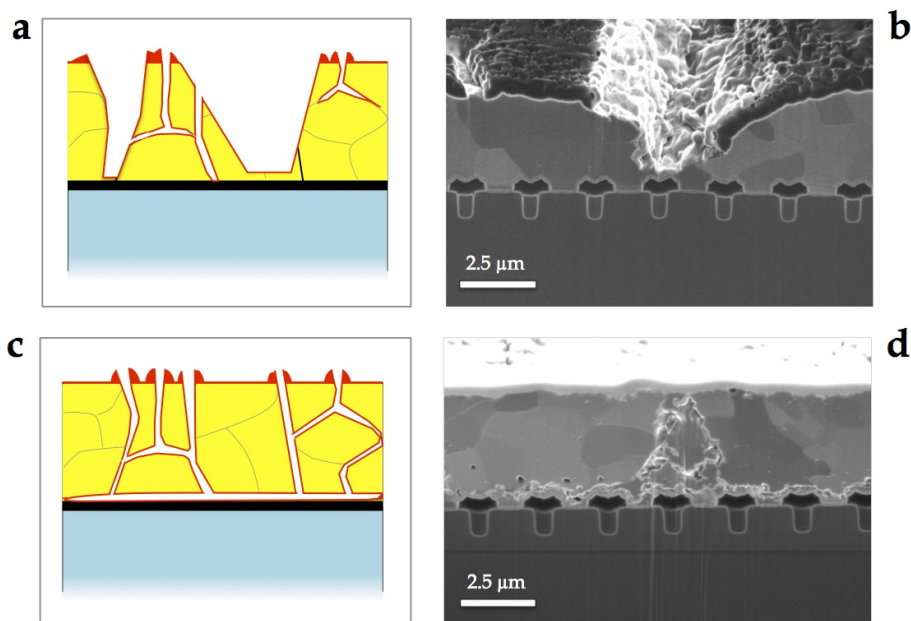
Figure 126: Crack propagation models through the Al layer at failure. (a) For SPD06 power modules at the final aging stage until failure, fatigues cracks running from the surface along the grain boundaries become broader and broader. (b) SIM cross-sectional image of the cracked metal in a failed SPD06, showing a crack width on the same order of the metallization thickness. (c) In To7D17 failed power modules, finer vertical cracks branch out and propagate horizontally all long the MOSFETs region. (d) Relative SIM cross-sectional imaging from a 70°C aged module.
