THÈSE

DOCTORAT DE L'UNIVERSITÉ DE TOULOUSE

**Modes de fatigue des métallisations à base d'aluminium dans les
composants MOSFET de puissance**

Fatigue mechanisms in Al-based metallizations in power MOSFETs

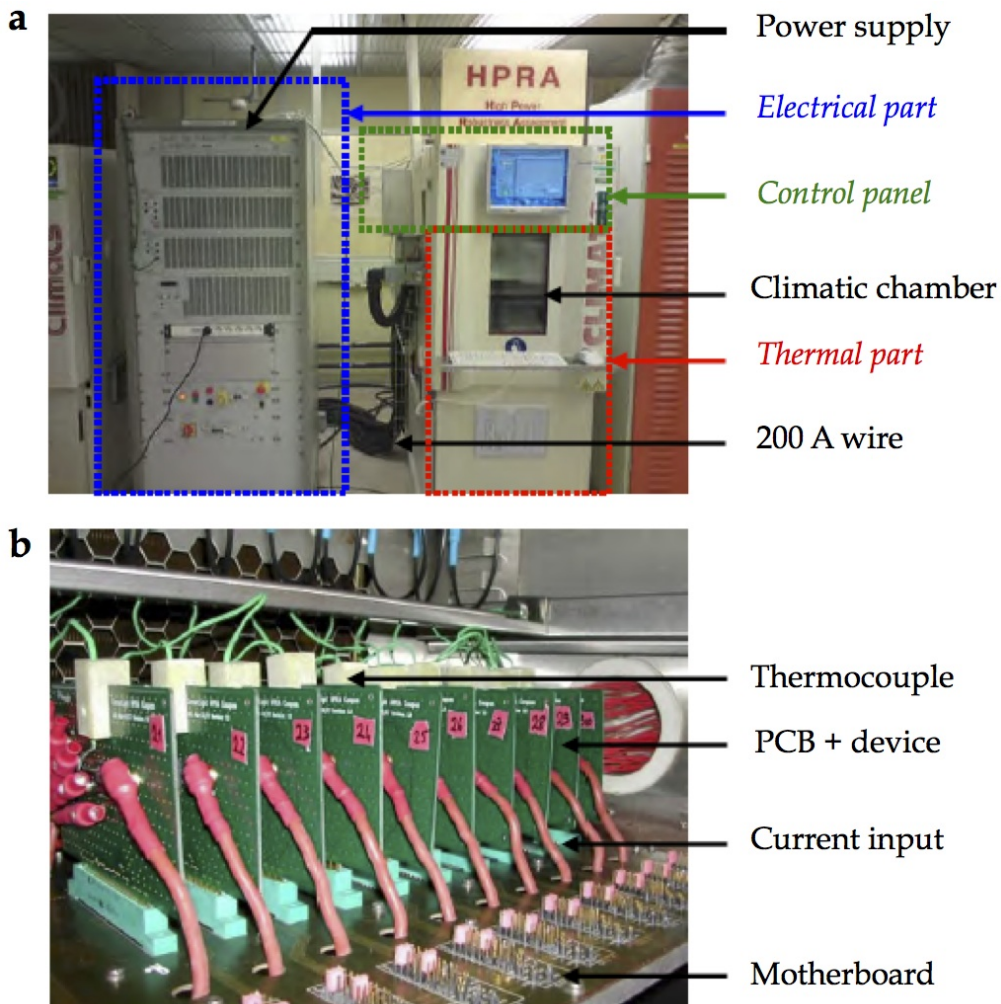
Figure 28: (a) Climats Sapratin Excal 2223-TE test bench at NXP Semiconductors. it consists in an electrical part (in blue), equipped with a 80 V, 200 A power supply and an active charge (5 - 200 A), a climatic chamber (-80°C - 180°C) containing the devices under test (in red), and a control panel (in green) with an electronic board that control the devices switching.

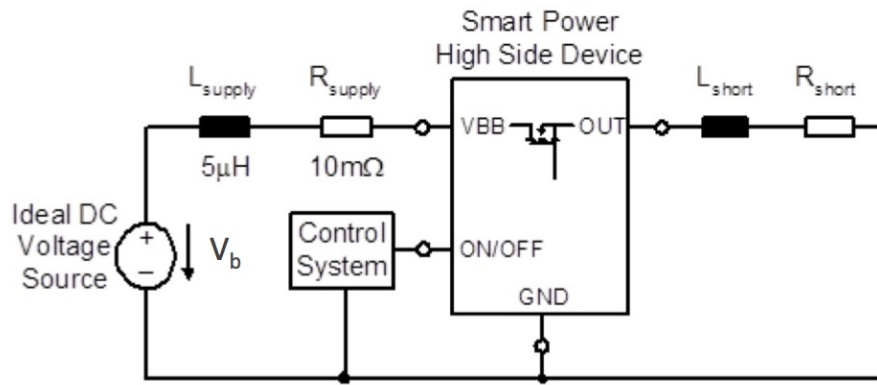
Figure 29: Accelerated aging test circuit.

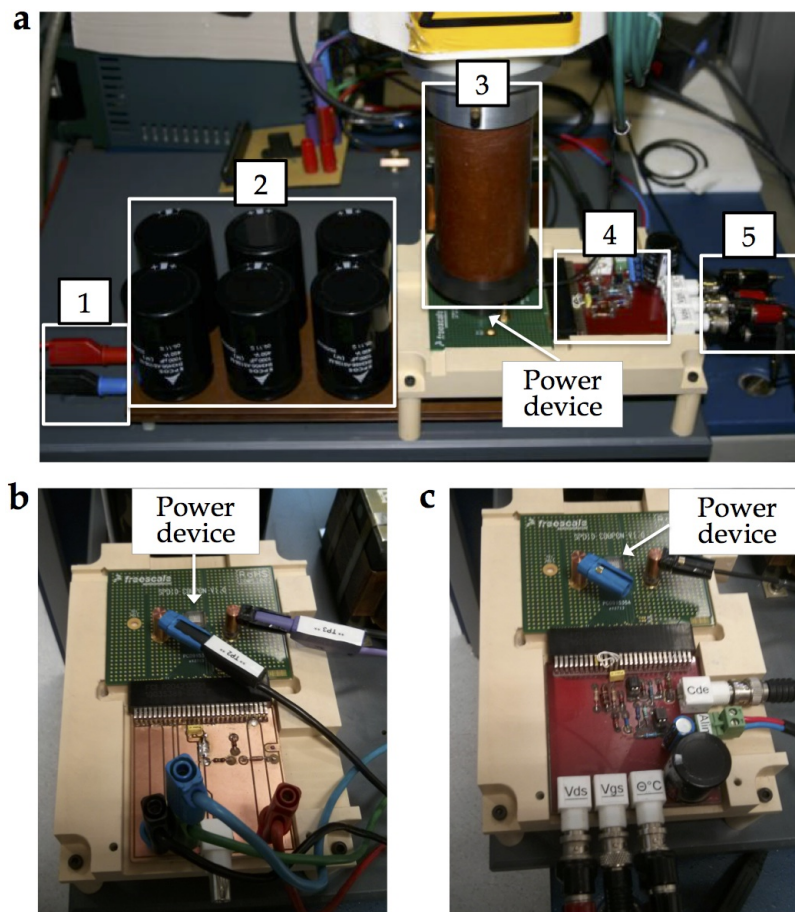
Figure 31: (a) Accelerated aging test bench set up at the Satie laboratory. The device under test can be connected to (b) a measuring board or to (c) the driving board.

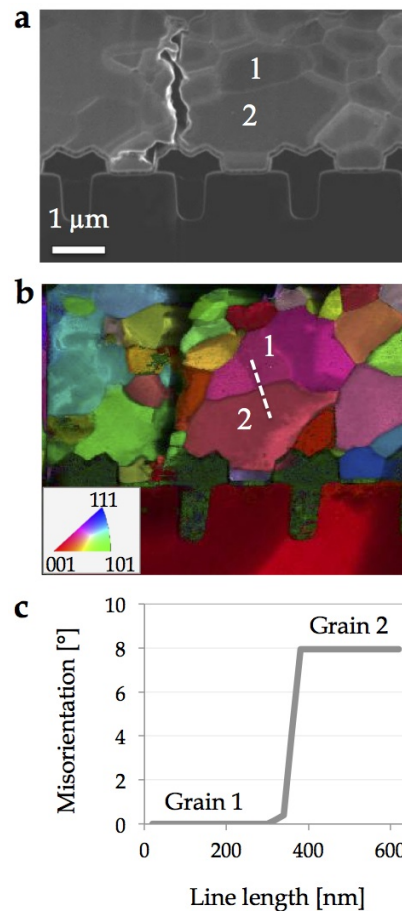
Figure 82: (a) FIB imaging and (b) ACOM orientation mapping of the source metal of an aged module (short circuit, 130k cycles) at the interface with the Si substrate. The standard stereographic triangle gives the color codes of the grain orientations, taken here along the horizontal direction. (c) The plot represents the misorientation between the grains 1 and 2 along the white line in b).

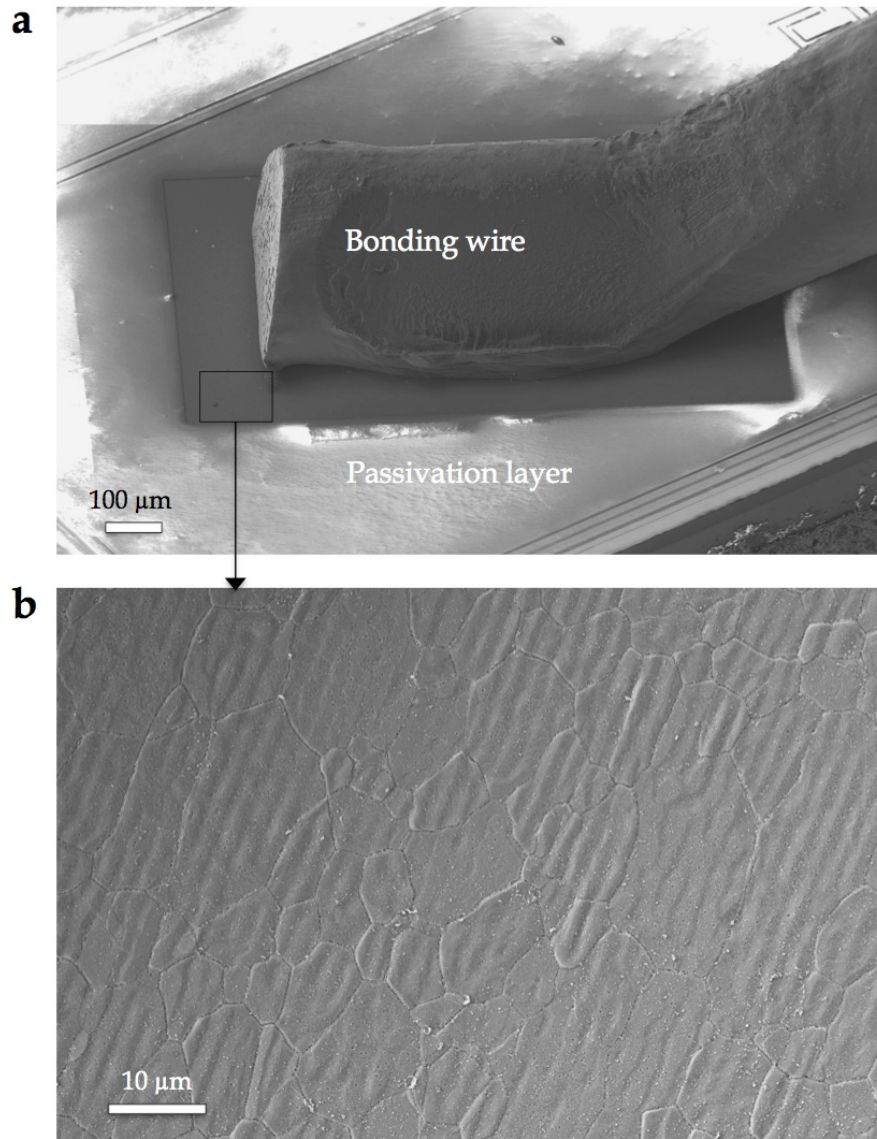
Figure 88: (a) SEM image of an Al bond wire welded on the Al source metallization on an as-is module. Away from the bonding area the metallization is coated by a SiO_2 passivation layer. (b) Higher magnification of the bare metallization close to the bonding wire.

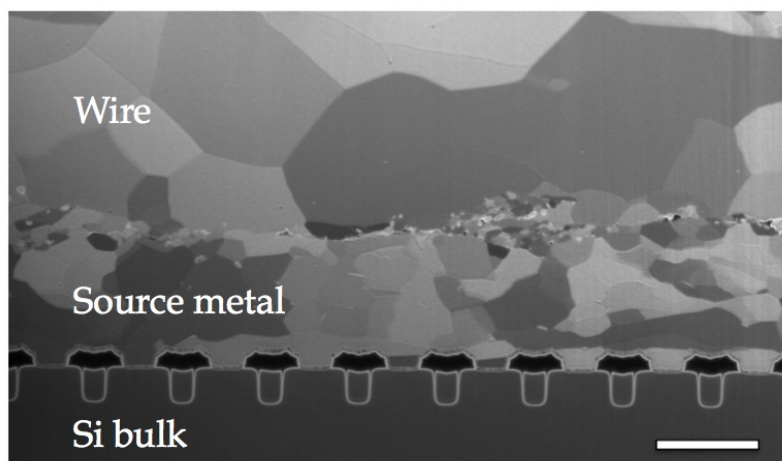
Figure 96: SIM images of the wire-source metallization interface, at the center of the bonding wire, in an as-processed module. Scale bar $2.5\ \mu\text{m}$.
