Influence of spindle condition on the dynamic behavior

CIRP Annals Manufacturing Technology

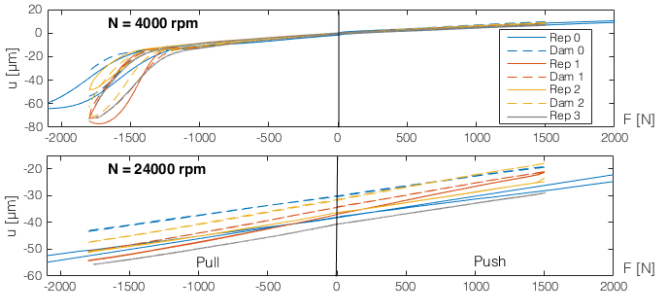
Figure 3. Spindle axial behavior, in relation to the spindle conditions.

Figure 3 presents the results of the axial measurements (axial shaft deflection *u* and axial force *F*) at low and high spindle speeds. The different plots refer to the different spindle conditions introduced in Figure 1. At low speed, the slope at low force level shows that there are low variations of the axial stiffness. Note that, contrary to the other ones, Rep0 experiments were conducted over +/-2100 N. More deviations can be observed under -1500 N, where there is a significant drop of the stiffness. It is due to a contact loss in the front bearings. The behavior in this zone is determined by the preload systems and the rear bearings. At high speed, there is no contact loss in the bearings. The axial stiffness (the slope) only differs from one reassembly of the spindle to another one (between colors). The reference of shaft deflection *u*=0µm corresponds to *F*=0N at low speed, for every experimental campaign (see Fig.3). At high speed, the shaft deflects out of the spindle housing (negative vertical displacement *u*), mainly due to centrifugal forces on balls. At *F*=0N, small variations can be observed between repaired spindles. Lower and more dispersed values are obtained for damaged spindles.

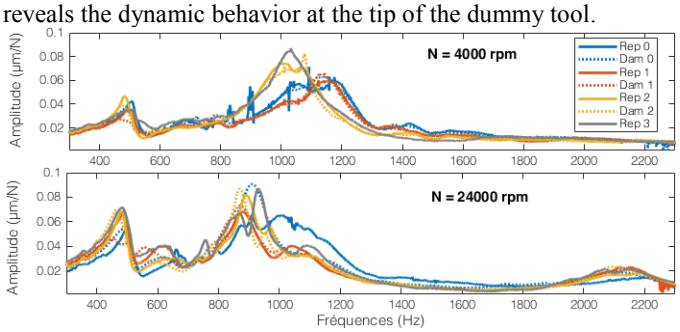
Figure 4. Spindle FRF, in relation to the spindle conditions.

At low speed, eigenfrequencies are visible at around 500 and 1100Hz. The frequency of the mode at 500Hz is constant with speed, but the other frequencies are evolving due do dynamic effects. Some modes appear at high speed (at 600 and 2100Hz).

Larger deviations are obtained between reassemblies of the spindle, rather than between repaired and damaged conditions. Notably for Rep2 and Rep3, at low speed, the dominant mode (which is at 1150Hz for Rep0 and Rep1) has switched with the 1000Hz mode due to evolutions of mode coupling. This phenomenon is also visible at high speed, for Rep0. The frequency of the 500Hz mode is almost constant, but its amplitude decreases for Dam1 damaged spindles. The frequency can also vary, as for Dam2 at 900Hz at high speed.

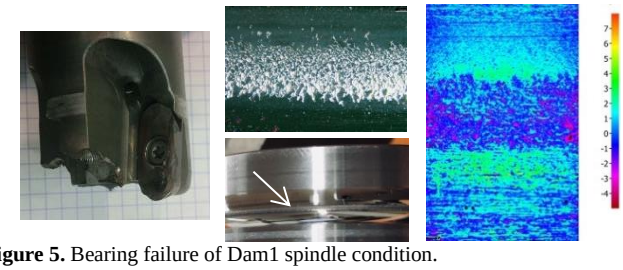
Figure 5. Bearing failure of Dam1 spindle condition.

Concerning the failures of Dam0, Dam1 and Dam2, several ball bearings were systematically damaged (at front or rear bearings) and presented a white strip on the contact zone of raceways, which is common for aluminum HSM spindles in aeronautics [12]. Bearing lubrication was defective for Dam0. Components of the tool clamping system and of the rotary union were worn for Dam0 and Dam1. Dimensions were out of tolerance (of several microns) concerning the HSK interface (Dam0&1) and the shaft (Dam0). Thus, the observed damaged spindles are representative of the main failures of HSM spindle.

We have investigated the failure of a Dam1 rear bearing, due to a tool breakage (Fig. 5). The raceways were measured with Alicona Infinite Focus. The worn white strip is a distributed defect on the whole circumference of the contact zone on the raceways with an areal roughness Sa=936µm (versus 643nm for unworn zone). It consists of a number of micro-indentations, of an average depth of -5µm. This bearing failure mode is a false-brinelling and it is due to the intensive vibrations [14].
