From early microstructural evolution to intergranular crack propagation in SAC solders under thermomechanical fatigue

E. Ben Romdhane, P. Roumanille, A. Guédon-Gracia, S. Pin, P. Nguyen, H. Frémont

E. Ben Romdhane, P. Roumanille, A. Guédon-Gracia, S. Pin, P. Nguyen, et al.. From early microstructural evolution to intergranular crack propagation in SAC solders under thermomechanical fatigue. Microelectronics Reliability, 2021, pp.114288. 10.1016/j.microrel.2021.114288 . hal-03375843

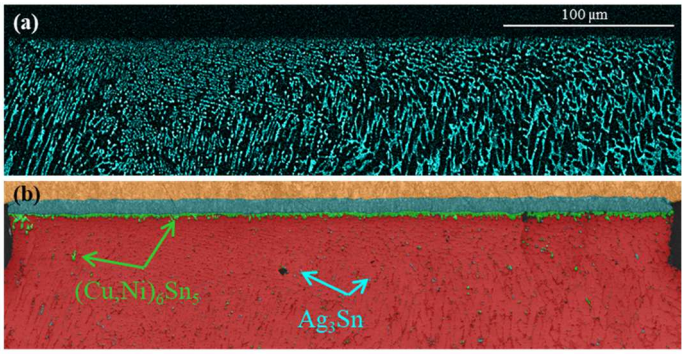
Figure 2 : As-reflowed BGA solder joint characterization, silver EDX (a) and crystalline phases maps

The presence of nickel in these precipitates depends on the amount of dissolved nickel from the finishes on the component and PCB pads. Nickel also participates to the formation of intermetallic layers at the component and PCB interfaces. The layers are also composed of $(Cu,Ni)_6Sn_5$ IMCs, depending on the quantity of nickel (Figure 2) .

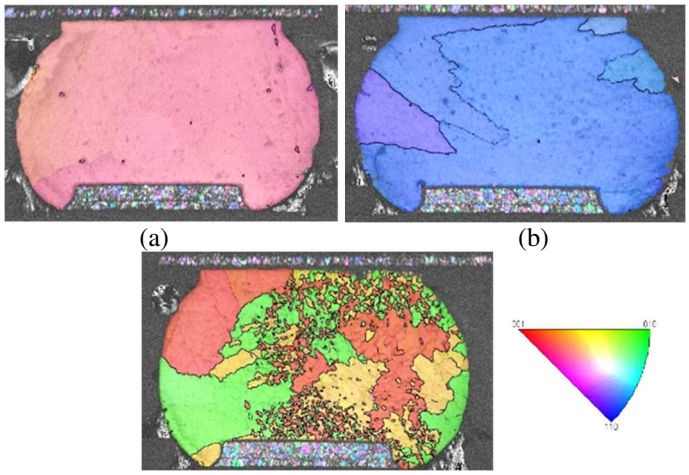
- Macro-grained morphology that contains one or more β-Sn grains with different crystalline orientations. The size of these macrograins is of the same order of magnitude of the joint's one (Figure 3).
- Cyclic twinned morphology (also known as beach ball structure) which is referred to a highly textured microstructure consisting in three major twin orientations, which cyclically repeat about 60° around the [001] axis.
- Mixed morphology that is characterized by the presence of both the cyclic and interlaced twinned morphologies that are known to be due to the sixfold twinning of tin. The interlaced structures were often localized near the interface between the solder and the copper pad on component or PCB side and at the nucleation site of the beach ball structure (Figure 3).

Figure 3. Different morphologies observed in as-reflowed solder joints, (a) single-grained, (b) poly-grained, (c) mixed

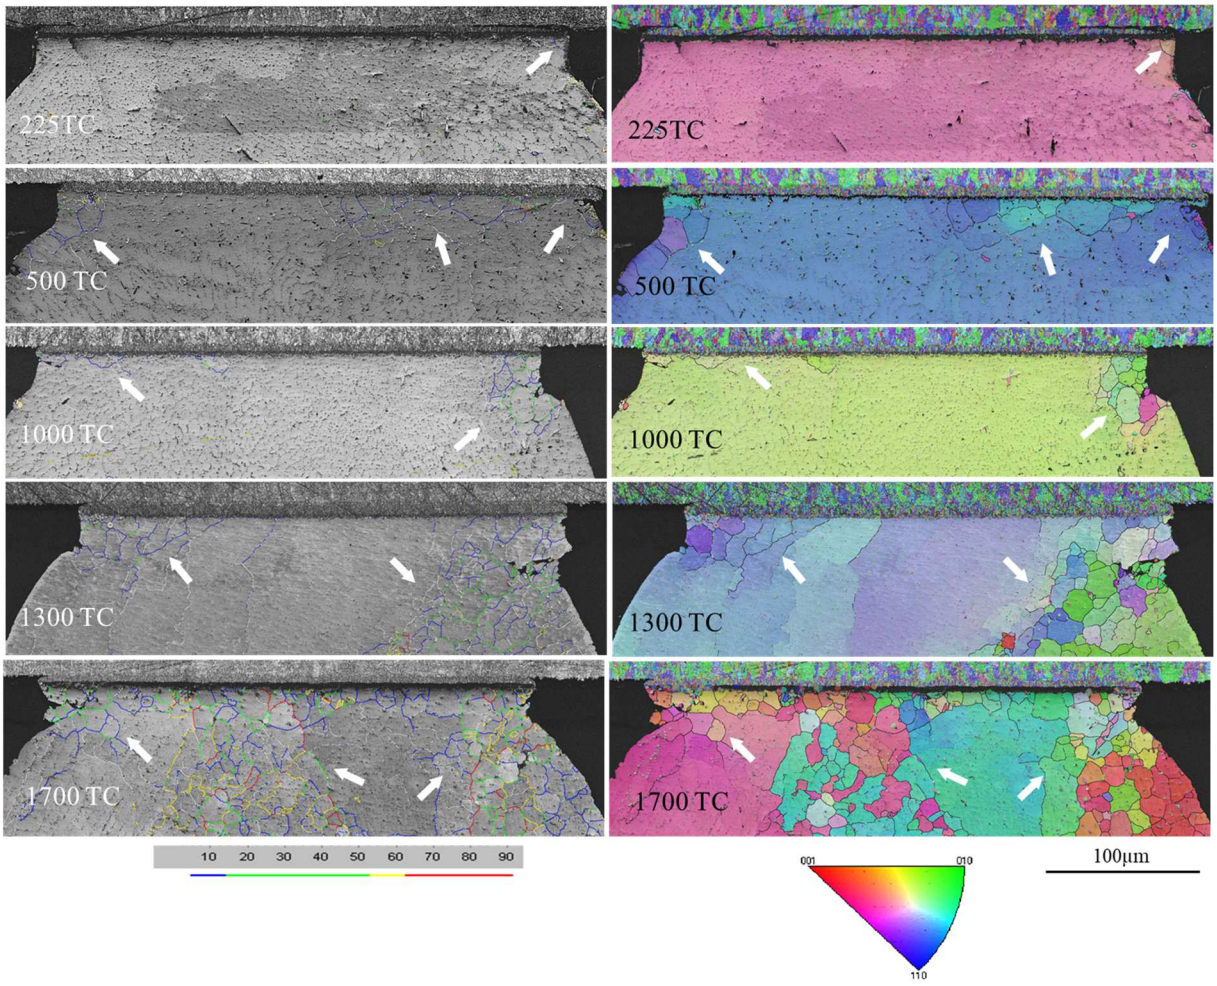
Microstructural analyses have been performed on components taken out of the thermal chamber during the first temperature cycles (0 – 1700 cycles) to set up the successive steps of recrystallization and its propagation in the solder joint. EBSD analysis showed that solder degradation has already started before 225 cycles. A recovery process has begun by the formation of β-Sn sub-grains (misorientation <5°) and low disorientated grains (<15°) in the most stressed area at the solder neck (Figure 4). These low grain boundaries angles were not detected in as-reflowed solder EBSD maps. Then tin recrystallization starts in the critical strain zone after 500 cycles. Grain boundaries with larger angles (>15°) appear and delimit new tin grains along the solder pads.

Figure 4 : Evolution of the SAC305 solder joints after several thermal cycles, (a) grain boundaries angles, (b) crystallographic orientations (IPF Z)

This network of recrystallized grains spreads along the interface with the solder pad or along the diagonal until total recrystallization of the high strain area. This evolution leads to an attenuation of the initial macrograin texture induced by the progressive formation of more and more highly misoriented recrystallized grains during thermal cycling (Figure 4).

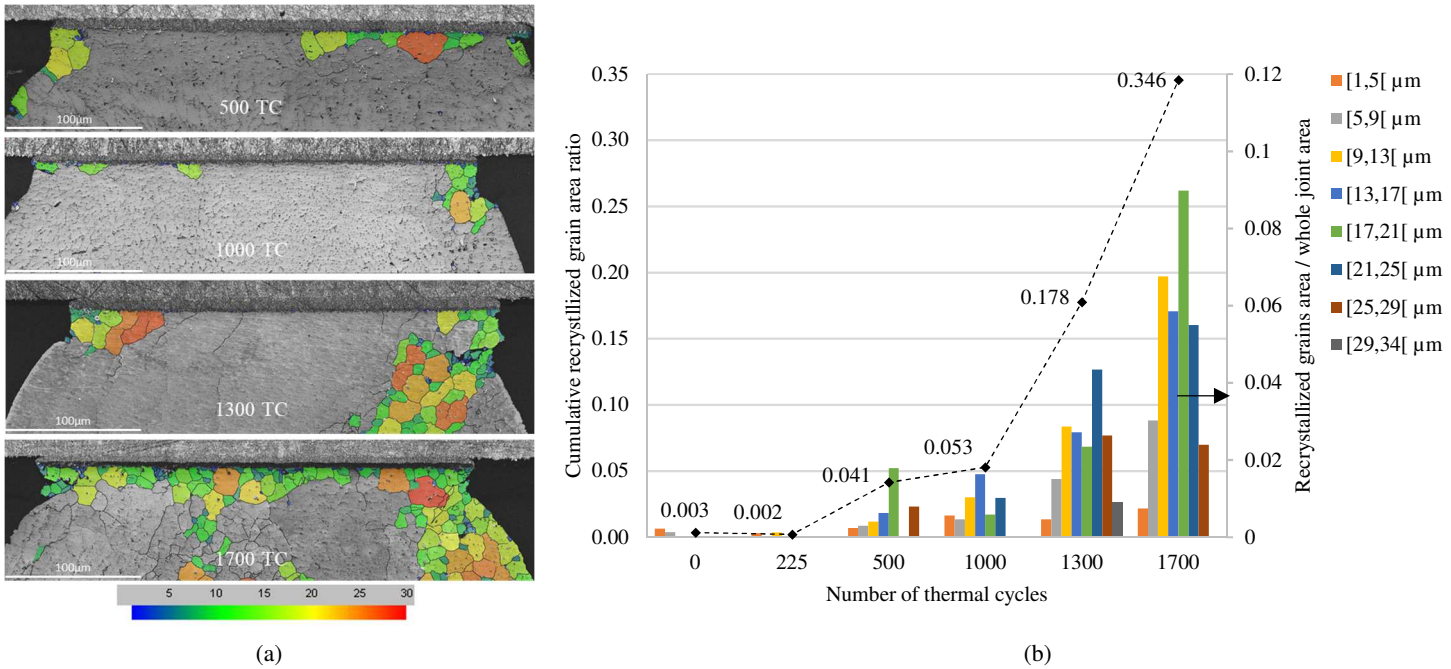
Figure 5 : Evolution of the recrystallized β-Sn grains distribution with thermal cycling, (a) equivalent grain diameter range (µm) and localization, (b) grains area proportion for different equivalent diameter ranges

β-Sn grains' size measurements have also been conducted using EBSD image analysis of joints with different damage levels. They show that new recrystallized tin grains size is between 1 and 30 µm whatever the level of cycling (Figure 5.a). However, their population evolution in the highest stressed zone during thermomechanical cycling presents an increase in the recrystallized grains area percentage, which means the propagation of recrystallization throughout the joint. Figure 5.b shows that the recrystallized grains area for the first 1000 cycles does not exceed 5% of the whole solder area. Then, it is interesting to see that this percentage significantly rises until reaching 35% of the total joint surface at 1700 cycles.

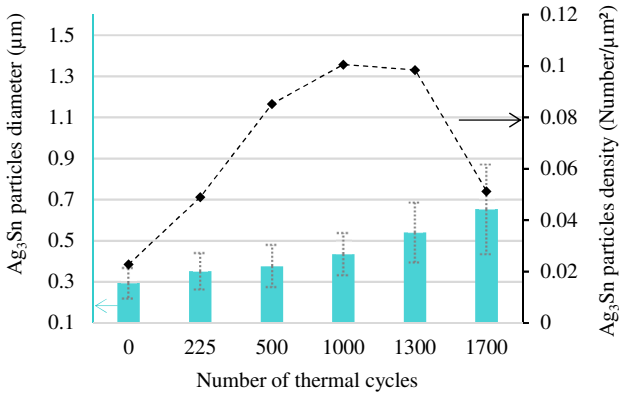
Ag_3Sn particles size and density were measured at different damage levels using EBSD analyses. Figure 6 shows an increase in Ag_3Sn IMCs equivalent diameter from ~ 0.3 µm to ~ 0.65 µm during thermal cycling which highlights the coarsening of the largest Ag_3Sn precipitates. In the other hand, the growth in the Ag_3Sn particles density observed until 1000 cycles may be explained by the coarsening of very small precipitates (diameter < 0.25 µm) that were not detected in the very first cycles. Then this density drops because of the observed disappearance of the nano-Ag_3Sn IMCs in the high stressed region from 1300 cycles. This is coupled with a growth of spacing between Ag_3Sn particles (Figure 9.b).

Figure 6 : Evolution of the Ag_3Sn particles population with thermal cycling

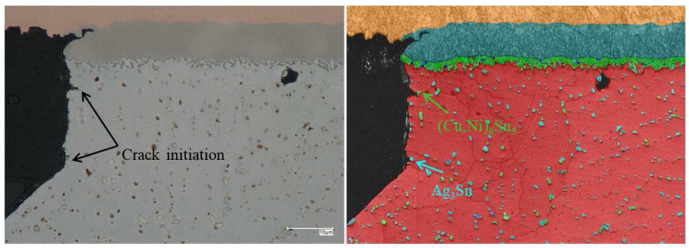
Results show that crack initiation in BGA solder joints appear very early and could take place as soon as the recovery phase occurs. It was already observed in solder joints sampled between only 360 cycles and 1000 cycles in the geometrical singularity zones of the assembly near the joint neck.

Figure 7 : Crack initiation site at 360 cycles

The presence of relatively large intermetallic particles in highly stressed areas also appears to facilitate crack initiation. EBSD mapping was made to characterize the crack initiation zone. The crystalline phases map shows the presence of large $(Cu,Ni)_6Sn_5$ and Ag_3Sn IMCs near the crack initiation site which can cause local brittleness in the solder (Figure 7). It is noteworthy that the crack initiation area was always characterized by the presence of IMCs in all analyzed samples. This was also observed on SAC solder joints of chip resistors assembled on

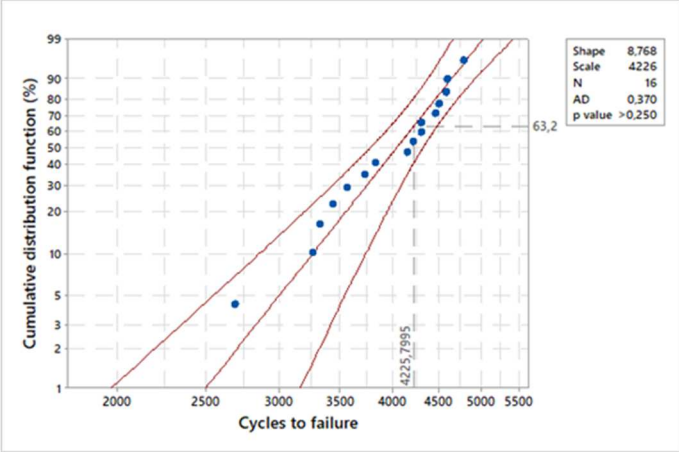
Figure 8 : Weibull distribution for the outermost joints row in BGA components

The number of cycles after which crack initiation was observed in the various joints turns out to be very low compared to the measured lifetimes. The electrical monitoring of the outermost joints row of the same BGA components show that their measured fatigue lifetime is around 4225 cycles (Figure 8). This means that the crack initiation phase represents 9 to 24 % of the measured life and that solder fatigue lifetime is controlled by crack propagation.

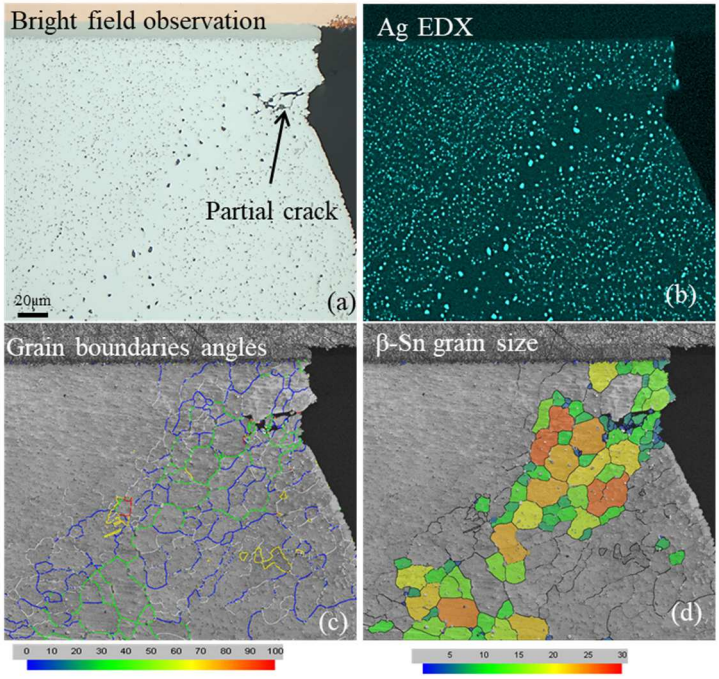
After 1000 cycles, partial cracks were observed in the recrystallized area with low density of Ag_3Sn particles. Measurements revealed a significant increase of 18 % in the total recrystallized grains surface accompanied with a drop in Ag_3Sn precipitate density at 1300 cycles (Figure 5.a and Figure 6), that's was observed at the same time when first cracks (detected before 1000 cycles) start to propagate. This results show that a well-defined recrystallization amount coupled with an Ag_3Sn particle density threshold is required to trigger the intergranular cracks propagation (Figure **9**).

As Ag_3Sn particles coarsening takes place, the dislocation motion is favored. After reflow, finely dispersed Ag_3Sn particles can proceed as barriers to the viscoplastic strain-induced dislocations motion and inhibit SAC305 solder degradation by dislocation pinning process [5][12]. However, with larger spacing between Ag_3Sn IMCs, the dislocations are no longer blocked, the largest particle can constitute good nucleation sites and recrystallization is accelerated. Moreover, Ag_3Sn precipitates tend to move towards high-disoriented grain boundaries as coalescence occurs. This migration weakens the grain boundaries leading to intergranular crack propagation.

Figure 9 : Favorable intergranular crack path in BGA solder joint after 1300 cycles, (a, b) Ag_3Sn coarsening and migration, (c, d) network of highly misorientated recrystallized β-Sn grains
