Tsunami vulnerability of buildings and people in South Java – field observations after the July 2006 Java tsunami

S. Reese¹, W. J. Cousins², W. L. Power², N. G. Palmer², I. G. Tejakusuma³, and S. Nugrahadi³

¹National Institute of Water and Atmospheric Research (NIWA), Wellington, New Zealand

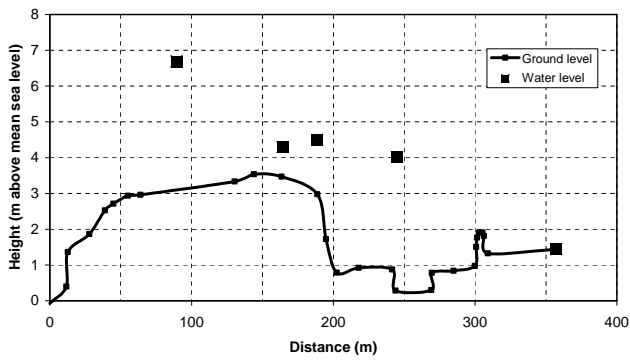
Fig. 2. Ground profile and flow depths measured at Widarapayung (Transect 1).

Elevation and depth measurements (Transect 1) were taken here. The sand dune beneath the pool complex was about 150 m wide and rose to a height of about 3.5 m above mean sea level (m.s.l.) (Fig. 2). The inland edge of the dune fell sharply to paddy fields about 1 m above m.s.l., then a further 0.5 m to a sluggish river running parallel to the beach for several kilometres. The tsunami flooded the paddy fields and river, and the subsequent rapid drainage washed away the approaches to a bridge across the river. Inland of the river there were more paddy fields that had been lightly inundated up to about 50 m beyond the river, giving a total inundation distance of about 350 m. There were extensive deposits of fresh sand on the sand dune (measured between 14 and 25 cm; Fig. 3), often covering low vegetation and ground litter, and deposits of compacted sandy silt in the paddy fields between the dune and the river. The crops in those paddy fields had been destroyed.

Figure 2 (above) shows the ground profile and estimated flow depths at Widarapayang. Zero distance represents the edge of the sea at the time of the profile measurement. At this location the beach was about 40 m wide. Except the urban areas most of the transects typically followed the same profile. There was usually a gently sloping beach, followed by relatively flat sand dune 200 to 400 m wide (bearing houses and trees), and then a steep descent to lower-lying paddy fields. At Widarapayang the topography was slightly different due to a river that cut through the fields.

The maximum observed water level at this site was 6.7 m, the maximum flow depth 3.75 m and the inundation limit 357 m. The water level estimate at 250 m from the coast was from an eye witness account that the water reached the handrail on a bridge across the river behind the near-shore dune. It appears unrealistically high, but might have been from a bow-wave that could have occurred during the post-tsunami flood flow down the river, rather than during the initial tsunami.

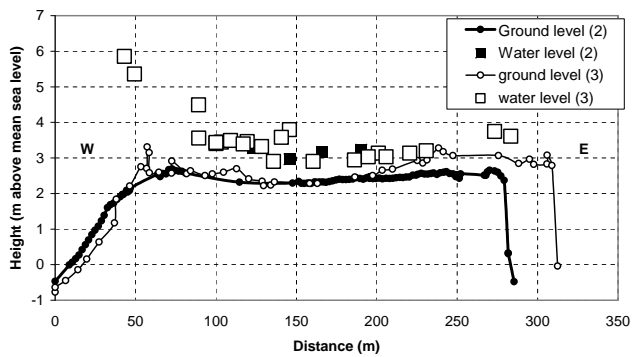
Fig. 7. Ground profile and estimated water levels of transect 2 & 3 in Pangandaran. The steep drop at the right-hand (east) side is a sea wall at the eastern end.

The next example (Fig. 7, Transects 2 and 3) is from urban locations in Pangandaran. According to eye-witnesses the tsunami struck the western part of the peninsula first (about 16:19 LT), travelled around the tombolo, and hit the eastern part of the peninsula about 1 min later. This is consistent with Lavigne et al.'s (2007) observations. According to eye-witnesses, the water met not exactly in the middle but slightly further east around 200 m from the western beach, because of the time delay of the eastward wave. These observations are reflected in our inundation graphs which indicate a minimum water depth at about the 200 m mark.

The maximum measured wave height and flow depth for Transect 2 were 3.27 m and 0.95 m, respectively, and 5.86 m and 3.10 m for transect 3. These seem to correspond with the survey results from Lavigne et al. (2007) and Tsuji et al. (2007). Note also the very rapid decrease in water depth, from about 3 m to less than 1 m, in a distance of about 100 m.

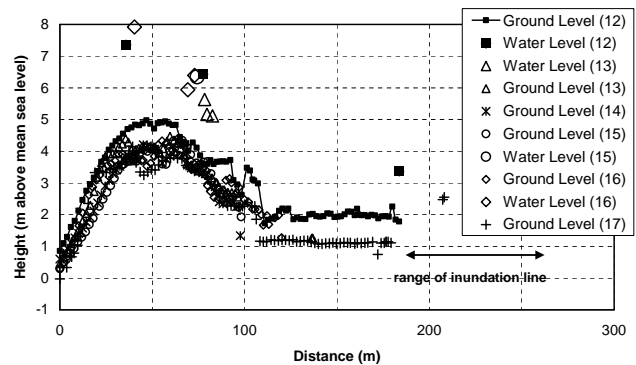
Fig. 8. Ground profiles 12–17 and water levels throughout Batuhiiu.

Profile 12 was at the easternmost end, profile 17 at the westernmost (Fig. 8). There was a steady decrease in height of the entire ground profile, by about 1 m, from east to west. Profile 12 traversed the dune then crossed paddy fields to an “island” in the paddy fields, while profile 17 traversed the coastal dune then paralleled a road through the paddy fields. The remaining profiles terminated at the inland edge of the

coastal dune. All the measurements show the same pattern with the maximum water level around the dune crest (e.g. 7.9 m, flow depths 3.7 m along transect 16), decreasing to 2 m around the buildings and 1 m in the paddy fields. The Inundation line was observed to lie between 260 m (transect 12) and 180 m (transect 17).

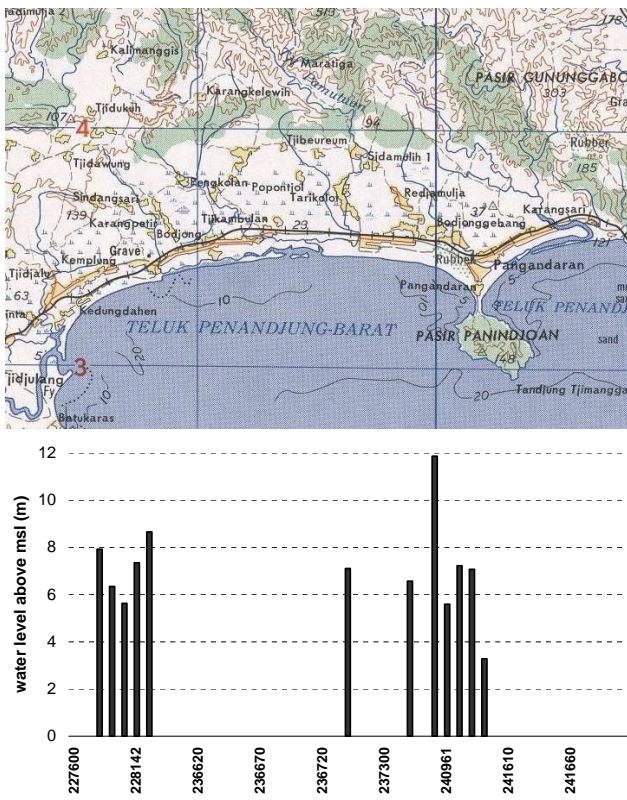
Fig. 9. Maximum observed water levels in the Pangandaran area.

Along the coast in the Pangandaran district the maximum water levels ranged from 3.3 m in the sheltered areas close to the Pangandaran peninsula, to 11.9 m in Pananjung Village (Fig. 9). The water height of 11.9 m (above m.s.l. – corresponding to a depth of about 9 m above ground level) was an observation made by the manager of a hotel in relation to palm trees between the hotel and the sea. It is much higher than all other estimates and so, assuming that it is as reliable as the others, must have been a localised phenomenon. The

fact that other teams did not measure water levels of this dimension in this area might argue for an overestimation. Our other levels are in line with the measurements from Lavigne et al. (2007) and Tsuji et al. (2007).

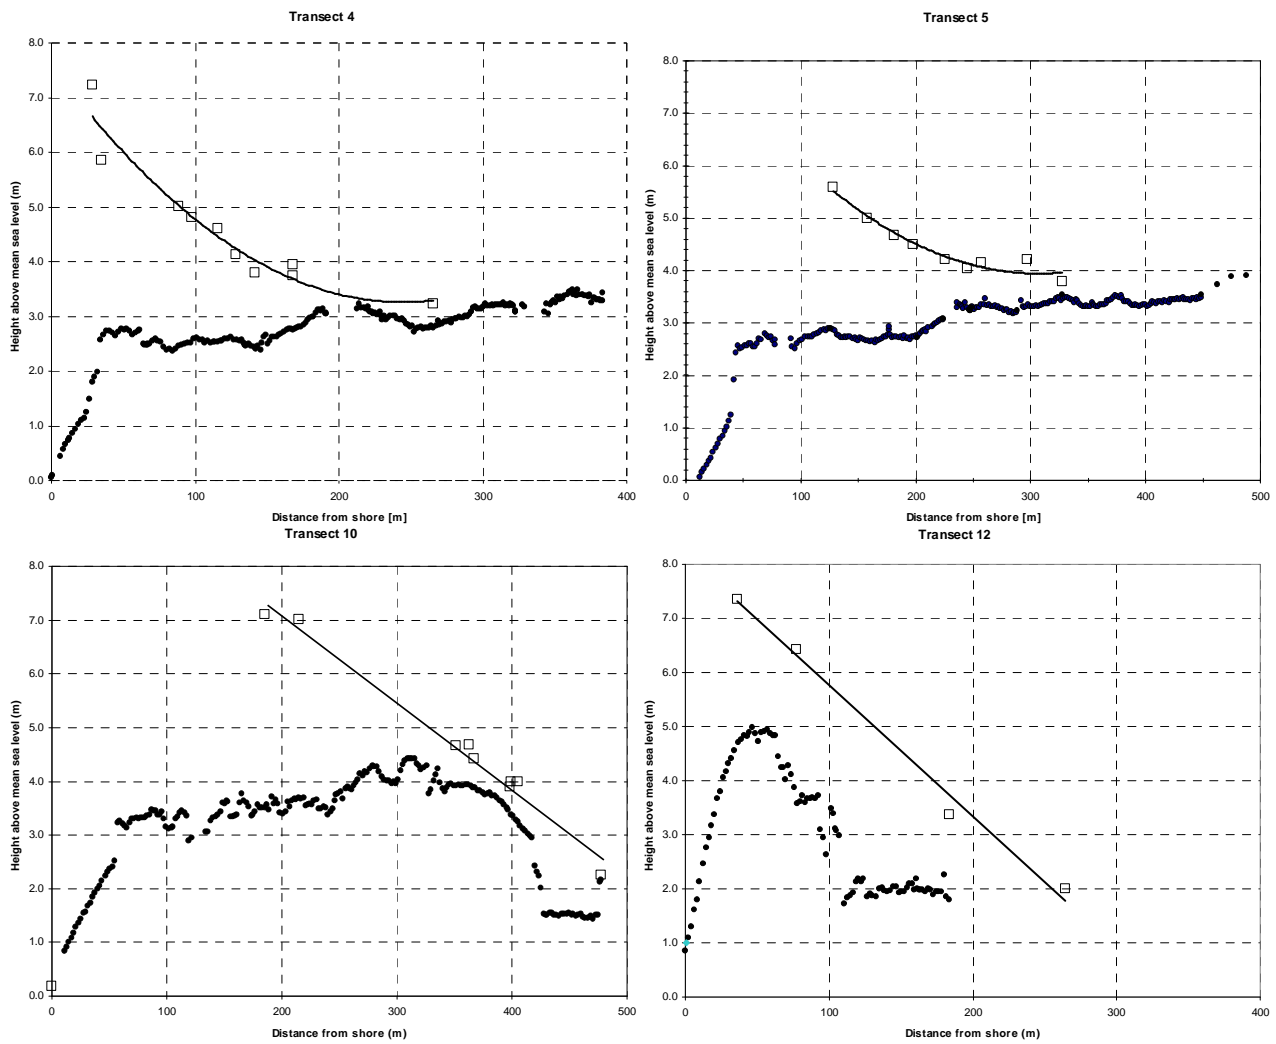
Fig. 10. Decay of on-shore water level.

Comparing the various ground profiles and wave height measurements shows how the on-shore topography affects the flow of the tsunami wave. By taking the wave heights/water levels and adding a trend-line reveals two different patterns, a linear and an exponential decay of the water level (Fig. 10).

The upper graphs show a profile with a gradually increasing terrain while the topography of the lower transects is characterised by a steep descent towards a lower-lying hinterland. Looking at the trend-lines, the two top graphs illustrate an exponential decay of the on-shore wave and is more or less what you would expect from drag (trees, buildings) over a distance inland. However, the linear trend-lines indicate that the dunes may have acted as a broad-crested weir, causing the waves to speed up on the down-slope side, as has also been observed during the Indian Ocean Tsunami (see EERI, 2005).

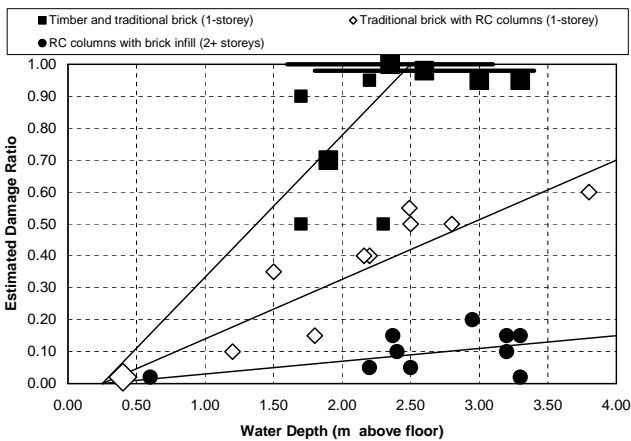
Damage ratios, defined as (cost to repair)/(cost to replace), were derived from subjective estimates of the proportionate levels of damage to the four main structural elements of the damaged buildings, with the four elements being the foundation and floor (estimated 15% of total construction cost), walls (50%), roof and ceiling (15%) and fittings & services (20%). The importance of reinforcement was very clear – traditional unreinforced brick buildings were essentially totally destroyed (damage ratio = 1) at an inundation depth of 2 m, whereas adding minimal reinforced-concrete columns reduced the damage levels to one third of that (0.33) (Fig. 15). Multi-storey buildings with substantial reinforced-concrete frames suffered relatively very low levels of damage. Figure 15 shows the damage ratios for the four construction types. Based on these damage ratios, simplistic linear fragility curves were derived. Damage functions or fragility curves are the most common way to estimate hazard related damage because there is usually a correlation between monetary losses (or the damage state) and the hazard intensity, in this case inundation depth. The zero points for the straight lines are not well constrained, and probably are only

Fig. 15. Estimated damage ratios and fragility curves as a function of inundation depth for various types of Pangandaran buildings. The large symbols represent averages from large groups of buildings (60 or more) that had relatively uniform levels of damage, and the small symbols one to few buildings. Two of the large symbols are associated with ranges in water depth indicated by horizontal bars. A damage ratio of 0.9 indicates that the concrete floor was potentially reusable, 1.0 indicates that the area had been bulldozed clear.

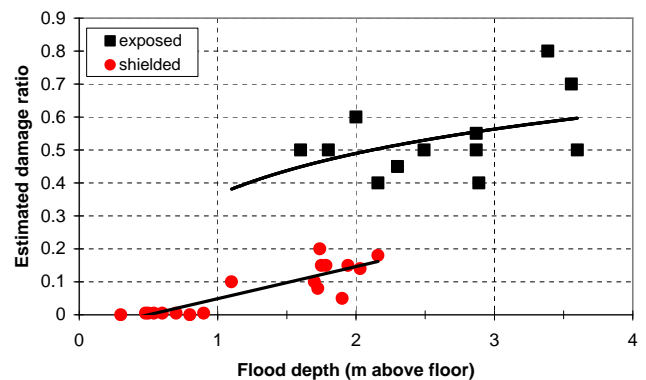
Fig. 16. Damage ratios and fragility curves as a function of inundation depth and exposure for traditional brick buildings with RC columns.

made of brick with RC columns sustained damage not greater than 20%, similar exposed buildings all suffered damage above 40% and were exposed to greater flood depths (Fig. 16). Thus, these buildings need to be separated and accordingly two different fragility curves are required. A regression analysis suggests two completely different shapes. For the exposed buildings a logarithmic shape fits best while for the shielded buildings an exponential shape seems more appropriate.

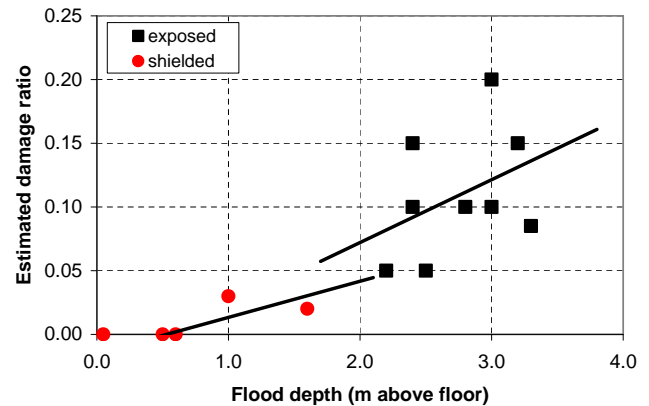
Looking at the well-constructed, reinforced buildings under this perspective doesn't show a clear trend as before (Fig. 17), but it is likely that this is due to the smaller number of samples. Nevertheless, a difference in the level of damage is still visible. The exposed buildings have sustained damage levels 2 to 5 times higher than the shielded ones.

Fig. 17. Damage ratios and fragility curves as a function of inundation depth and exposure for buildings made of RC columns with brick infill.

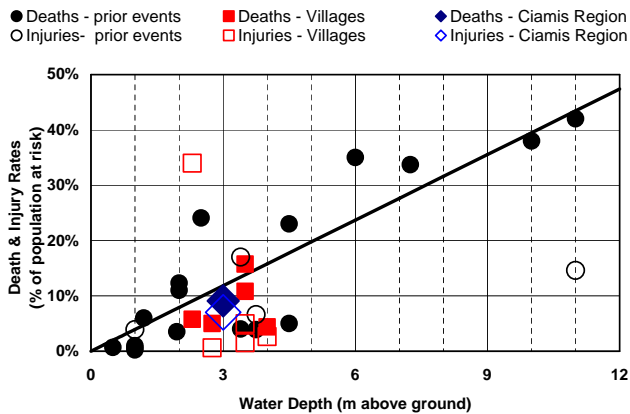
Fig. 18. Death and injury rates as functions of water depth. The trend line is fitted to the death data from prior events (Saunders (compiler) 2006).

It was also assumed that for every three persons indoors there was one additional person outdoors and nearby (children, workers, shoppers, tourists, fishermen). Not included were paddy-field workers, because the paddy-fields were usually further from the coast than the damaged houses. Given the above assumptions, Fig. 18 compares our estimate of the death and injury rates from the five villages and the whole Ciamis district with rates from other tsunami.

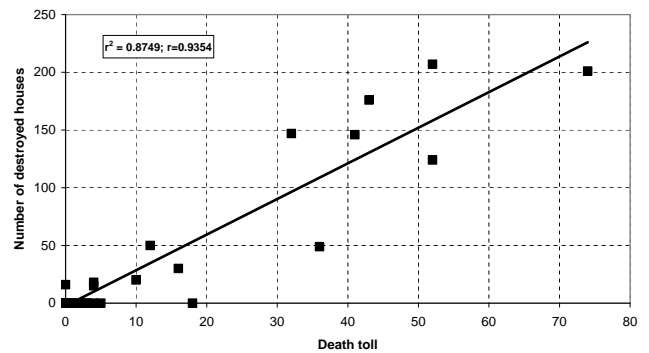
More recently there has been a tendency to relate casualties to levels of damage. The detailed Java data enabled us to analyse the data regarding a possible correlation between the death toll and the number of houses destroyed. There appeared to be a clear correlation between the two parameters (Fig. 19), possibly providing a way of estimating casualties when direct counts are not available.

Fig. 19. Death rates as functions of building destruction.
