Seismically reactivated Hattian slide in Kashmir, Northern Pakistan

Jean F. Schneider

Jean F. Schneider. Seismically reactivated Hattian slide in Kashmir, Northern Pakistan. *Journal of Seismology*, 2008, 13 (3), pp.387-398. <10.1007/s10950-008-9103-5>. <hal-00478432>

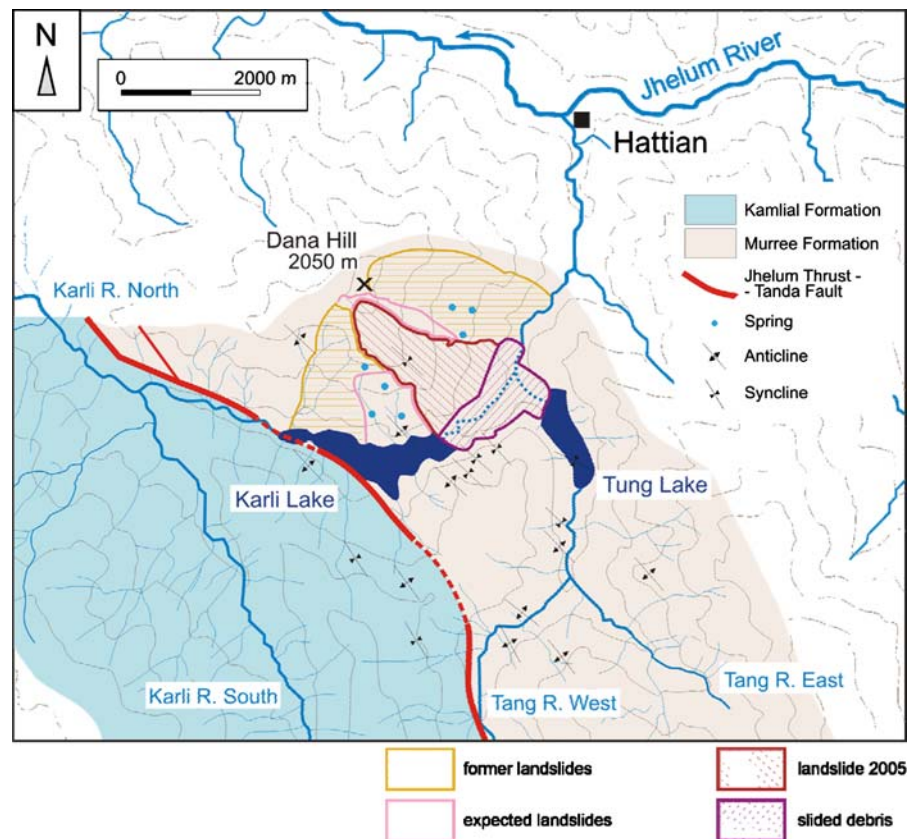
altitude 2,080 m) and moved approximately eastwards, creating a natural dam on the valley bottom blocking the waterways of the Karli and Tung tributaries of the Jhelum River, and burying Dandbeh hamlet on the way (Figs. 2 and 3). The reported death toll varies greatly (estimated to be a few hundred by the author and 1,000 by Dunning et al. 2007). Satellite images and ground checks show that several local farms were affected, but no true village is visible on the scenes taken before the event. The remaining farm houses most endangered by further mass movements have subsequently been evacuated. The debris dam (Fig. 4) created by the landslide has formed two lakes. The larger one, called Karli Lake, has resulted in a flooding hazard threatening parts of Hattian further downstream, due to a possible overflow with backward erosion or due to possible flood waves created by, in fact likely, mass movements into the growing lake.

Fig. 3 View from top of the natural dam (1446 m a.s.l.) westwards towards slide scar on Dana Hill. The asymmetric, ESE dipping syncline can be recognized as well as the large central debris mass that remained in the lower half of the slide. The author postulates an older consolidated slide mass, only partly affected by the actual slide, and partly buried below this actual debris. Secondary slumps appear at the front of this mass and a secondary steeply inclined slide is clearly visible at the right (northern) edge of the photograph of early December 2005

space and time. The historically documented earthquake of 1555 was assigned to this gap and could be responsible for the younger of the above-mentioned Holocene landslides; but further seismological and geological investigations are necessary to verify this hypothesis. The actual landslide of 2005 (Figs. 3 and 4) was triggered just north of the eastern extension of the activated Jhelum or Tanda thrust fault, which strikes NW-SE and separates the Kamliyal Formation from the Murree Formation (Early Miocene). The latter is composed of red sandstone, siltstone and claystone,

During the consultancy, satellite images from before and after the event using the CORONA, LANDSAT, TERRA ASTER and SPOT platforms were collected. They show an older (possibly historic) sliding mass at the location of the new landslide, which was overrun by the actual slide (Figs. 2, 3 and 12). The bulging mass in the centre of the actual slide seems to consist in the lower part to a large extent of older slide material (Figs. 3 and 4). Some boulders on the actual dam deposit are clearly cemented former slide breccias as shown on Fig. 13a, in comparison to the actual slide debris shown on Fig. 13b. At the valley bottom, the Karli stream incised deep into the former landslide mass. On the CORONA stereo pair (Fig. 14), the massively eroded left (western) river-bank with slumps can be clearly recognized.
