Seismically reactivated Hattian slide in Kashmir, Northern Pakistan

Jean F. Schneider

Received: 20 March 2008 / Accepted: 3 April 2008 / Published online: 14 May 2008
© Springer Science + Business Media B.V. 2008

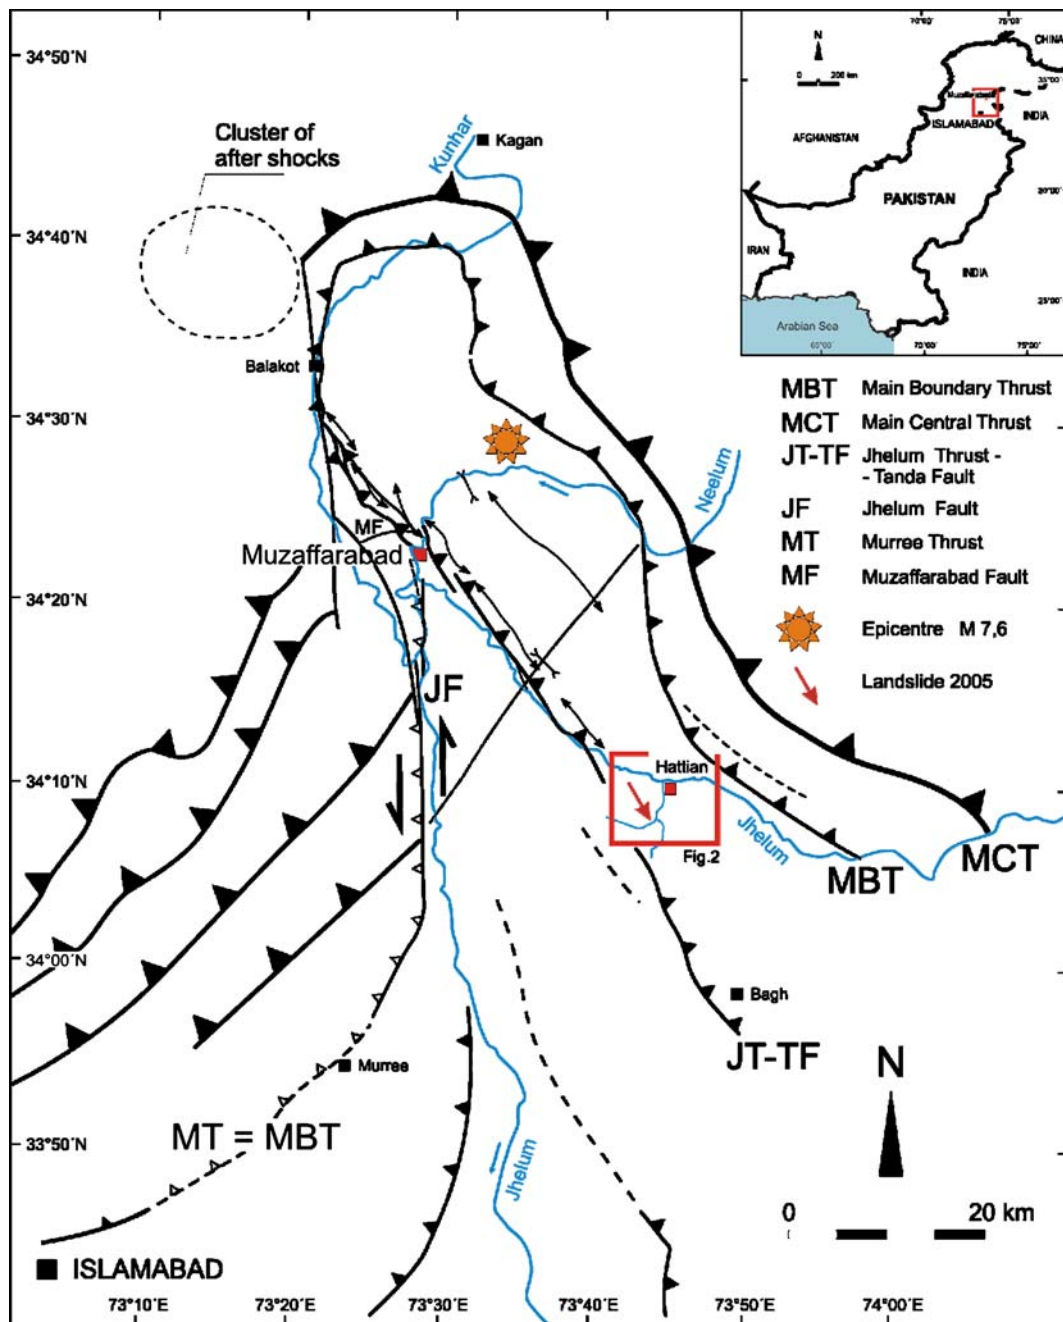
Fig. 1 Seismotectonical sketch map of the Hazara Kashmir Syntax. The Hattian Landslide is marked with a red arrow in the right centre of the map. The orange star north of it marks the epicentre of the 8-10-2005 earthquake; the main cluster of

aftershocks situated NNW of it. The investigation area shown in Fig. 2 is marked here in red and located near the SE-end of the visible Tanda Fault (compiled from different sources, see text)
