Stripping phenomenon in thick pavement top layers

N. Vulcano Greullet, Jean Pierre Kerzreho, Armelle Chabot, V. Mauduit

N. Vulcano Greullet, Jean Pierre Kerzreho, Armelle Chabot, V. Mauduit. Stripping phenomenon in thick pavement top layers. 11th International Conference on Asphalt Pavements, Aug 2010, Nagoya Aichi, Japan. pp.552-561. hal-00559938

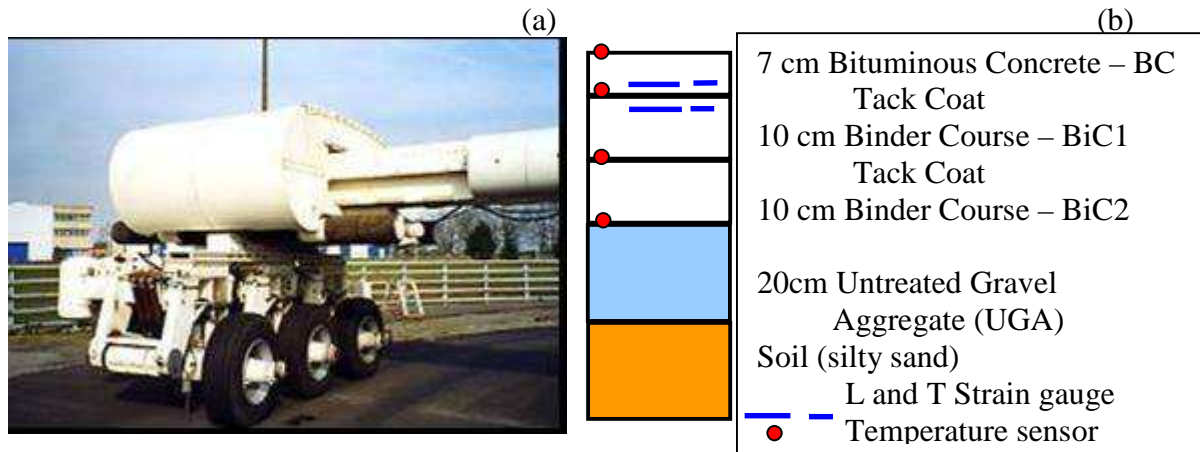
Figure5: Configuration of the LCPC's circular test track experiment (a) Large wheel triple axle running gear (b) Pavement structure and instrumentation.

This section presents a study conducted using the LCPC’s circular test track facility to examine an instrumented pavement very similar to case 3 pavement structure (Figure 5a). An interesting finding of this experiment is the partly unexpected behaviour of the first interface, which varies significantly depending on the temperature.

The objective of the test is to examine stress on both side of the wearing course/binder course interface on a thick pavement structure (Figure 5b). The moving load consists of a large wheel triple axle equipped with type 385/65 R 22.5 Dunlop tyres. The gauge of wheel is 138 cm. Transverse and longitudinal gauges are embedded in the lower part of the BC layer and in the upper part of the binder course (Binder Course 1- BiC1). Temperature sensors are placed at all the interface levels within the structure.

Structure implementation conditions are satisfactory. The tack coat quality between each layer is good with a residual bitumen content of 300g/m² within the emulsion. The pavement reference deflection value is 30 1/100 mm under a 130 KN dual wheel axle at 15°C for a load velocity of 3.5 km/h. For recording the signals, the triple axle is positioned so that the load is applied with the middle of the tread of tyres passing right above the sensors placed inside the pavement. The load applied by each wheel is 42.5 KN at a speed of 42 km/h. Measurements are carried out for both temperature profile presented in Table 2.
