**GIS Evaluation of the Impacts on the Built and the ‘Natural’ Environment of the 11 March 2011 Tsunami in Rikuzentakata, Iwate Prefecture, Japan**

C. Gomez<sup>1,2\*</sup>, P. Wassmer<sup>3,4</sup>, C. L. Kain<sup>1</sup>, M. De Villiers<sup>1</sup>, K. Campbell<sup>1</sup>, S. Ward<sup>1</sup>, A. Moghaddam<sup>1</sup>

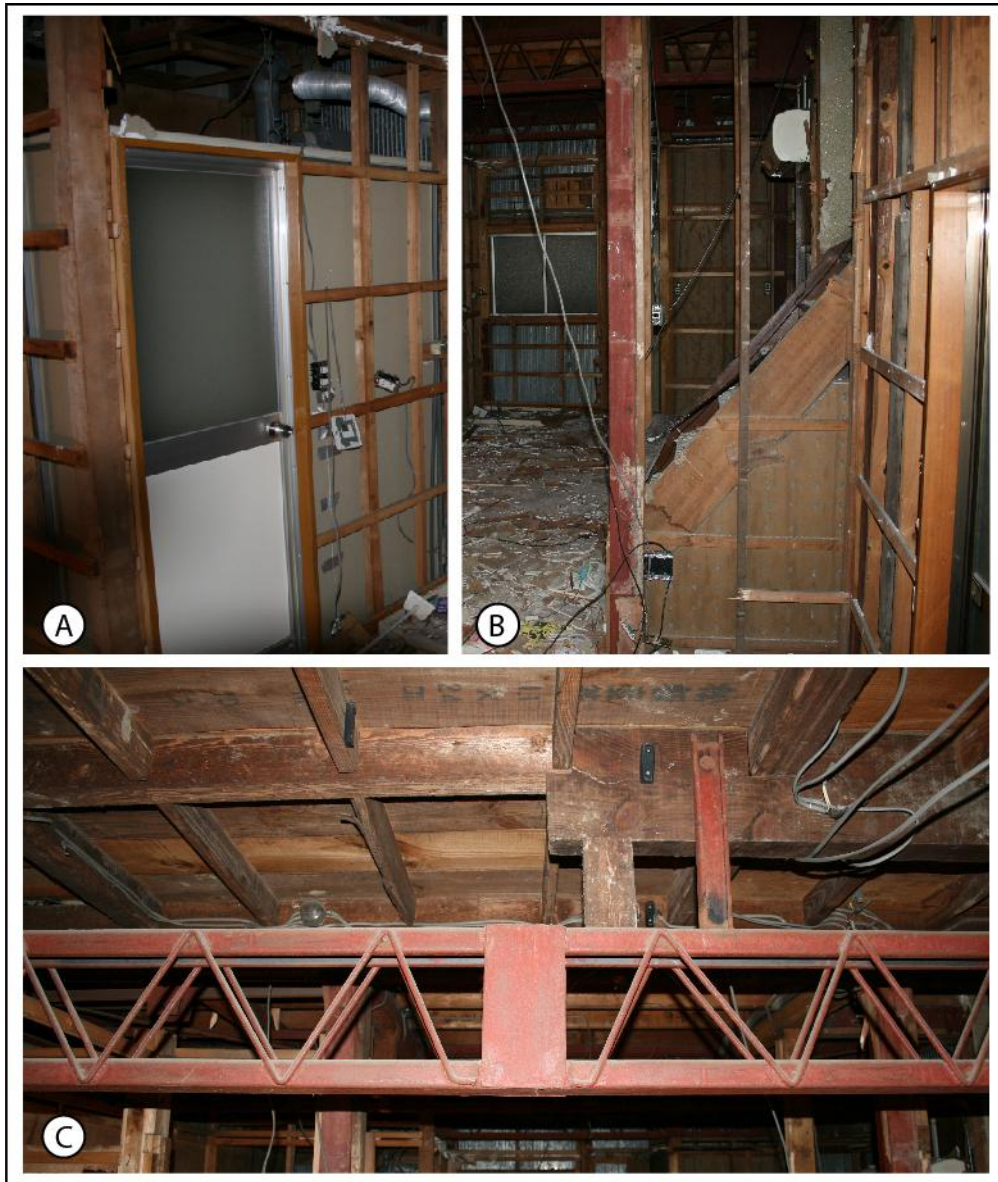
Fig. 8 Typical timber-frame structure house, which has been reinforced by a metallic structure during the Showa period (1926-1989). We can also appreciate the external wall panels made of painted steel. (Photos: C. Gomez, 2006)

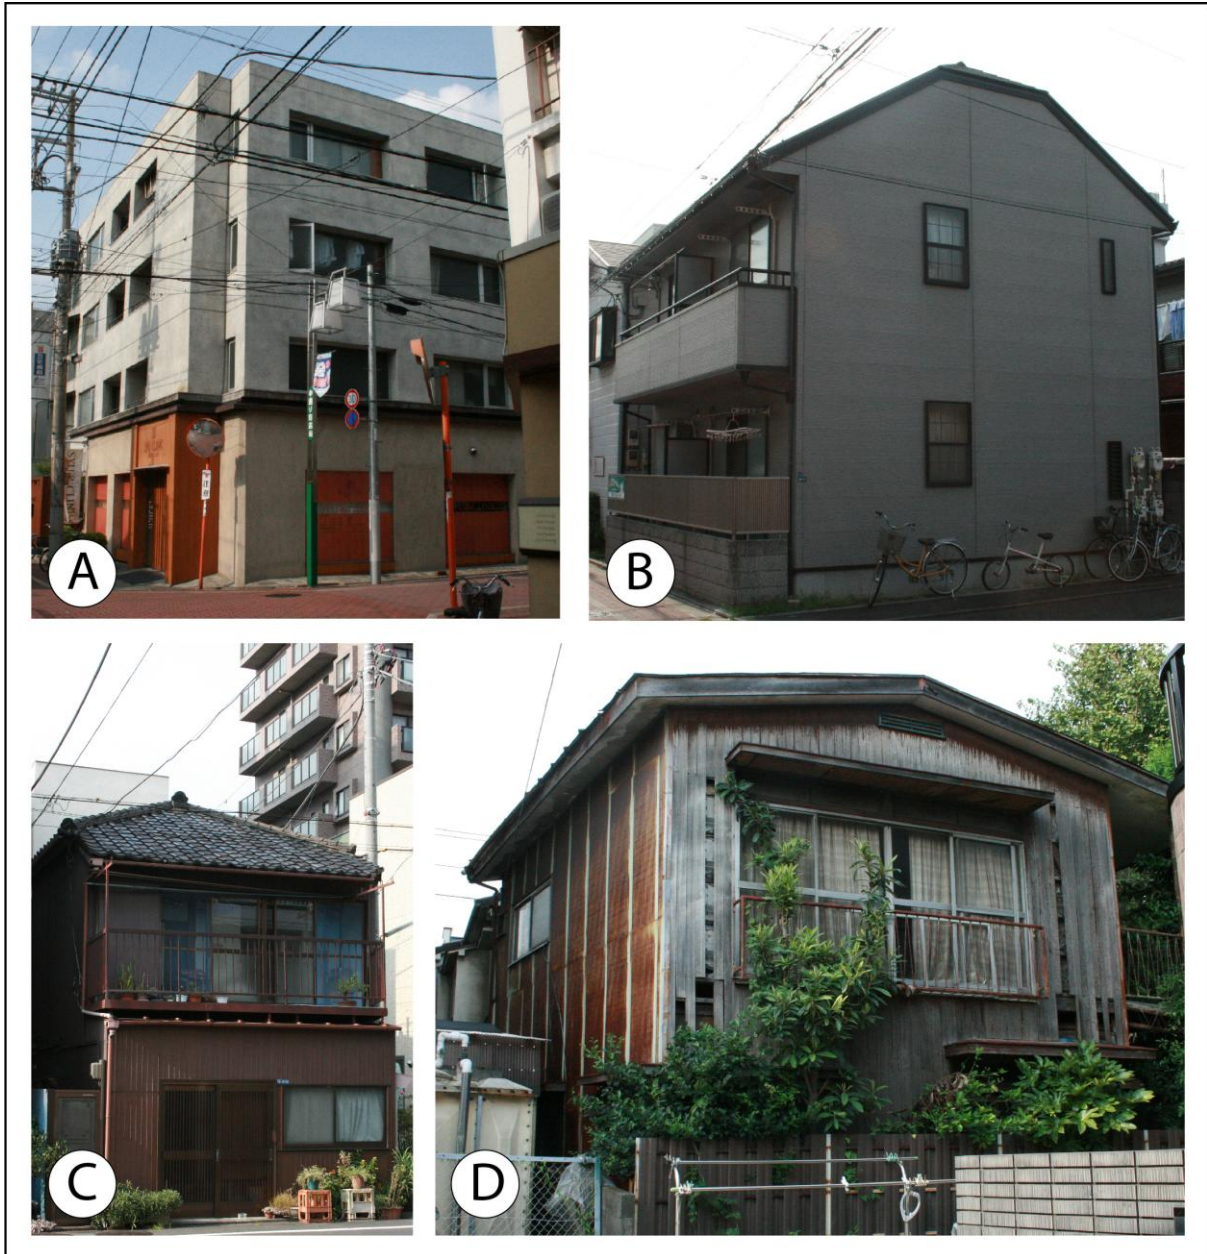
Fig. 9 Buildings' external walls: (A) Concrete building; (B) Wood panels covered by plastic sheets; (C) Aluminium sheets; (D) Traditional wood boards. (Photos: C. Gomez, 2007)
