GIS Evaluation of the Impacts on the Built and the 'Natural' Environment of the 11 March 2011 Tsunami in Rikuzentakata, Iwate Prefecture, Japan

GIS Evaluation of the Impacts on the Built and the ‘Natural’ Environment of the 11 March 2011 Tsunami in Rikuzentakata, Iwate Prefecture, Japan

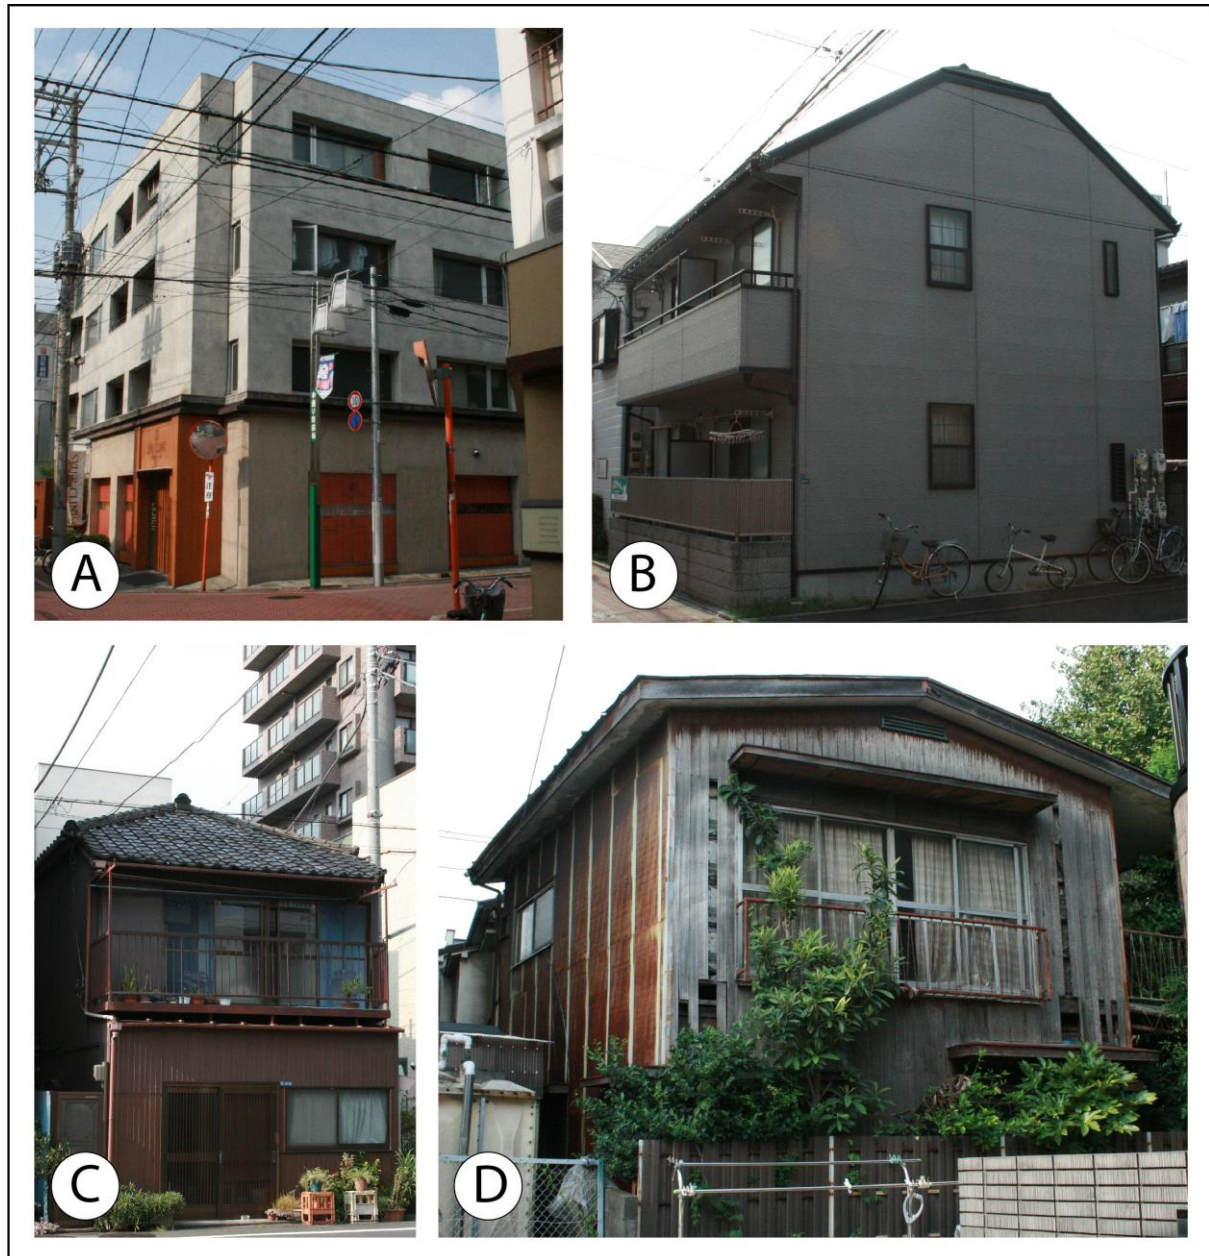
Fig. 9 Buildings' external walls: (A) Concrete building; (B) Wood panels covered by plastic sheets; (C) Aluminium sheets; (D) Traditional wood boards. (Photos: C. Gomez, 2007)
