Compressive Failure of UD-CFRP Containing Void Defects: In situ SEM Microanalysis

Julia Hapke^{*,a}, F. Gehrig^b, N. Huber^a, K. Schulte^b, and E.T. Lilleodden^a

Abstract

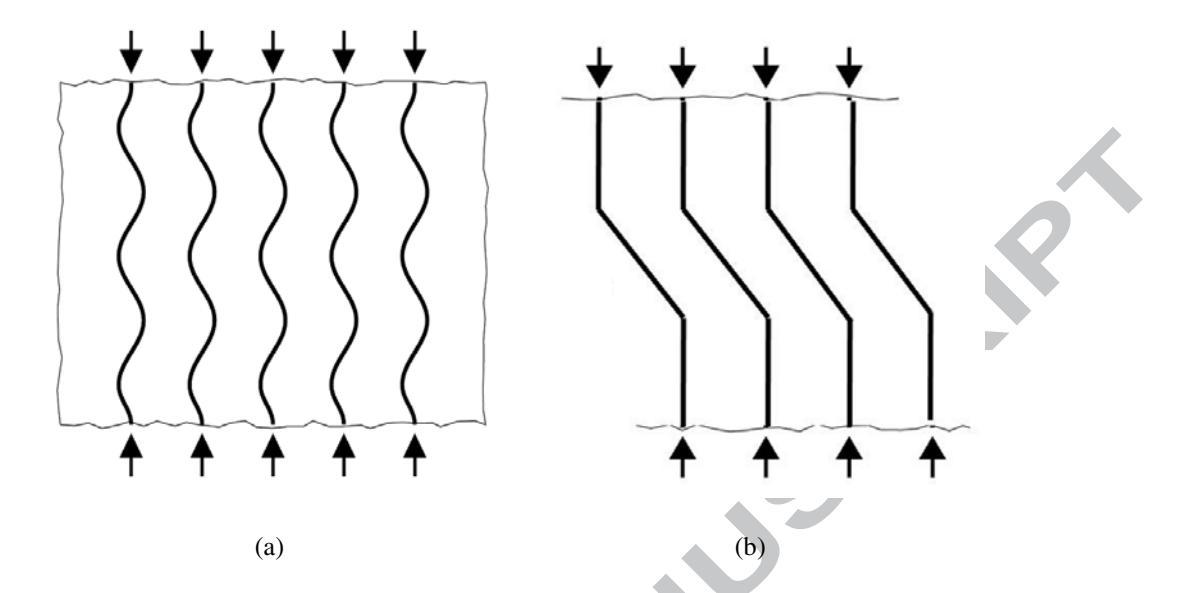
Figure 1: Schematics of the two major deformation modes proposed for fibre composite materials: In (a), deformation is accommodated by in-phase microbuckling of the fibres as predicted by Rosen [4], (b) shows a direct fibre deflection into a kinked shape according to Argon [10]

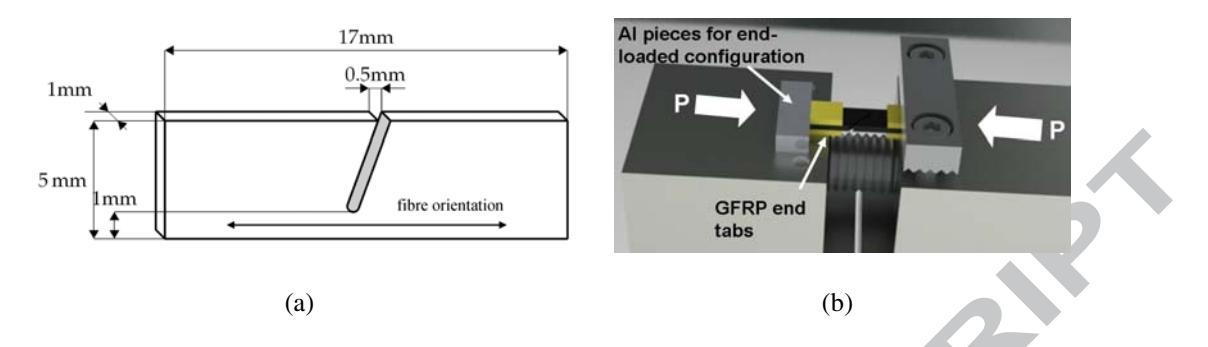
Figure 2: (a) Final geometry of the test specimens including a notch introduced as stress riser to locate failure area; (b) Loading configuration for testing with pieces of Al used to establish a mainly end-loaded configuration, GFRP-tabs are attached to the specimen's ends to increase the contact area and to reduce friction.
