Experimental Simulation of the Paks-2 Cleaning Tank Incident Through Separate Effect and Integral Tests

Z. Hózer^{*}, M. Horváth, M. Kunstár, L. Matus, I. Nagy, T. Novotny, E. Perez-Feró, A.
Pintér-Csordás, N. Vér, A. Vimi, P. Windberg

ABSTRACT

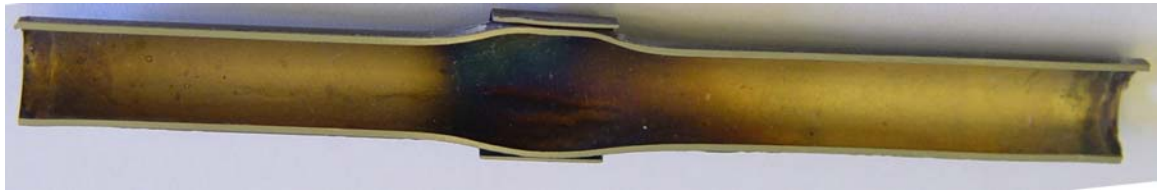
Hózer, Fig. 3.

Fig. 3. Cross section of ballooned tube

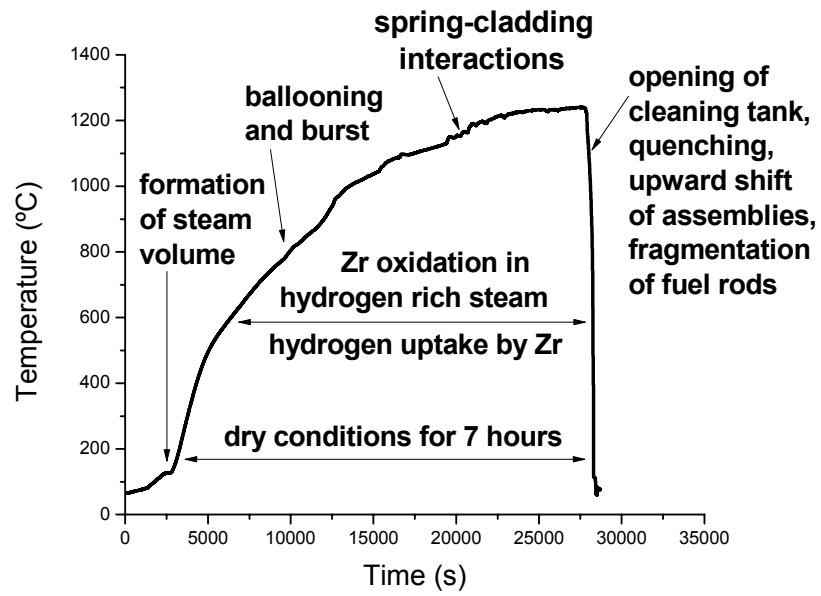
Hózer, Fig. 16.

The CODEX-CT integral tests simulated the main events of the Paks-2 incident, but the investigation of some special phenomena needed special separate effect tests. The sequence of fuel behaviour related events could be deduced considering both integral and separate effect tests. Fig. 16 shows the temperature history curve of CODEX-CT-1 test with the indication of the temperature ranges for several events and processes.

Fig. 16. Probable sequence of events in the Paks-2 incident
